Tree Inventory & Protection Plan

Prepared for: Byron Equities

1 Rosetta Street. Georgetown, ON. L7G 3P1

March 11, 2021

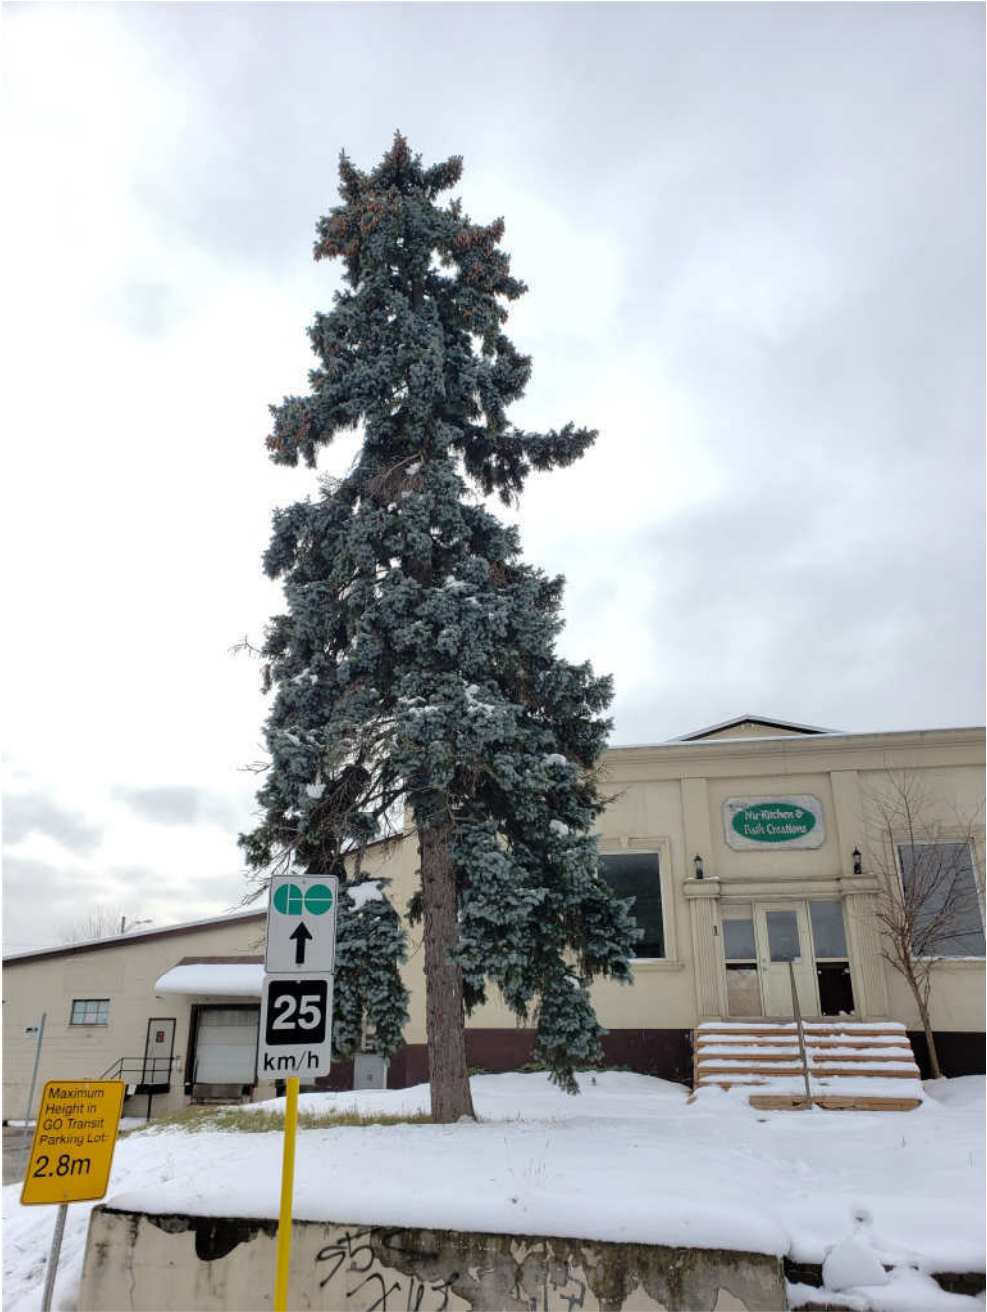
Tree 662

Tag #	Common Name	Botanical Name	Diameter at Breast Height (cm)								Crown Radius (m)	Health Condition	Structural Condition	Notes	Recommendations Based on Site Plan	Minimum TPZ (m)	Proposed TPZ (m)	Replacement Ratio
656	Colorado Spruce	Picea pungens	32									2.5	Average	Average		2.4	-	-
657	Sweet Cherry	Prunus avium	28									3.5	Average	Average	Co-dominant	1.8	-	-
658	Manitoba Maple	Acer negundo	22	x	20	x	15	x	20			4	Poor	Poor	Grown from stump of previously failed tree	1.8	-	-
659	Black Locust	Robinia pseudoacacia	68	x	40							5	Average/Poor	Average/Poor	Co-dominant, some breakage and some deadwood	4.2	-	-
660	Norway Maple	Acer platanoides	54									5	Average	Average		3.6	-	-
661	Manitoba Maple	Acer negundo	28	x	16	x	14					3	Average	Poor	Leaning heavy north, growing out of side of building	1.8	-	-
662	Norway Maple	Acer platanoides	10	x	9							1	Poor	Poor	Been hit over by a car, leaning heavy	1.2	-	-

Tag #	Common Name	Botanical Name	Diameter at Breast Height (cm)	Crown Radius (m)	Health Condition	Structural Condition	Notes	Recommendations Based on Site Plan	Minimum TPZ (m)	Proposed TPZ (m)	Replacement Ratio
656	Colorado Spruce	Picea pungens	32		Average	Average		Remove	2.4	-	-
657	Sweet Cherry	Prunus avium	28		Average	Average	Co-dominant	Remove	1.8	-	-
658	Manitoba Maple	Acer negundo	22	20	Poor	Poor	Grown from stump of previously failed tree	Remove	1.8	-	-
659	Black Locust	Robinia pseudoacacia	68	40	Average/Poor	Average/Poor	Co-dominant, some breakage and some deadwood	Remove	4.2	-	-
660	Norway Maple	Acer platanoides	54		Average	Average		Remove	3.6	-	-
661	Manitoba Maple	Acer negundo	28	16	Average	Poor	Leaning heavy north, growing out of side of building	Remove	1.8	-	-
662	Norway Maple	Acer platanoides	10	9	Poor	Poor	Been hit over by a car, leaning heavy	Remove	1.2	-	-
663	Colorado Spruce	Picea pungens	43		Average	Average		Remove	3	-	-
