CULTURAL HERITAGE IMPACT ASSESSMENT

PROPOSED MCGIBBON CONDOMINIUM PROJECT  
69 MAIN STREET SOUTH, 71-77 MAIN STREET SOUTH, 79 MAIN STREET SOUTH, AND 94-96 MILL STREET,  
FORMER ESQUESING TOWNSHIP, HALTON COUNTY  
COMMUNITY OF GEORGETOWN, TOWN OF HALTON HILLS, ONTARIO

ASI File: 15TS-266

February 2016

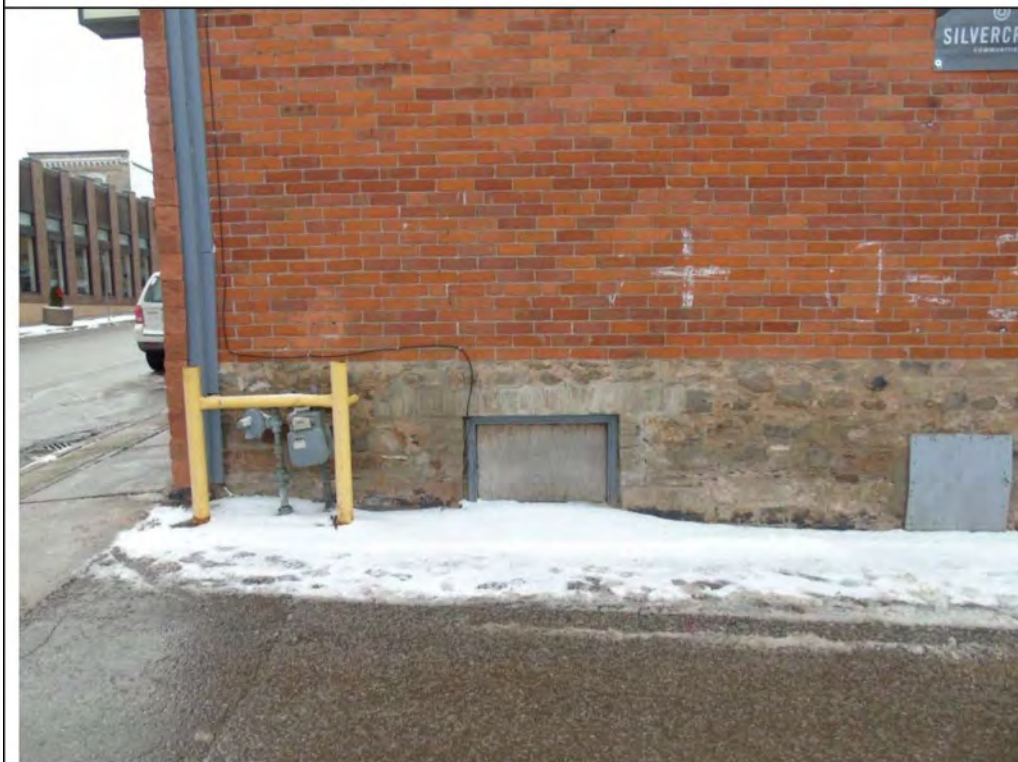
Plate 22: Detail of the brickwork and foundation on the east elevation of the structure at 94-96 Mill Street, looking west.

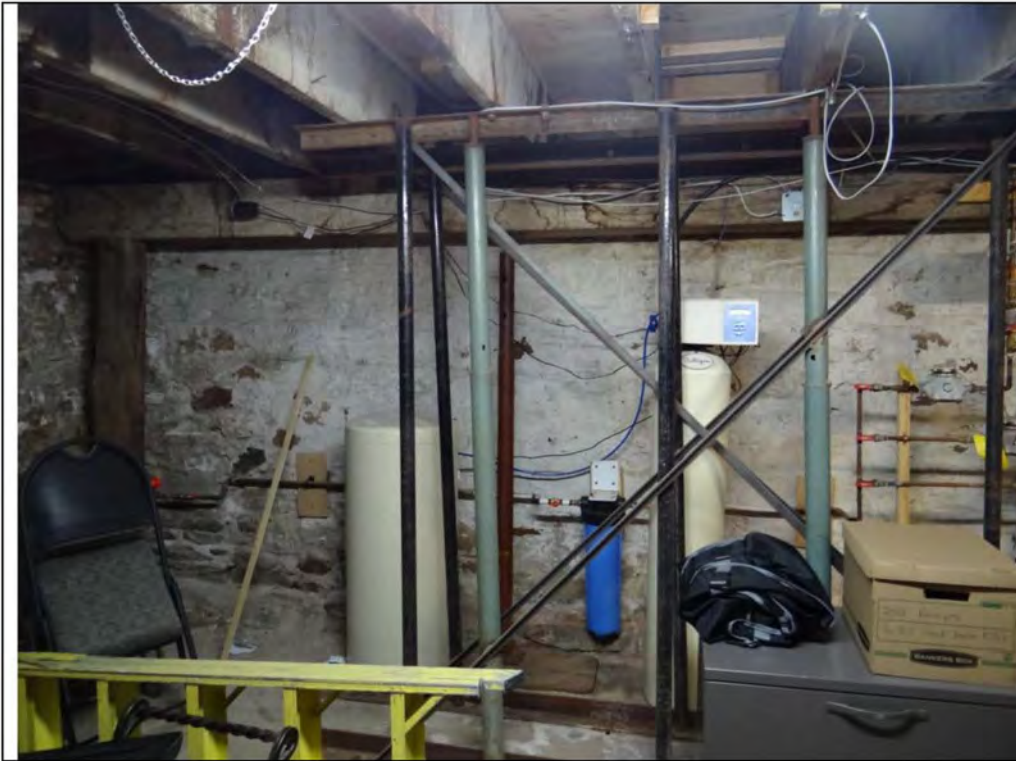
Plate 31: Detail of modern structural steel posts added to reinforce the main floor joists in the basement at 94-96 Mill Street.

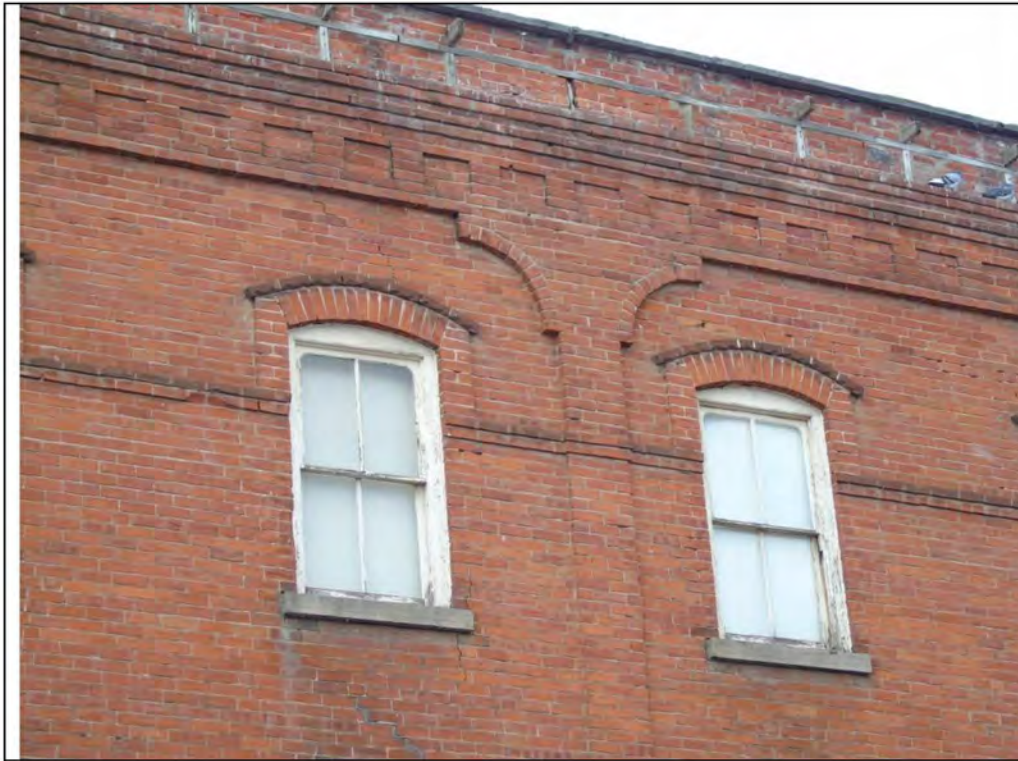
Plate 49: South elevation of 79 Main Street South, showing decorative brickwork, sash windows with segmental arches, and repairs to the roofline, looking northeast.

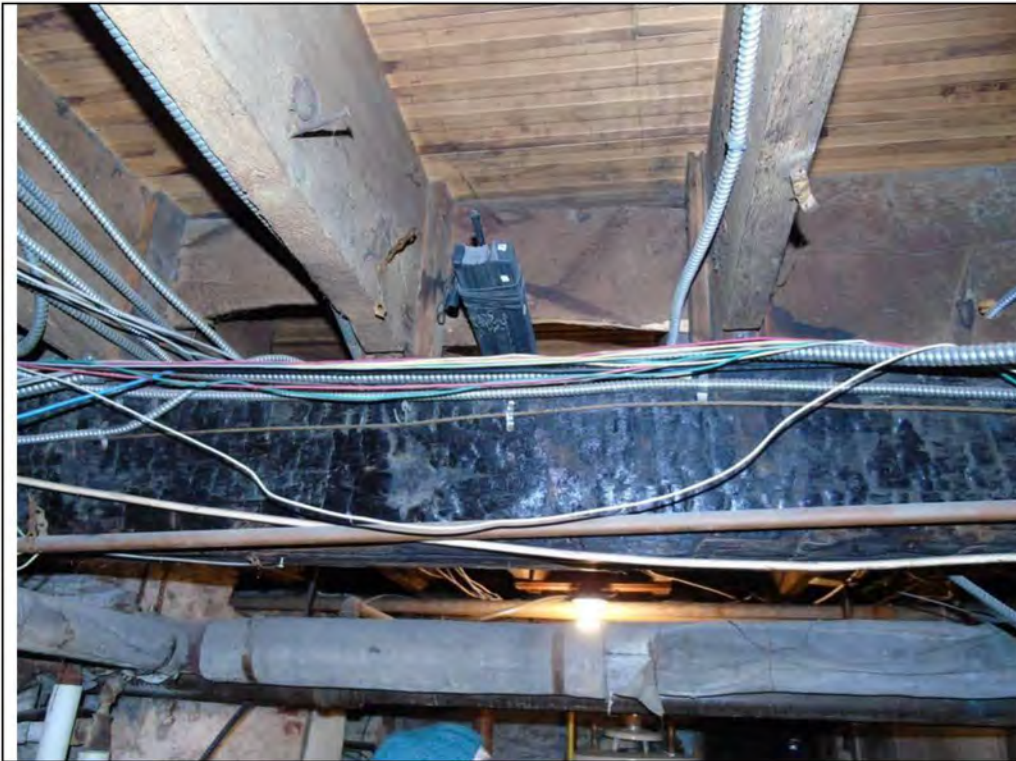
Plate 73:  
Basement of 79  
Main Street  
South, showing  
charred hewn  
wooden support  
beam, damaged  
by 1880s hotel  
fire.

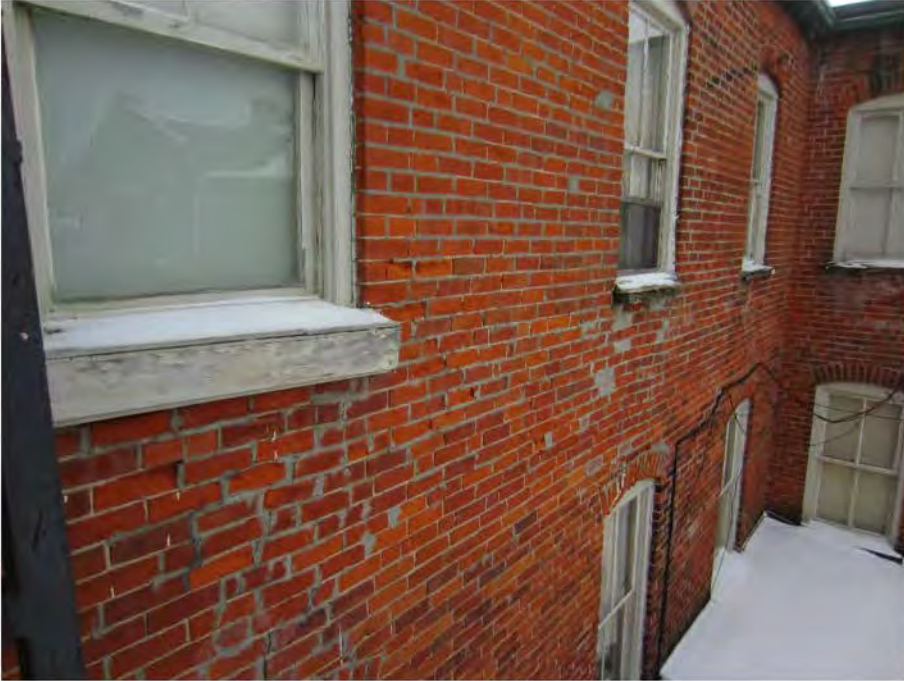
Photo #7: Visible cracks and repair on facade

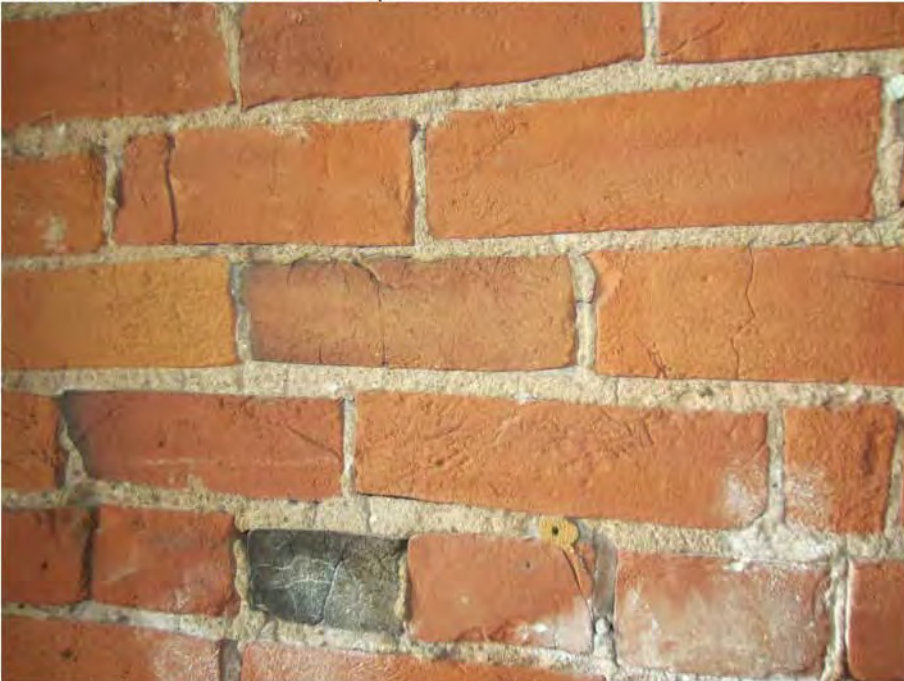
Photo #8: Visible cracks

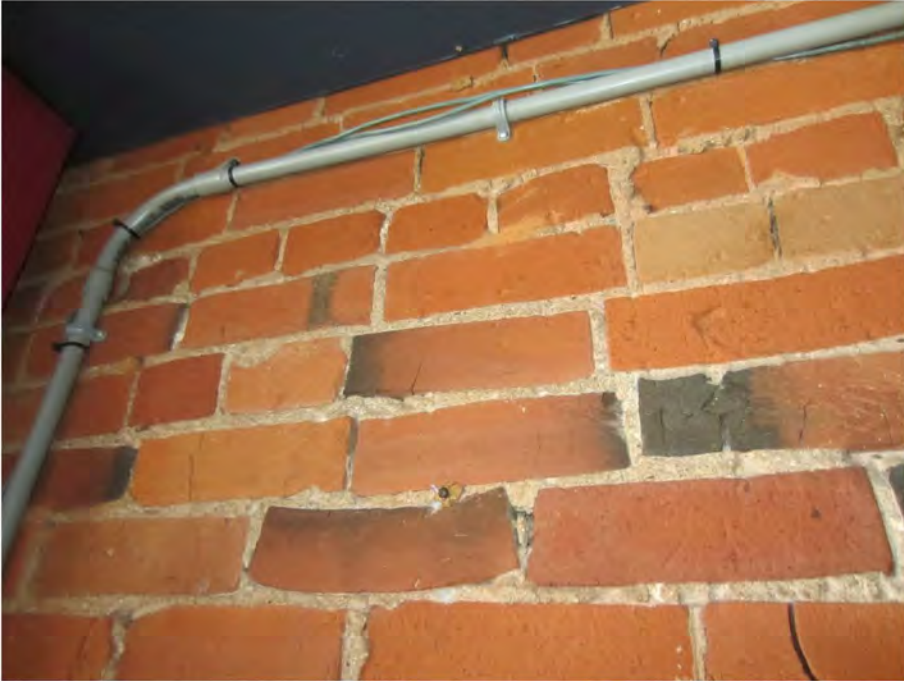
Photo #9: Visible cracks

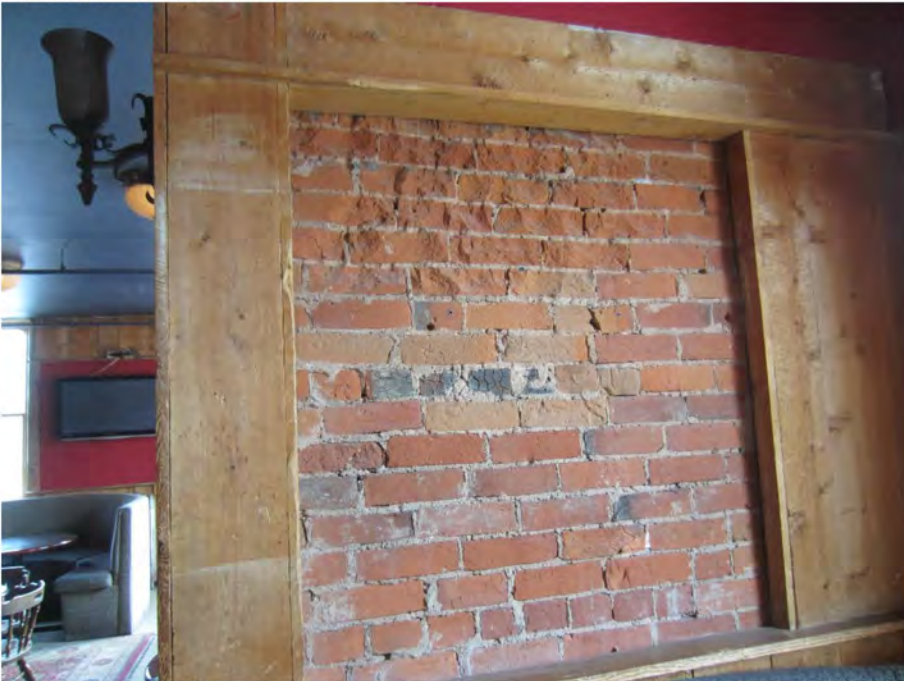
Photo #10: Visible cracks and spalling

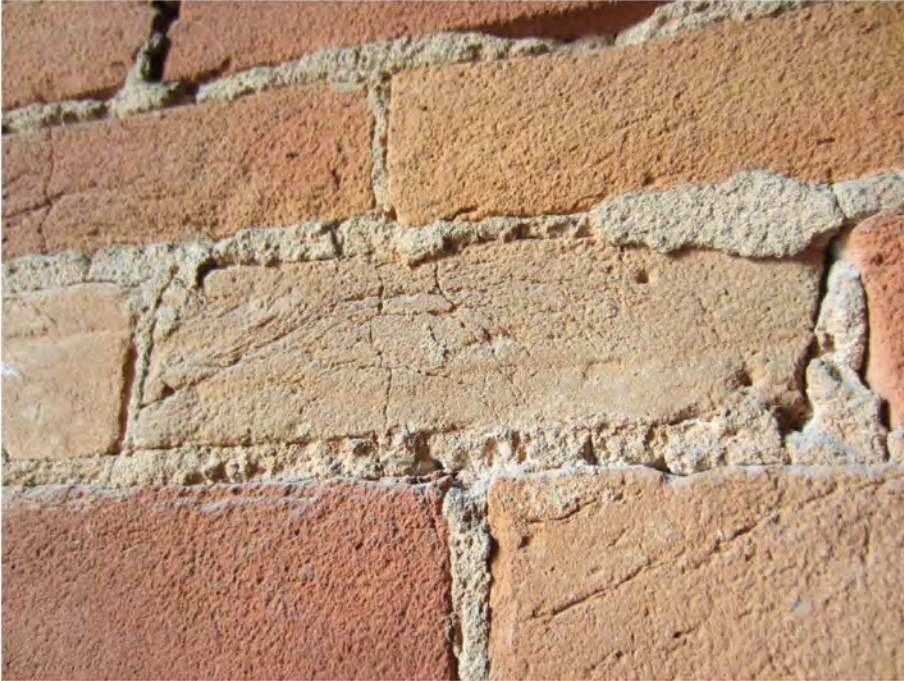
Photo #11: Visible cracks
