November 13, 2019

**Re: Glen Williams Subdivision – Confederation Street and Bishop Court
Tree Assessment Report**

Tree Assessment Sketch

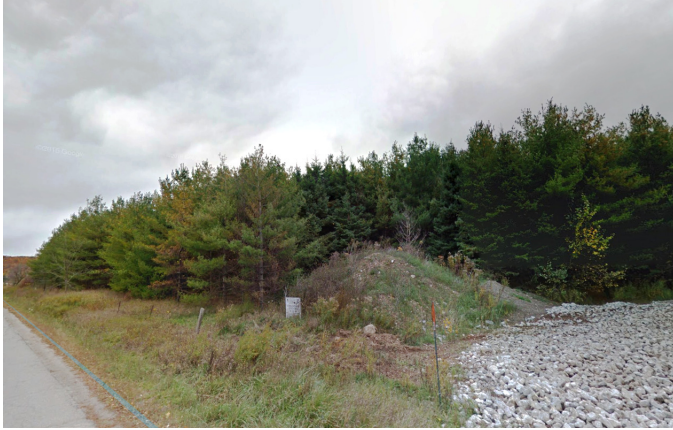
Image 1. View of west plantation looking northwest

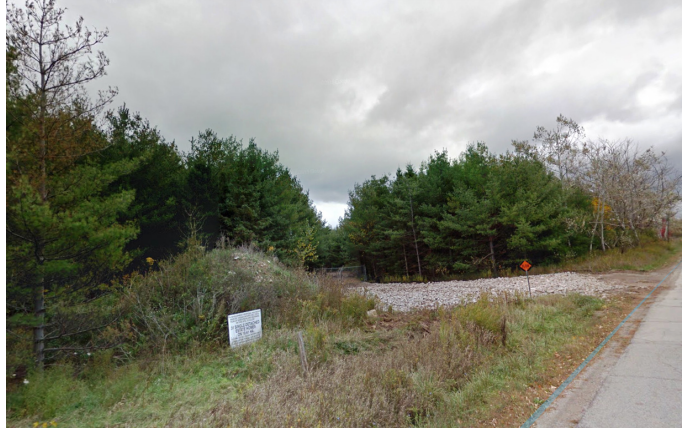
Image 2. View of west plantation looking south east

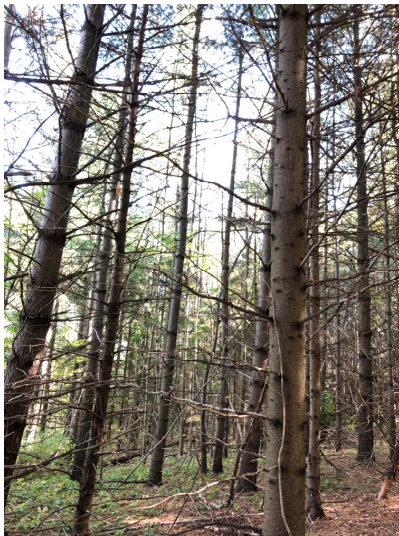
Image 3. Interior of west plantation

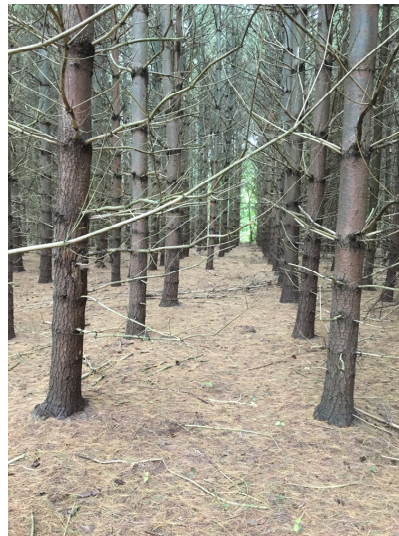
Image 4. Interior of west plantation

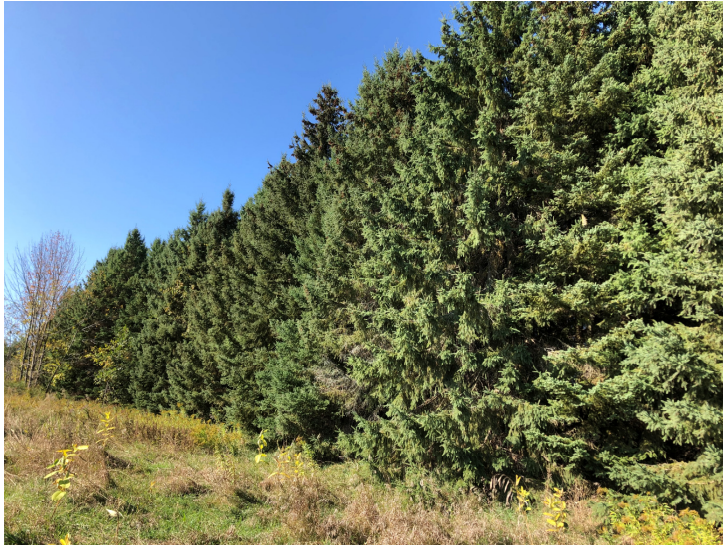
Image 5. Exterior of north plantation

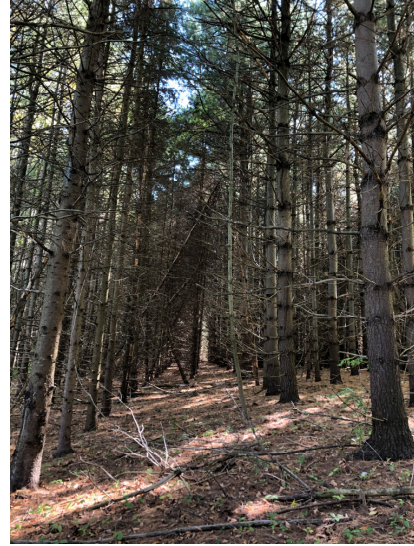
Image 6. Interior of north plantation

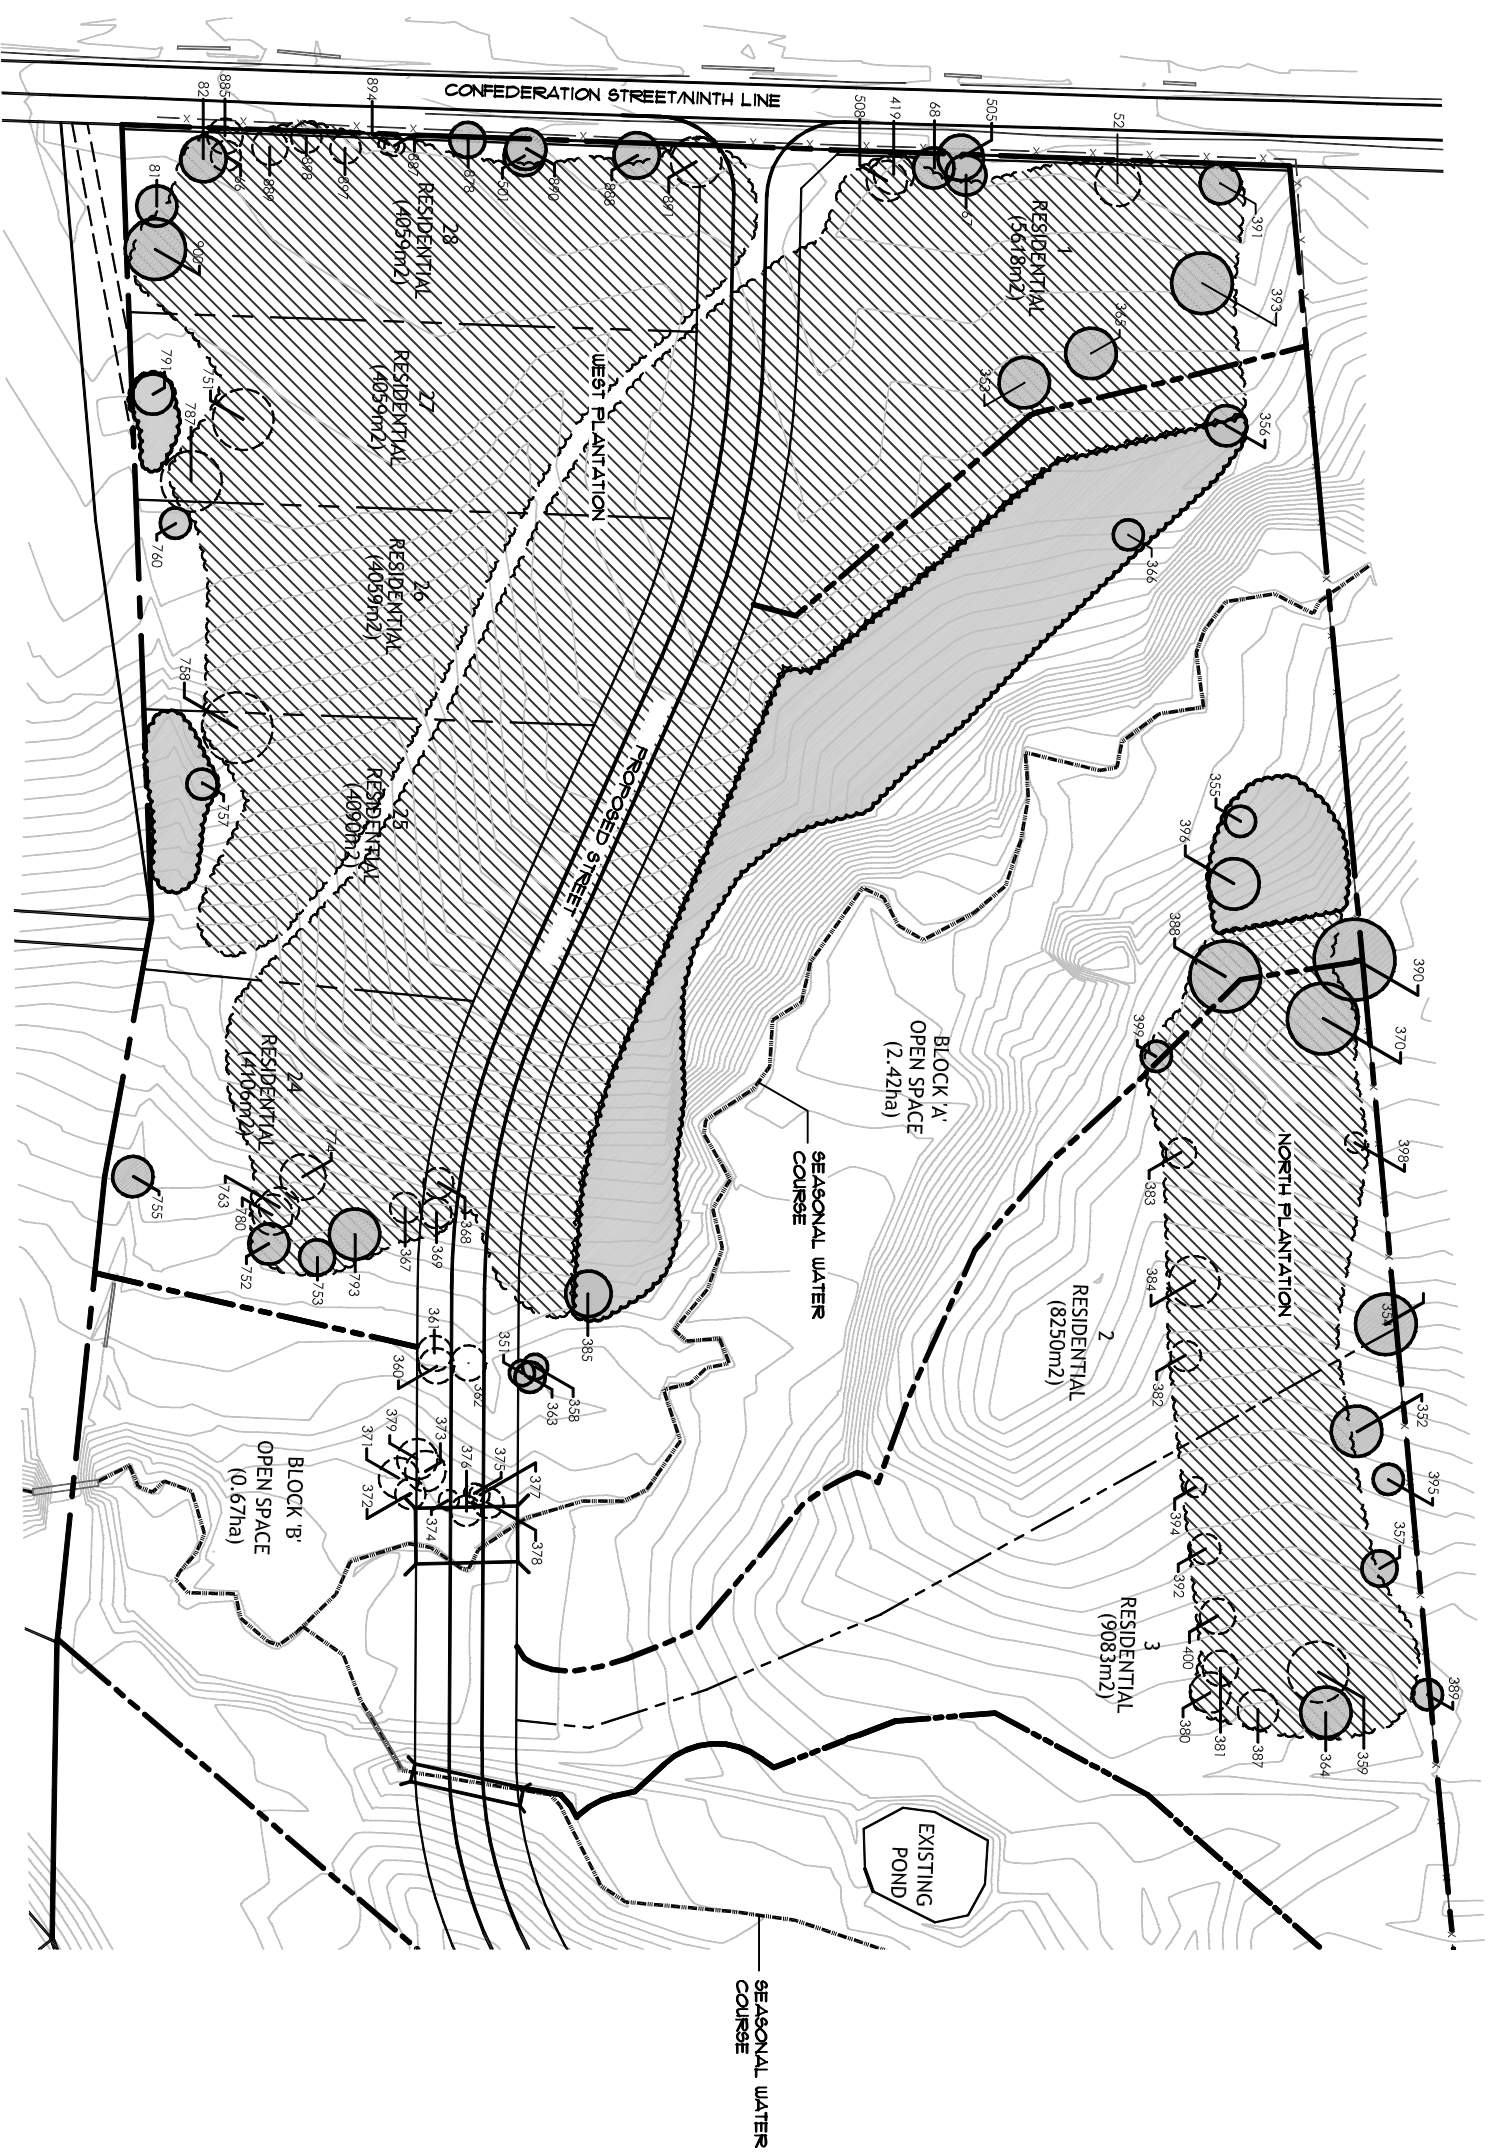
Of the trees deemed suitable for retention based on species and condition, Figure 1 illustrates those that can be potentially retained with the proposed draft plan development. It is also possible to preserve portions of the west and north plantations as sections occur in the open space block.

1. Preservation of the plantations as untouched natural features is not expected to be successful long term due to the current age, spacing and condition of the trees, lack of diversity in the species and corresponding risks of insect and disease infestation.
2. Preservation of certain trees described in Figure 1, as well as sections of the plantations that lie within the proposed open space block is possible with the proposed Draft Plan of Subdivision.
3. If preservation of portions of the plantation(s) is considered, areas to be cleared should include a buffer to residential lots, as the newly exposed interior trees will be at greater risk of failure.
