Appendix D

Fluvial Geomorphology

APPENDIX D-2
Headwater Drainage Feature Assessment Memo
June 3, 2016

Subject: Results of Headwater Drainage Feature Assessment for Premier Gateway Scoped Subwatershed Study

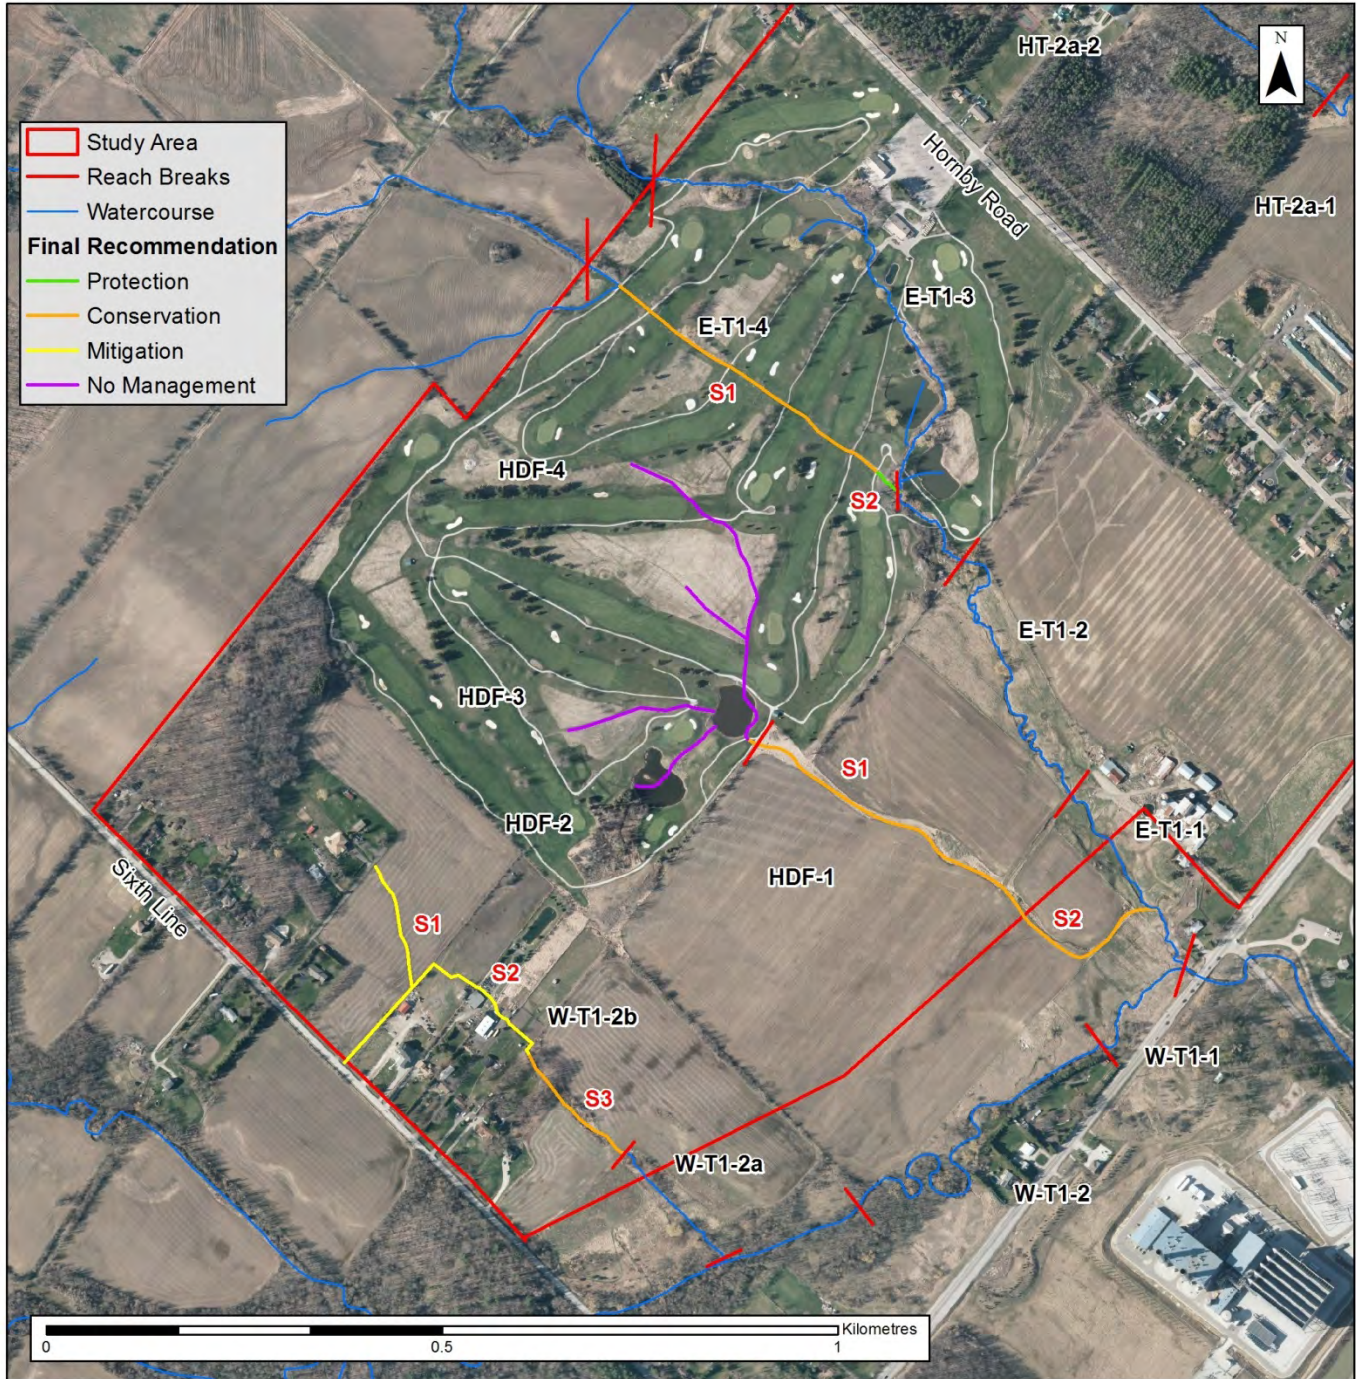
Figure 4 - Final Management Recommendations for HDFs in Western Portion of Study Area

Drainage mapping for W-T1-2b indicates that it should flow straight in a north-south direction. During Site Visit #1 it was noted that within Segment 1 (S1), the feature made a 90 degree turn at the property line and then drained toward Sixth Line as opposed to continuing southward (Photo 136, Appendix C). The drainage line has been modified to show this in the mapping (Appendix B). The connection between S1 and Segment 3 (S3) is unclear due to a lack of access to the properties on which Segment 2 is located. At the upstream end of S3, minimal surface flow was noted during Site Visit #1 (Photo 139, Appendix C). Modified drainage made it difficult to determine connectivity and drainage within this feature. Based on upstream (S1) and downstream (S3) conditions and review of aerial photography, the majority of S2 can be given a preliminary management recommendation of 'Mitigation' (Appendix A). Currently, the break between S2 and S3 coincides with the property boundary to indicate where the segment of W-T1-2b which could not be accessed (shown in Figure 3, Appendix B). The downstream end of S2 should be considered part of S3 due to consistent riparian vegetation (scrubland) and would therefore receive the recommendation of 'Conservation' (shown in Figure 4, Appendix B).

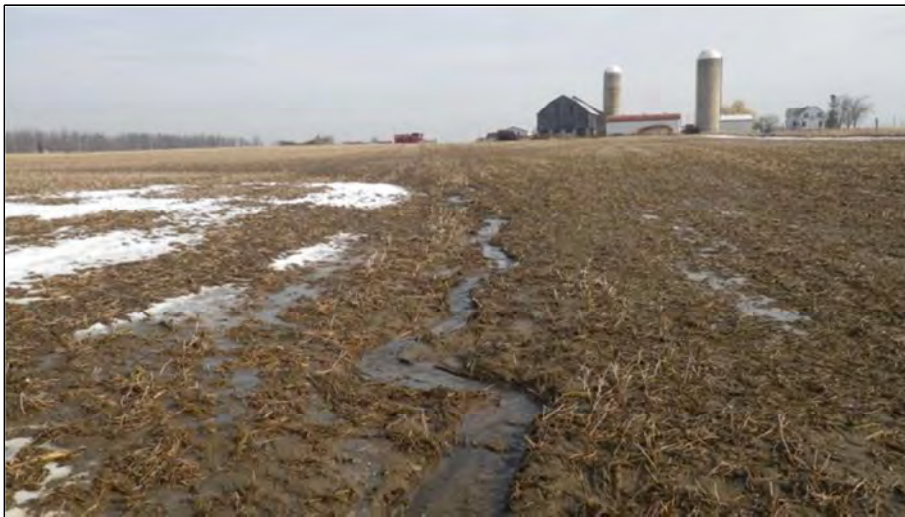
*Matrix Solutions Inc.
March 8, 2016 (Site Visit 1)*

2. **HT -2b -3b.** Mid -feature, facing upstream. Note defined flow path and some development of sinuosity. Feature type is swale and flow condition is surface flow minimal.

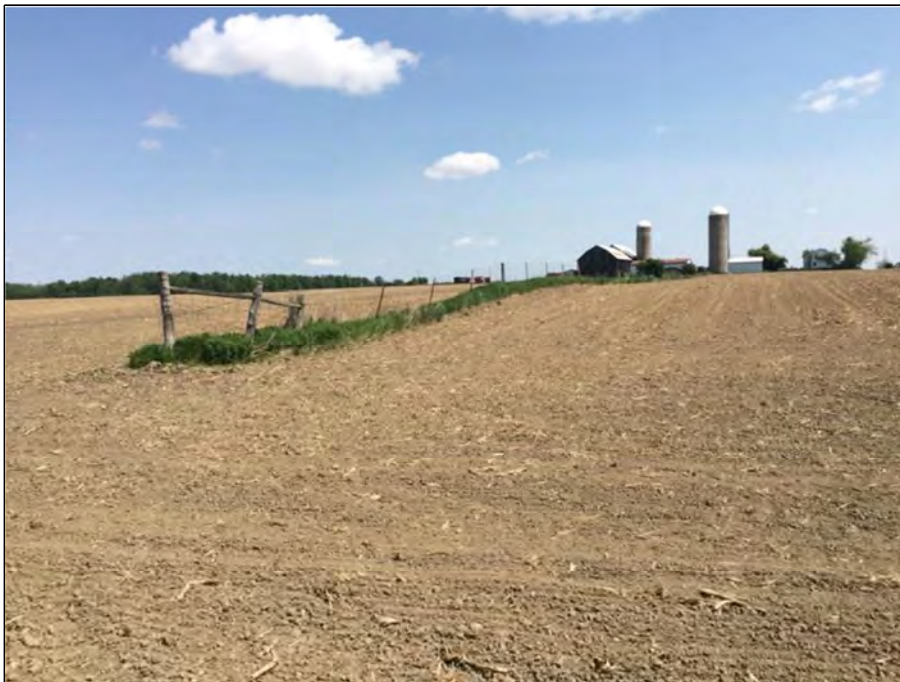
*Matrix Solutions Inc.
May 28, 2015 (Site Visit 2)*

10. **HT -2b -3a.** Facing upstream in vicinity of feature. No depression was visible. Flow condition was no surface water and feature type was swale. **Management Recommendation: No management required.**

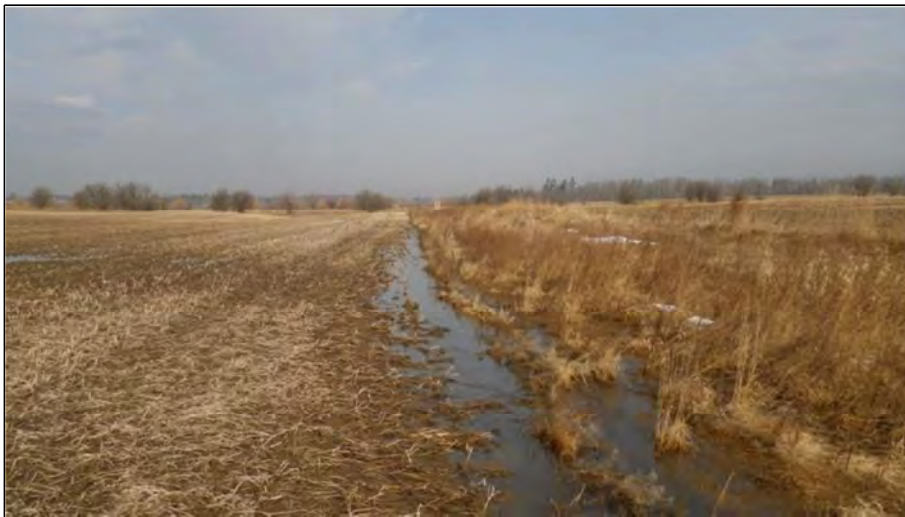
*Matrix Solutions Inc.
March 8, 2016 (Site Visit 1)*

12. HT -2b -3. Standing water adjacent to vegetated area and cropland, near upstream end. Feature type is no defined feature (overland flow only) and flow condition is surface flow minimal.

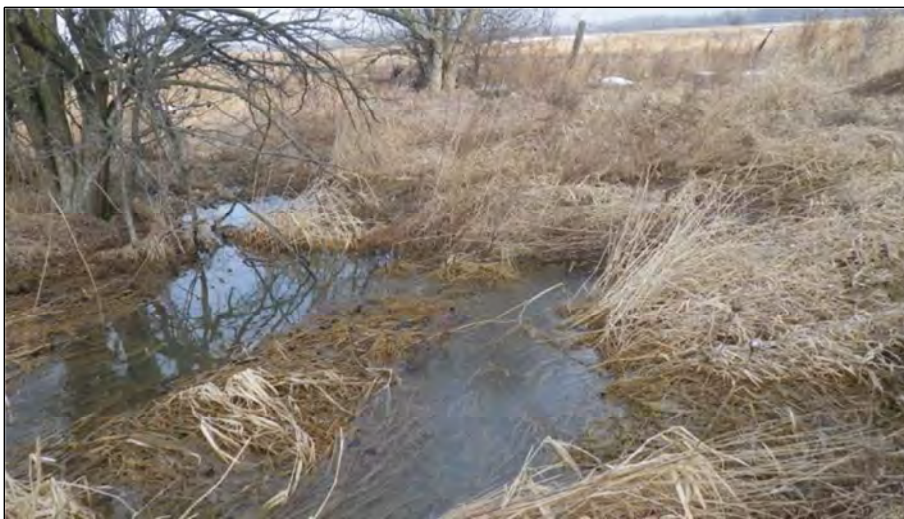
*Matrix Solutions Inc.
March 8, 2016 (Site Visit 1)*

20. **HT -2b -2 (Segment 1).** At upstream end of feature where water flows off agricultural fields upstream. Maximum water depth was at upstream end where water was pooling in several locations (max depth approx. 20cm). Feature type is multi -thread and flow condition is surface flow substantial.

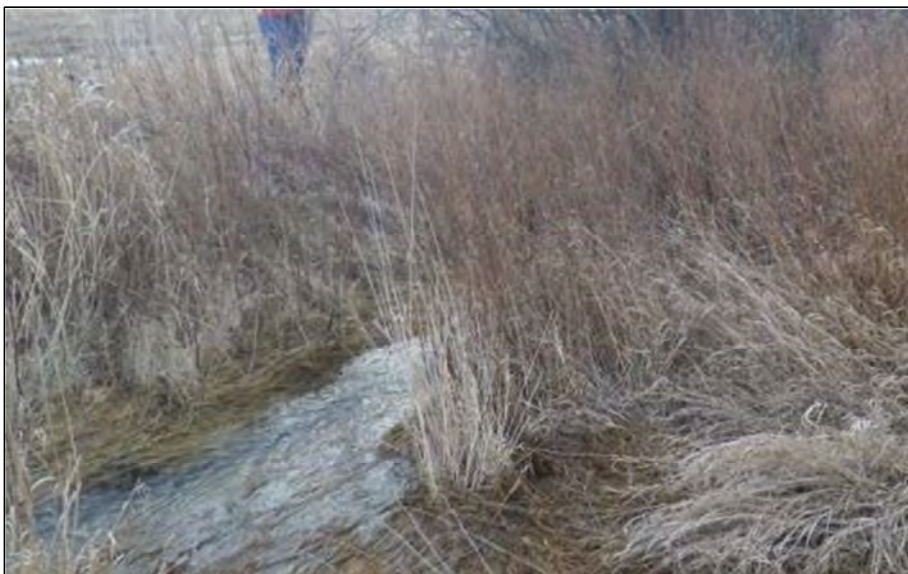
*Matrix Solutions Inc.
March 8, 2016 (Site Visit 1)*

28. HT -2b -2 (Segment 2). Facing downstream at end of Segment. Feature type is swale and flow condition is surface flow substantial.

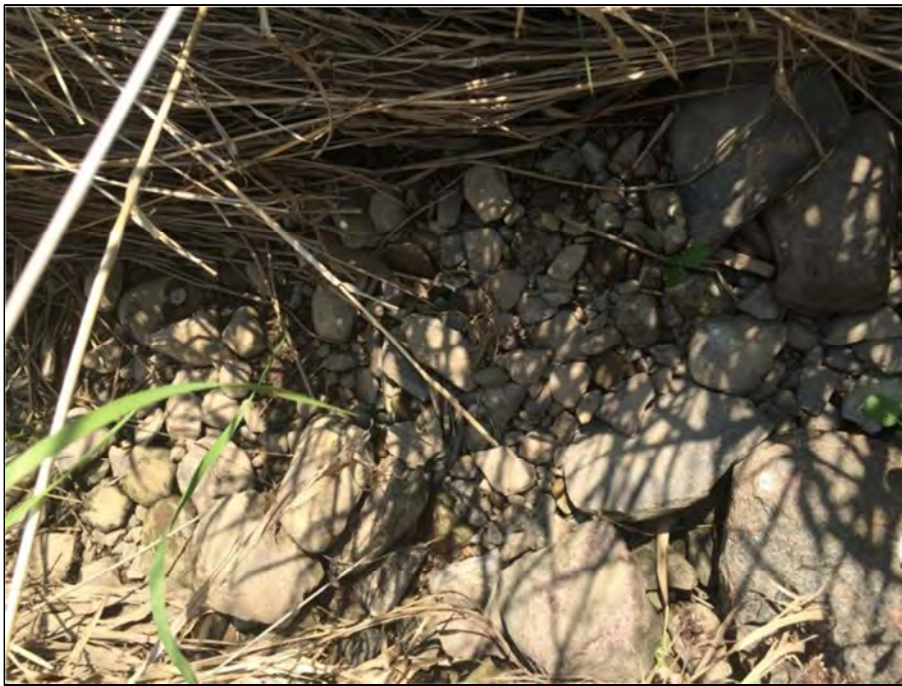
*Matrix Solutions Inc.
May 28, 2015 (Site Visit 2)*

38. HT -2b -2 (Segment 3). Gravel bed substrates within Segment 3. Feature type is defined natural channel (visible banks); flow condition is no surface water.

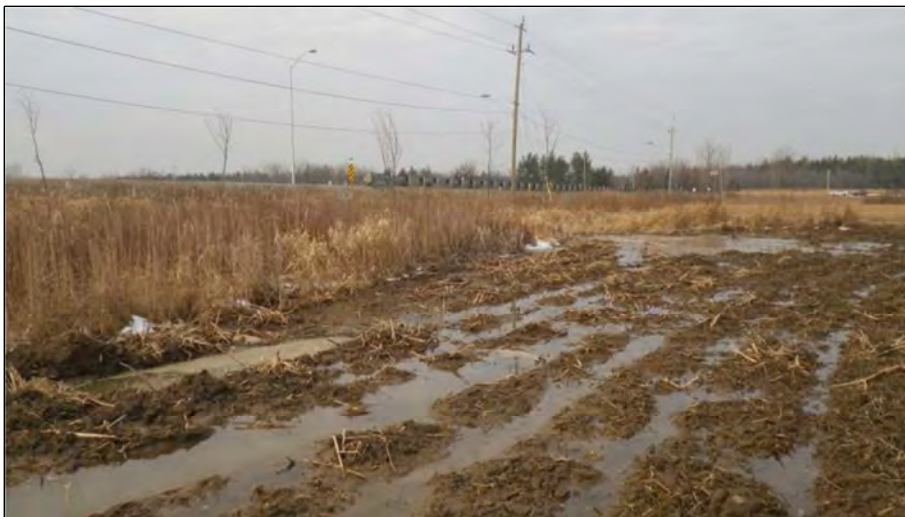
*Matrix Solutions Inc.
March 8, 2016 (Site Visit 1)*

46. HT -2b -4 (Segment 1). Facing downstream to large ponded area where water runs off the fields. Feature type is no defined feature (overland flow only); flow condition is standing water.

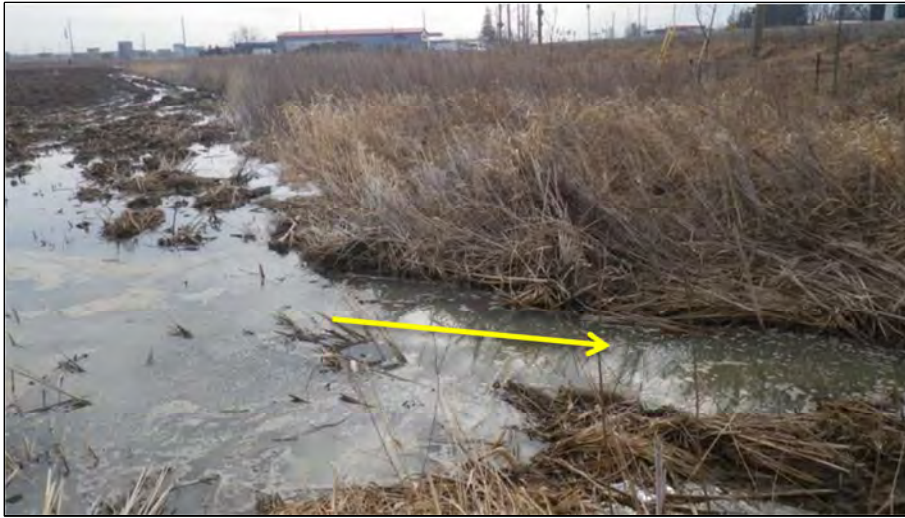
*Matrix Solutions Inc.
March 8, 2016 (Site Visit 1)*

47. HT -2b -4 (Segment 1). Facing upstream, ponded water draining off the fields toward roadside ditch. Feature type is no defined feature (overland flow only); flow condition standing water.

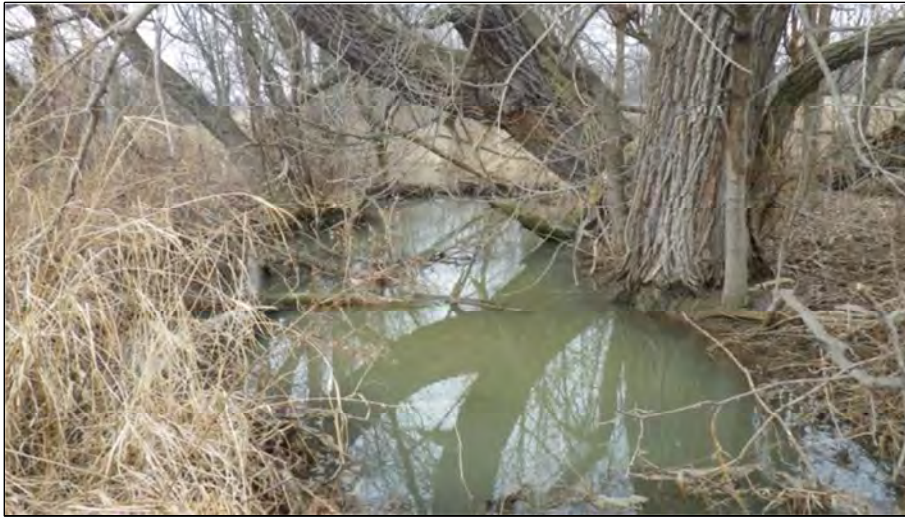
*Matrix Solutions Inc.
March 8, 2016 (Site Visit 1)*

65. E -T1 -4 (Segment 1). At upstream end of golf course facing upstream. Water is standing and pooled, approximately depth of 20 cm. Feature type is classified as tiled drainage (buried stream/pipe) because the feature is primarily piped through the extent of the golf course. Flow condition is surface flow substantial.

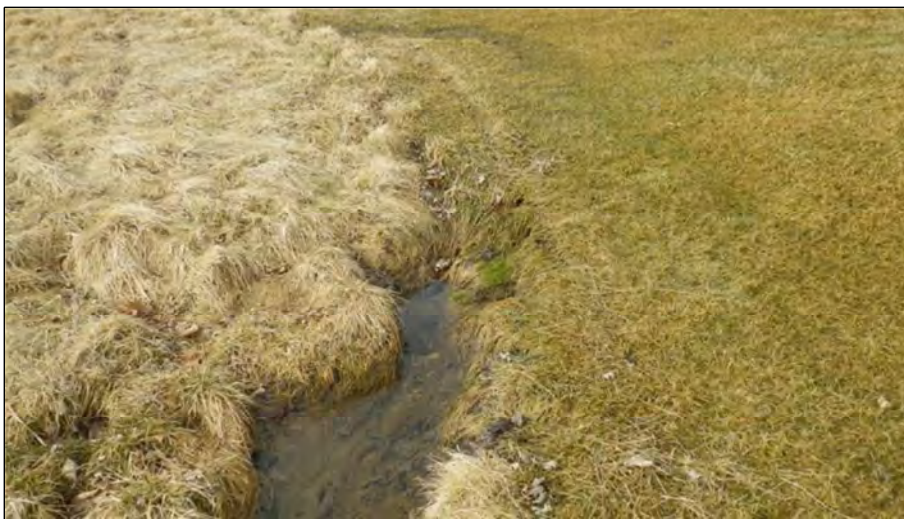
*Matrix Solutions Inc.
March 8, 2016 (Site Visit 1)*

90. HDF -4. At upstream end of feature where flow initiates. Feature type is swale and flow condition is surface flow minimal.
