Appendix F
Stream Morphology

APPENDIX A
Field Data Summaries

Project: Premier Gateway SWS: HT-1 Detailed Site

APPENDIX B
Field Photograph Summary

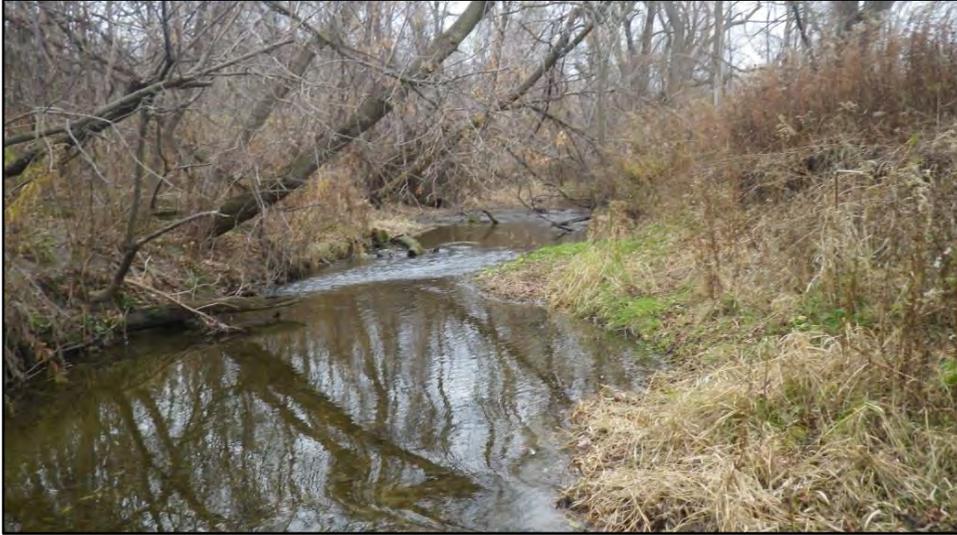
1. W-T1-3 Riffle and lateral bar formation along right bank

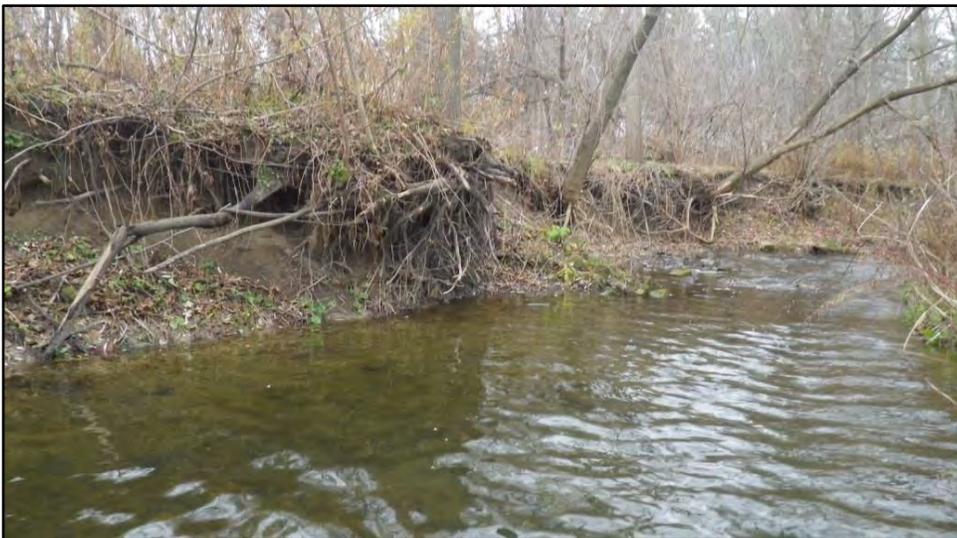
2. W-T1-3 erosion on bank causing leaning trees

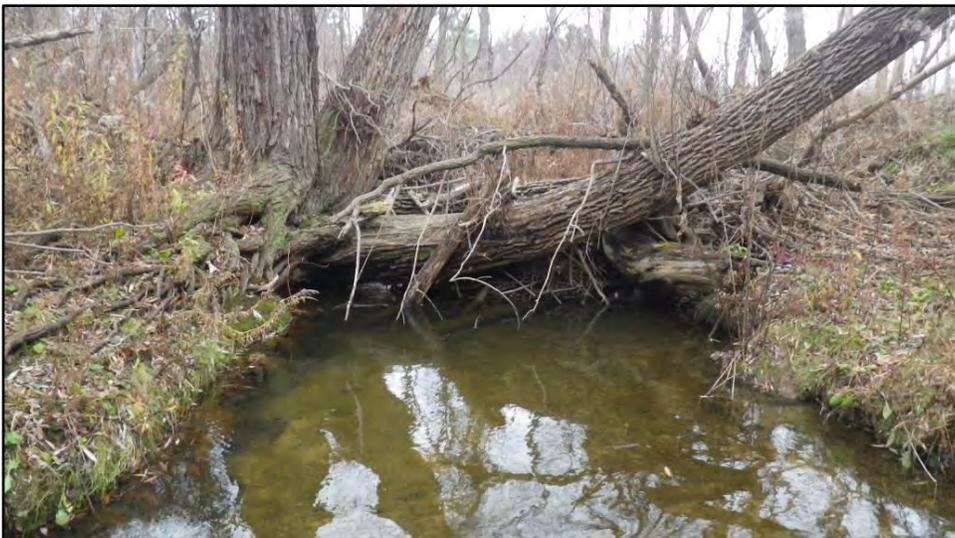
4. W-T1-3 Major woody debris jam at upstream end of reach

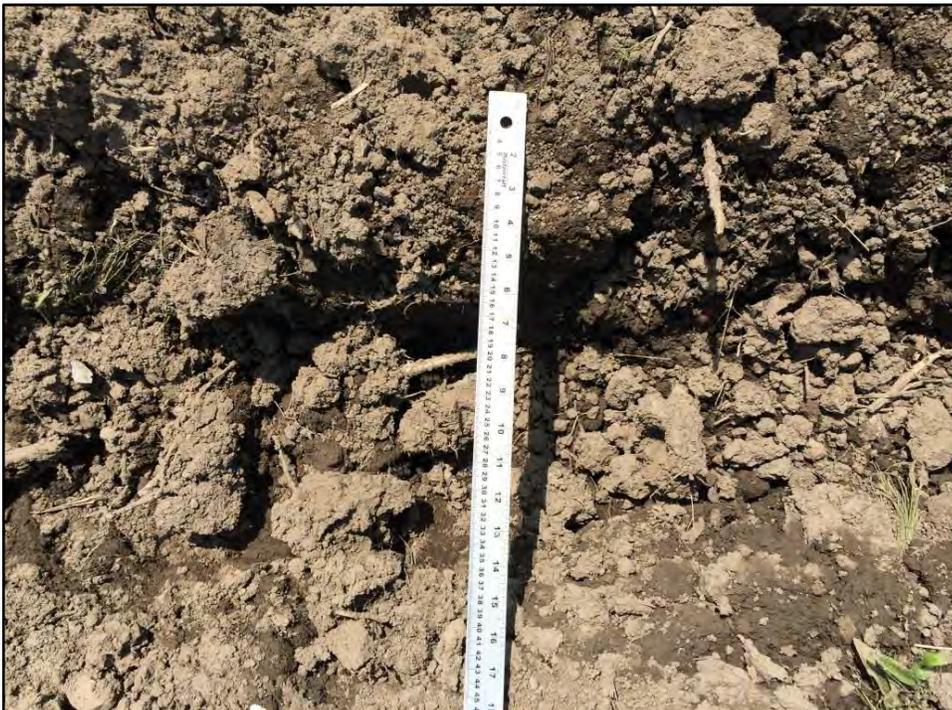
6. W-T1-2b width of channel (approximately 24cm) at far upstream end of reach.

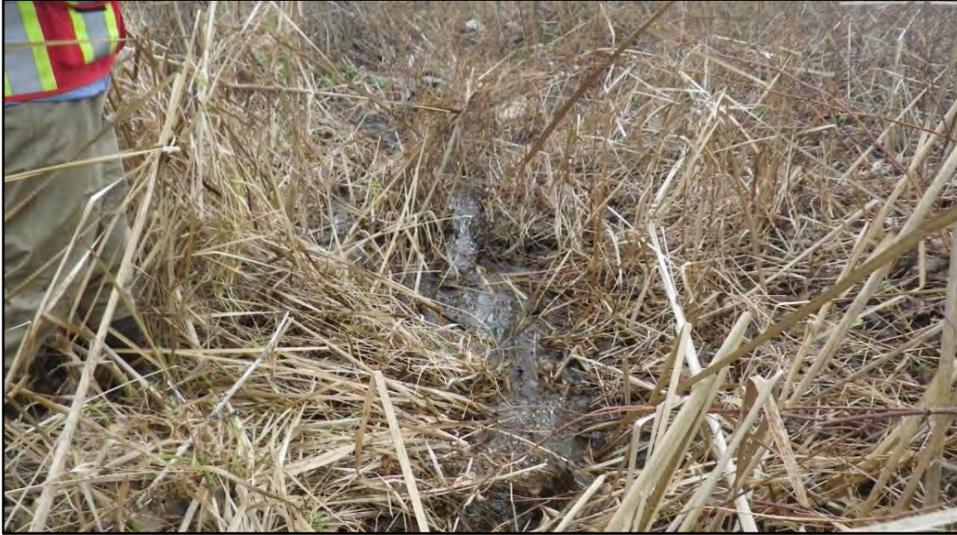
7. W-T1-2b facing downstream. Flow path through tall grasses at downstream end of reach.

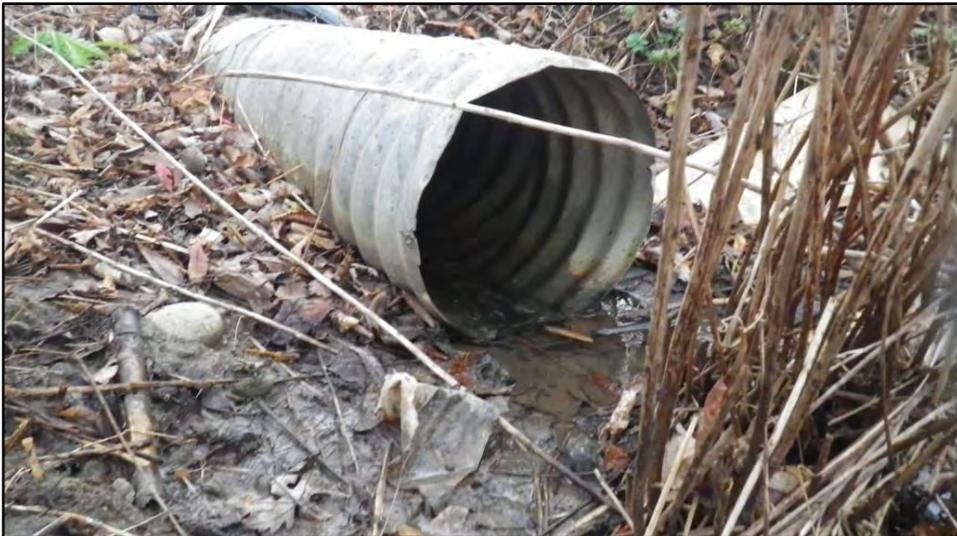
8. W-T1-2b facing downstream. Flow into CSP located under farm lane.

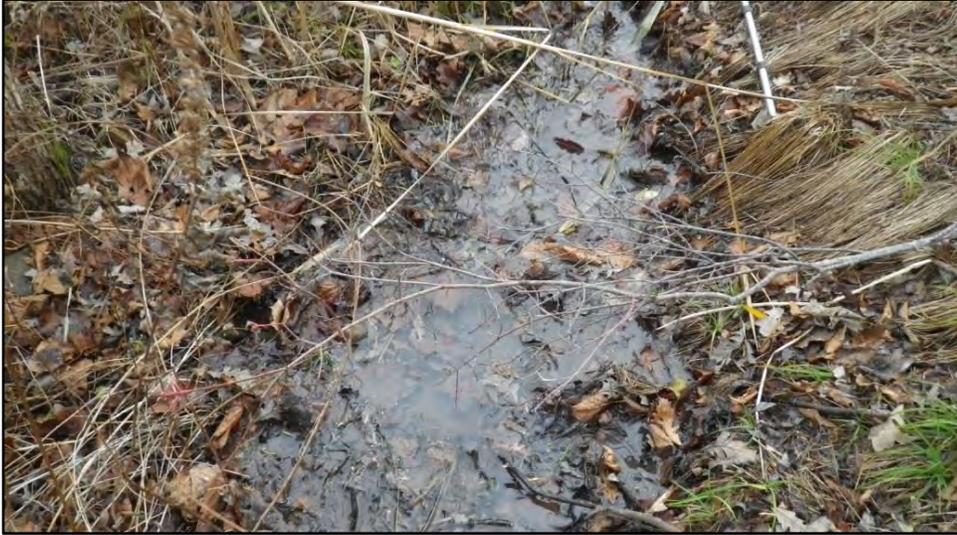
9. W-T1-2a Channel flowing out of phragmites patch which widens downstream.

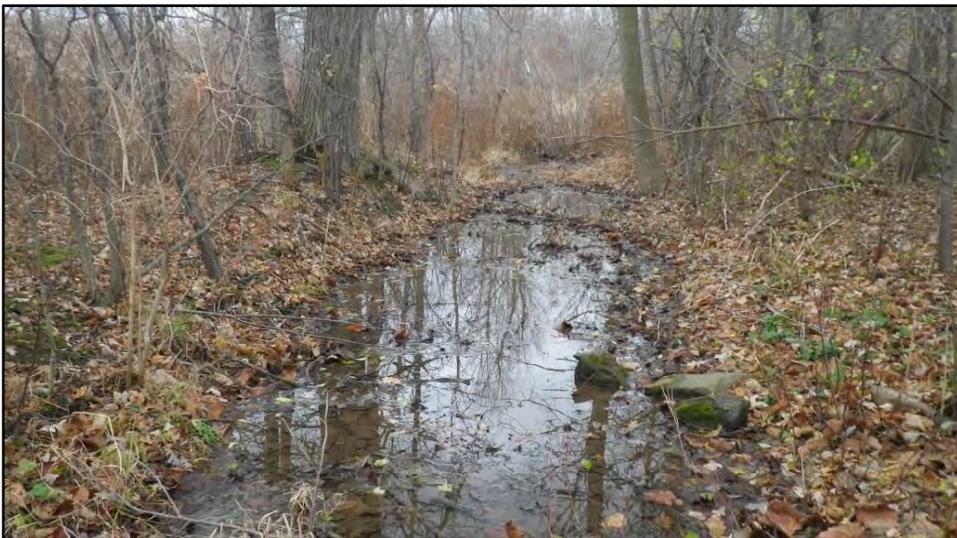
10. W-T1-2a facing downstream through treed section. Shallow wetted width and low banks.

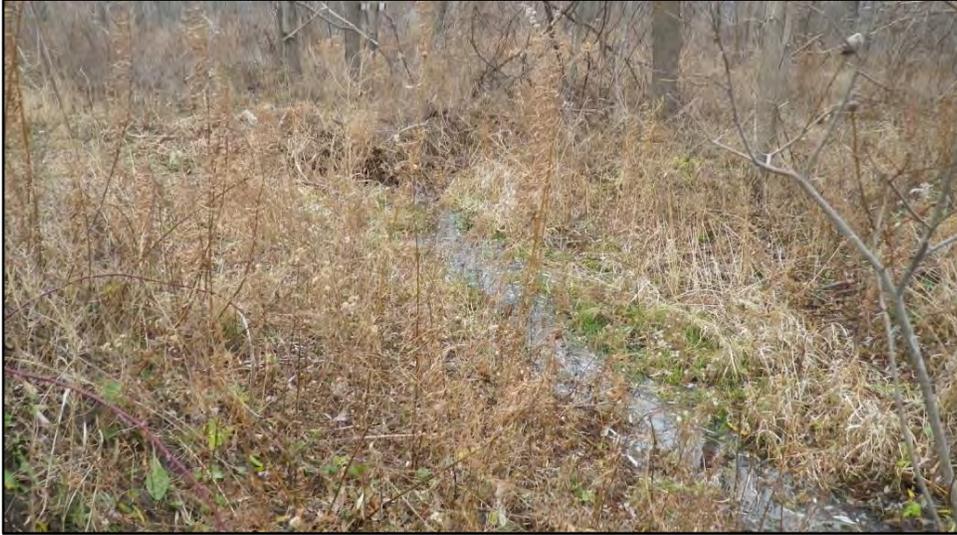
11. W-T1-2a facing downstream. Channel more narrow and less defined as it travels through grasses.

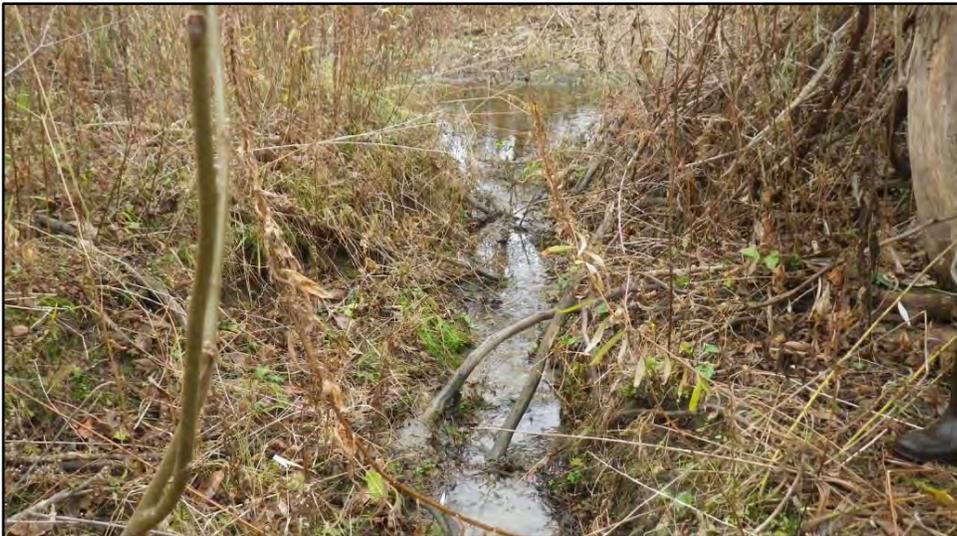
12. W-T1-2a facing downstream. Channel is very narrow at the confluence with the main channel.

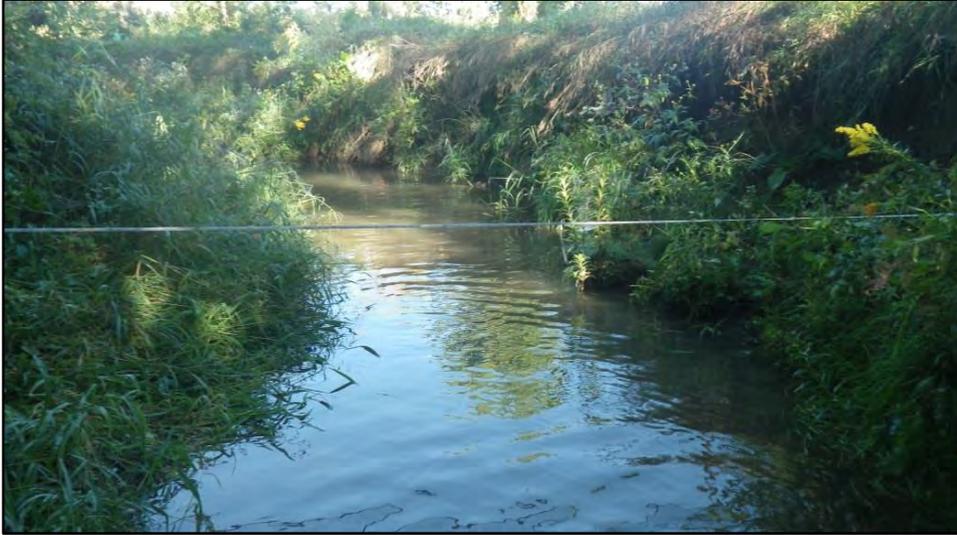
13. W-T1-2 Cross-section 1 facing upstream

LB is eroded with vertical banks
RB is low angled bank
xs is in end of meander bend
exposed clay along LB

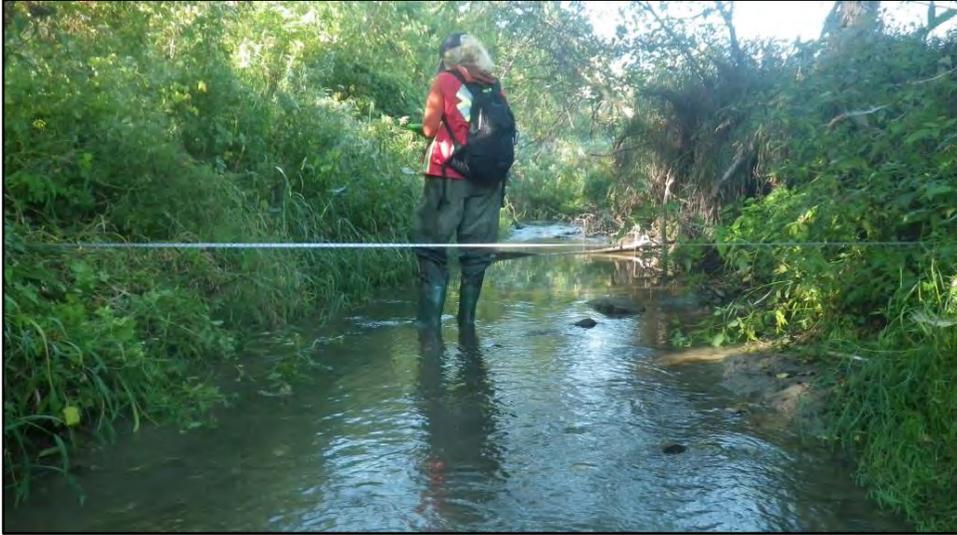
15. W-T1-2 Cross-section 2 facing upstream

exposed clay along LB
LB is eroded and vertical
RB is eroded at toe with lower bank angle
xs at apex of meander

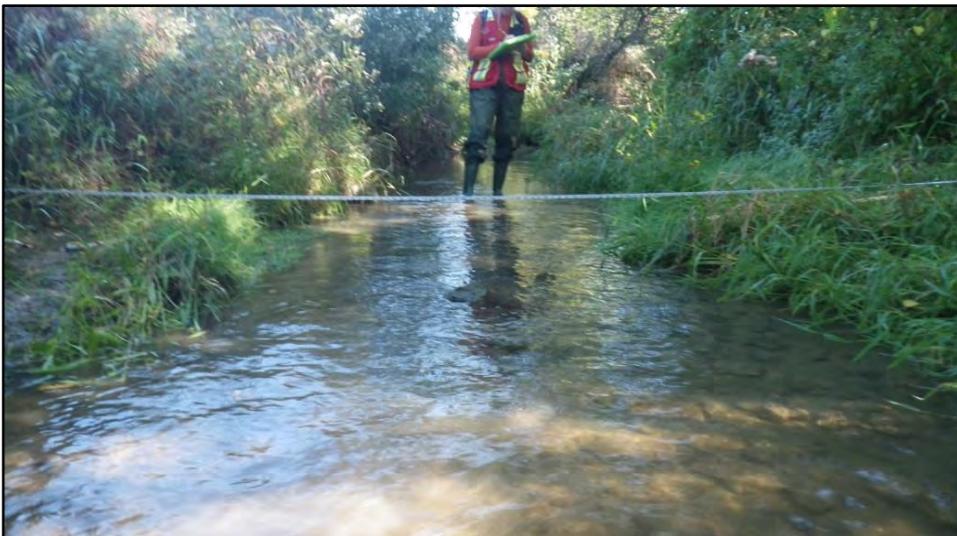
20. W-T1-2 Cross-section 4 facing downstream

LB has exposed clay along toe and bed
LB is vertical an slumped
RB has low bank angle

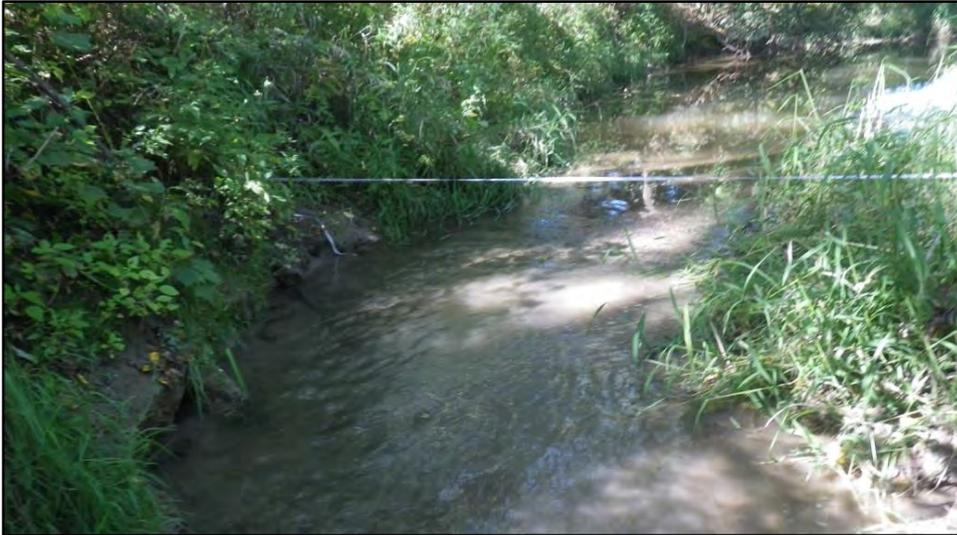
21. W-T1-2 Cross-section 5 facing upstream

RB is eroded with vertical banks and exposed clay
LB has low bank angle with a piont bar
channel widens into large pool 1m U/S

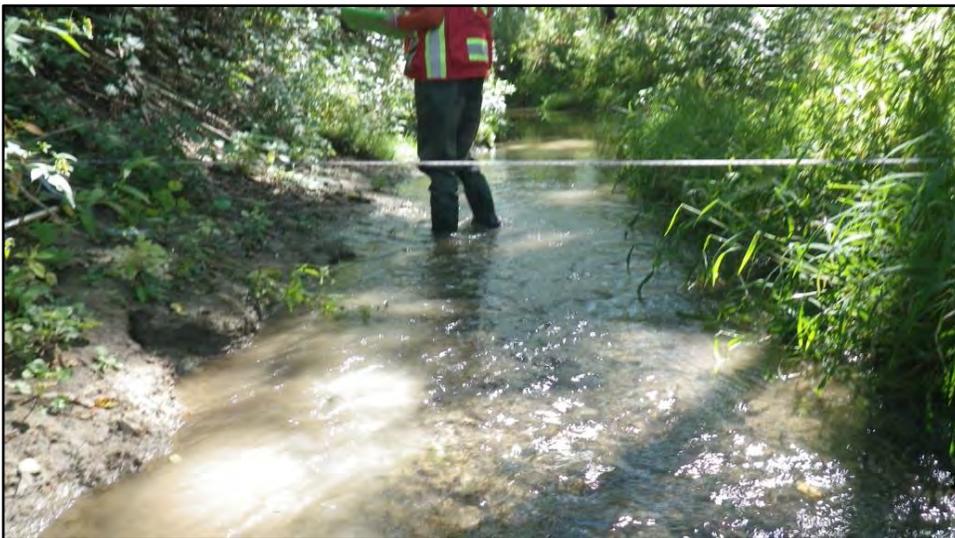
24. W-T1-2 Cross-section 6 facing downstream

RB has low bank angle
LB is eroded with vertical banks near the top of bank.
LB has exposed clay

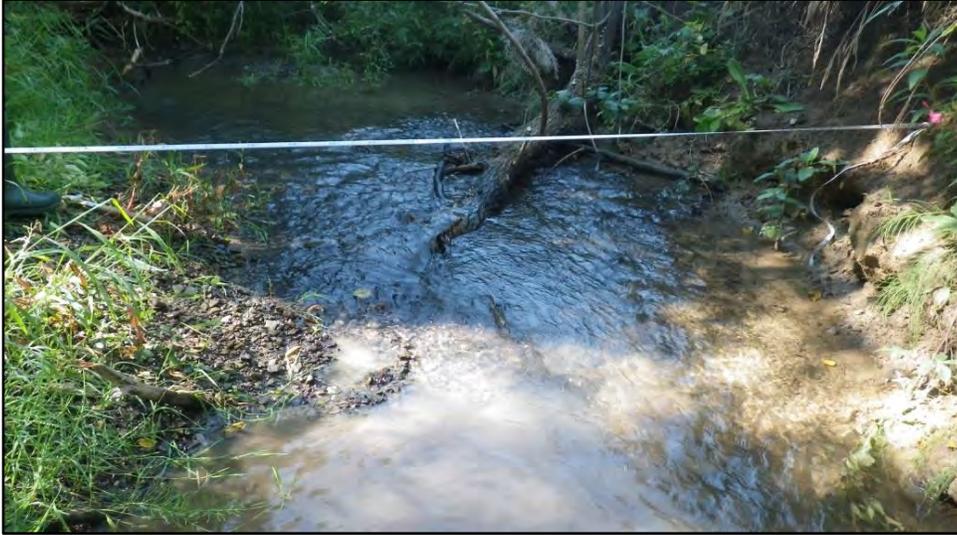
25. W-T1-2 Cross-section 7 facing upstream

LB overhanging and eroded bank with exposed clay
RB has low angle with small gravel piont bar

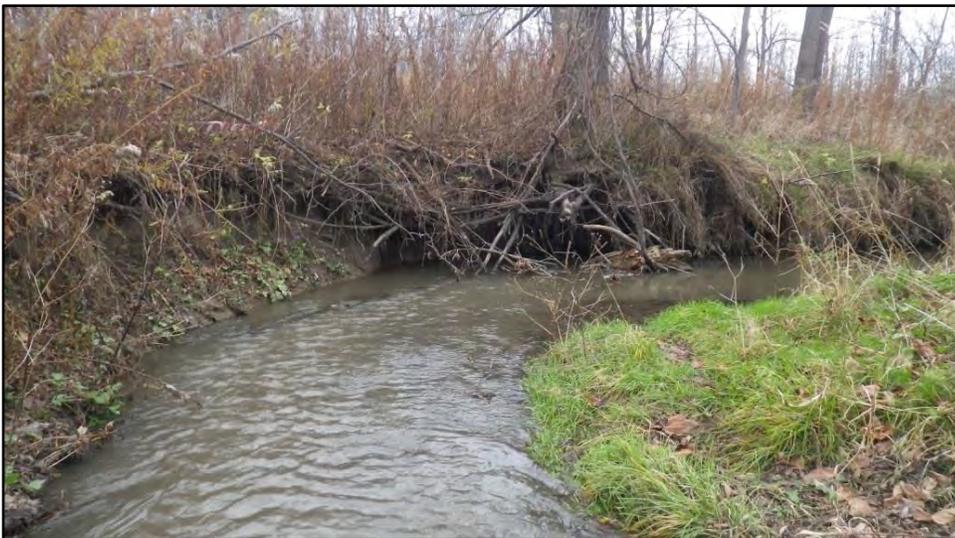
28. W-T1-3 Banks experiencing erosion opposite of bars producing bank slumping and undercutting which exposes roots.

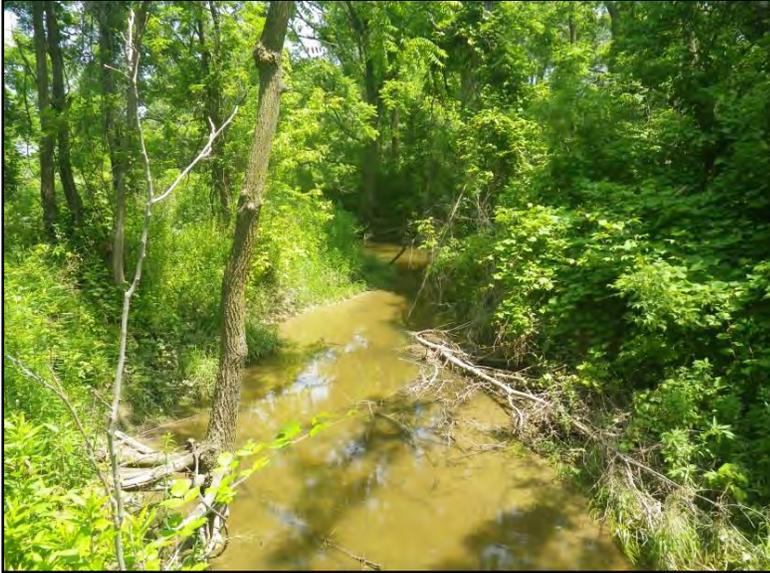
29. W-T1-2 typical conditions.

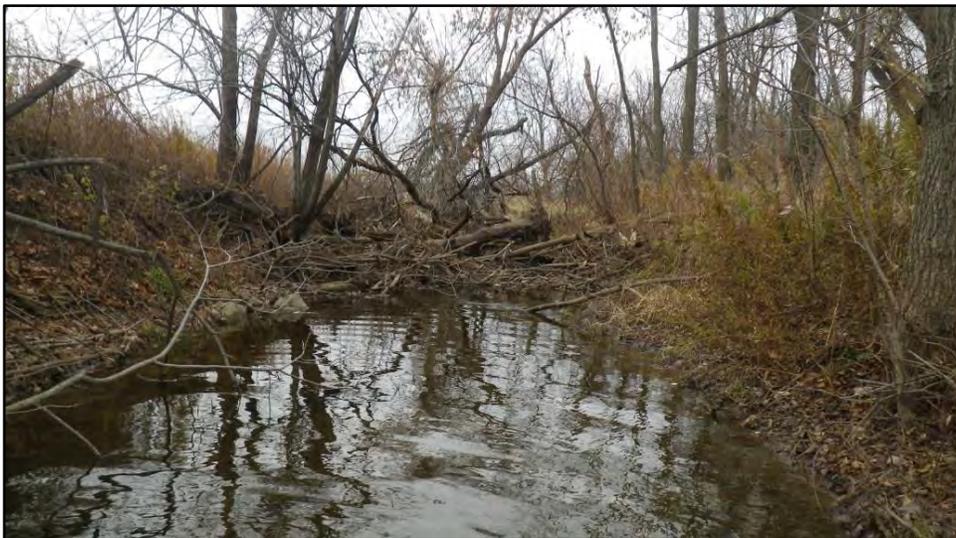
30. W-T1-2 Large woody debris jam at upstream end

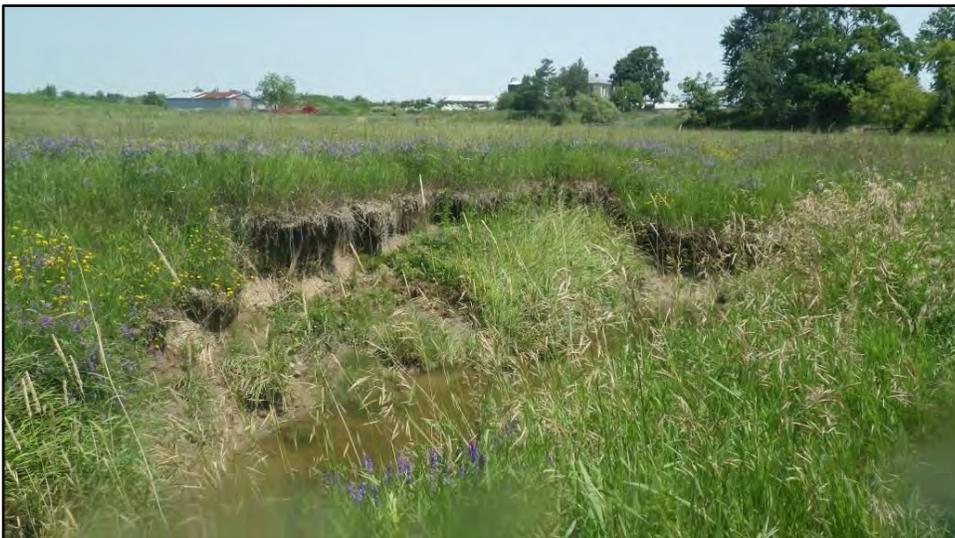
32. W-T1-1 calving of bank material.

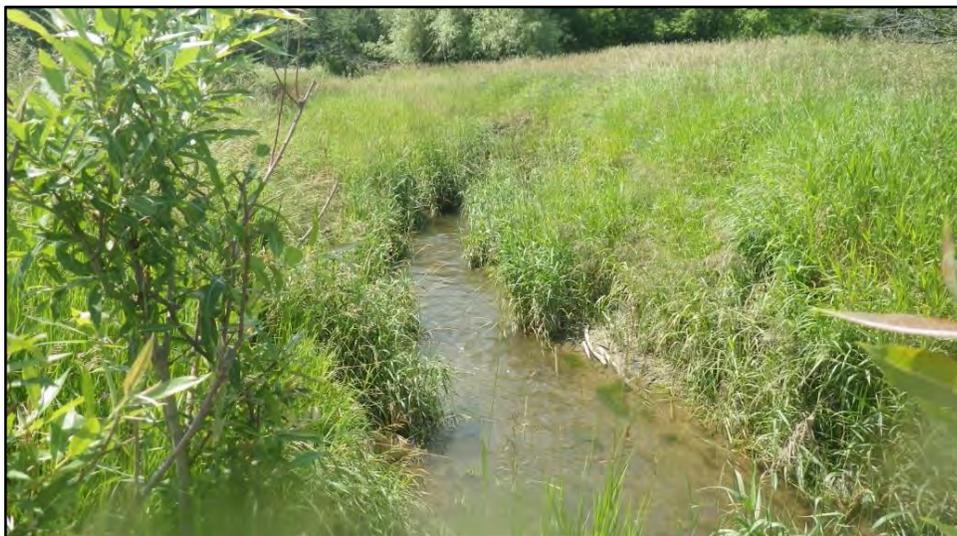
34. W-T1-1 Narrowing of wetted width due to dense grass vegetation.

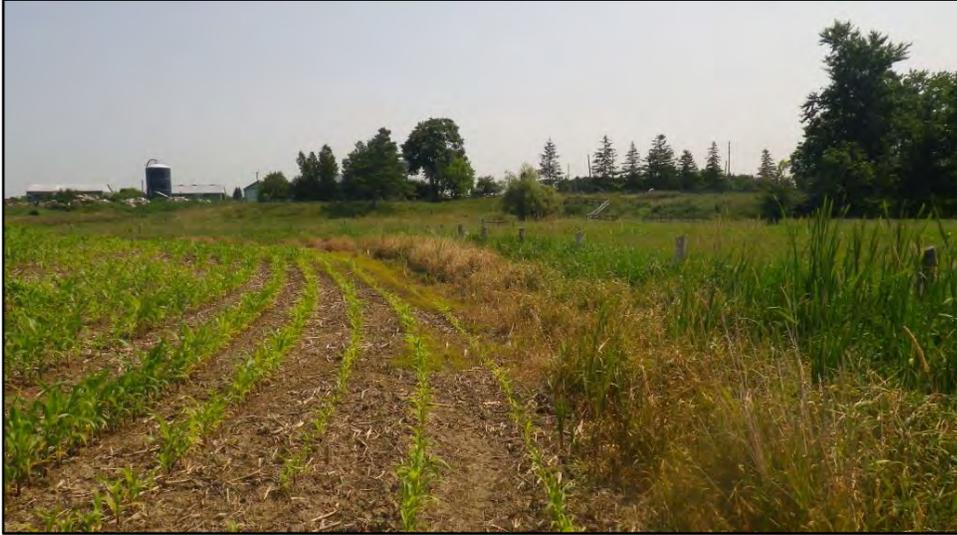
41. HDF-1 Channel flows as drainage ditch along fenceline (right side of photograph)

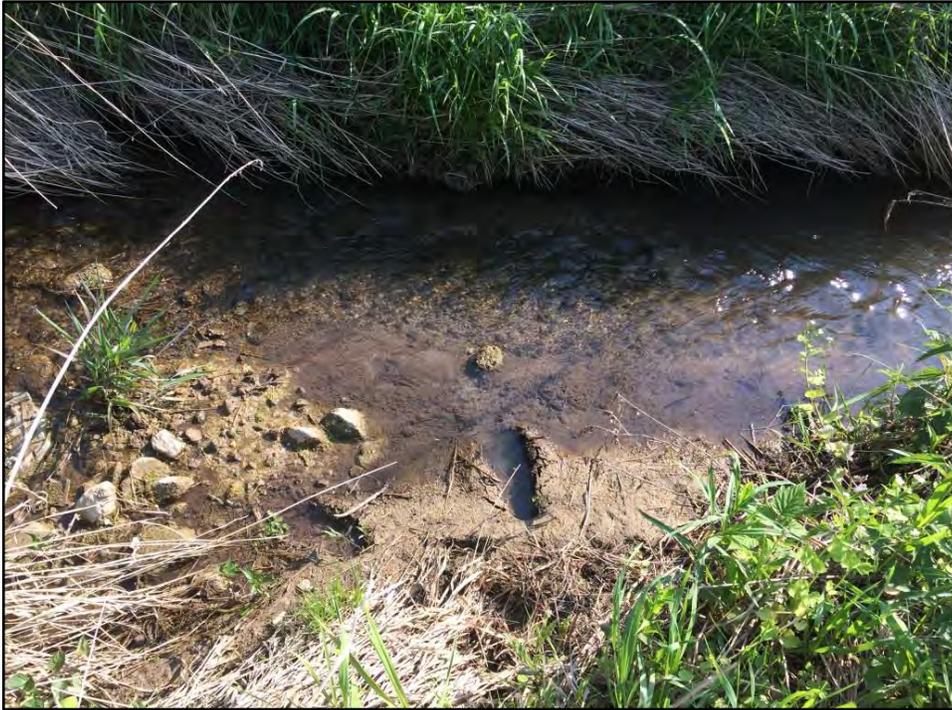
46. E-T1-3 Small pebbles and gravel through thalweg and silt accumulation (10-15cm) in other areas.

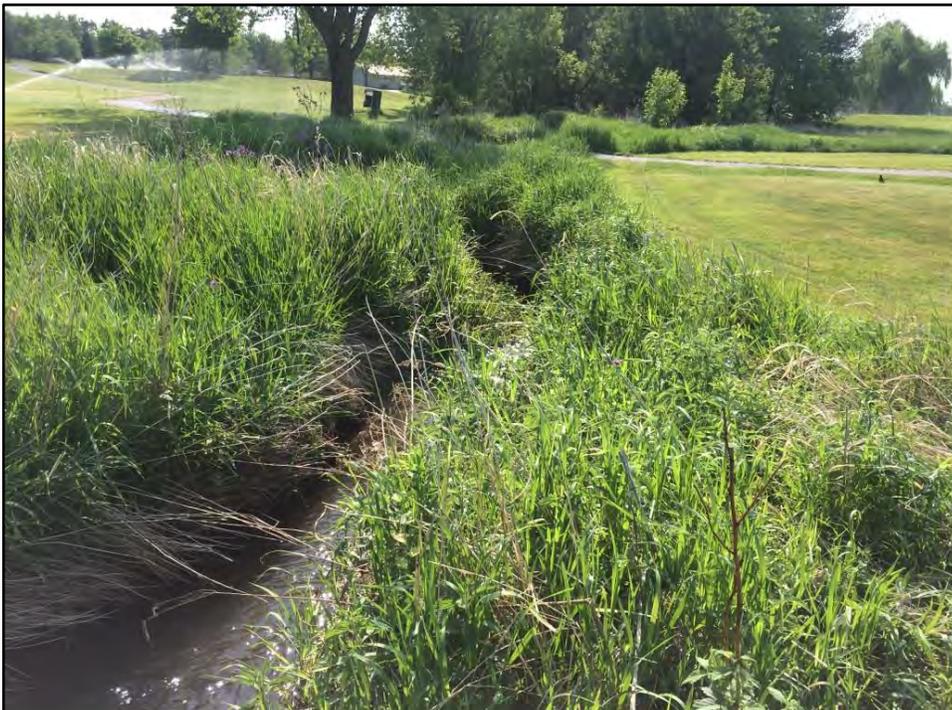
47. E-T1-3 Good grass riparian buffer between the channel and golf course.

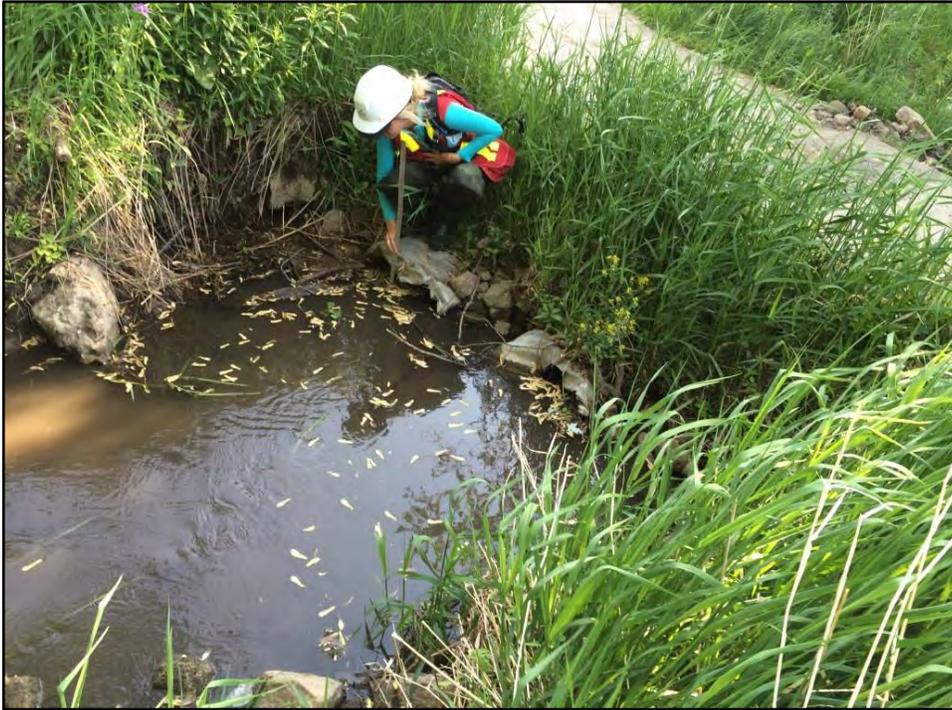
48. E-T1-3 CSP's damaged by weight of crossing, did not convey water efficiently.

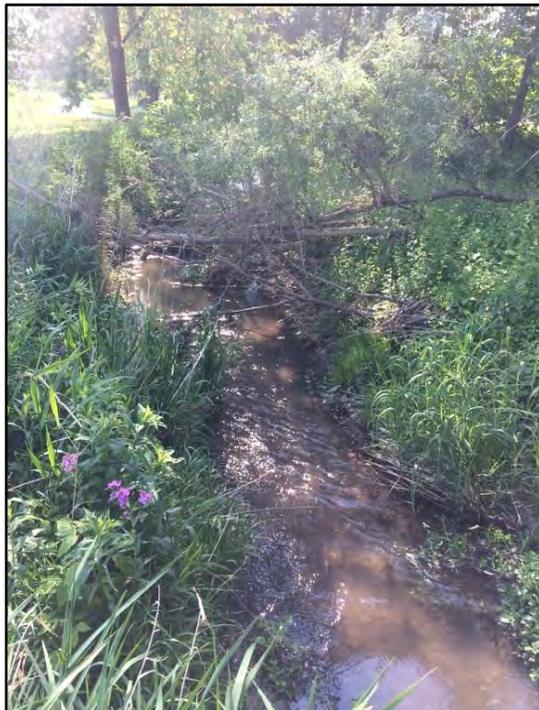
49. E-T1-3 Channel runs through woodlot as it approaches clubhouse.

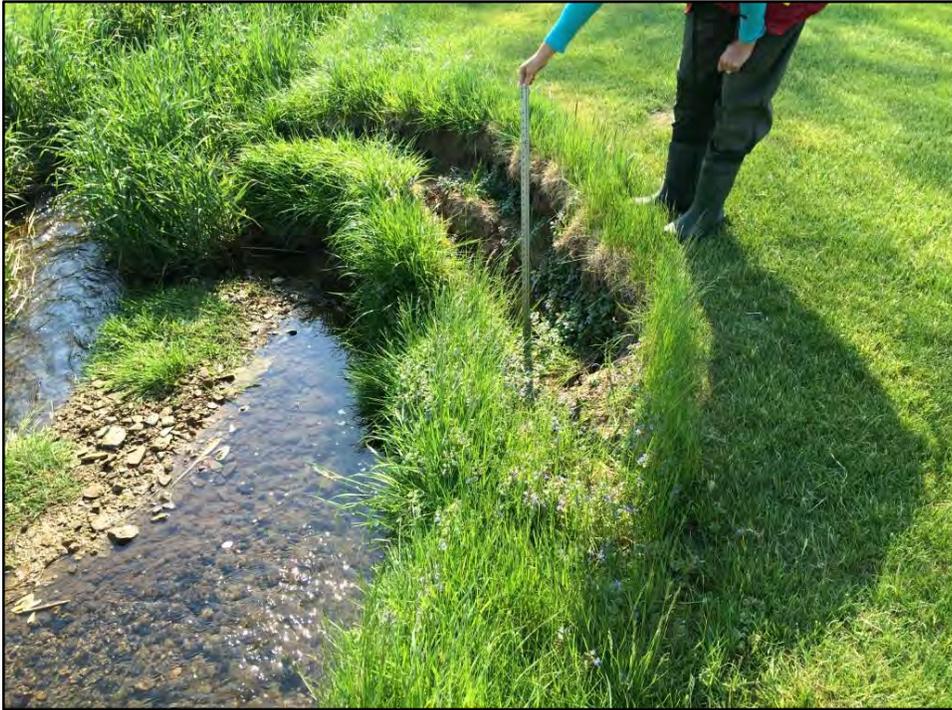
50. E-T1-3 Manicured lawn next to putting green is slumping.

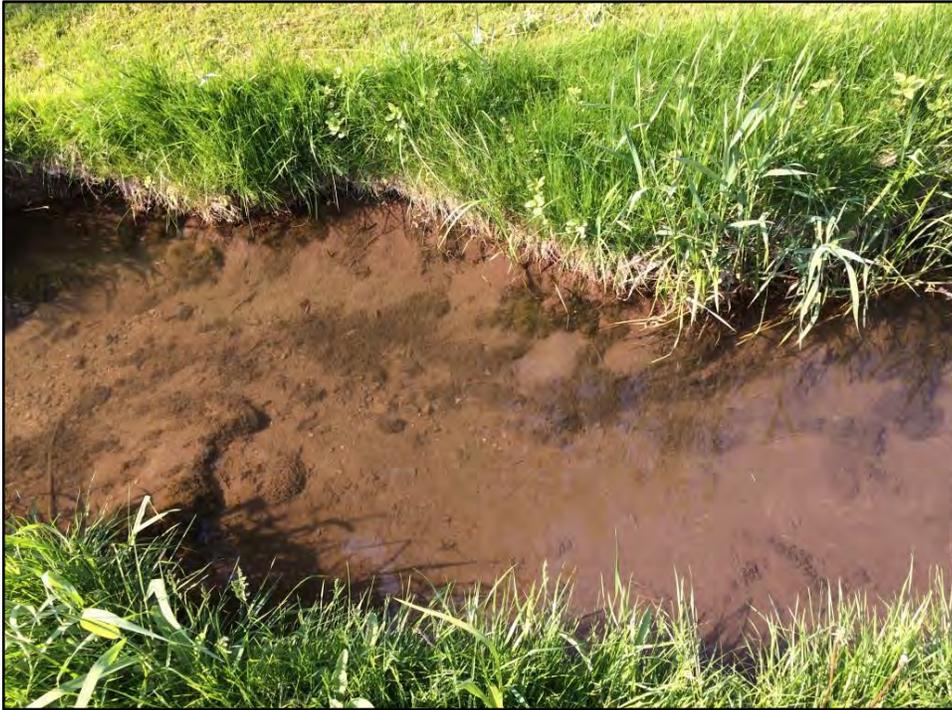
52. E-T1-3 Silt accumulation in multiple areas of the channel.

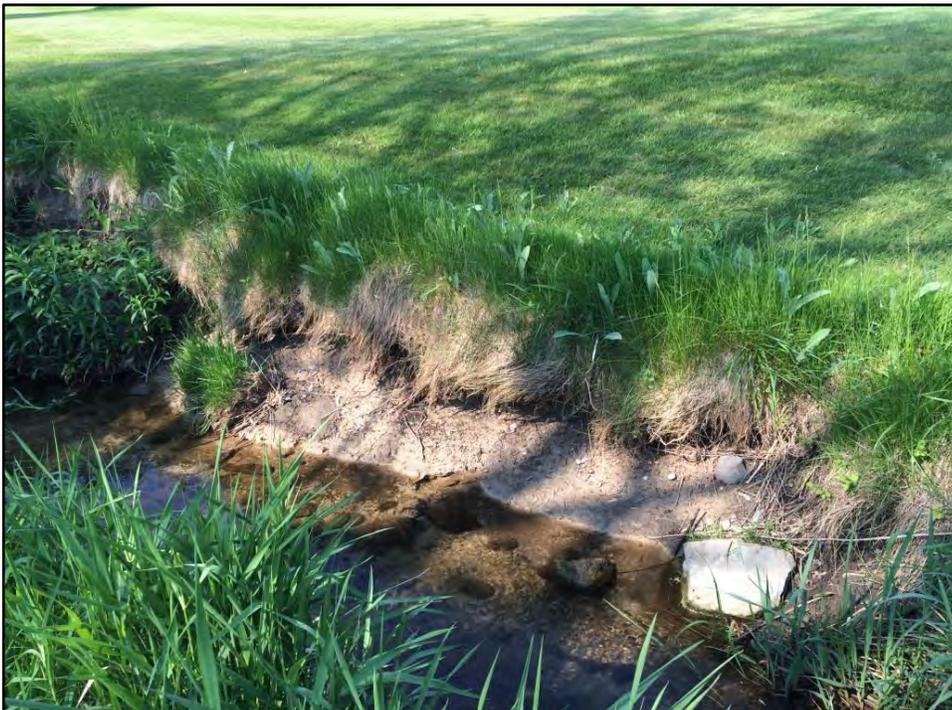
53. E-T1-3 Area of active erosion in areas lacking riparian buffer.

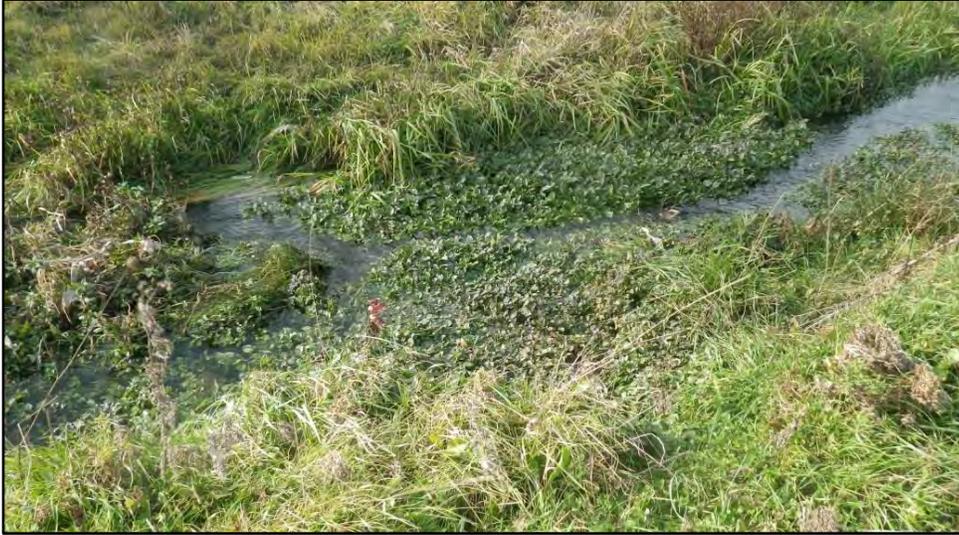
54. E-T1-2 Dense emergent aquatic vegetation, including algae (not seen in photograph).

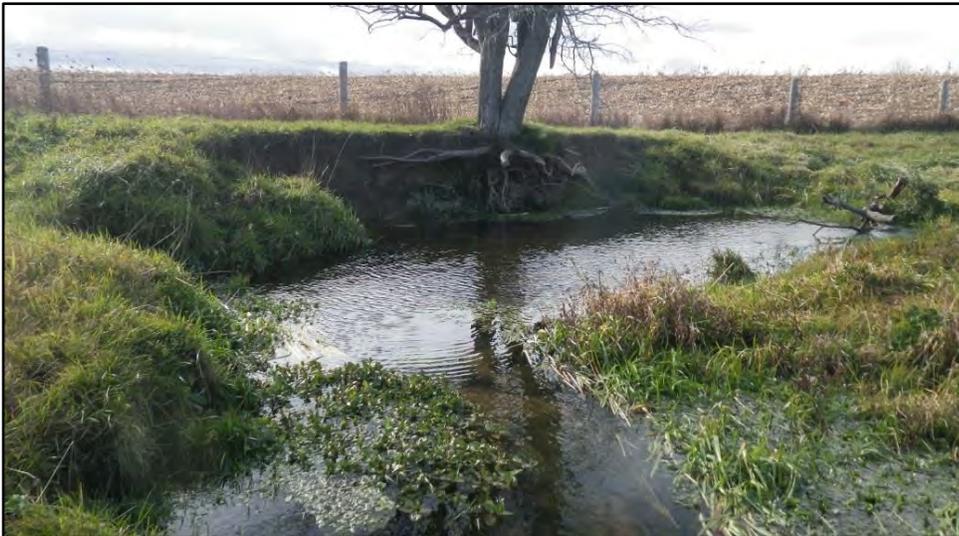
55. E-T1-2 Bank failure and other areas of erosion due to surrounding landuse.

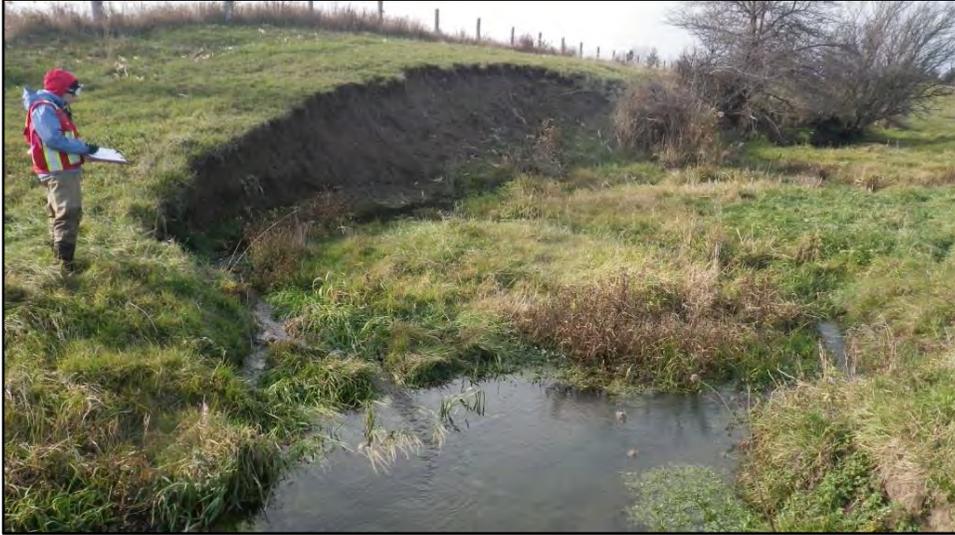
56. E-T1-2 Flow splits due to large island formation in center of channel.

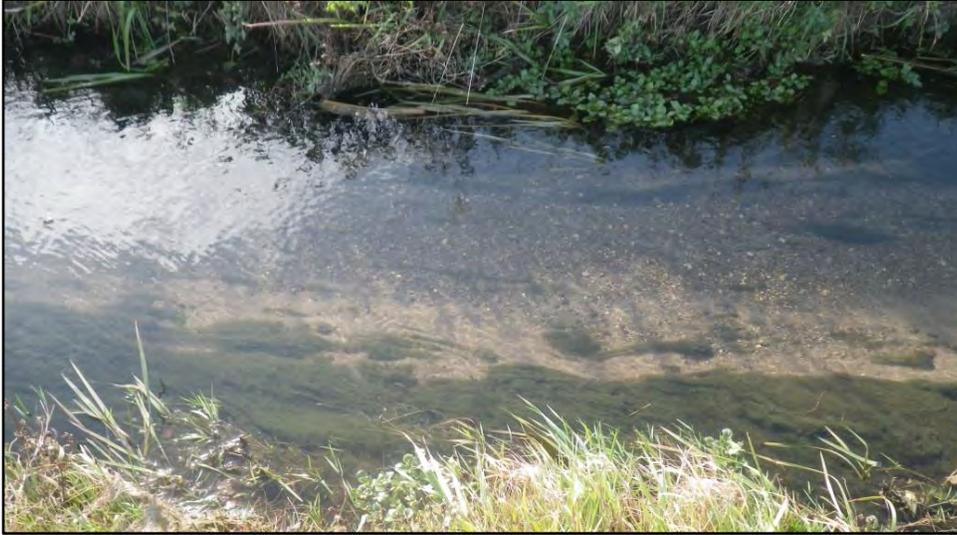
58. E-T1-2 Substrate upstream is more firm consisting of sands and gravel, as opposed to silt downstream.

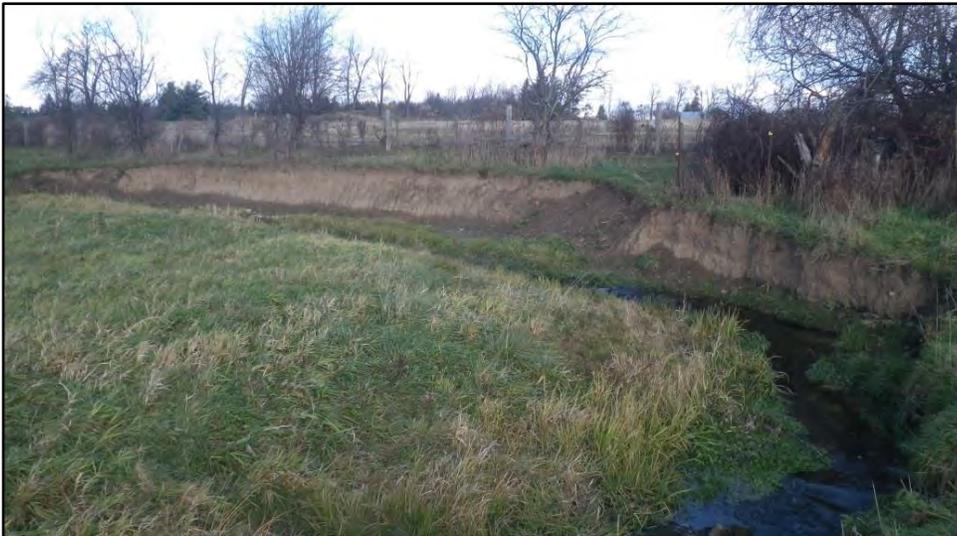
59. E-T1-2 Long eroding exposed bank face at upstream extent of reach walk. Bank height approximately 1.5-2m in height.

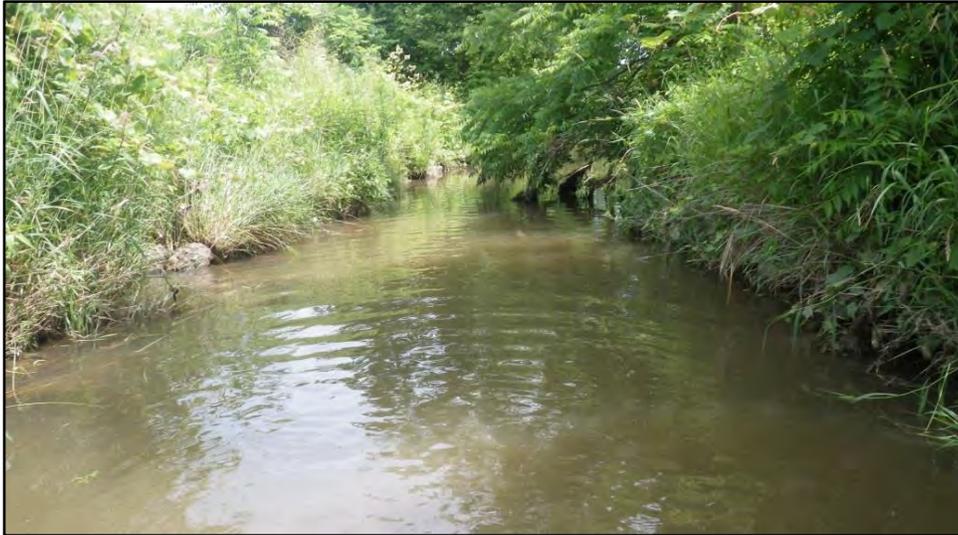
62. T1 Low gradient and slow moving flow with slight erosion on banks hidden by overhanging vegetation.

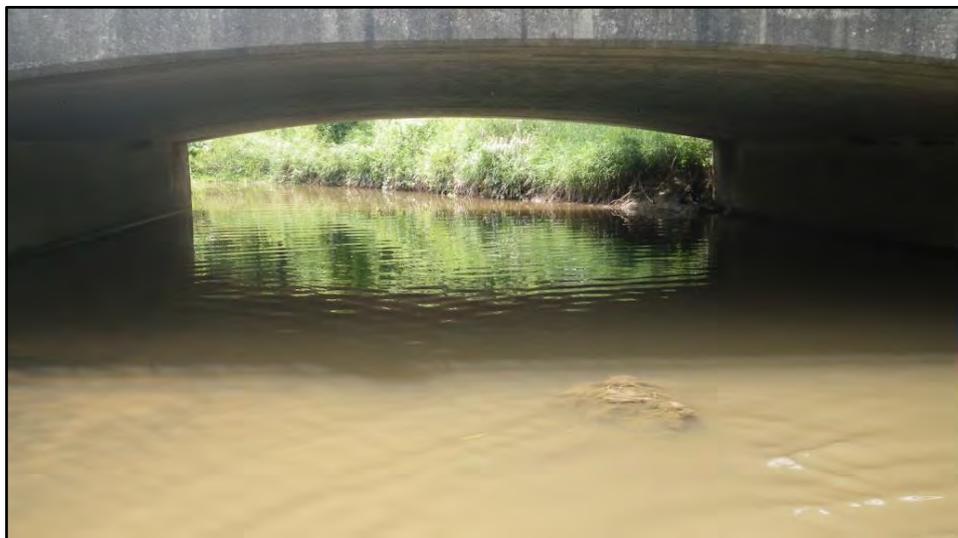
63. T1 Bridge crossing is quite low with major siltation underneath the structure.

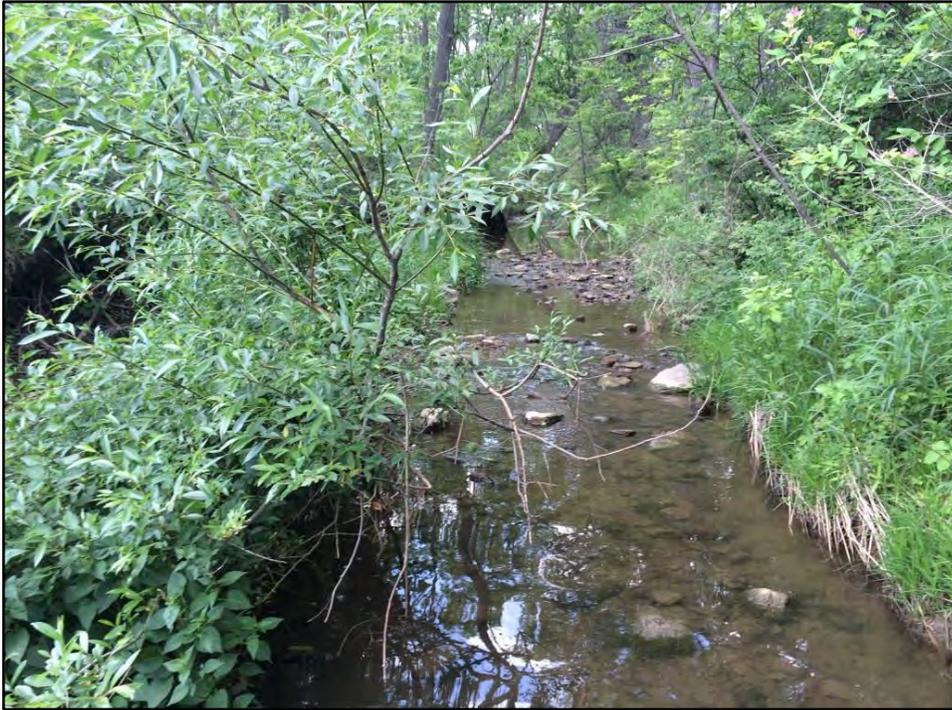
65. HT-2a-2 Erosion and undercutting along right bank. Two small riffle in channel just upstream of double box culvert at Trafalger Rd.

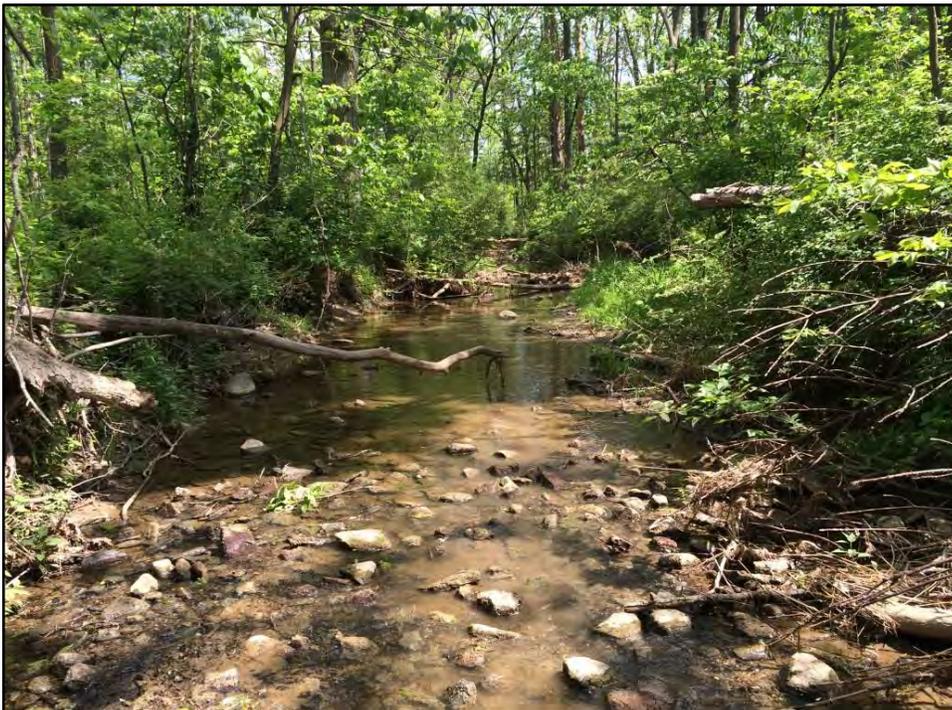
66. HT-2a-2 Erosion along both banks with leaning trees over channel (elevated). Large angular riffle material.

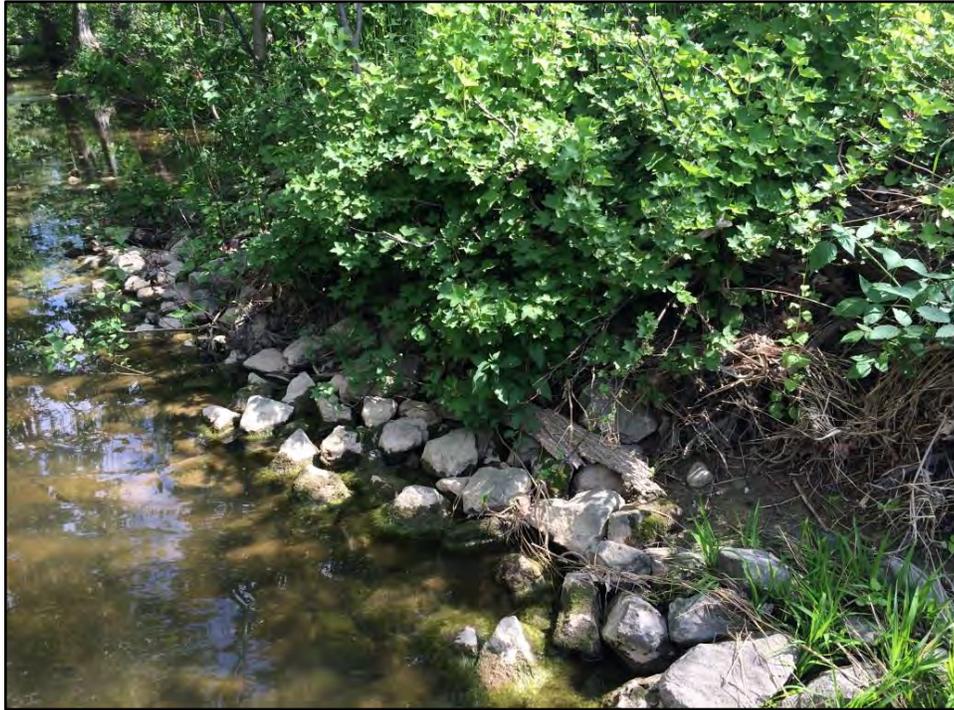
67. HT-2a-2 Rip rap placed along toe of right bank protecting private property.

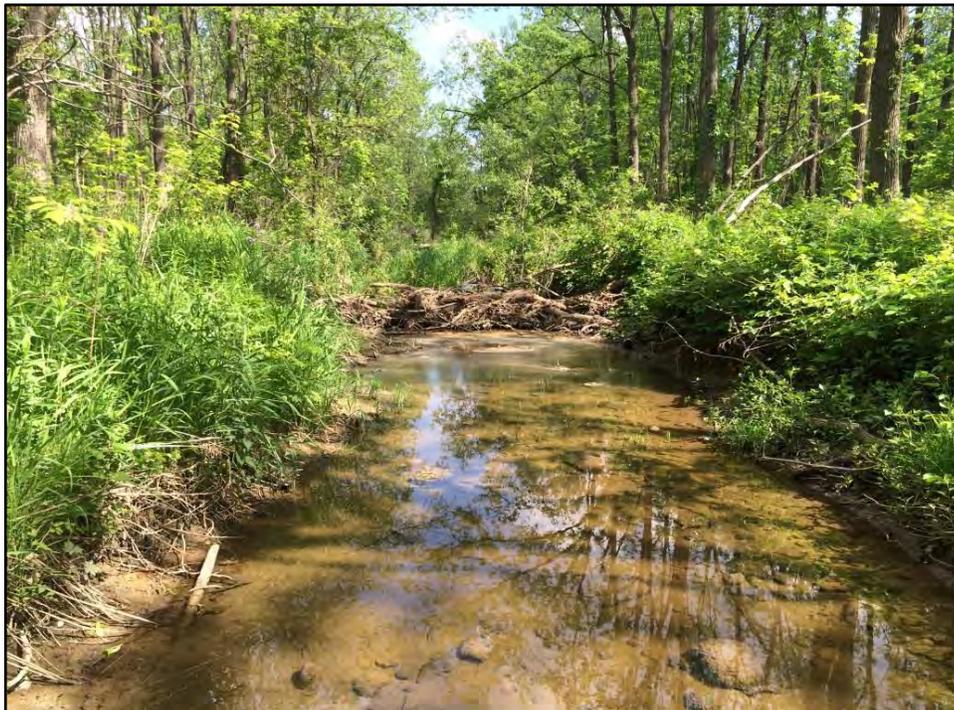
68. HT-2a-2 Woody debris jam consisting of large vegetation causing siltation upstream of it. WDJ found at downstream end of reach.
