Appendix F
Stream Morphology

APPENDIX A
Field Data Summaries

Project: Premier Gateway SWS: HT-1 Detailed Site

APPENDIX B
Field Photograph Summary

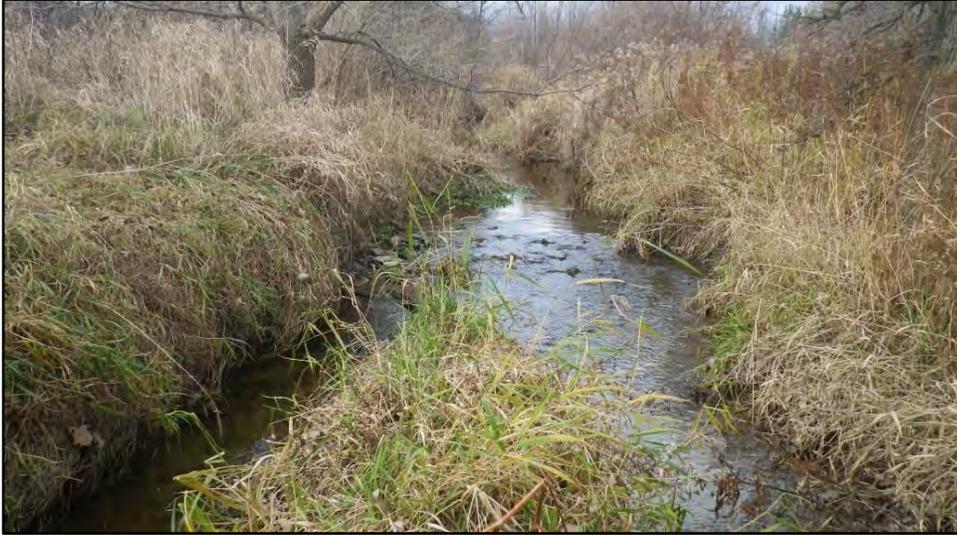
69. HT-2a-1 Flow splits around vegetated bar in center of channel. Channel does this multiple times within reach.

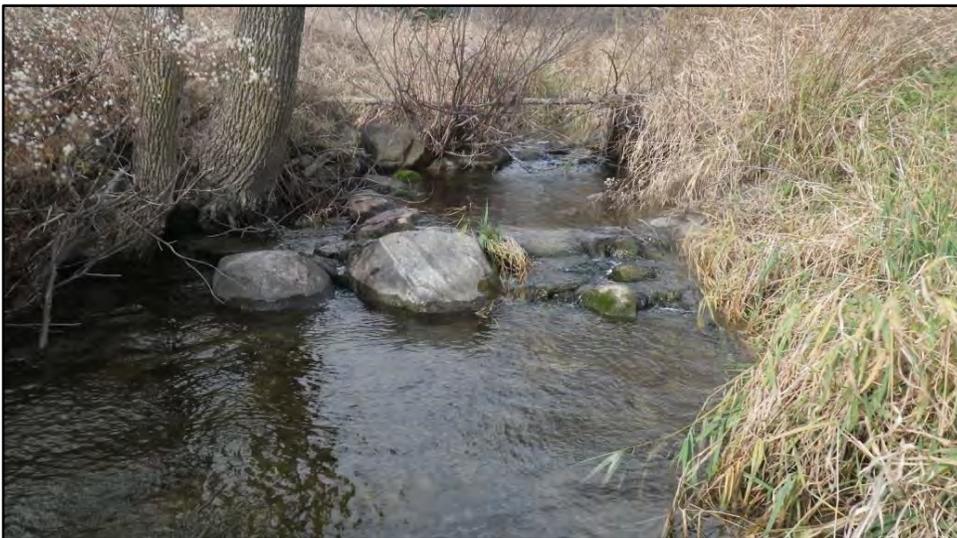
70. HT-2a-1 Boulders placed to make weir structure.

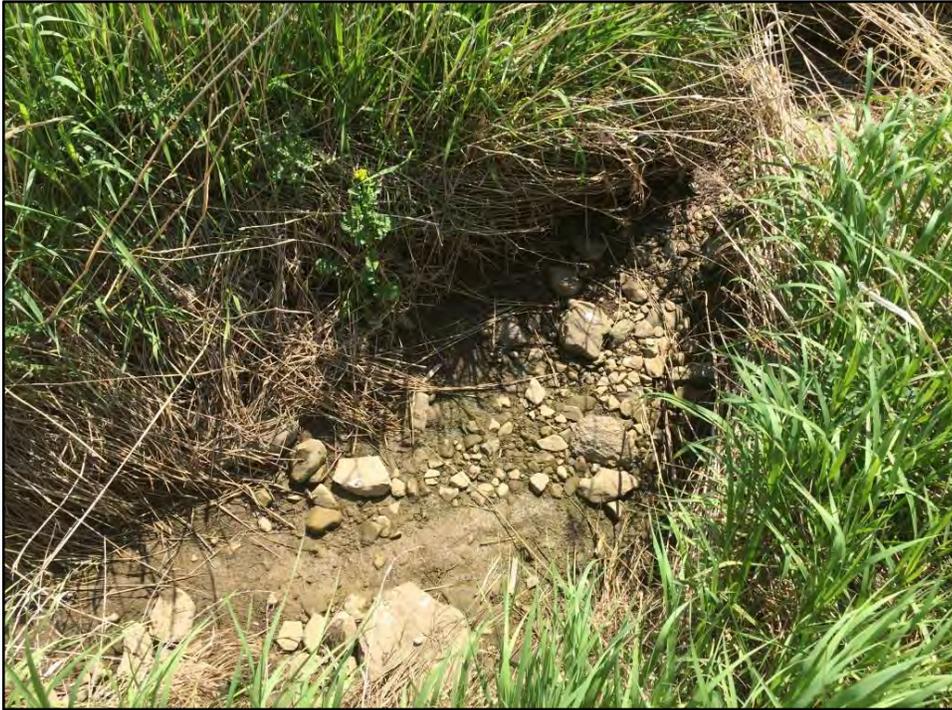
74. HT-2b-2 Feature dry but well defined with signs of riffle features.

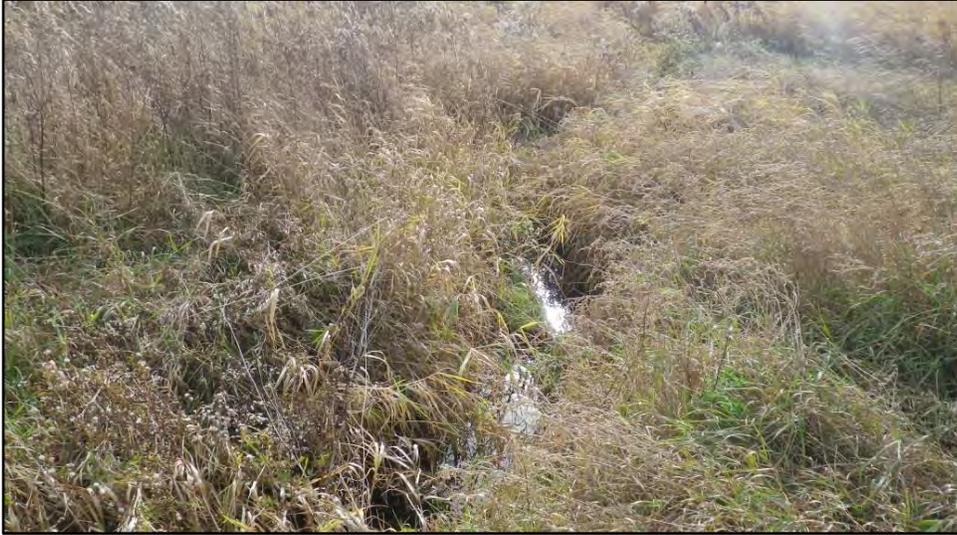
76. HT-2b-1 Narrow channel with dense overhanging grasses.

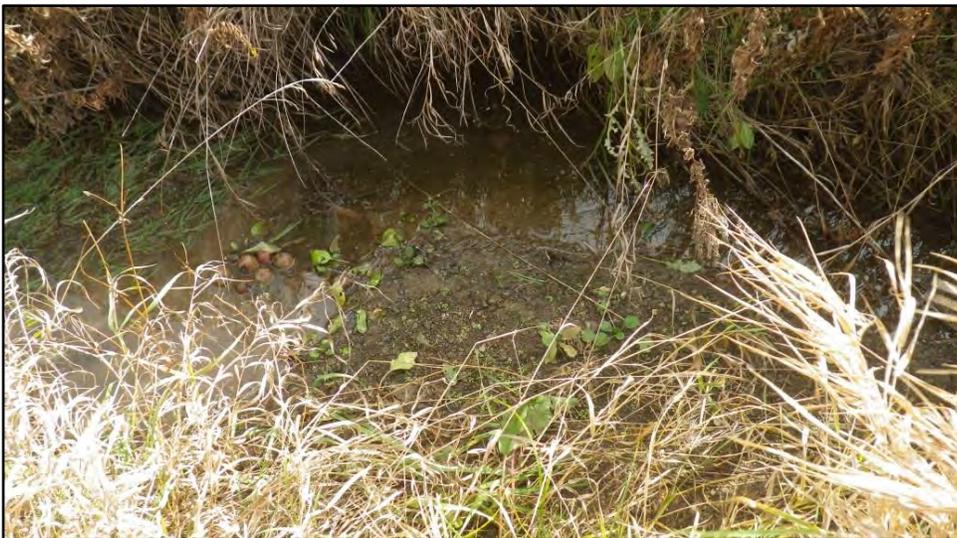
77. HT-2b-1 Lateral bar formation on right bank. Primarily consisting of 1cm particles, pebbles and fine.

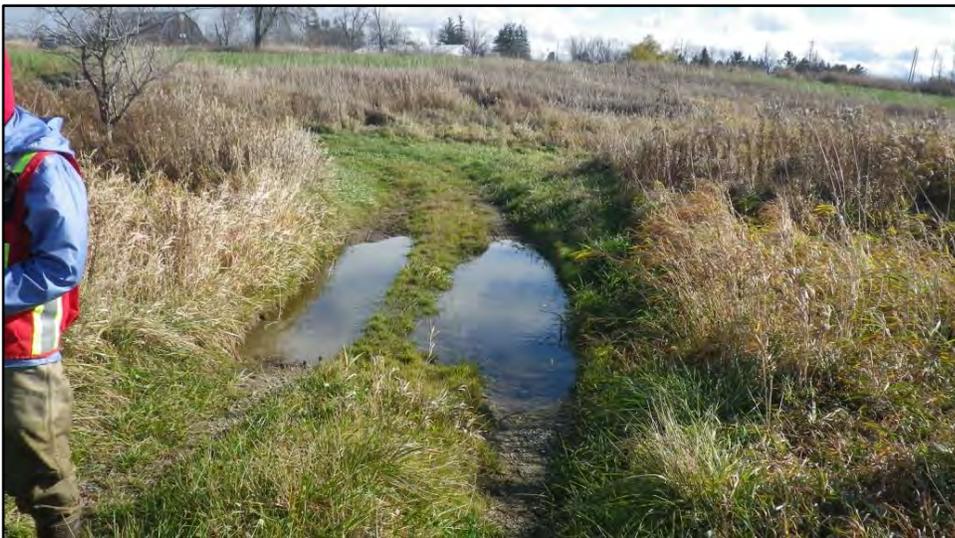
79. HT-2b-1 Farm crossing of channel with no CSP to convey flow.

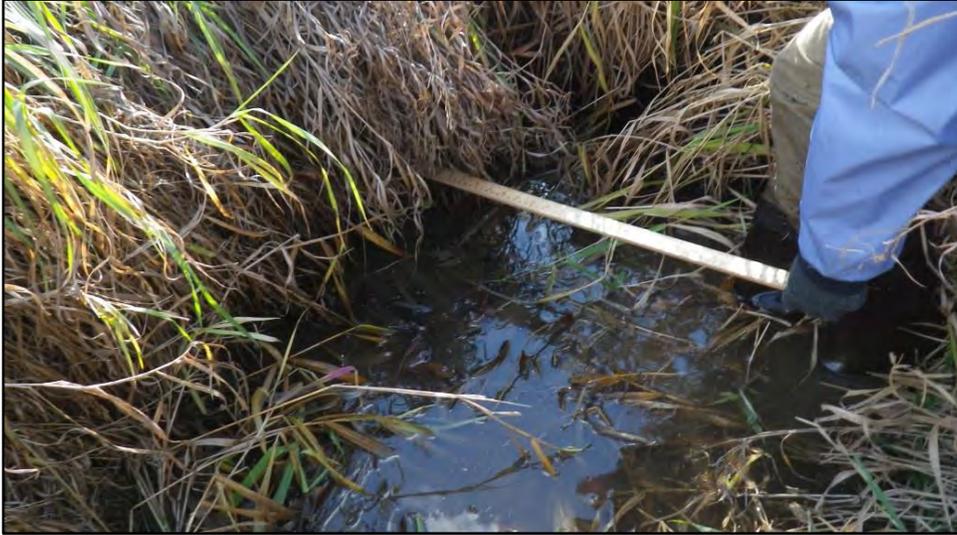
80. HT-2b-1 Severe undercutting found at parts of the reach. Up to 0.30m of undercutting observed.

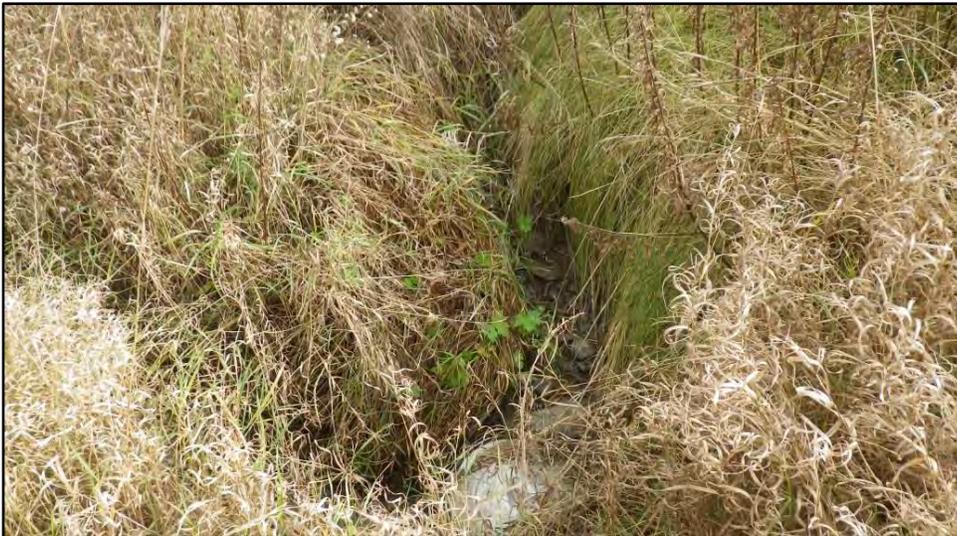
90. HT-2b-1 Parts of channel are quite sinuous.

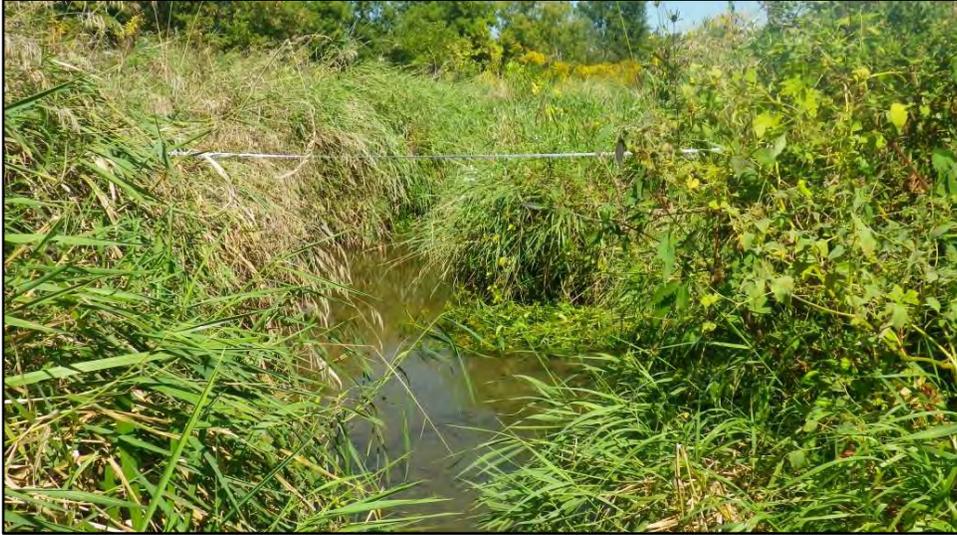
91. HT-1 Cross-section 1 facing upstream

RB is 30cm undercut

large cobble with silt overlay

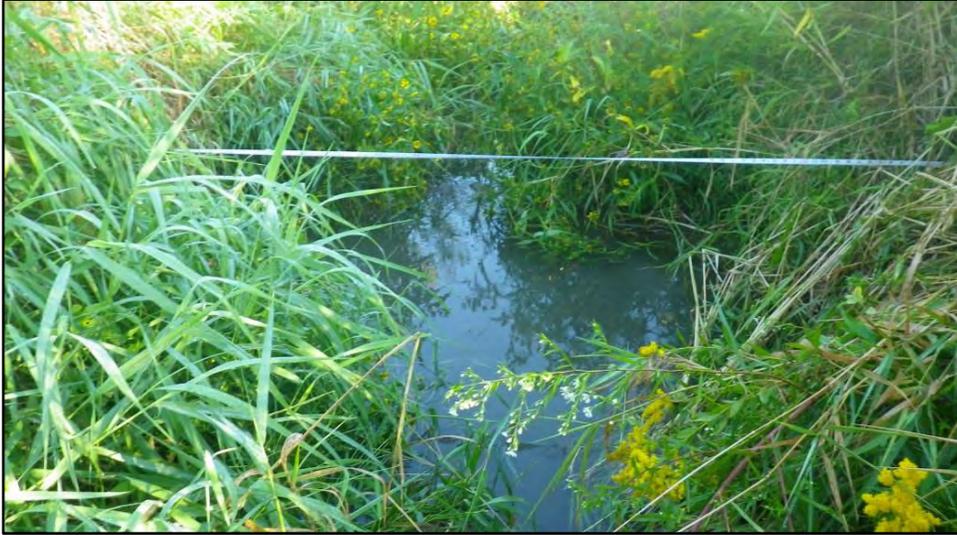
93. HT-1 Cross-section 2 facing upstream

A lot of silt deposition with larger cobbles

Aquatic vegetation in channel

banks are slumping

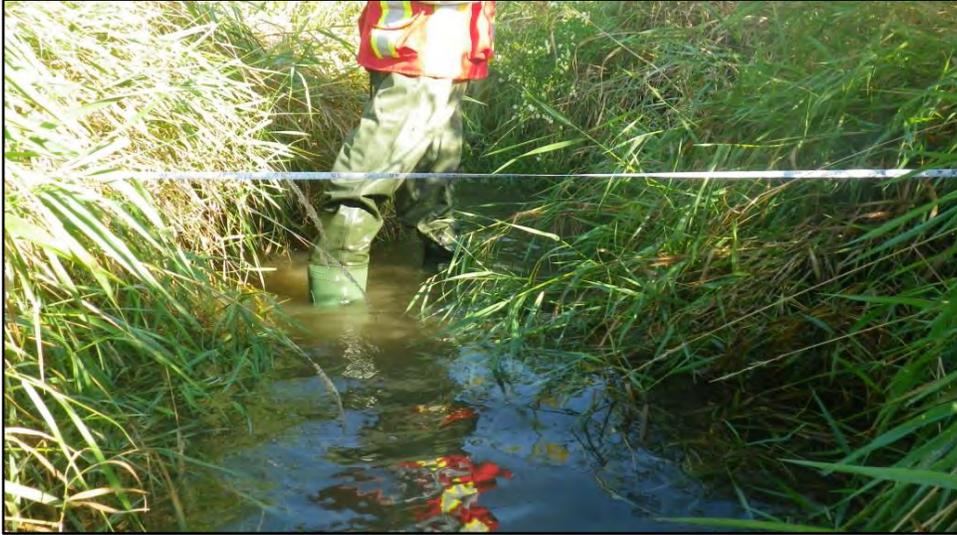
95. HT-1 Cross-section 3 facing upstream

plate-like particles

banks are slumping

banks are heavily vegetated

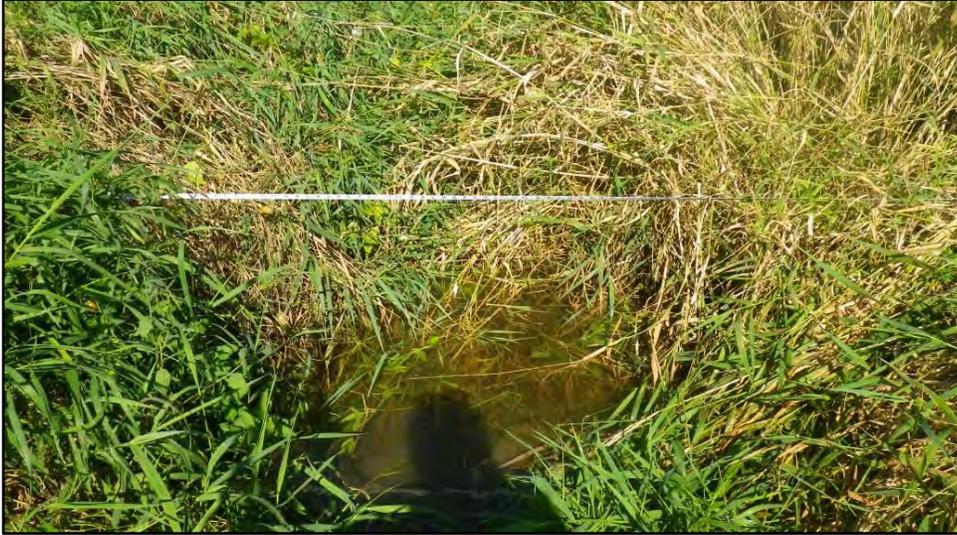
97. HT-1 Cross-section 4 facing upstream

left bank is terraced

heavily vegetated banks

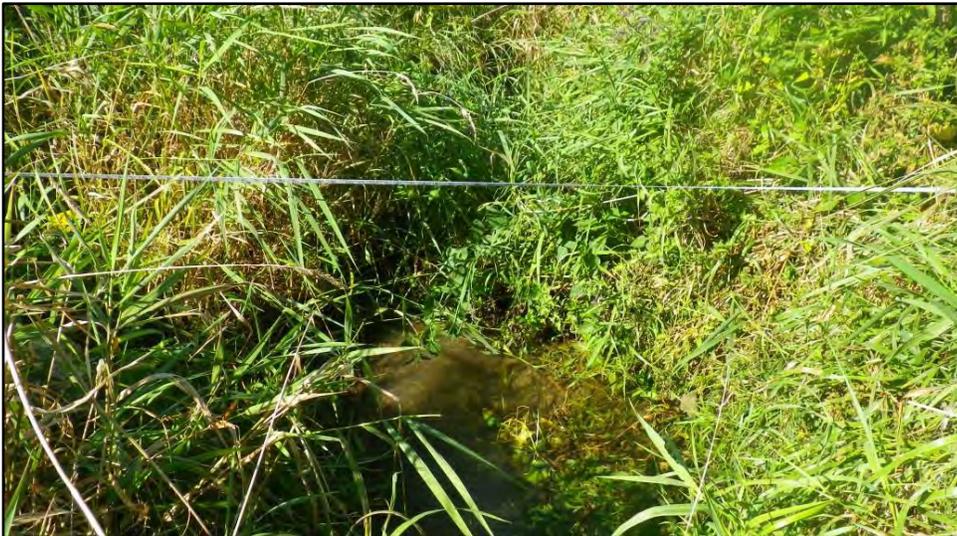
100. HT-1 Cross-section 5 facing downstream

vertical banks

small pebbles in riffle

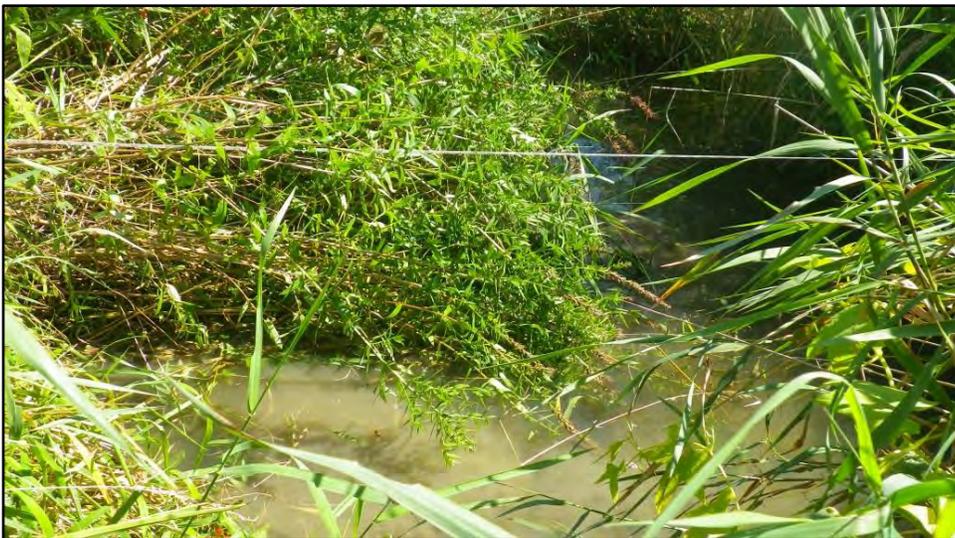
102. HT-1 Cross-section 6 facing downstream

LB is slumped 30cm U/S

substrate is unconsolidated

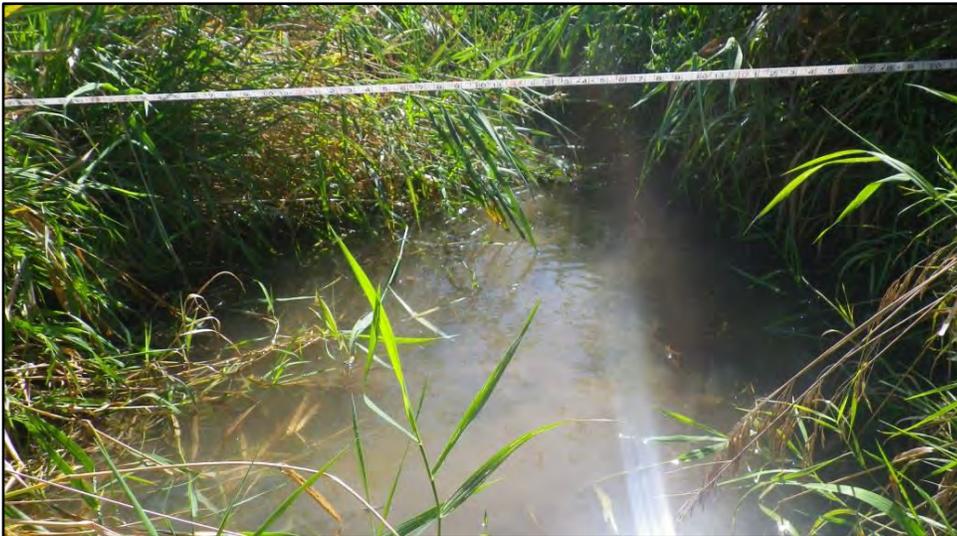
104. HT-1 Cross-section facing downstream

LB is slumped

substrate has coarser gravel, cobbles with silt overlay

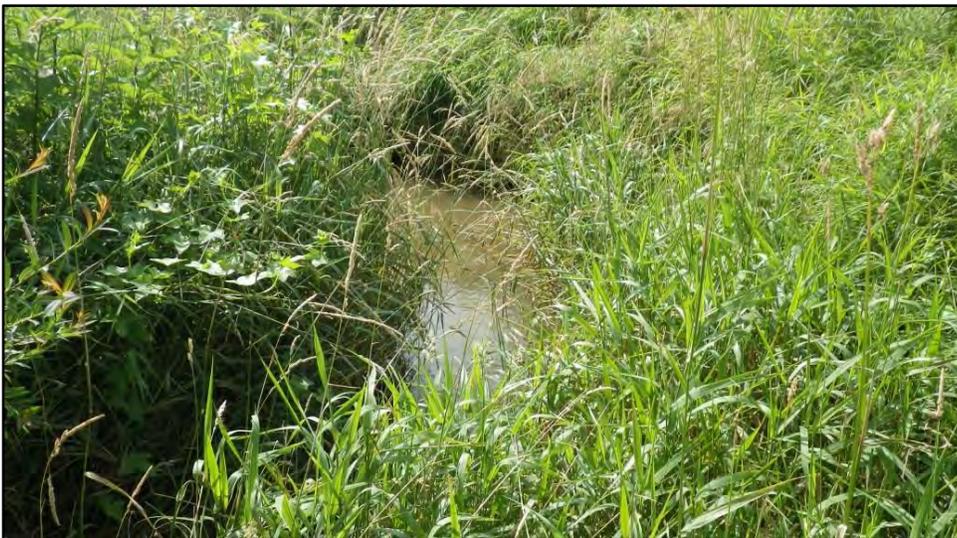
106. HT-1 Channel narrows in multiple areas to a wetted width of approximately 1m.

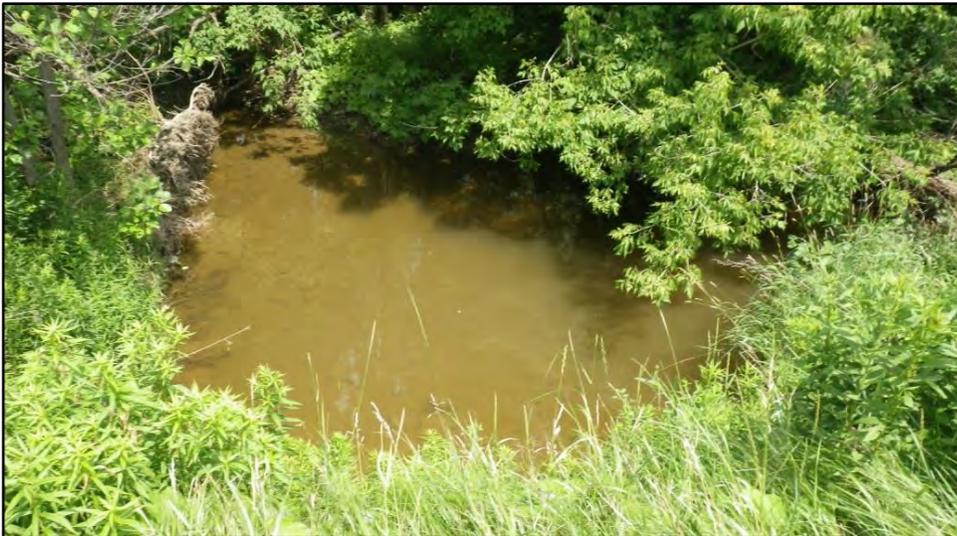
108. HT-1 downstream extent of reach is more sinuous than further upstream. Bends become over widened with evidence of planform adjustment.
