June 3, 2016

Matrix 21510-522

**Subject: Results of Headwater Drainage Feature Assessment for Premier Gateway Scoped Subwatershed Study**

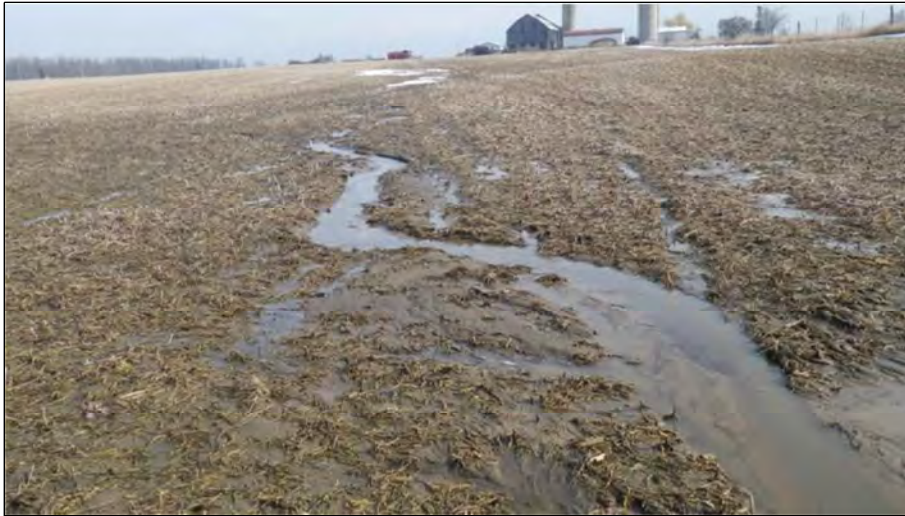
3. **HT -2b -3b.** Near downstream end of feature, facing upstream. Feature type is swale and flow condition is surface flow minimal. Feature had sinuosity development and transport of fine sediments.

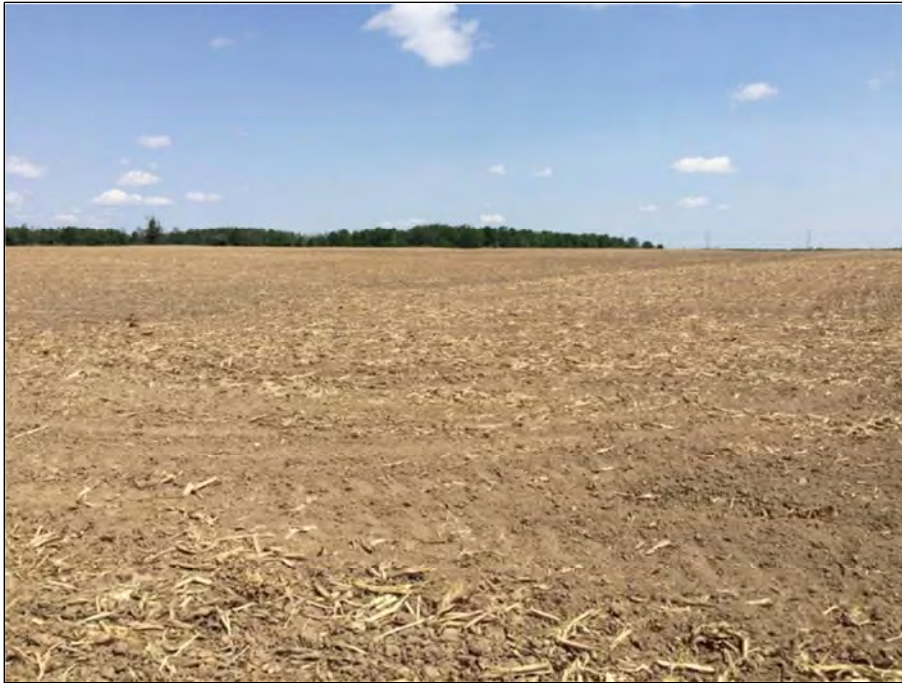
5. **HT -2b -3b.** Area where feature would be located facing upstream. Feature type is swale, flow condition is dry. **Management recommendation: No Management**

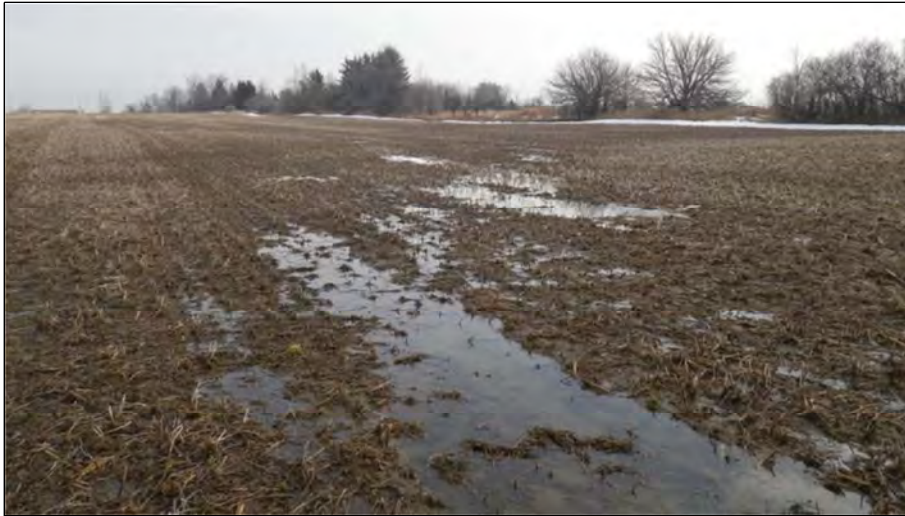
7. **HT -2b -3a.** Mid -feature, facing upstream. Water is primarily standing and does not have a well-defined flow path. Feature type is swale and flow condition is standing water.

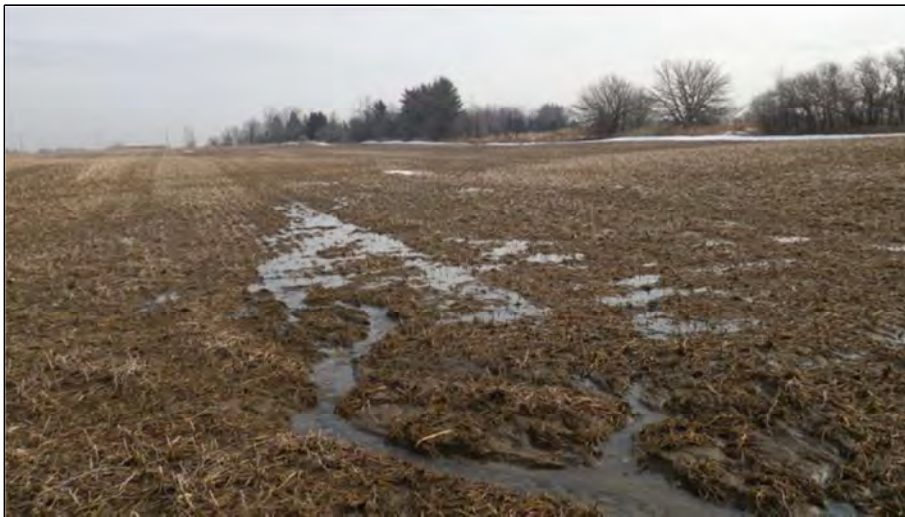
8. **HT -2b -3a.** Approaching downstream end, facing upstream. Flow becomes more defined as it approaches confluence with HT -2b -3. Feature type is swale and flow condition is standing water.

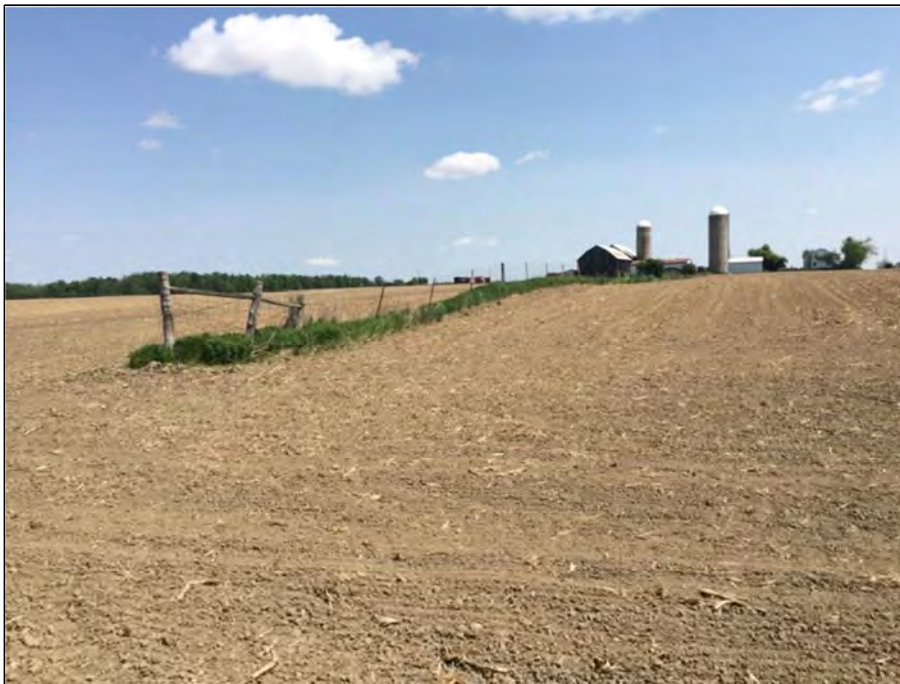
10. **HT -2b -3a.** Facing upstream in vicinity of feature. No depression was visible. Flow condition was no surface water and feature type was swale. **Management Recommendation: No management required.**

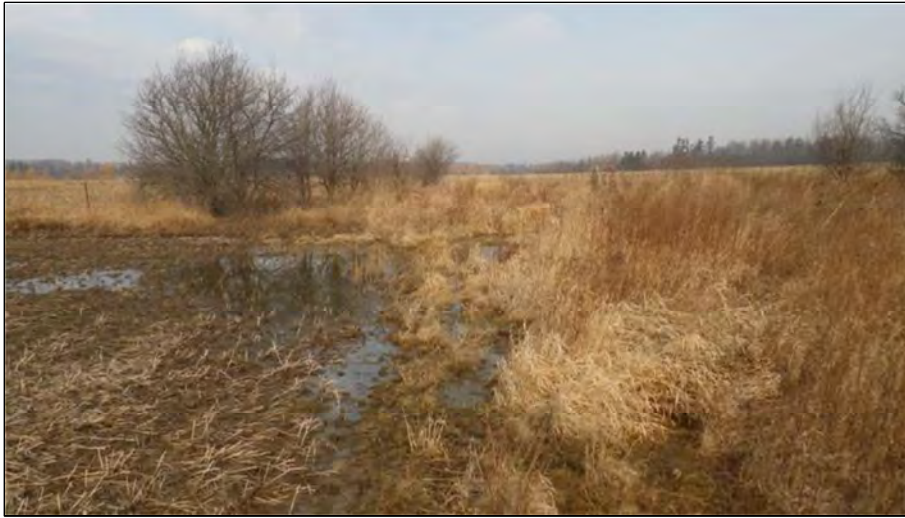
**11. HT -2b -3.** Standing water adjacent to vegetation and cropland at upstream end of feature.  
Feature type is no defined feature (overland flow only) and flow condition is surface flow minimal.

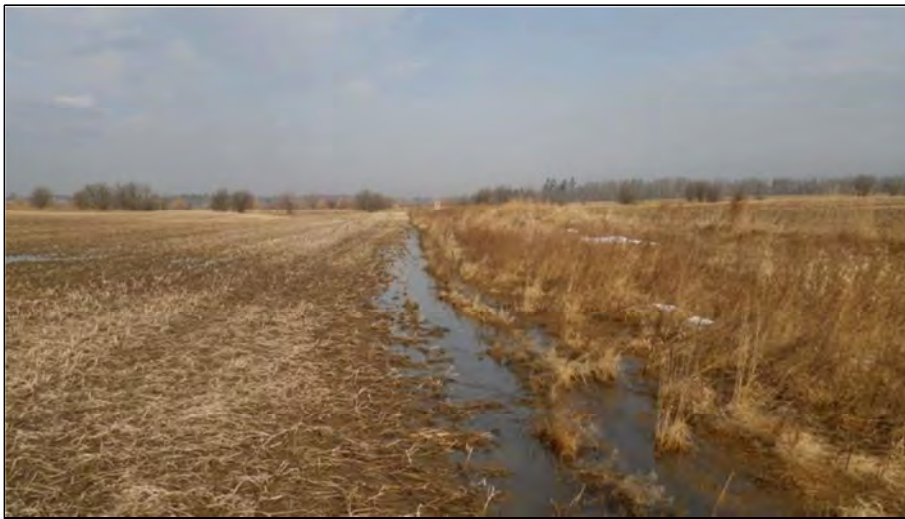
**12. HT -2b -3.** Standing water adjacent to vegetated area and cropland, near upstream end. Feature type is no defined feature (overland flow only) and flow condition is surface flow minimal.

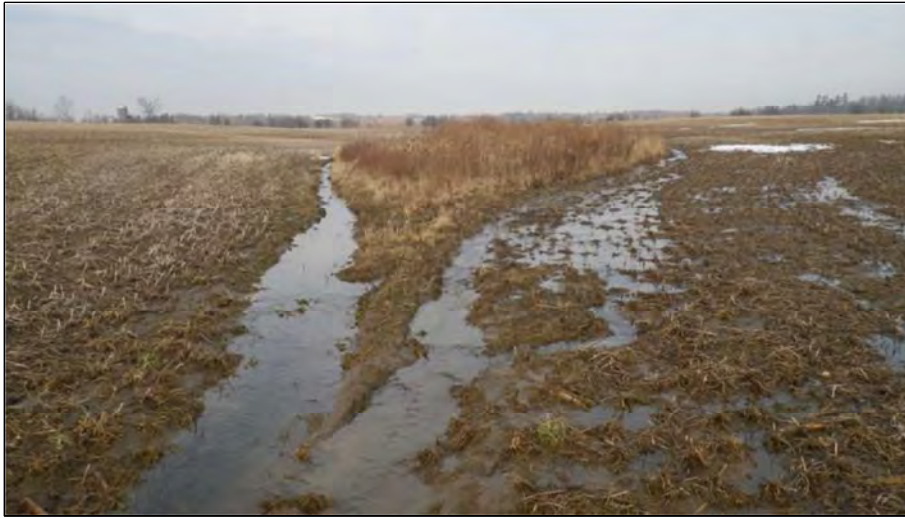
**13. HT -2b -3.** Water on either side of vegetated area between two crop fields. Facing upstream. Feature type is no defined feature (overland flow only) and flow condition is surface flow minimal.

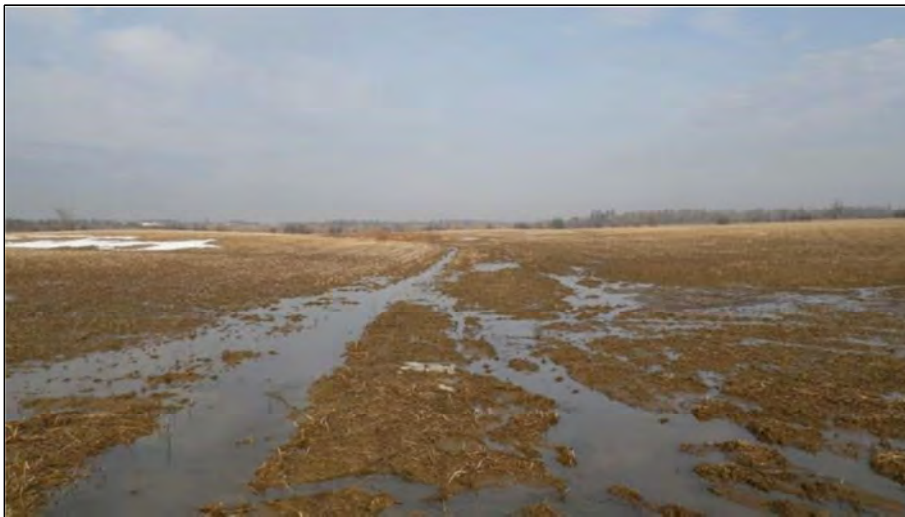
**14. HT -2b -3.** Near downstream end of feature, facing upstream. Flow is more spread out over flatter area. Feature type is no defined feature (overland flow only) and flow condition is surface flow minimal.

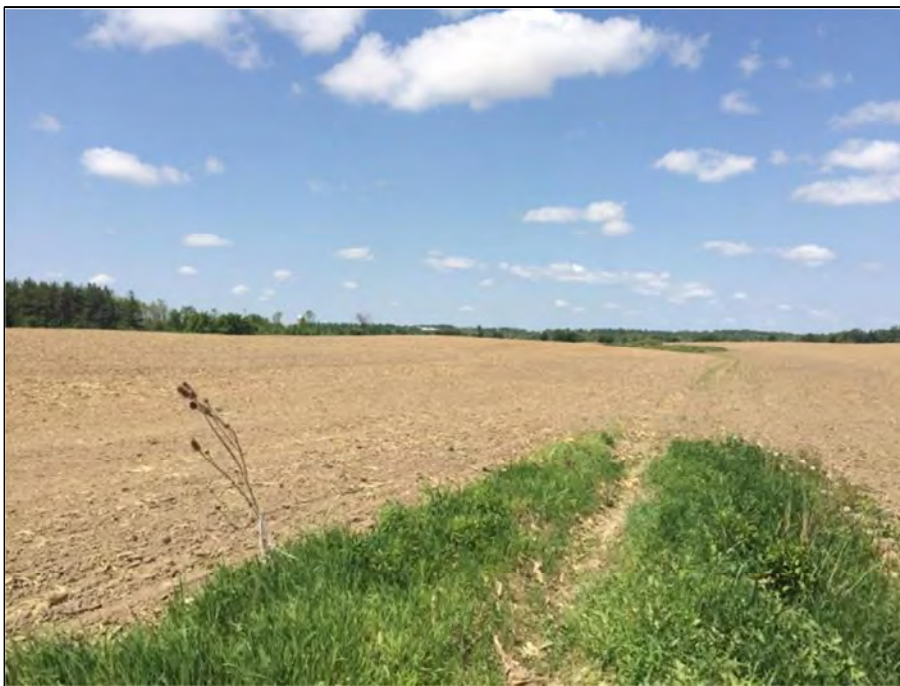
**18. HT -2b -3.** Facing upstream, near downstream end of feature. Feature type is no defined feature (overland flow only) and flow condition is no surface water.

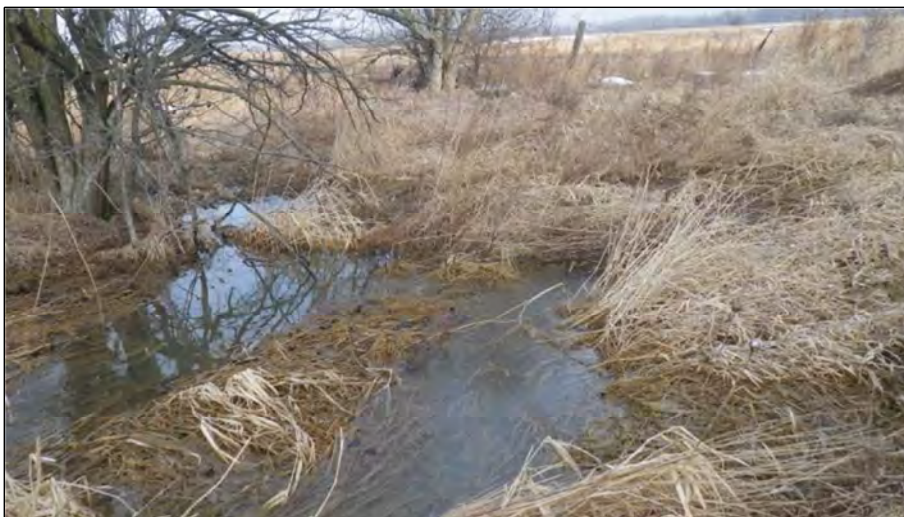
20. **HT -2b -2 (Segment 1).** At upstream end of feature where water flows off agricultural fields upstream. Maximum water depth was at upstream end where water was pooling in several locations (max depth approx. 20cm). Feature type is multi -thread and flow condition is surface flow substantial.

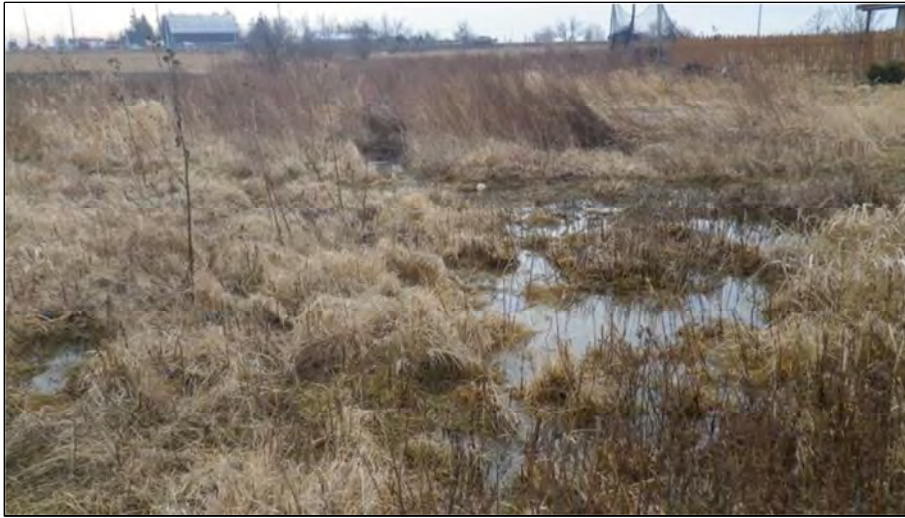
**21. HT -2b -2 (Segment 1).** Facing downstream, multiple poorly defined flow paths. Feature type is multi -thread and flow condition is surface flow substantial.

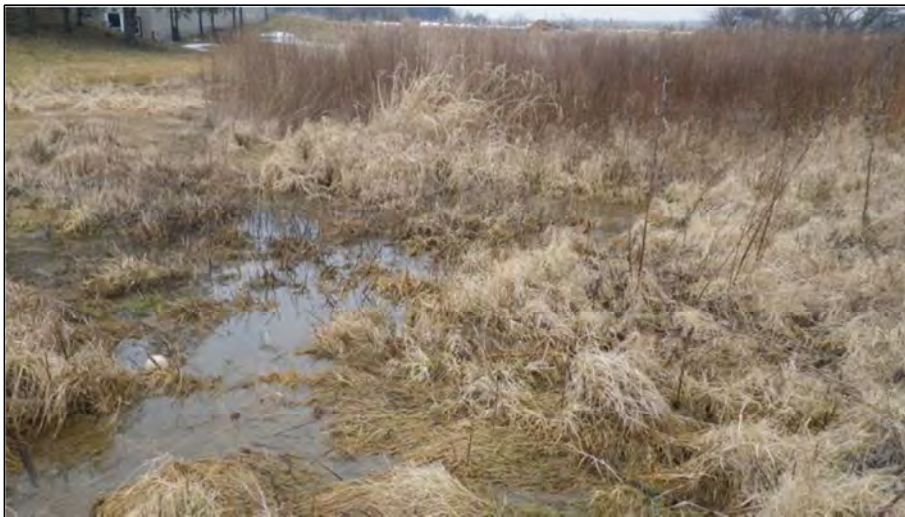
**22. HT -2b -2 (Segment 1).** Facing upstream at downstream end of Segment. Multiple poorly defined flow paths upstream of small pedestrian boardwalk on property. Feature type is multi -thread and flow condition is surface flow substantial.

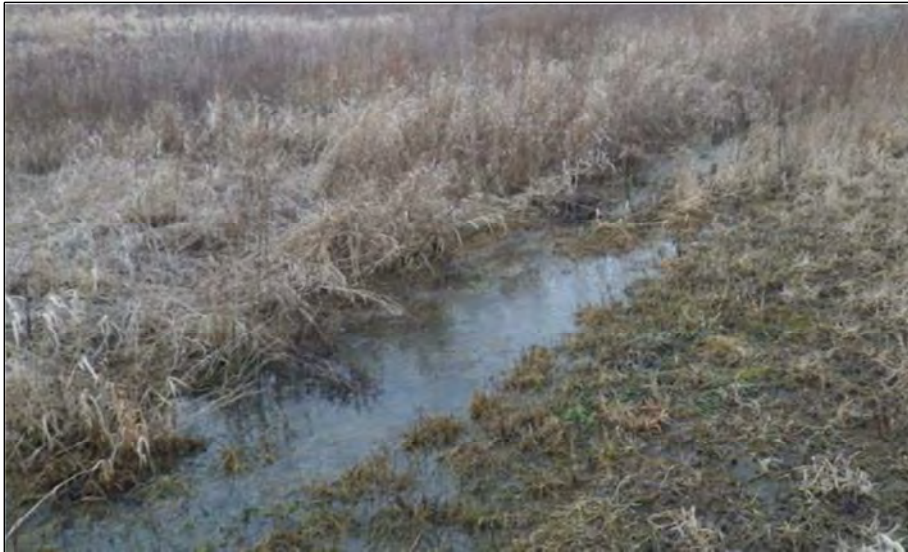
**27. HT -2b -2 (Segment 2).** Facing upstream, mid -Segment. Feature type is swale and flow condition is surface flow substantial.

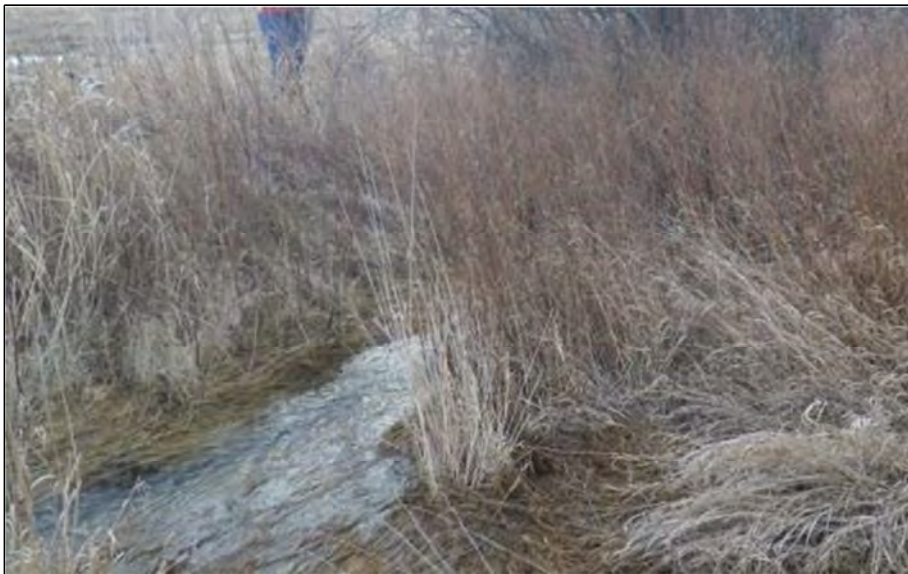
**28. HT -2b -2 (Segment 2).** Facing downstream at end of Segment. Feature type is swale and flow condition is surface flow substantial.

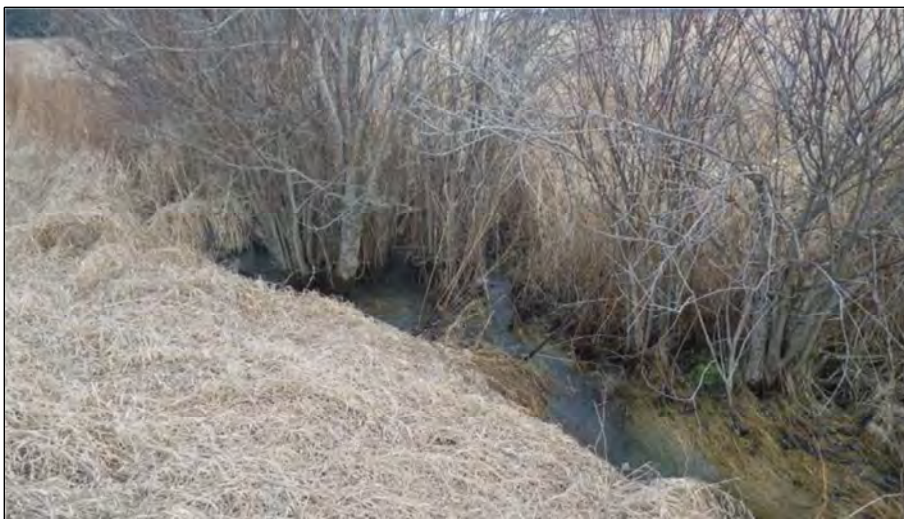
**32. HT -2b -2 (Segment 3).** Upstream end of Segment where feature transitions into feature type defined natural channel (visible banks). Flow condition is surface flow substantial.

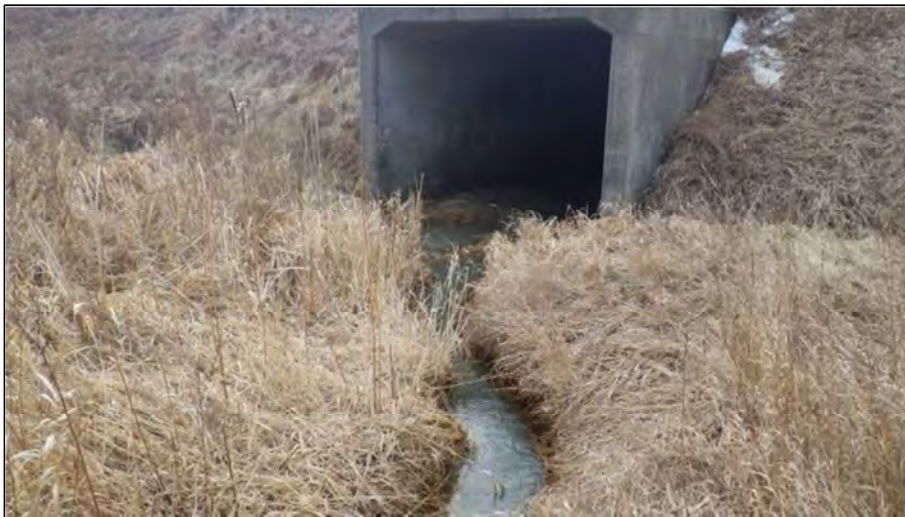
**34. HT -2b -2 (Segment 3).** Facing downstream to culvert at Trafalgar Road, note well -defined channel banks. Feature type is defined natural channel (visible banks); flow condition is surface flow substantial.

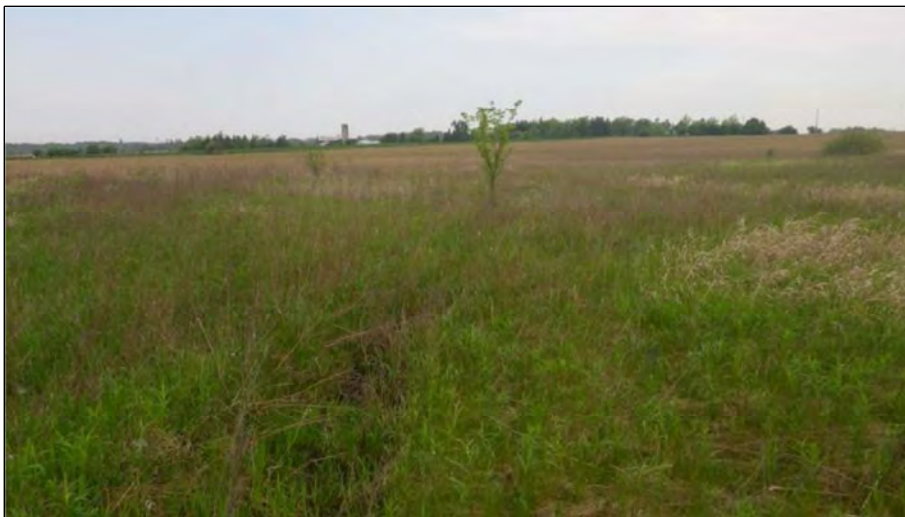
**50. HT -2b -4 (Segment 1).** Facing downstream towards agricultural fields. Several depressions no singular flow path. Feature type is no defined feature (overland flow only); flow condition is no surface water.

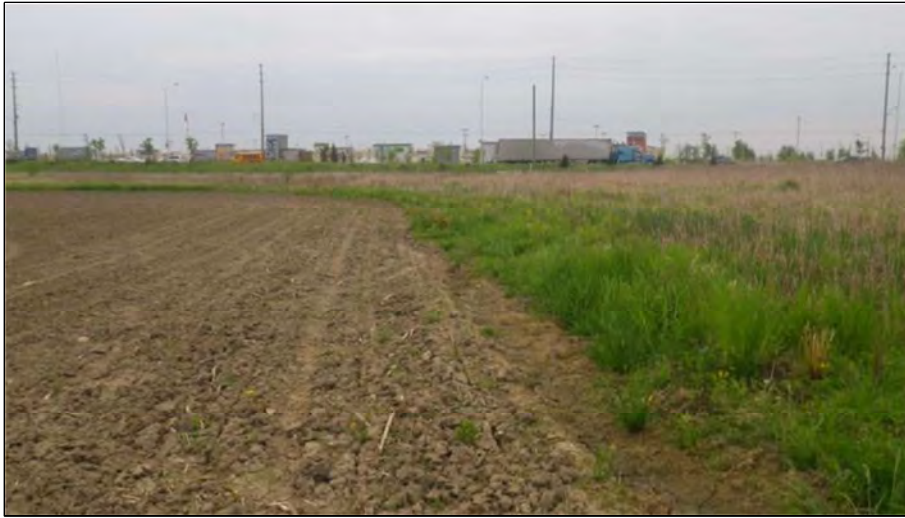
**51. HT -2b -4 (Segment 1).** Facing upstream towards Steeles Avenue from agricultural field. Feature type is no defined feature (overland flow only); flow condition is no surface water.

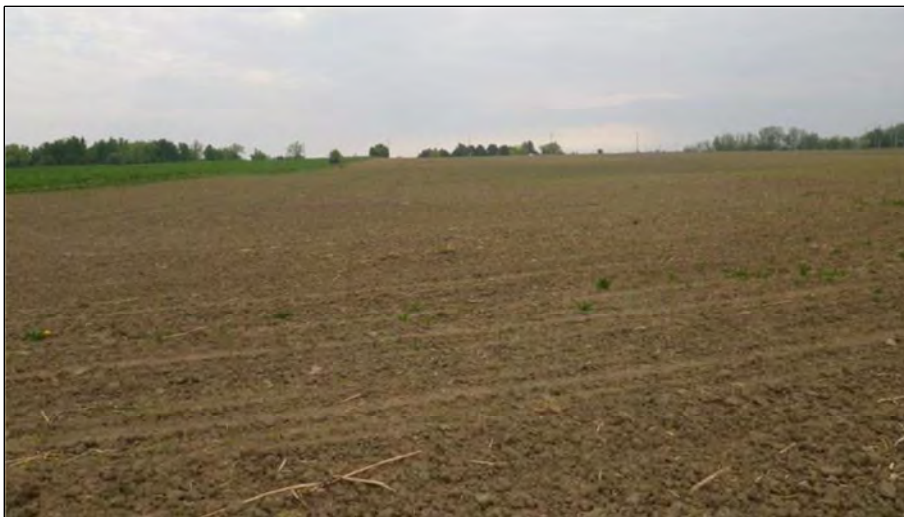
**64. HT -2b -4b.** Facing east across field where feature was located at Site Visit #1. Feature is no longer visible as field appears to have been reworked. Flow condition is dry, feature type is channelization (modified agricultural). **Management Recommendation: No management required.**
