Appendix F

Stream Morphology

Project: Premier Gateway SWS: HT-1 Detailed Site

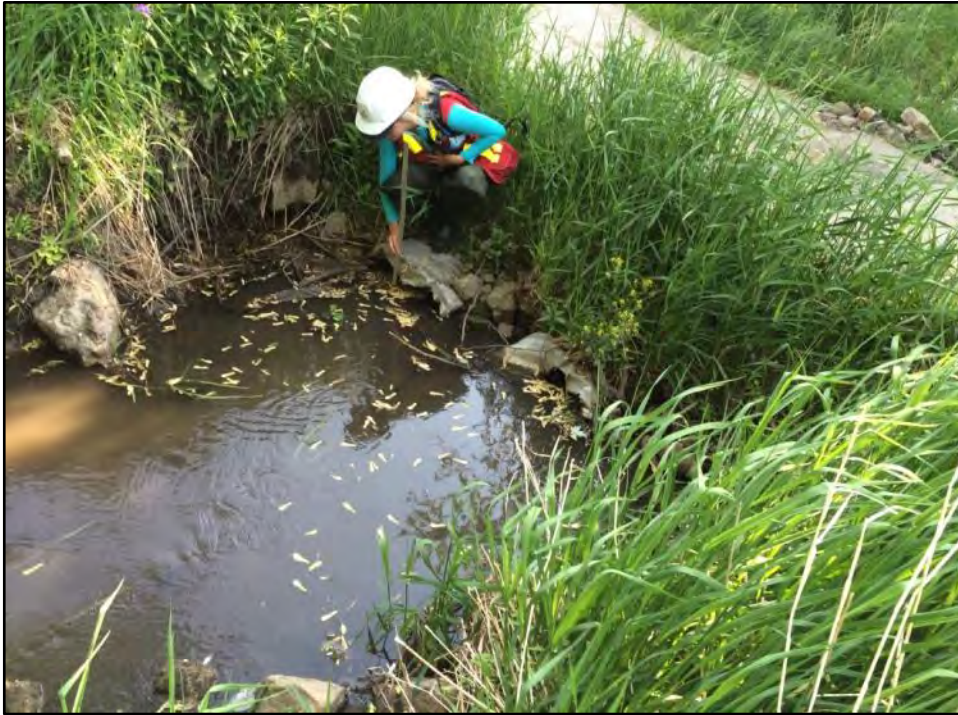
48. E-T1-3 CSP's damaged by weight of crossing, did not convey water efficiently.

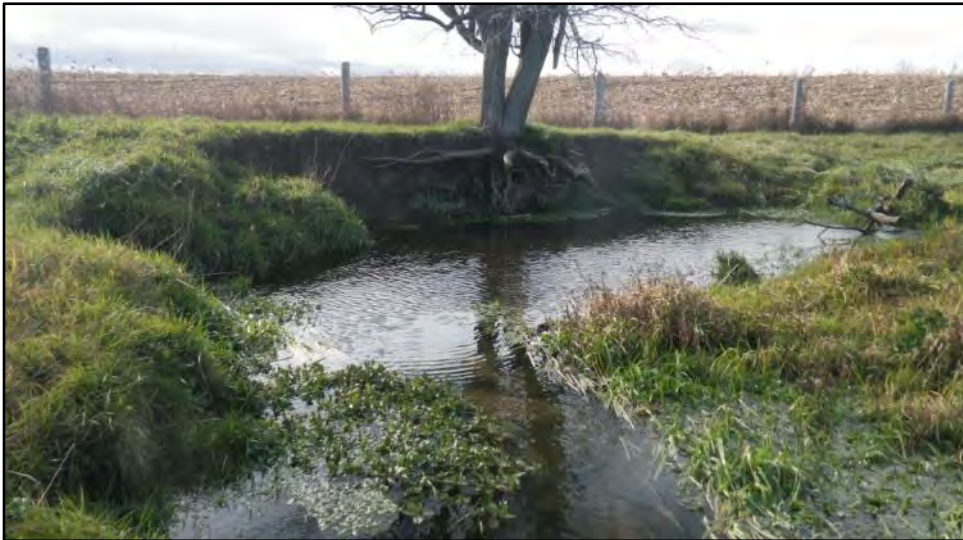
55. E-T1-2 Bank failure and other areas of erosion due to surrounding landuse.

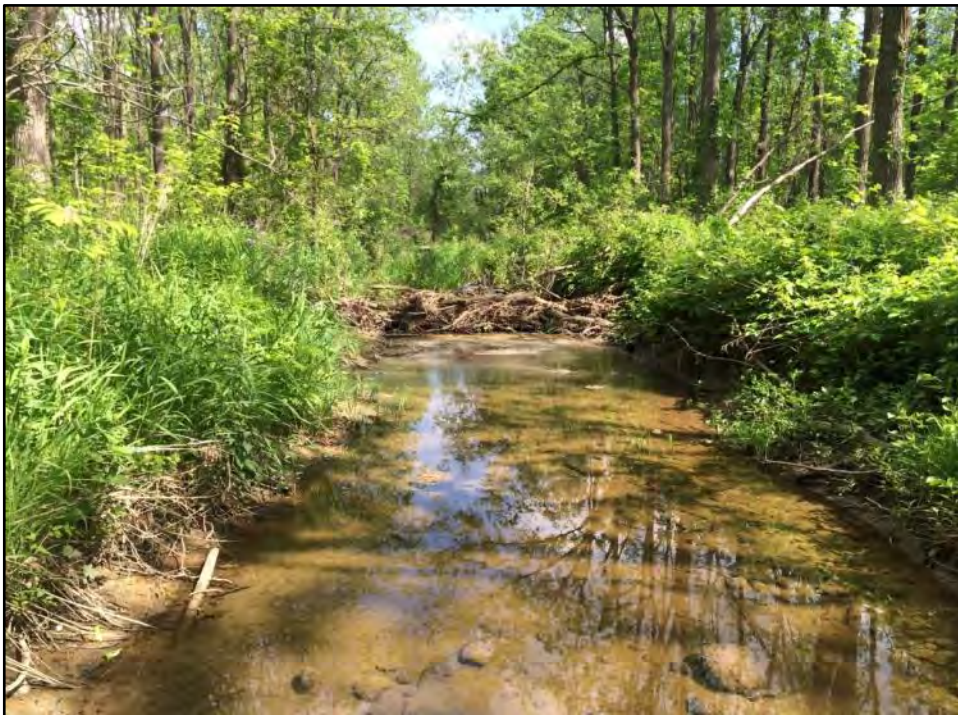
83. HT-2a-2 Woody debris jam consisting of large vegetation causing siltation upstream of it. WDJ found at downstream end of reach.

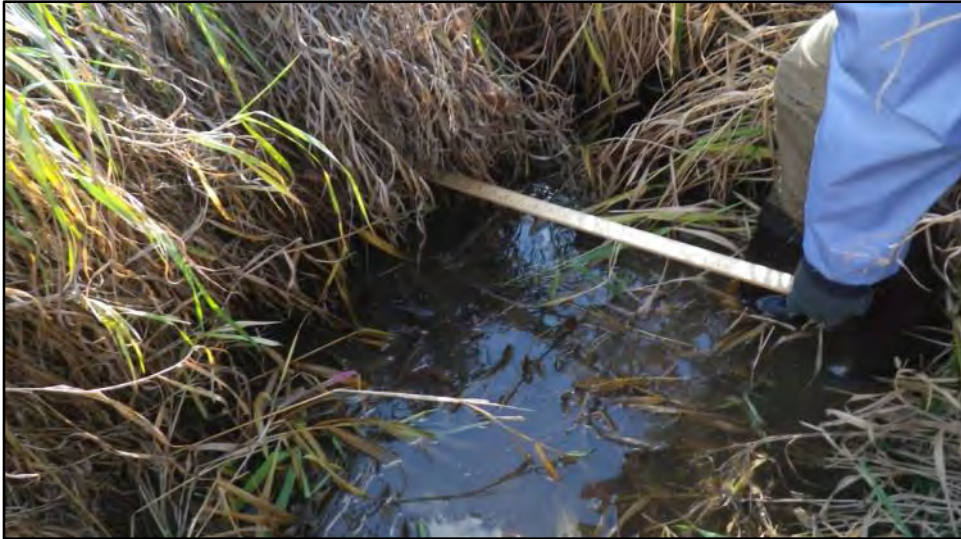
96. HT-2b-1 Severe undercutting found at parts of the reach. Up to 0.30m of undercutting observed.

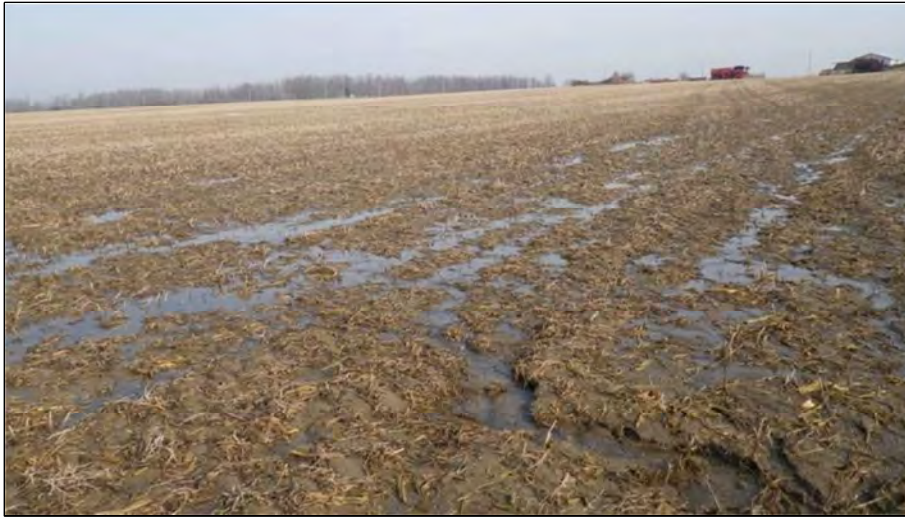
1. **HT -2b -3b.** At upstream end of feature where flow begins to follow defined flow path. Facing upstream. Feature type is swale and flow condition is surface flow minimal.

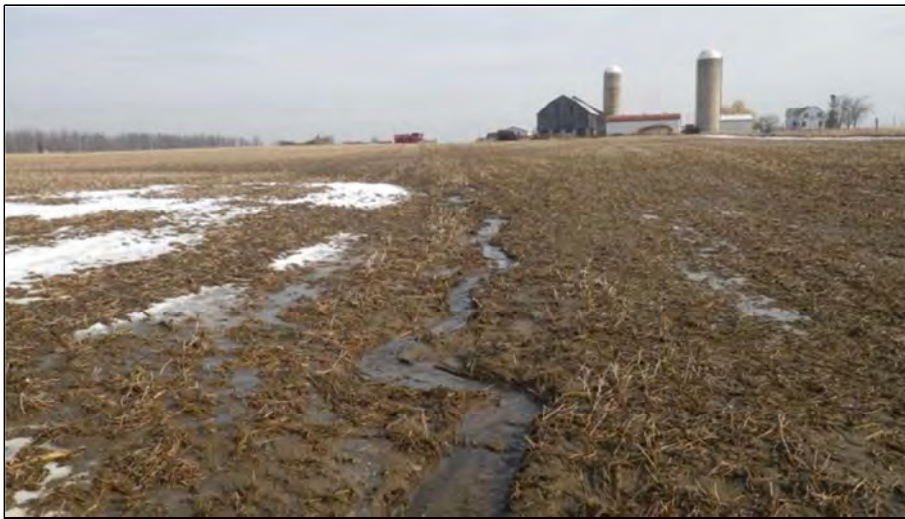
2. **HT -2b -3b.** Mid -feature, facing upstream. Note defined flow path and some development of sinuosity. Feature type is swale and flow condition is surface flow minimal.

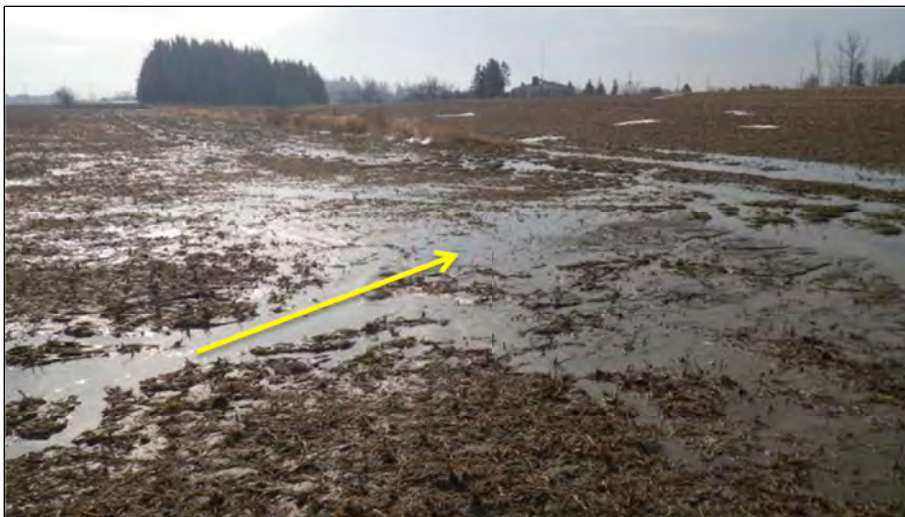
4. **HT -2b -3b.** Downstream end of feature where it meets HT -2b -3, flow disperses. Feature type is swale and flow condition is surface flow minimal. Yellow arrow indicates direction of flow.

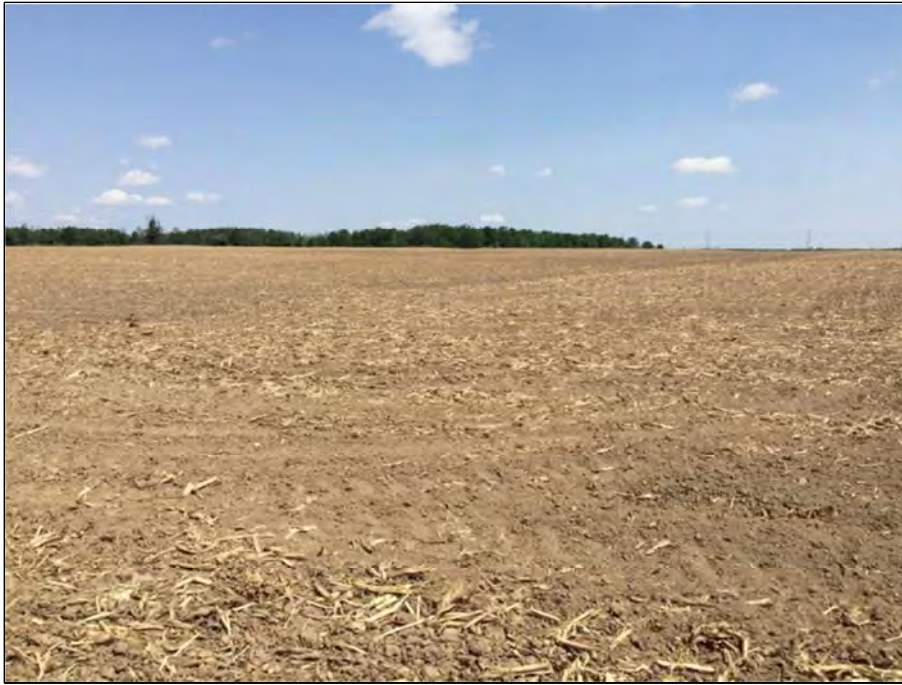
5. **HT -2b -3b.** Area where feature would be located facing upstream. Feature type is swale, flow condition is dry. **Management recommendation: No Management**

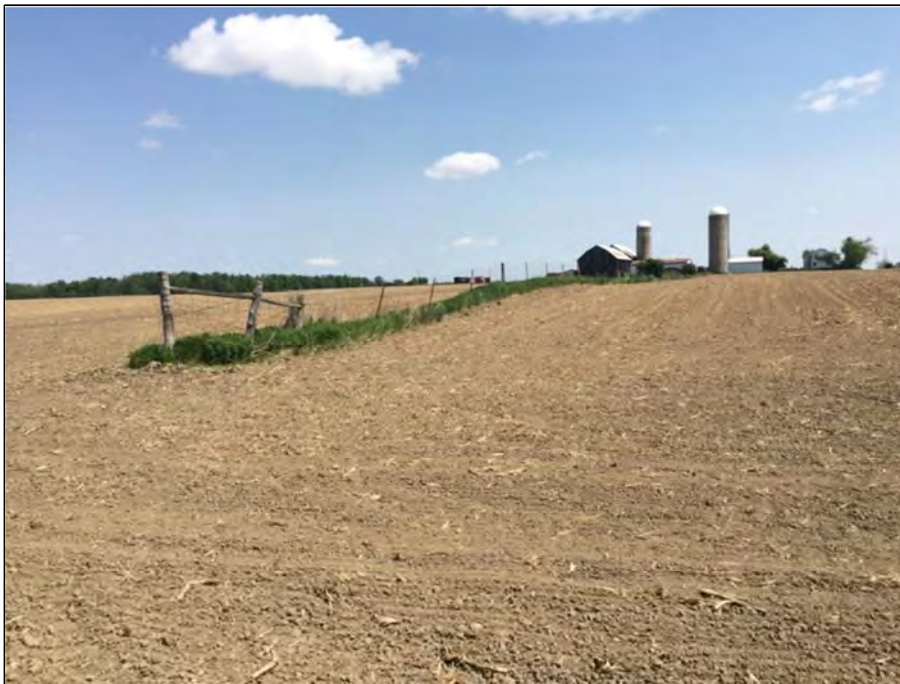
10. **HT -2b -3a.** Facing upstream in vicinity of feature. No depression was visible. Flow condition was no surface water and feature type was swale. **Management Recommendation: No management required.**

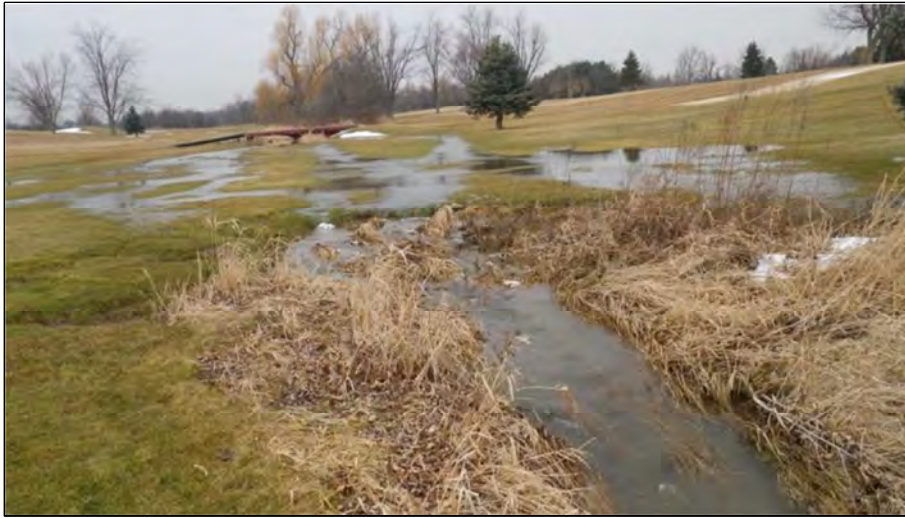
71. E -T1 -4 (Segment 1). Facing upstream towards third cart path crossing. In background of photo water is pooling at surface where it has overwhelmed the pipe. In foreground, pipe outlets into grasses area, where flow is relatively fast and erosion has occurred around the outlet. Wetted depth is 14cm. Feature type is classified as tiled drainage (buried stream/pipe) because the feature is primarily piped through the extent of the golf course. Flow condition is surface flow substantial.

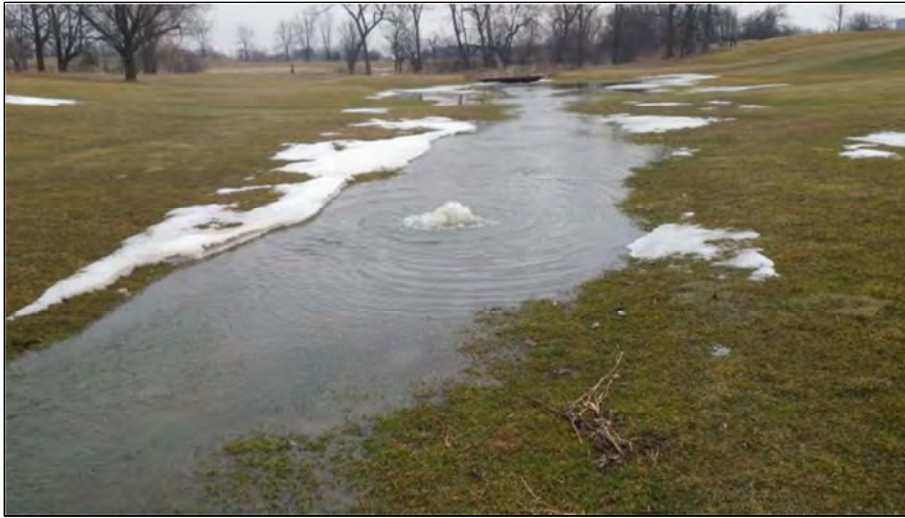
73. E -T1 -4 (Segment 1). Facing downstream towards fifth cart path crossing. Overland flow through piped section downstream of fourth cart path crossing. Hole in pipe as indicated by bubbling water in photo. Feature type is classified as tiled drainage (buried stream/pipe) because the feature is primarily piped through the extent of the golf course. Flow condition is surface flow substantial.
