**PHASE ONE  
ENVIRONMENTAL SITE ASSESSMENT  
1 ROSETTA STREET  
GEORGETOWN, ONTARIO**

**Prepared for:** 1 Rosetta Street (Halton Hills) GP Limited  
700 Lawrence Ave. W #375  
Toronto, Ontario  
M6A 3B4

File No 1-20-0249-41  
September 29, 2020

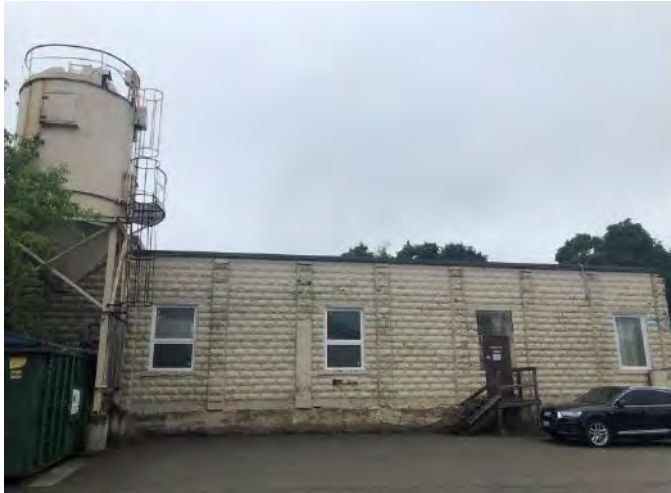
Photograph 1

Location: Phase One Property (1 Rosetta Street)  
Viewing: West  
Description: Viewing the east side of the building on the Property.

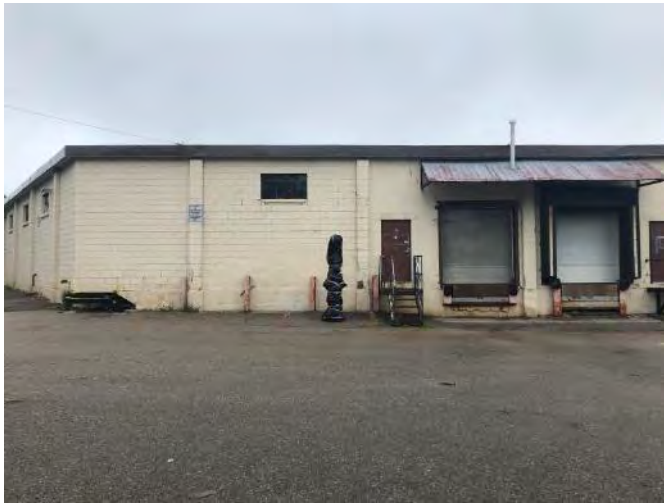
Photograph 2

Location: Phase One Property (1 Rosetta Street)  
Viewing: East  
Description: Viewing the west side of the two building on the Property.

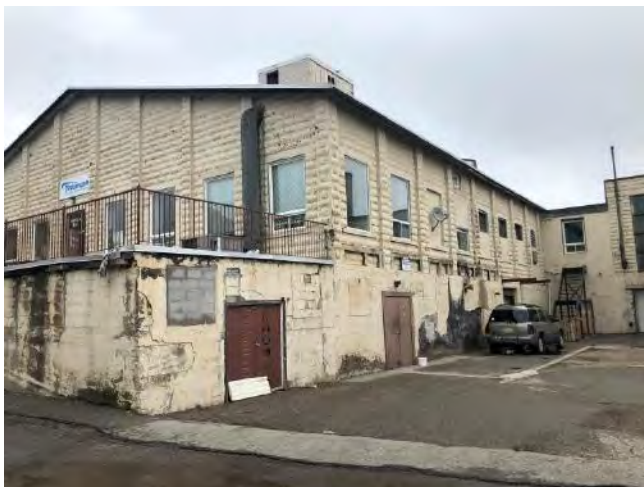
Photograph 3

Location: Phase One Property (1 Rosetta Street)  
Viewing: Northeast  
Description: Viewing the west side of the building on the Property

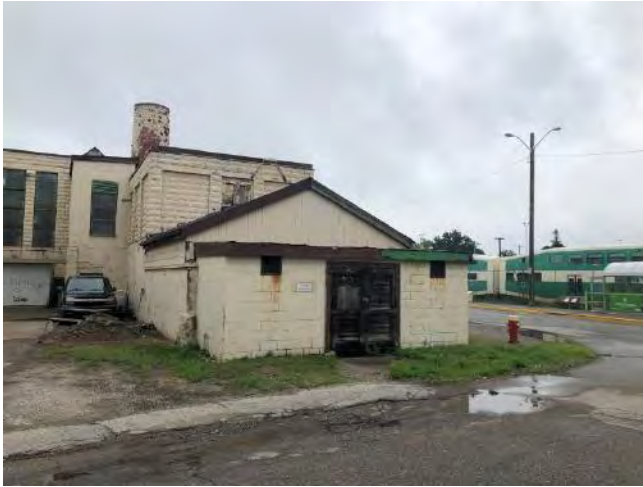
Photograph 4

Location: Phase One Property (1 Rosetta Street)  
Viewing: East  
Description: Viewing the west side of the building on the Property.

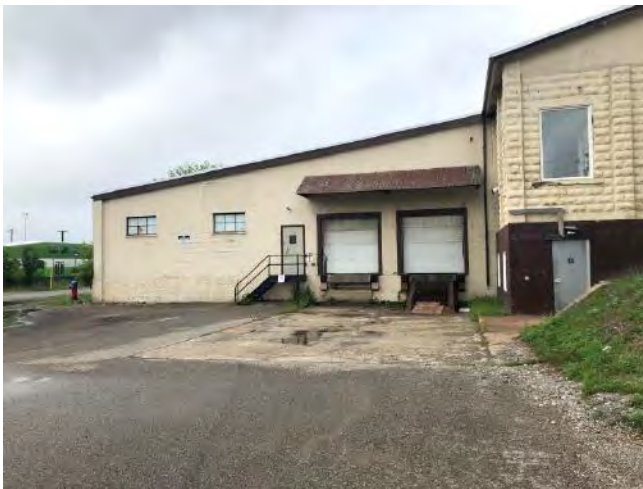
Photograph 5

Location: Phase One Property (1 Rosetta Street)  
Viewing: West  
Description: Viewing the east side of the building on the Property.

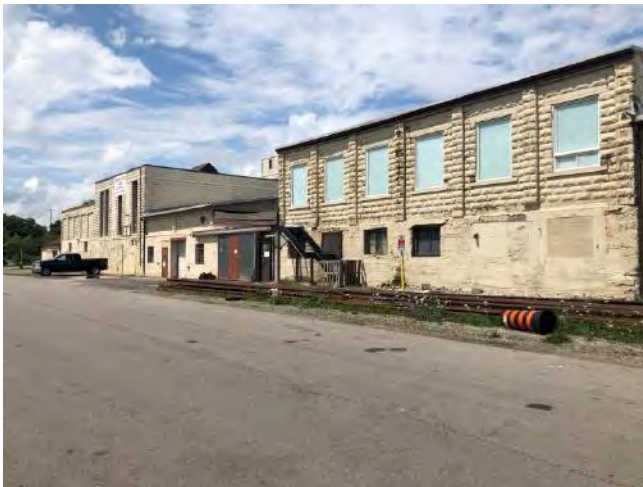
Photograph 6

Location: Phase One Property (1 Rosetta Street)  
Viewing: Northwest  
Description: Viewing the south side of the building on the Property.

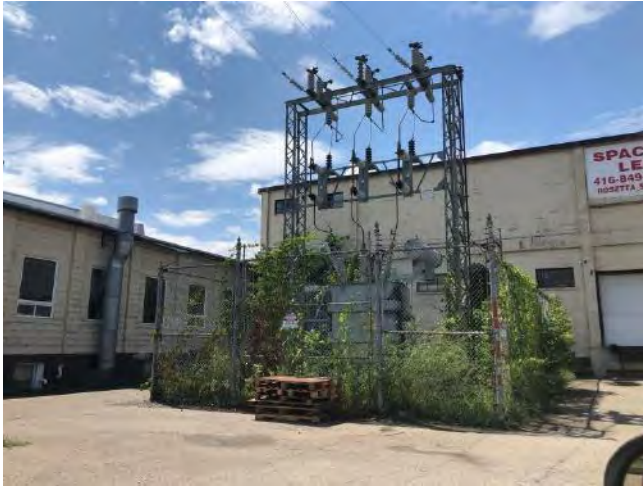
Photograph 7

Location: Phase One Property (1 Rosetta Street)  
Viewing: West  
Description: Viewing the east side of the building on the Property with transformer.

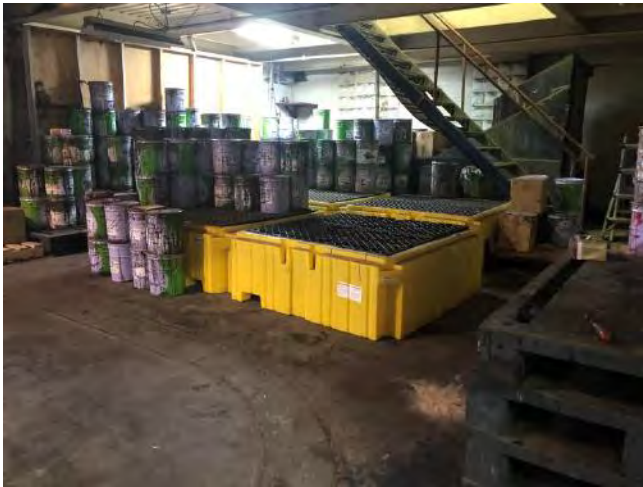
Photograph 8

Location: Phase One Property (1 Rosetta Street) – Unit 4  
Viewing: N/A  
Description: Viewing coatings leaks containments and coatings storage at Unit 4 of the building on the Property.

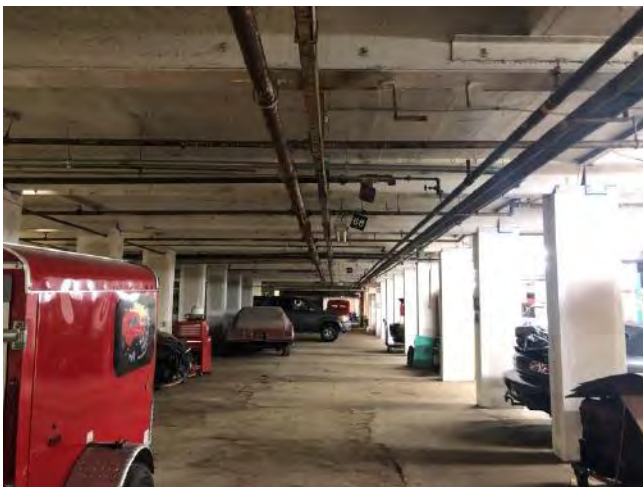
Photograph 9

Location: Phase One Property (1 Rosetta Street) – Unit 11  
Viewing: N/A  
Description: Viewing garage inside Unit 11 of the Phase One Property.
