**Phase I Environmental Site Assessment at
16-18 Mill Street
Georgetown, ON**

**Report #6967 – AGK Georgetown
January 12, 2023**

Re: A Phase I Environmental Site Assessment at 16-18 Mill Street, Georgetown, Ontario

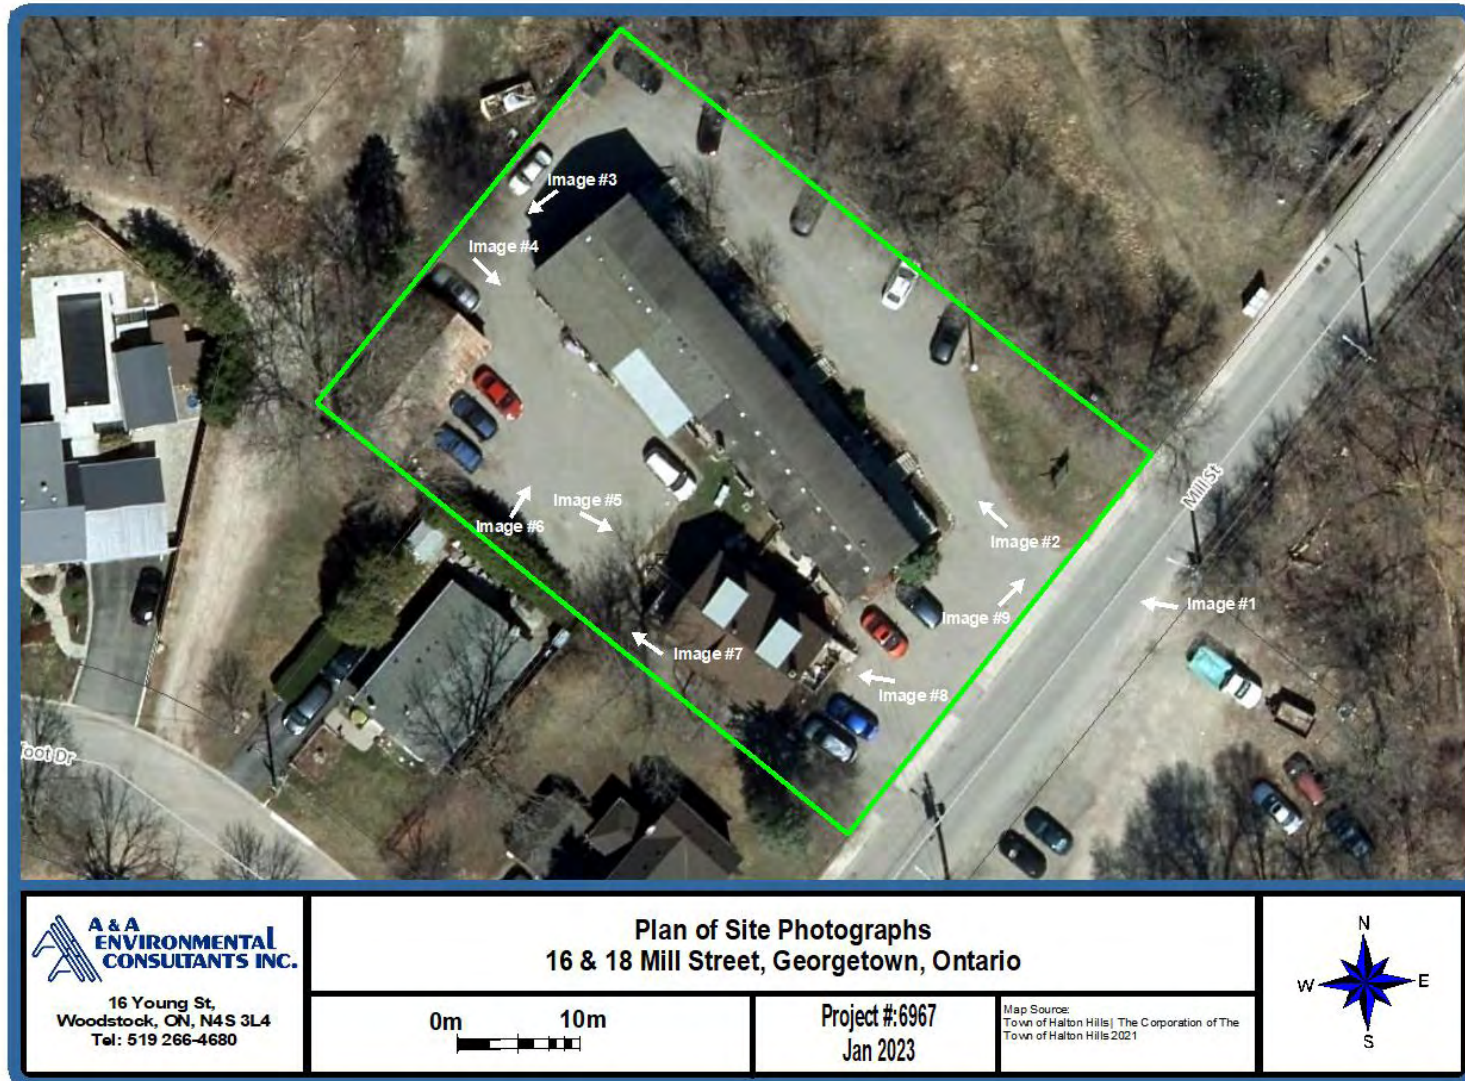
Figure 7 – Plan of Site Photographs

A photographic record of the site inspection and a plan with photo directions are shown in the figures below.

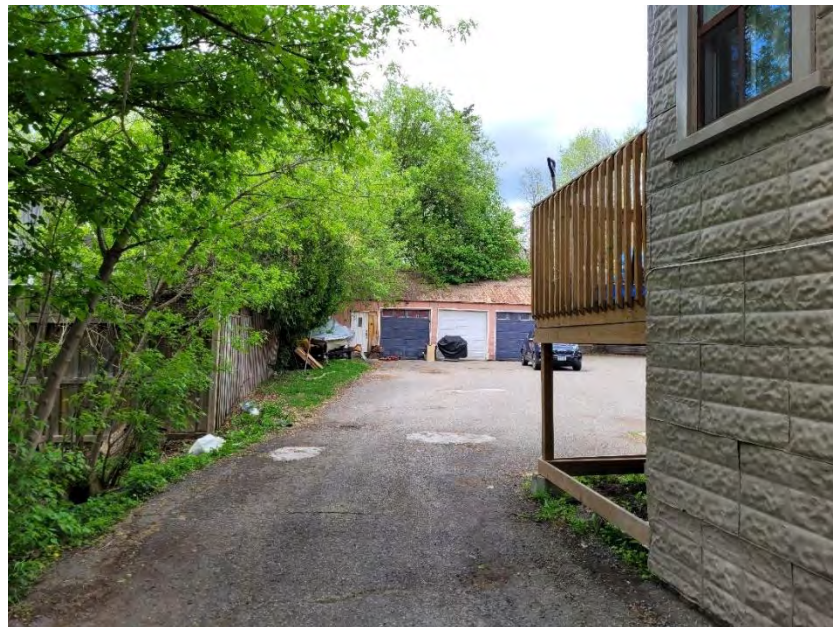
Image #7
View looking west
along 18 Mill Street
at the detached
garage building in
the southwest
corner of the
property

There was also a three-car detached garage noted on the western corner of the site. Constructed of metal clad siding and a tin roof. No access was granted for the garage building.
