Glen Williams Phase II: Addendum 2

Charleston Developments
(1404649 Ontario Limited)

Glen Williams Phase II EIR: Addendum 2

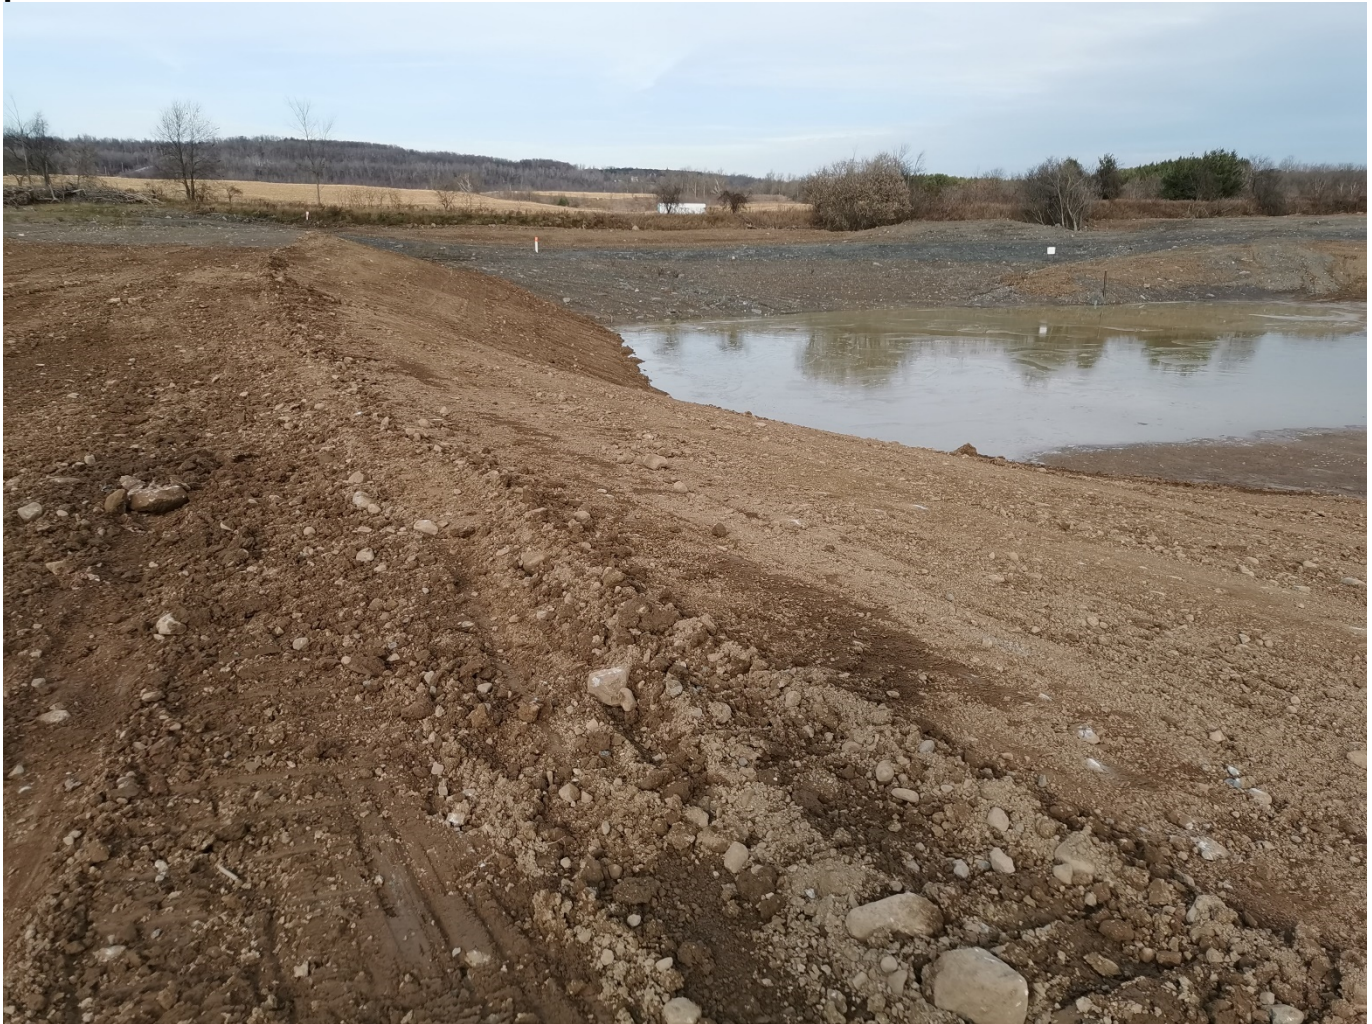
Figure 2. Photo of the area where the wetland was removed looking toward the northeast portion of the site

Soil is banked at a low gradient near the depression. Figure 2 provides a photo of the area where the wetland was removed.

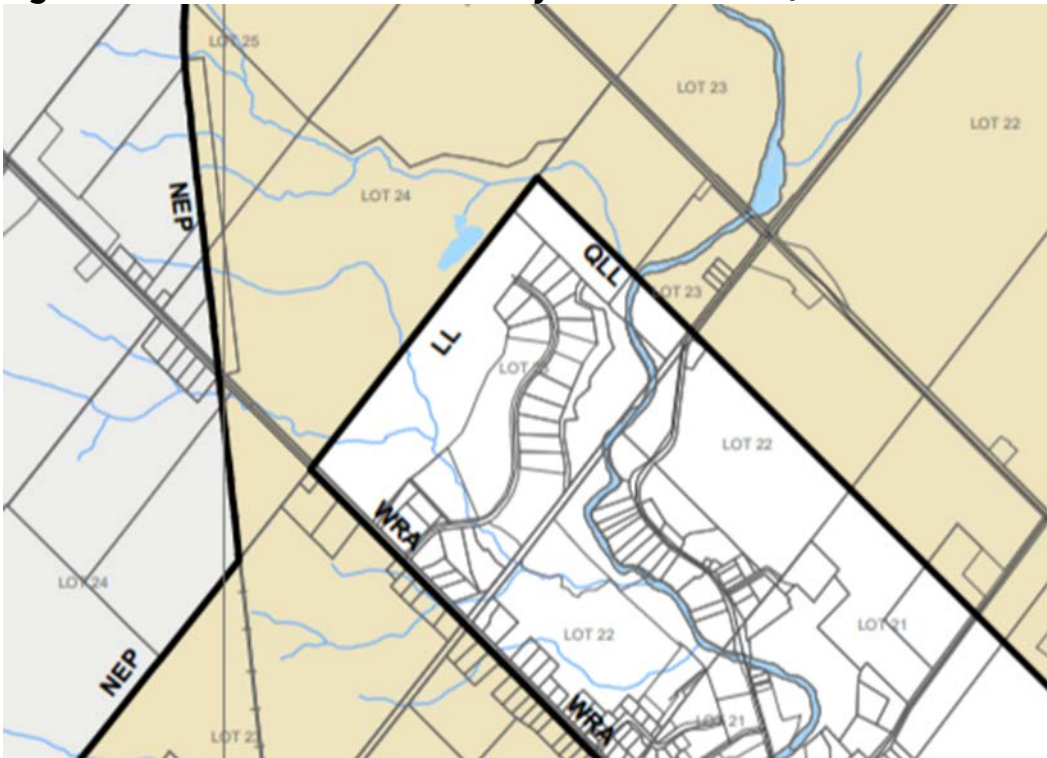
Figure 5. Greenbelt Protected Countryside to the North, East and West of the Site

The Greenbelt Natural Heritage System to the north of the site is shown in Figure 5. The Greenbelt Natural Heritage System protects Key Natural Heritage Features and Key Hydrologic Features. Key Natural Heritage Features include:

The off-site forest unit to the east is within the Greenbelt Natural Heritage System, as shown in Figure 5. It is considered a Key Natural Heritage Feature. The buffer associated with Key Natural Heritage Features within the Greenbelt is 30 m. However, this buffer requirement does not apply within the site.

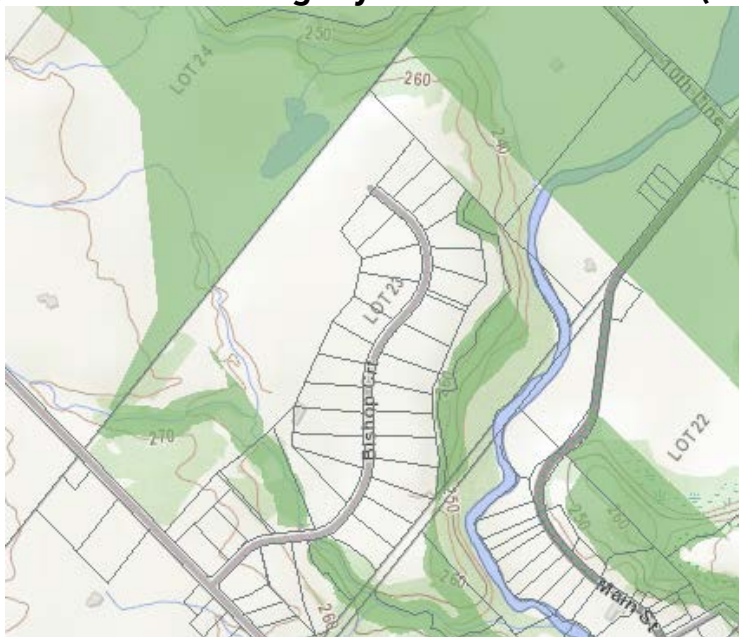
Figure 6. Natural Heritage System for the Greenbelt (Off-site) and Region of Halton (On-site)

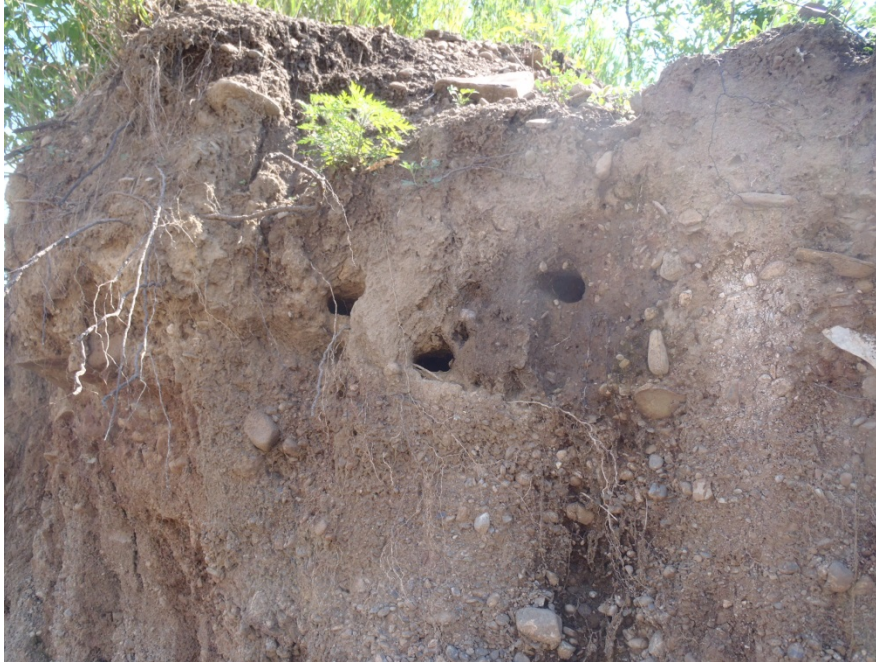
Figure 3. Photograph of Bank Swallow nesting holes at subject property. Photograph taken by CVC staff on July 15, 2015.
