# **ENVIRONMENTAL IMPLEMENTATION REPORT**

**PROPOSED RESIDENTIAL DEVELOPMENT  
2147925 ONTARIO INC.  
LOCATED IN GLEN WILLIAMS  
(MCMASTER STREET AND MEAGAN DRIVE)**

**EDEN OAK HOMES  
1443 HURONTARIO STREET  
MISSISSAUGA, ONTARIO  
L5G 3H5**

**LGL PROJECT TA4886**

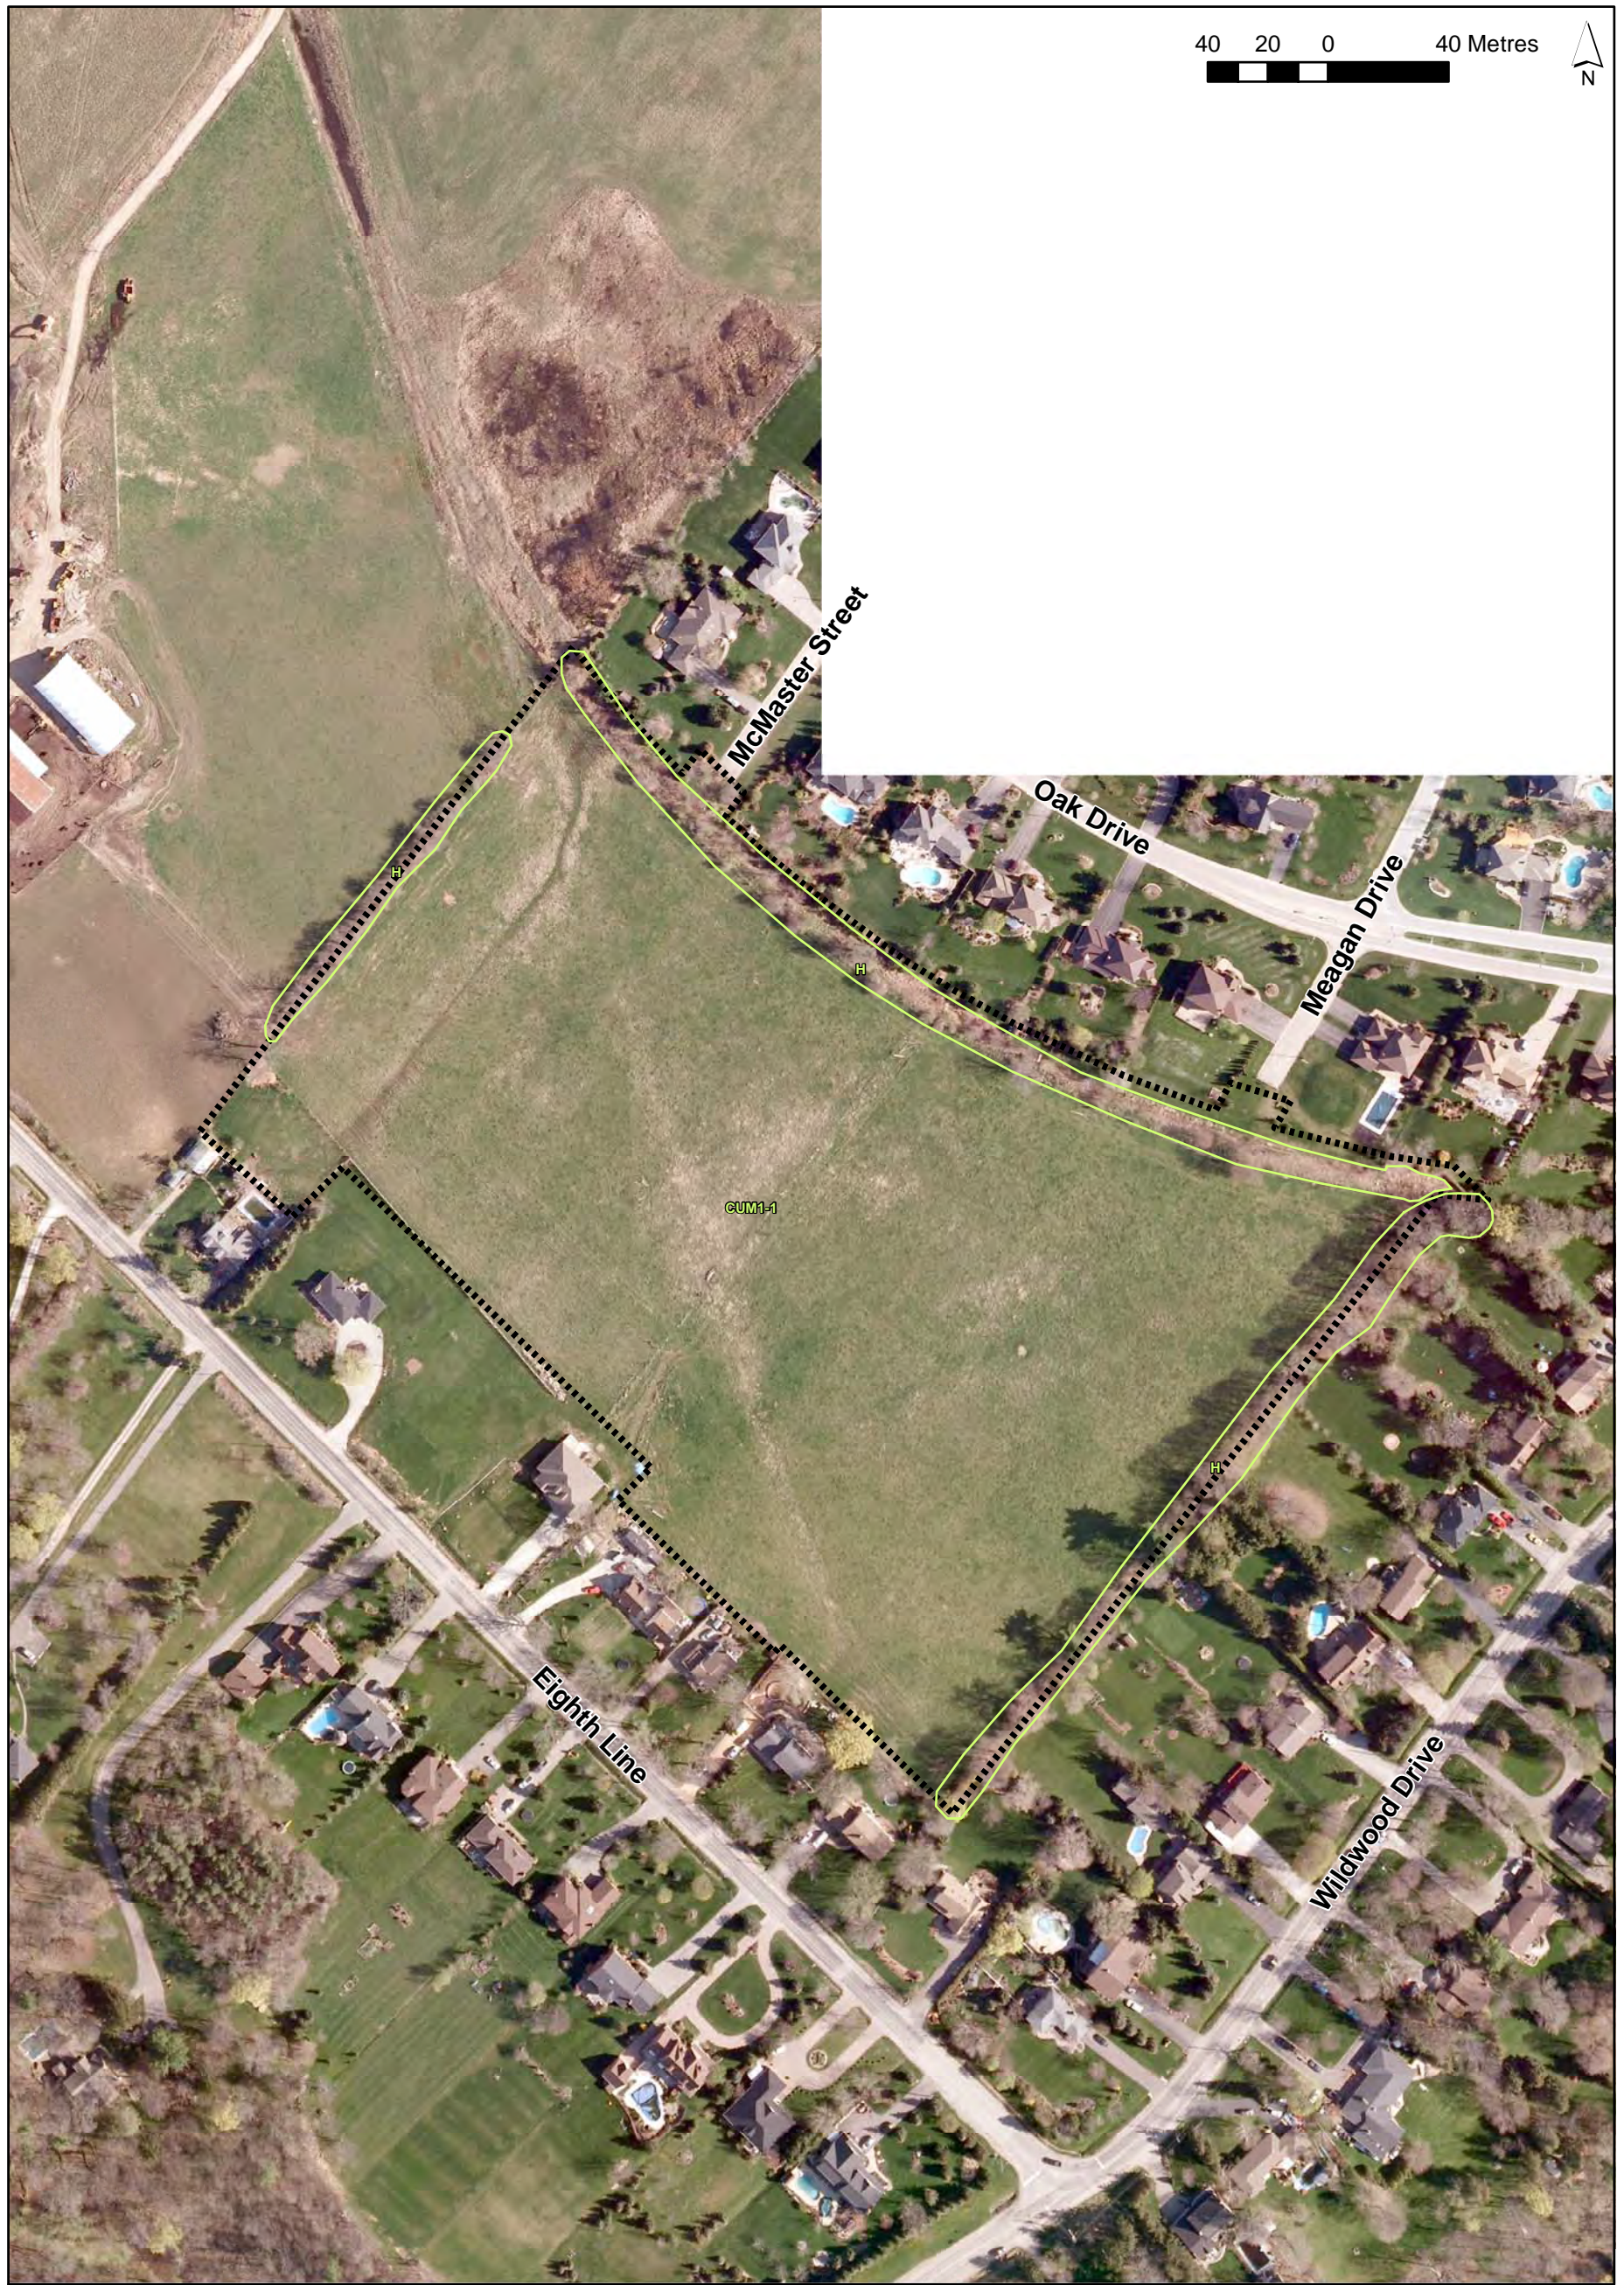
-   Development Limit
- Vegetation Communities**
-   Vegetation Community Boundary
-   Dry-Moist Old Field Meadow Type
-

Lands on and adjacent to the subject property have been cleared of original forest cover to accommodate existing agricultural, residential and infrastructure (former railway) land use. The subject property is predominantly used for agriculture which makes up at least 90% of the site. A small cultural meadow measuring less than 0.5 ha is located in the northwest corner of the property. This vegetation community is considered widespread and common in Ontario and secure globally. This vegetation community is delineated on **Figure 3** and described in **Table 1**. No other vegetation community was identified; however, there are several hedgerows along the perimeter of the property. Some of the trees within the hedgerows are located at the rear boundary of adjacent residential lots. The majority of the hedgerows along the north-western and south-eastern boundaries are located on private property; therefore an inventory of these trees was not carried out. The trees located along the north-eastern boundary occur

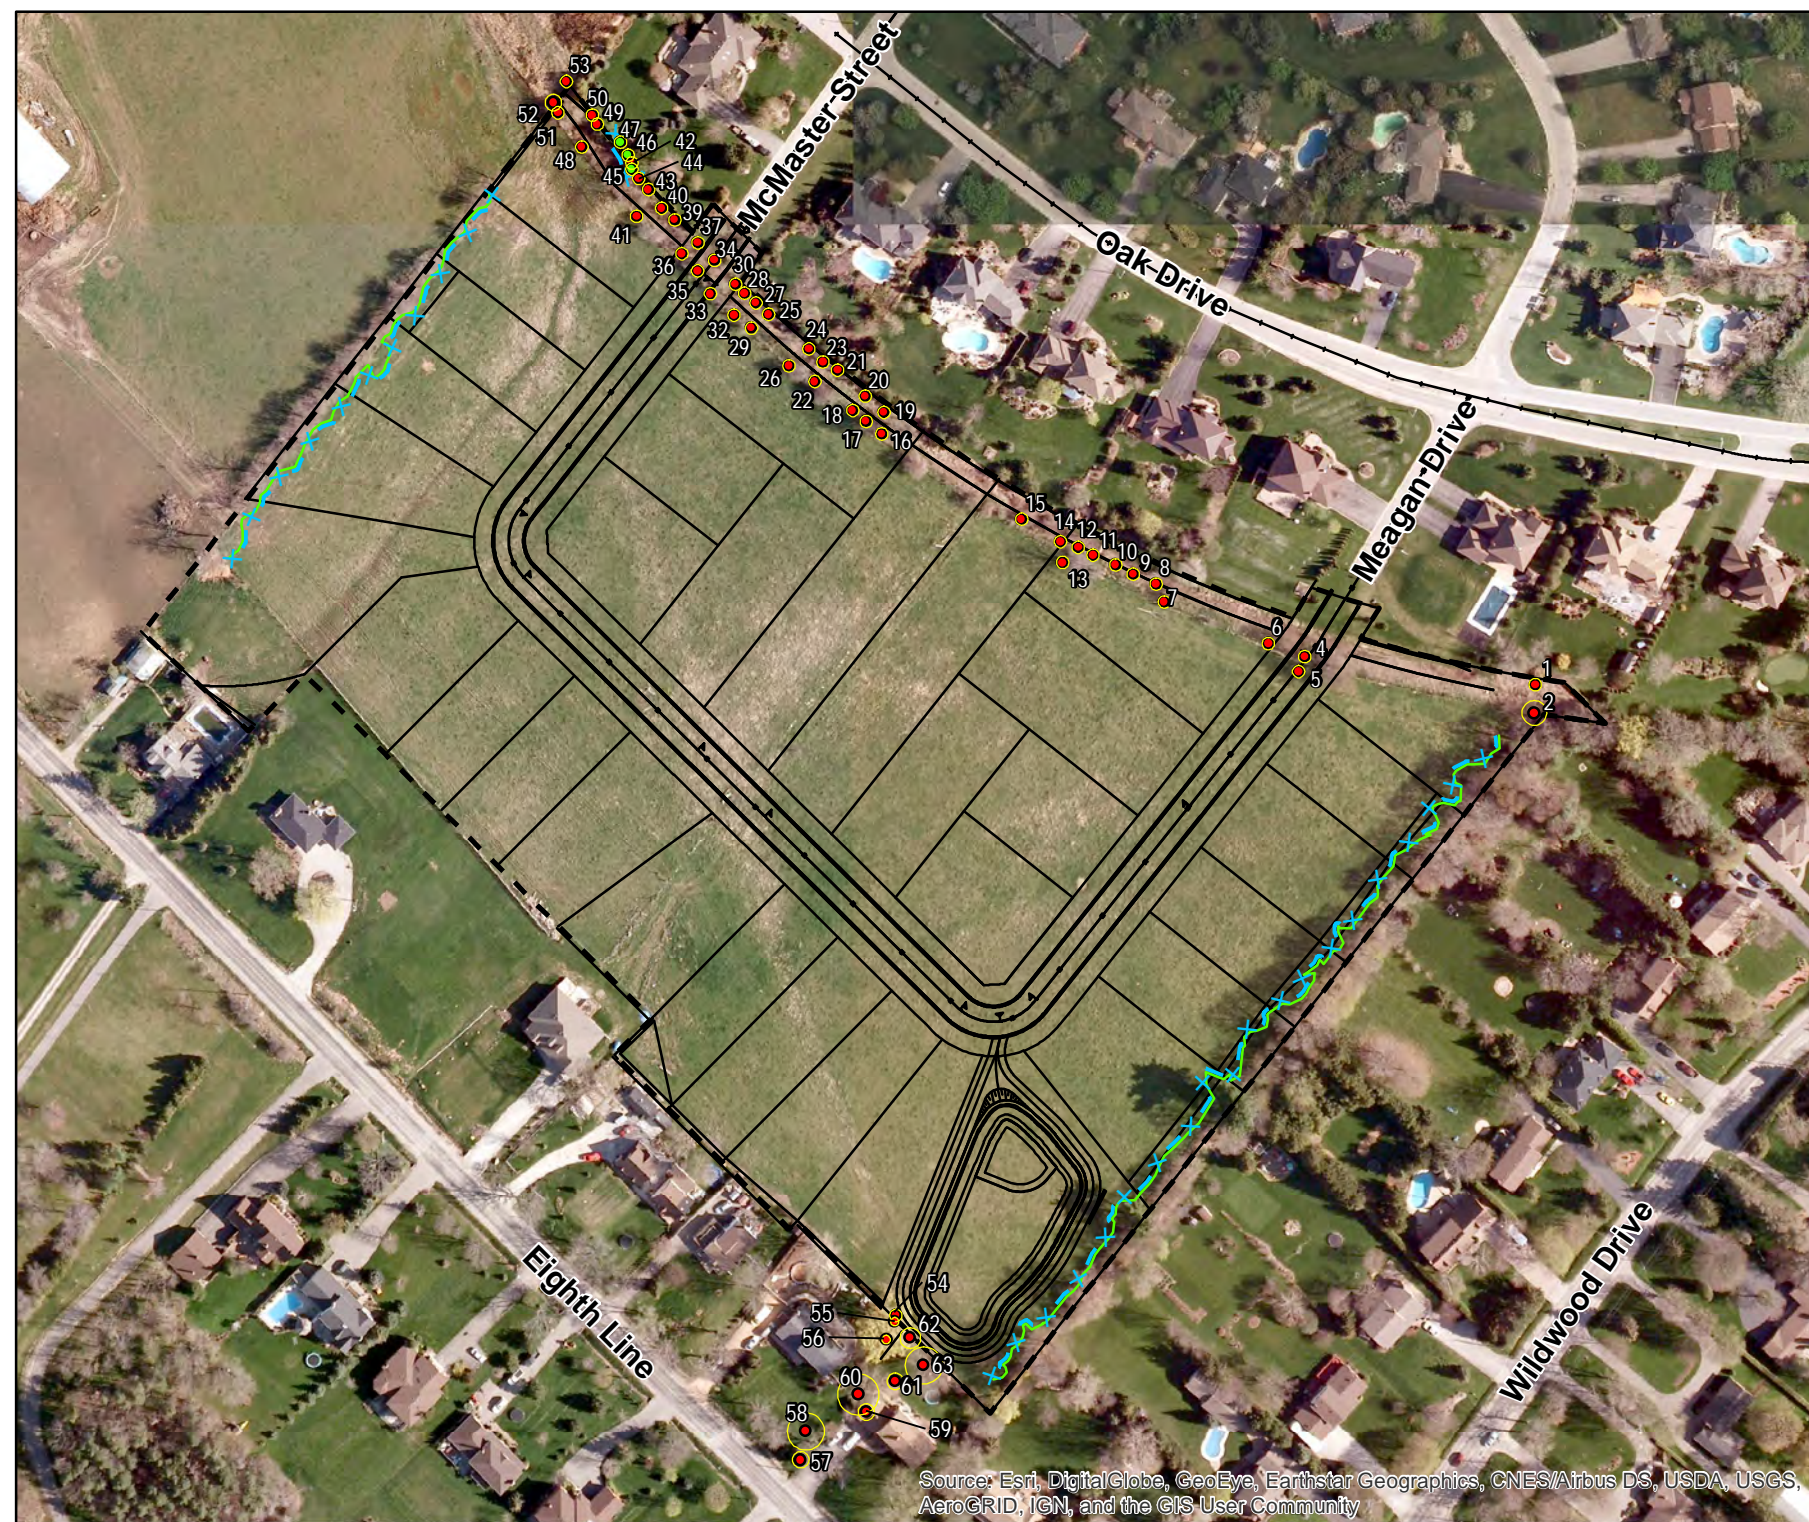
## TREE PRESERVATION PLAN Part of Lot 21, Concession 9

3. TREE PROTECTION FENCING: Tree Protection Fencing should be 1.2 m (4ft.) high and consist of orange plastic web snow fencing on a wood frame made of 2"x 4"s. All supports and bracing to safely secure the fencing should be outside to TPZ. All such supports and bracing should minimize damage to roots outside of the TPZ.

Project: TA4886	Figure: 4
Date: July, 2019	Prepared By: JJP
Scale: 1 : 2,200	Checked By: LMC

To mitigate impacts to trees on adjacent properties tree protection fencing is recommended at a minimum 1 m beyond the dripline of the trees within the north-western and southern-eastern hedgerows. Consequently, grading within Block 33 has been minimized to the extent possible and will remain outside of the dripline plus 1 m of these hedgerows. The locations of the recommended tree protection fencing are presented on the Tree Preservation Plan (**Figure 7**).
