**PHASE ONE  
ENVIRONMENTAL SITE ASSESSMENT  
WEST HALF LOT 21, CONCESSION 9 (ESQUESING)  
GLEN WILLIAMS, ONTARIO**

**Prepared for:** 2147925 Ontario Inc.  
c/o Condeland Engineering  
350 Creditstone Road, Suite 200  
Concord, L4K 3Z2

File No 1-18-0438-41  
November 14, 2019  
©**Terraprobe Inc.**

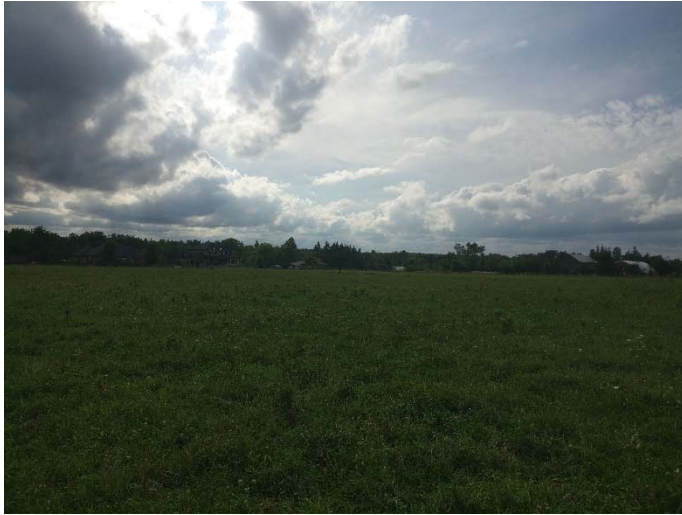
Photograph 1

Location: Subject Property

Viewing: Northwest

Description: Vacant pasture field, showing farm property to the north and residential to the west.

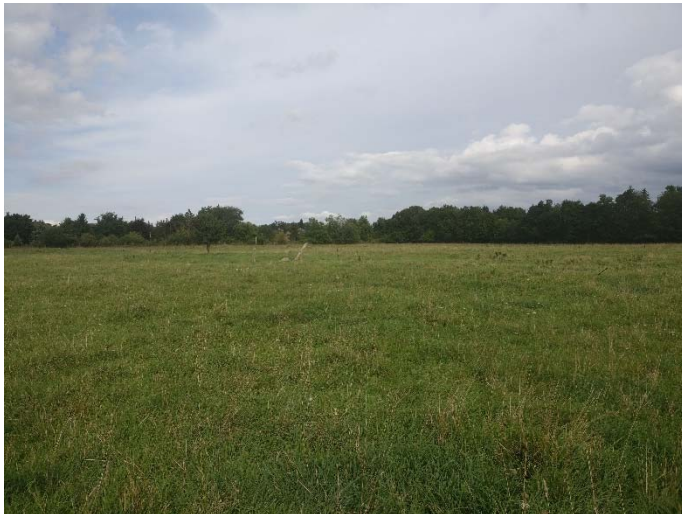
Photograph 2

Location: Subject Property
