**CULTURAL HERITAGE RESOURCE ASSESSMENT**

**TOWN OF HALTON HILLS PREMIER GATEWAY PHASE 1B EMPLOYMENT AREA SECONDARY PLAN  
LOTS 1 AND 2, CONCESSIONS 7 AND 8, FORMER TOWNSHIP OF ESQUESING**

**TOWN OF HALTON HILLS,  
REGIONAL MUNICIPALITY OF HALTON, ONTARIO**

Revised May 2018

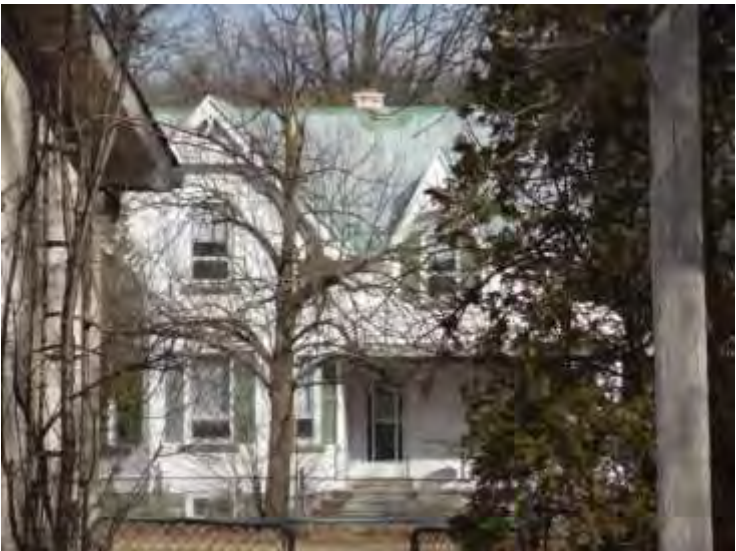
<p>View of the main residence from Hornby Road, looking east.</p>

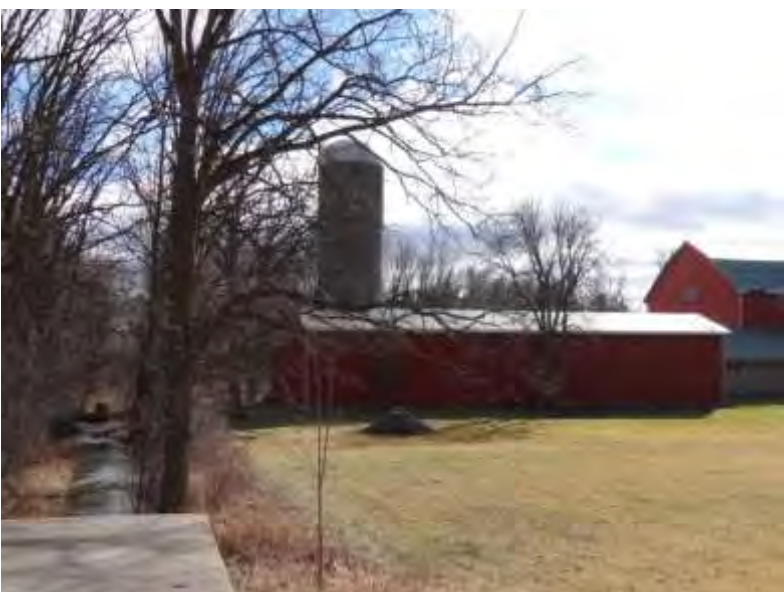
<p>View of barn, silo, and outbuilding, with mature trees and creek at left, looking west from Trafalgar Road. Source: Bing Maps, 2015</p>

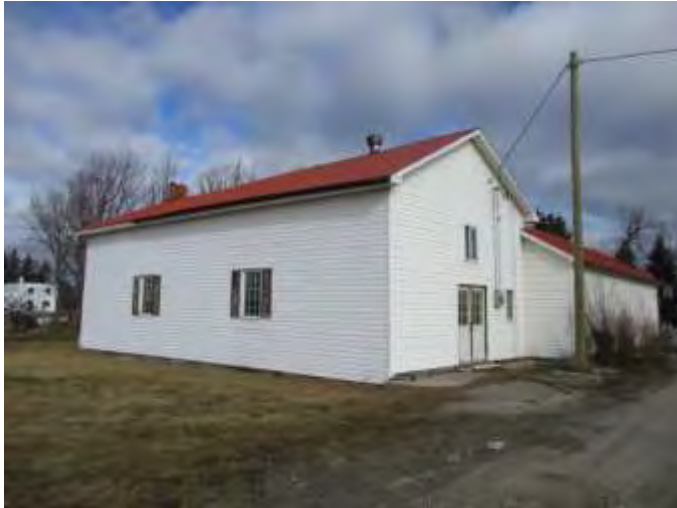
BHR 1	12927 Steeles Avenue, Lot 1, Concession 7	Community Hall	Listed in the Town of Halton Hills Municipal Heritage Register	<p><i>Existing Conditions:</i></p> <ul style="list-style-type: none"> <li>-One storey community hall structure with and L-shaped plan and intersecting gable roofs located on the north side of Steels Avenue.</li> <li>-Structure consists of two components clad in white siding, with the western structure featuring an end gable roof with a main entrance composed of double doors with nine-paned lights on each located on the south elevation adjacent to Steels Avenue. There is a small rectangular window to the east of the main entrance, and a second small rectangular window above the entrance.</li> <li>-The west elevation features two symmetrically-spaced fixed windows with fifteen lights, bordered by louvered shutters.</li> <li>-The east elevation of the western component features paired central sash windows bordered by louvered shutters, while the east elevation of the eastern structure features a central six-over-six sash window bordered in louvered shutters.</li> <li>-The property is currently occupied by 'Livno Meats'.</li> <li>-Landscape features include an established entrance drive and parking facilities.</li> </ul> <p><i>Historical Summary:</i></p> <p>This site, Loyal Orange Lodge, is identified as having heritage value because it is “one of the oldest buildings in Hornby, serving as a municipal building, community meeting place, and Loyal Orange Lodge.”</p> <p>On the 1858 Tremaine’s Map this property is within the Upper Hornby settlement area, no building is identified. On the 1878 Historical Atlas map the property is within the West Hornby historic settlement area, and may be identified as a shaded rectangle on the map. On the 1917 Guidal Landowners Map the property is within the Hornby historic settlement area. The building is not identified on the c. 1955 Tweedsmuir map. The building is visible in the 1954 aerial photography and on the 1973 NTS topographic mapping.</p> <p>From Halinet: “Oyster suppers were popular here and each Orangeman was able to invite one other couple. The 12th of July parade was always a big event. One time when the parade was held in Guelph, people at the Hornby station were told the train wouldn’t stop in Hornby to let people on to go west to Guelph. Bill Cunningham, who lived in Port Credit, had bought a ticket on the westbound train to Hornby. When the train stopped to let him off, all those going to the parade jumped on board.”</p>

<p>South and west elevations, looking northeast.</p>

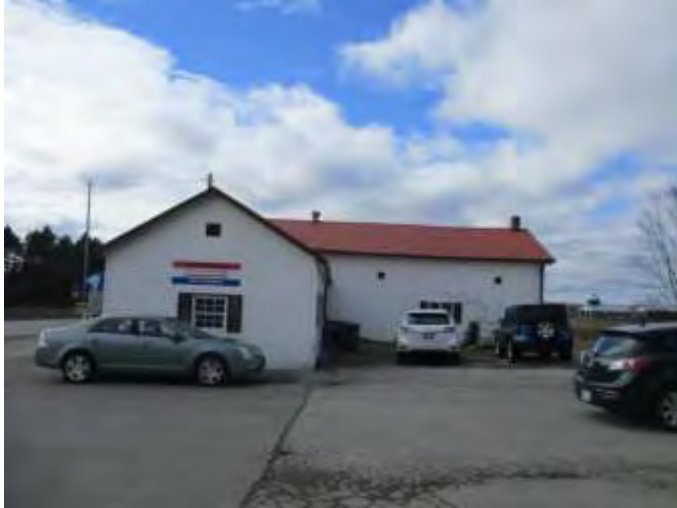
<p>East elevation, looking west.</p>

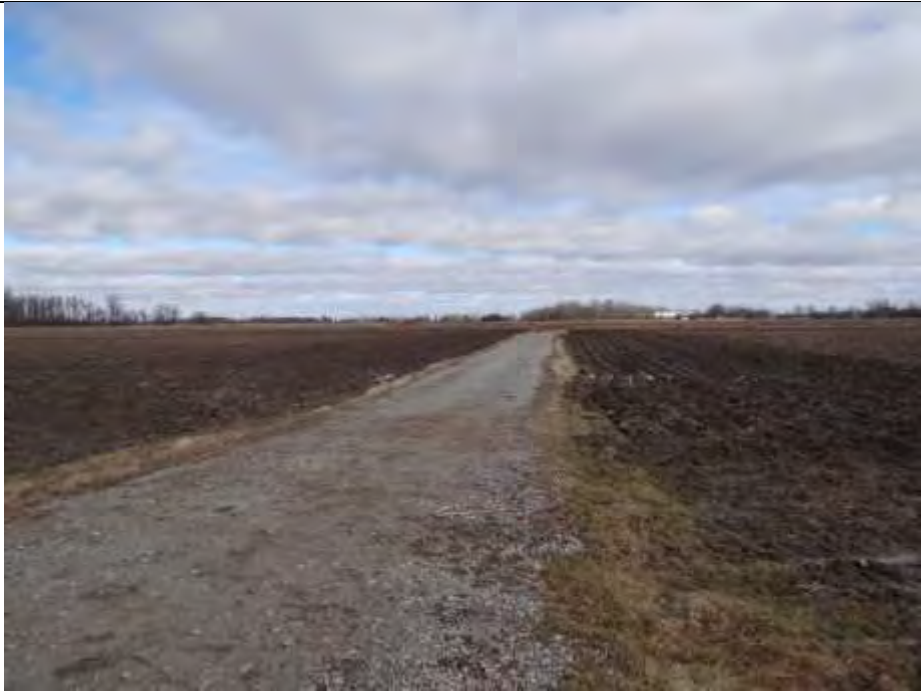
Table 2: Built Heritage Resources and Cultural Heritage Landscapes within the Premier Gateway Phase 1B Employment Area					
Feature	Location	Feature Type	Heritage Recognition	Description	Photograph(s)
CHL 2	8305 Eighth Line, Con 9, Lot 2	Remnant Farmscape	Identified during field review	<p><i>Existing Conditions:</i></p> <p>Remnant farmscape featuring fenced agricultural fields, established entrance drive, and the remains of several structures east of Eight Line.</p> <p><i>Historical Summary:</i></p> <p>On the 1858 Tremaine's Map this property is owned by Joseph Atkinson, no farmhouse is present on the property. On the 1878 Historical Atlas map the property is owned by Jos. Atkinson, two farmhouses are present on the property, along with the existing laneway. On the 1917 Guidal Landowners Map the property is owned by C. Campbell. On the c. 1955 Tweedsmuir map the property is owned by C. Campbell. The intact farmstead is visible in the 1954 aerial photography. In the 1973 NTS topographic mapping, the farmscape is no longer present.</p>

<p>Looking east from Eight Line.</p>

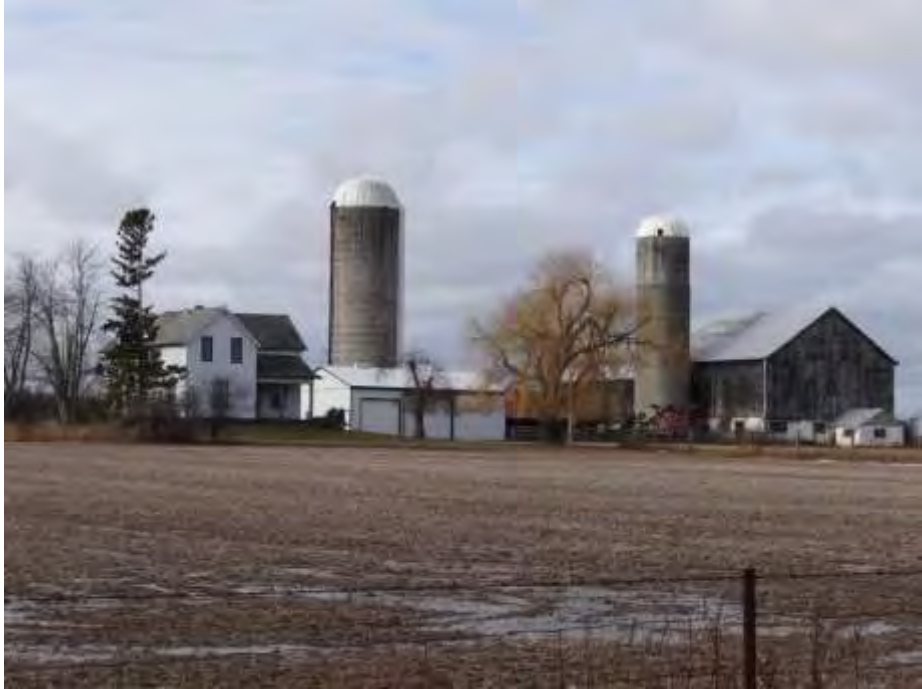
Table 2: Built Heritage Resources and Cultural Heritage Landscapes within the Premier Gateway Phase 1B Employment Area					
Feature	Location	Feature Type	Heritage Recognition	Description	Photograph(s)
CHL 3	8250 Eighth Line, Con 8, Lot 2	Farmscape	Identified: Field review and/or review of historical mapping	<p><i>Existing Conditions:</i></p> <ul style="list-style-type: none"> <li>-Farmscape consisting of a farmhouse, barn, outbuildings, silos, agricultural field, established circulation routes, and mature trees.</li> <li>-Farmhouse is a one-and-a-half-storey, L-shaped residence clad in white siding with intersecting gable roof and covered porch on the east elevation facing Eight Line. Windows are one-over-one sash.</li> <li>-Outbuildings include a metal end gable roofed barn with a painted fieldstone foundation and painted vertical barn board cladding, and associated concrete silo constructed of hoops at the base, and staves at the top as an addition.</li> <li>- More modern outbuildings include a smaller drive shed with a metal gable roof and clad in metal siding that features a large sliding door, used to store machinery and equipment. A second concrete hoop silo is also present.</li> <li>-Landscape features include an established entrance drive demarcated by a post-and-wire fence, agricultural fields with established field edges, mature trees, and internal circulation routes.</li> </ul> <p><i>Historical Summary:</i></p> <p>On the 1858 Tremaine's Map this property is owned by Joseph Atkinson, no farmhouse is present on the property. On the 1878 Historical Atlas map the property is owned by Chas. Campbell, a farmhouse and orchard is present on the property. On the 1917 Guidal Landowners Map the property is owned by C. Campbell. On the c. 1955 Tweedsmuir map the property is owned by C. Campbell. The intact farmstead is visible in the 1954 aerial photography. In the 1973 NTS topographic mapping the farmscape is still present.</p>	  <p>East elevation of the farmhouse, looking west from Eighth Line.</p>

<p>Residence, outbuildings, and landscape features, looking northwest from Eighth Line.</p>

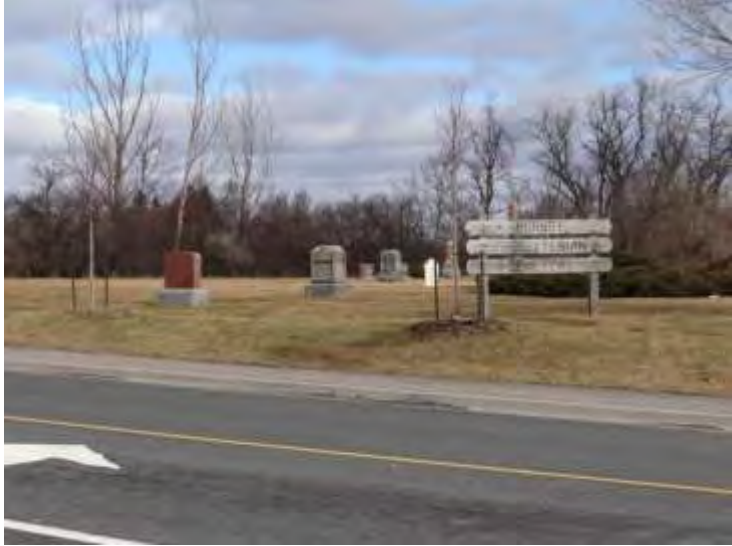
Table 2: Built Heritage Resources and Cultural Heritage Landscapes within the Premier Gateway Phase 1B Employment Area					
Feature	Location	Feature Type	Heritage Recognition	Description	Photograph(s)
CHL 5	8021 Eighth Line  Hornby Presbyterian Cemetery	Cemetery	Identified: Field review and/or review of historical mapping	<p><i>Existing Conditions:</i></p> <ul style="list-style-type: none"> <li>-Located on the northeast corner of the intersection of Steeles Avenue and Eighth Line.</li> <li>-The cemetery includes internments dating back to the nineteenth-century, including many of the founding members of the community of Hornby.</li> <li>-Internments continue to the present.</li> <li>-Landscape features include grave markers aligned in a northeast-to southwest orientation parallel with Steeles Avenue, surrounded by mature deciduous trees. One Chestnut tree is located on the southern limit of the cemetery, adjacent to the Steeles Avenue right-of-way.</li> </ul> <p><i>Historical Summary:</i></p> <p>On the 1858 Tremaine's Map this property is not identified. On the 1878 Historical Atlas map the property is identified as a cemetery, associated with the Presbyterian church. The cemetery is visible in the 1954 aerial photography. In the 1973 NTS topographic mapping the cemetery is still present.</p>

<p>Hornby Presbyterian Cemetery, looking northeast from Eighth Line.</p>

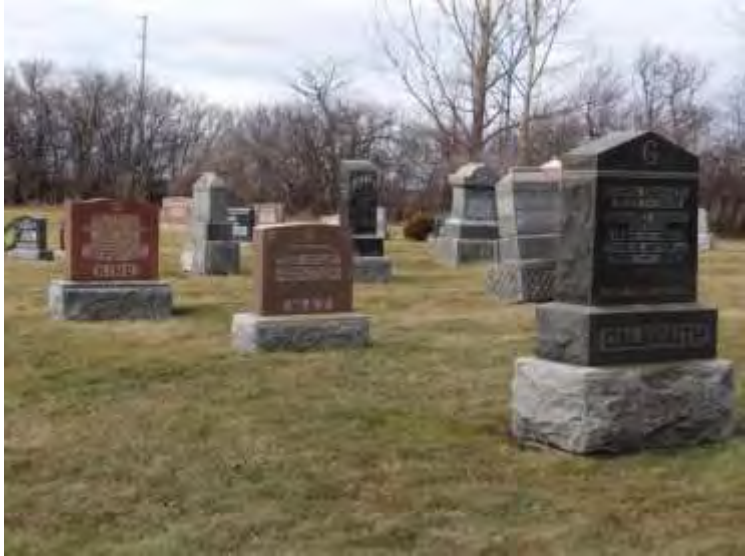
<p>Hornby Presbyterian Cemetery, looking northeast.</p>

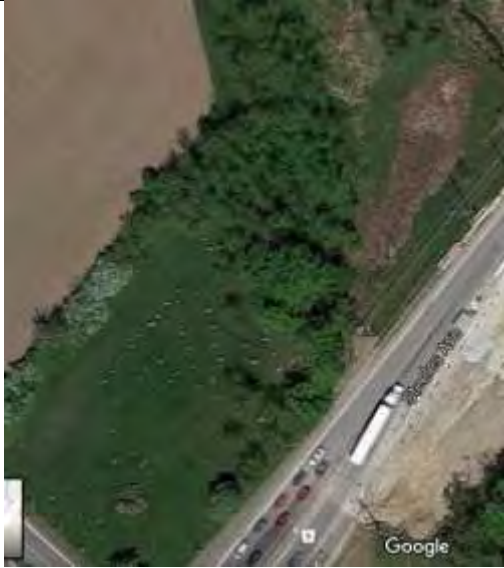
<p>CHL 6</p>	<p>8021 Eighth Line  Hornby Presbyterian Church</p>	<p>Former Church</p>	<p>Identified: Field review and/or review of historical mapping</p>	<p><i>Existing Conditions:</i></p> <p>-Currently all that remains of the church grounds is the extant Hornby Presbyterian Cemetery.</p> <p><i>Historical Summary:</i></p> <p>Hornby Presbyterian Church was established in 1838 at Lot 1, Concession 9, of Esquesing township. The original frame church was built in 1838, and replaced with a brick structure in 1878. In 1971, Hornby was amalgamated with Knox Church, Milton. In 1978, the brick church was destroyed by fire. Small footprints were found in the snow around the church and many people suspected arson, however no conclusion was ever reached on that matter.</p> <p>On the 1858 Tremaine's Map this property is owned by David Lindsay, no church is present on the property. On the 1878 Historical Atlas map the property is owned by D. Lindsay Jr., the church is present by this time. On the 1917 Guidal Landowners Map the church is still present. On the c. 1955 Tweedsmuir map the church is present. The intact church is visible in the 1954 aerial photography. In the 1973 NTS topographic mapping the church is still present.</p>

<p>Satellite view of the former church site courtesy of Google Earth</p>

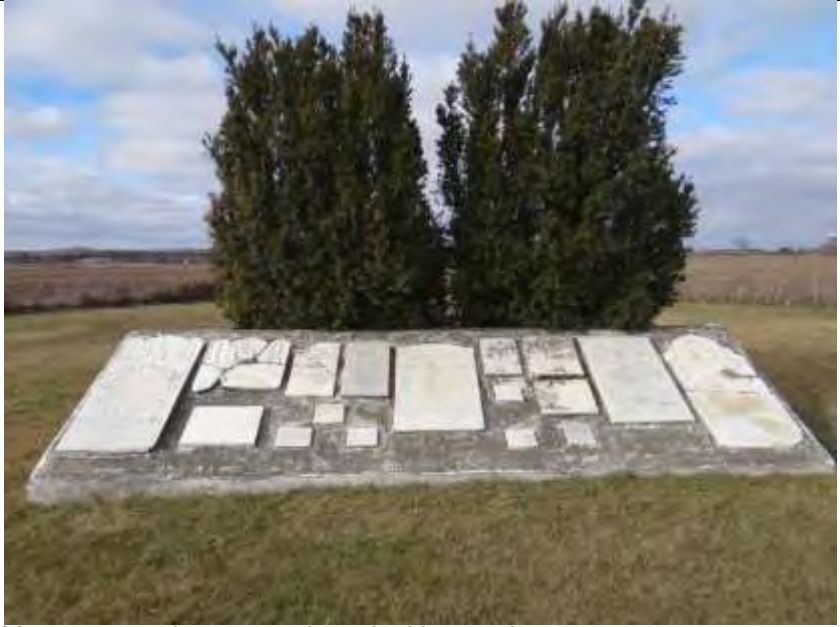
CHL 7	8008 Eighth Line	Cemetery	Identified: Field review and/or review of historical mapping	<p><i>Existing Conditions:</i></p> <ul style="list-style-type: none"> <li>-Pioneer cemetery is located at the northwest corner of Eighth Line and Steeles Avenue</li> <li>-Cemetery consists of a central monument with individual grave markers affixed, with two ornamental evergreens to the north of the monument.</li> <li>-Cemetery boundaries are marked with a chain-link fence, with Steeles Avenue to the south, Eighth Line to the east, and agricultural fields to the north and west.</li> </ul> <p><i>Historical Summary:</i></p> <p>On the 1858 Tremaine's Map this property is not identified. On the 1878 Historical Atlas map the property is identified as a cemetery, associated with the Presbyterian church. The cemetery is visible in the 1954 aerial photography. In the 1973 NTS topographic mapping the cemetery is not indicated.</p>

<p>Monument and grave markers, looking northwest.</p>

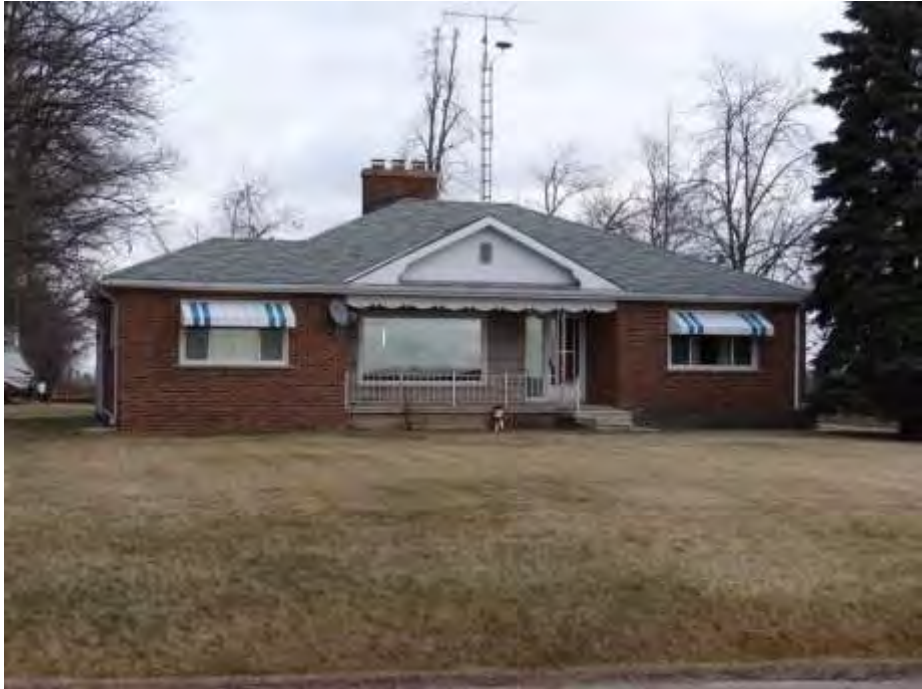
CHL 8	Various houses on Eighth Line	Residential area	Identified: Field review	<p><i>Existing Conditions:</i></p> <ul style="list-style-type: none"> <li>-This landscape is composed of a number of residences of similar scale and massing, located in a discrete cluster on Eighth Line, north of Steeles Avenue.</li> <li>-Typical residences are one storey Ranch style red brick residence with hipped or gable roofs.</li> <li>-Landscape features generally include mature trees, established fenced yards, and entrance drives off Eighth Line.</li> </ul> <p><i>Historical Summary:</i></p> <p>Residences are generally Ranch style, and have likely been constructed in the 1960s and 1970s. Residences are not present on the 1954 aerial photograph, but are present in the 1973 topographic map and in 1999 satellite imagery.</p>

<p>Representative residence looking east from Eighth Line</p>

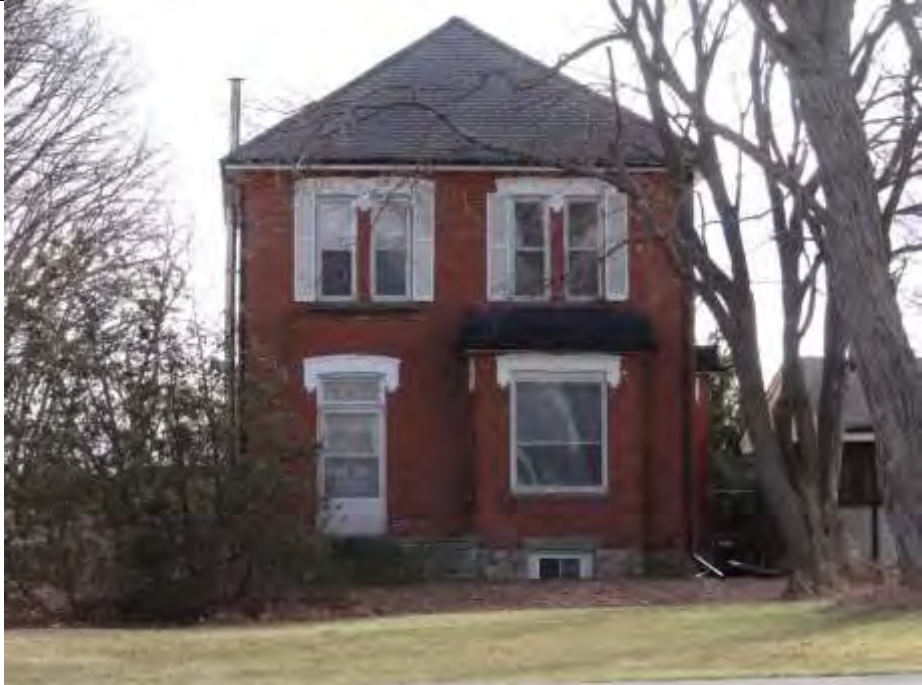
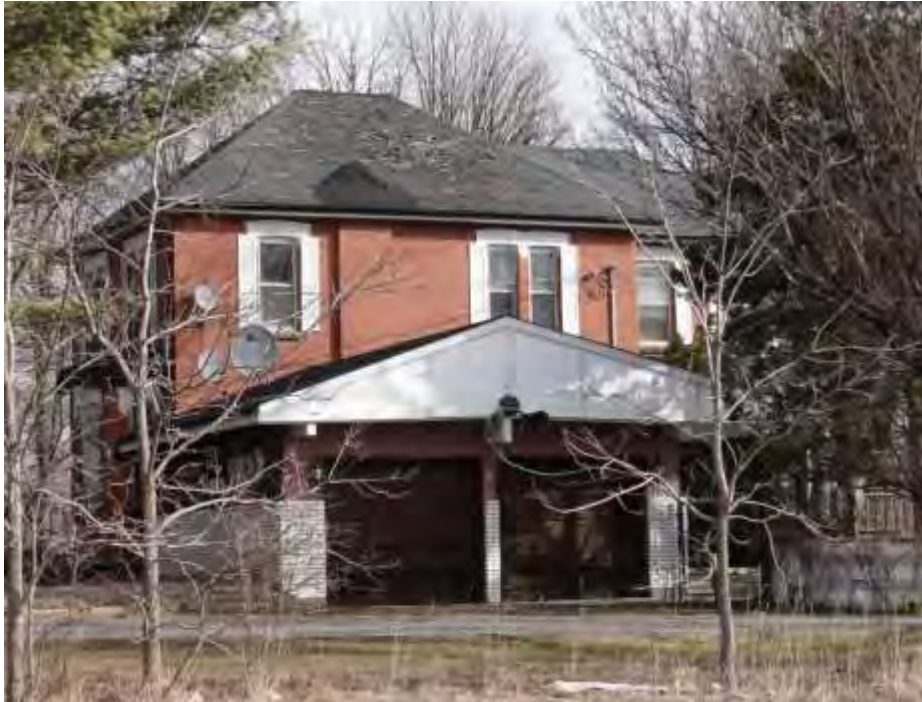
BHR 2	14030 Steeles Ave	Residential  Hornby Historic Settlement Area	Identified: Field review and/or review of historical mapping	<p><i>Existing Conditions:</i></p> <ul style="list-style-type: none"> <li>-Property consists of a residence with several modern outbuildings to the south, southeast of the intersection of Eighth Line and Steeles Avenue.</li> <li>-Residence is a two storey L-shaped red brick structure with a hipped pyramidal roof, and a stone foundation parged with concrete.</li> <li>-The north elevation features the original entrance doorway on the east half and a projecting rectangular frontpiece on the west half of the main floor, and two symmetrically-located window bays on the second floor. The second floor window bays feature two one-over one sash window separated by a narrow red brick divider, but share a common concrete sill and painted brick segmental arches above.</li> <li>-A modern, two-car garage addition is on the west elevation.</li> <li>-Landscape features include mature trees and an established entrance drive south from Steeles Avenue.</li> </ul> <p><i>Historical Summary:</i></p> <p>Identified as the Presbyterian Church Manse. On the 1858 Tremain's Map this property is owned by W. Barr, no house is present on the property. On the 1878 Historical Atlas map the building is identified, and is owned by the Presbyterian church. The building is visible in the 1954 aerial photography and in the 1973 NTS topographic mapping.</p>

North elevation of the residence, looking south from Steeles Avenue.

West elevation of the residence, looking east from shopping center parking lot.

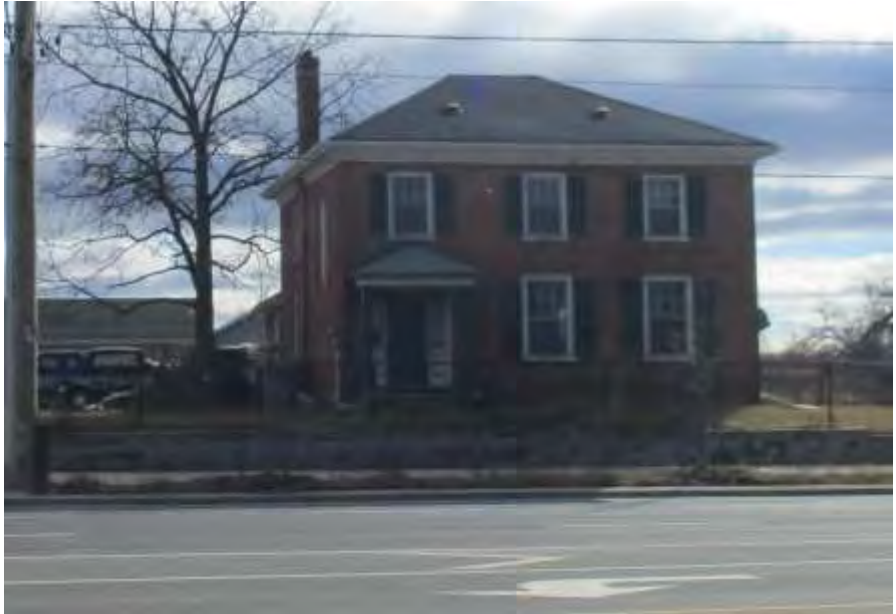
BHR 3	13584 Steeles Ave	Residential  Hornby Historic Settlement Area	Identified: Field review and/or review of historical mapping	<p><i>Existing Conditions:</i></p> <ul style="list-style-type: none"> <li>-Two storey red brick Georgian Revival residence with overhanging eaves, decorative frieze, and a hipped roof.</li> <li>-North elevation features three bays on the main floor, with the doorway furthest east. The doorway consists of a panel door with side and transom lights, enclosed by a roofed porch. Two windows are present to the west of the doorway, each consisting of six-over-six sash with segmental arches and louvered shutters.</li> <li>-The second floor of the north elevation features three symmetrically located six-over-six sash windows with segmental arches and louvered shutters.</li> <li>-The east elevation features a central, external red brick chimney, with one large rectangular window on the second floor on the northern portion, and one smaller rectangular window on both the main and second floors to the south. A single storey addition is present on the south elevation.</li> <li>-Landscape features include a fenced yard and mature trees.</li> </ul> <p><i>Historical Summary:</i></p> <p>On the 1858 Tremaine's Map this property is owned by Peter M. Rowe, no house is present on the property, although the property would likely be within the lower Hornby settlement area. On the 1878 North Trafalgar Map, identified as being owned by Samuel King, a farmhouse and orchard is present on the property. On the c. 1955 Tweedsmuir map the property is owned by R. King. The intact farmstead is visible in the 1954 aerial photography. In the 1973 NTS topographic mapping the farmscape is still present.</p>

<p>North and east elevations, looking southwest.</p>

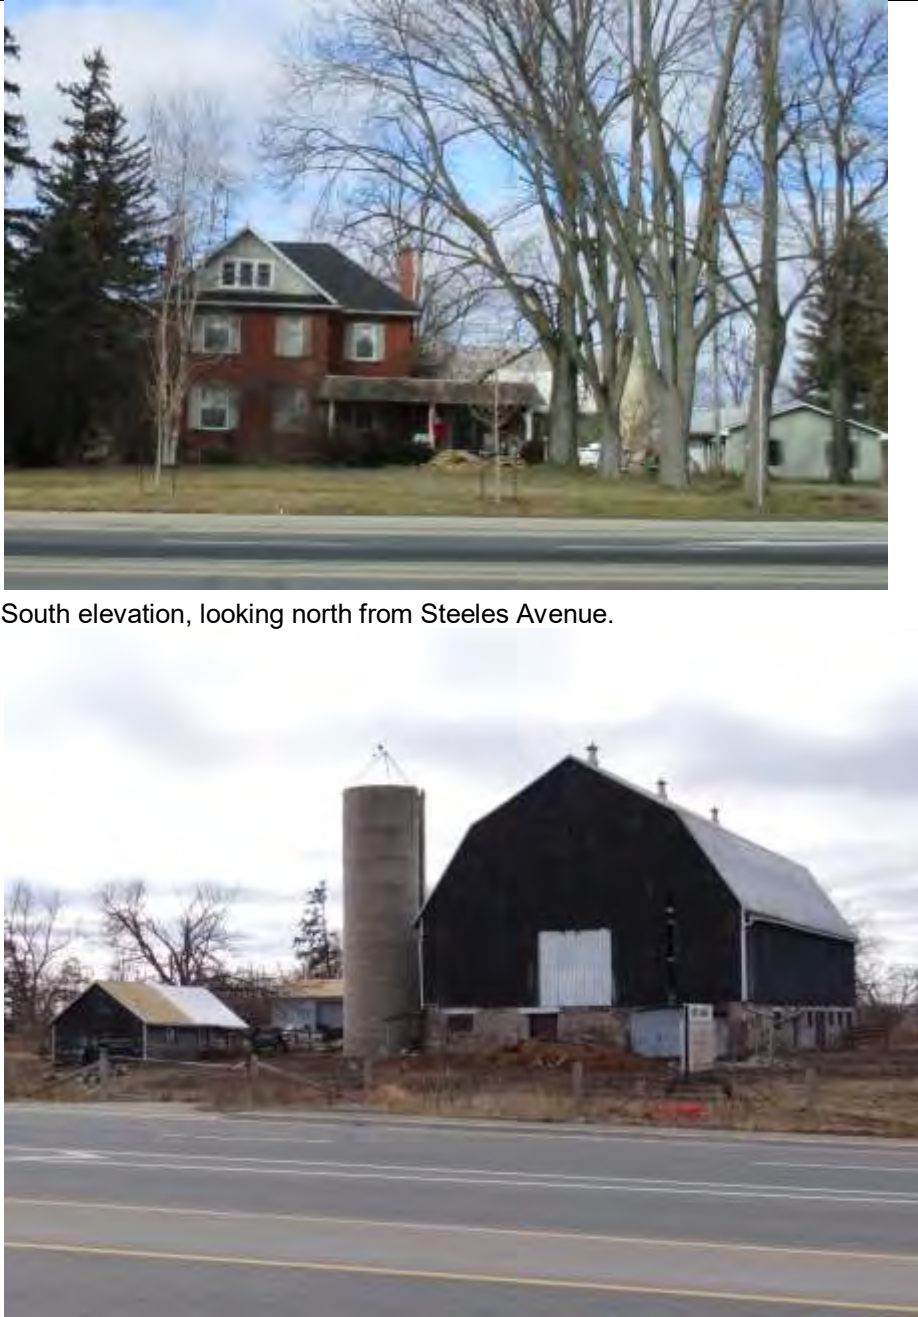
<p>CHL 9</p>	<p>13571 Steeles Ave</p>	<p>Farmscape</p>	<p>Identified: Field review and/or review of historical mapping</p>	<p><i>Existing Conditions:</i></p> <ul style="list-style-type: none"> <li>-Portion adjacent to Steeles avenue includes a two-and-a-half storey red brick residential structure with a hipped roof and a gabled dormer on the south elevation.</li> <li>-South elevation features three windows on both the main and second floors, with three windows on the gable end of the dormer under the peak.</li> <li>-The south and east elevations feature a wrap-around roofed verandah</li> <li>-Farmscape visible from Trafalgar road includes a gambrel roof barn, silo, stable, driveshed, and pens for horses.</li> <li>-Barn features a metal clad gambrel roof, with fieldstone foundations, clad in vertical board siding.</li> <li>-Stable features a metal gable roof, and is associated with the horse pen.</li> <li>-A modern driveshed is located on the western portion of the complex, and is composed of metal siding and a metal gable roof.</li> <li>-Currently used to stable horses.</li> <li>-Landscape features include established circulation routes, agricultural fields, pens with established fences, and other agricultural activity area.</li> </ul> <p>Operates as 'Cedar Creek Farm'</p> <p><i>Historical Summary:</i></p> <p>On the 1858 Tremaine's Map this property is owned by W. Pickard, no house is present on the property. On the 1878 Historical Atlas Map, the property is identified as being owned by Jn. MacMillan, a farmhouse and orchard is present on the property. On the 1917 Guidal Landowners Map the property is owned by J. McDowell. On the c. 1955 Tweedsmuir map the property is owned by C. McDowell. The intact farmstead is visible in the 1954 aerial photography. In the 1973 NTS topographic mapping the farmscape is still present, the Trafalgar Road realignment has been completed by this time.</p>

<p>South elevation, looking north from Steeles Avenue.</p> <p>East and north elevations of barn, stable, and silo, looking southwest from Trafalgar Road.</p>

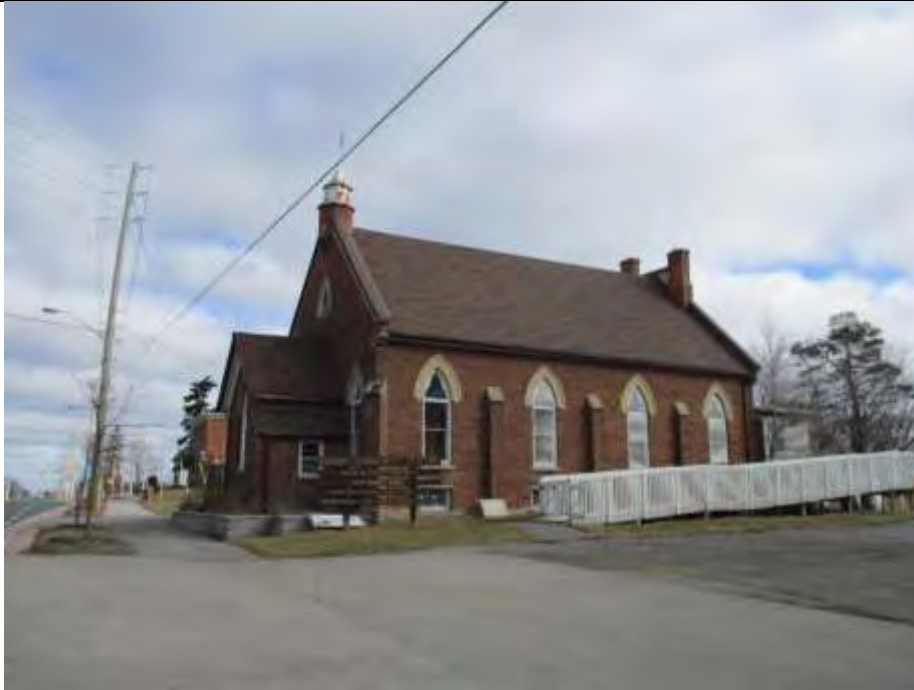
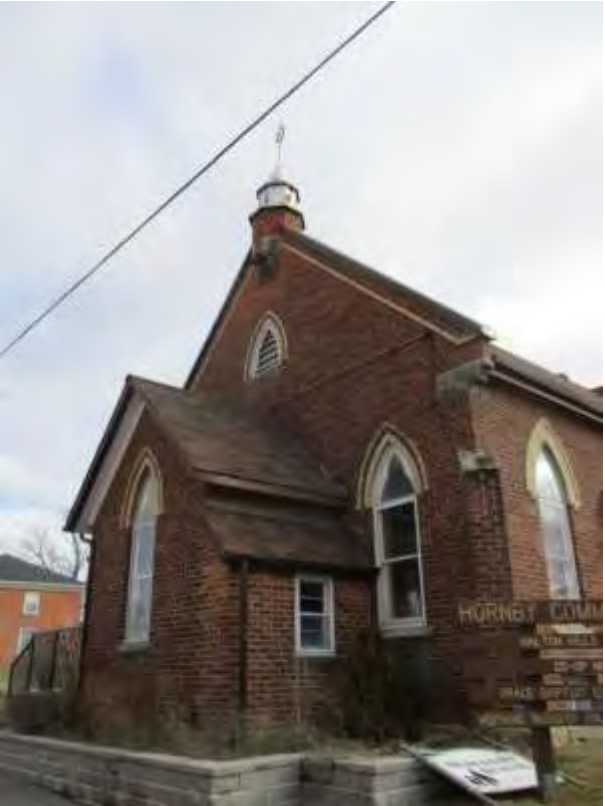
BHR 4	13526 Steeles Ave	Church / Community Centre  Hornby Historic Settlement Area	Identified: Field review and/or review of historical mapping	<p><i>Existing Conditions:</i></p> <ul style="list-style-type: none"> <li>-Constructed as a church, this polychromatic brick building features an end gabled roof with parapets, overhanging eaves, and a decorative spire with finial on the north portion of the roof.</li> <li>-Walls on the east and west elevations are supported by brick buttresses, and features four evenly spaced one-over one sash lancet windows with yellow brick segmental arches.</li> <li>-The north elevation features a projecting frontspiece that contains the main entrance, on the east side and a one-over-one sash lancet window on the north.</li> <li>-The north elevation features a lancet window on both sides of the frontspiece, and a lancet-shaped louvered vent below the main roof peak.</li> <li>-Landscape features include an established entrance drive, parking area, lawns, and trees.</li> </ul> <p><i>Historical Summary:</i></p> <p>Originally the Hornby Methodist Church, then the Hornby United Church. On the 1858 Tremaine's Map this property is owned by Peter M. Rowe, no church is present on the property. On the 1878 Historical Atlas map the property is owned by Samuel King., the church is present by this time. On the 1928 Lloyds Map of Halton the church is still present. On the c. 1955 Tweedsmuir map the church is present. The intact church is visible in the 1954 aerial photography. In the 1973 NTS topographic mapping the church is still present. The Hornby United Church spire was built and installed by Gordon Brigden at the machine shop in Hornby. After the congregations of Hornby and Ashgrove built Hillcrest United the old church was used as a community centre and then a nursery school.</p>

<p>West elevation, looking east.</p>

<p>North elevation, looking southeast from Steeles Avenue.</p>
--	--	--	--	--	---

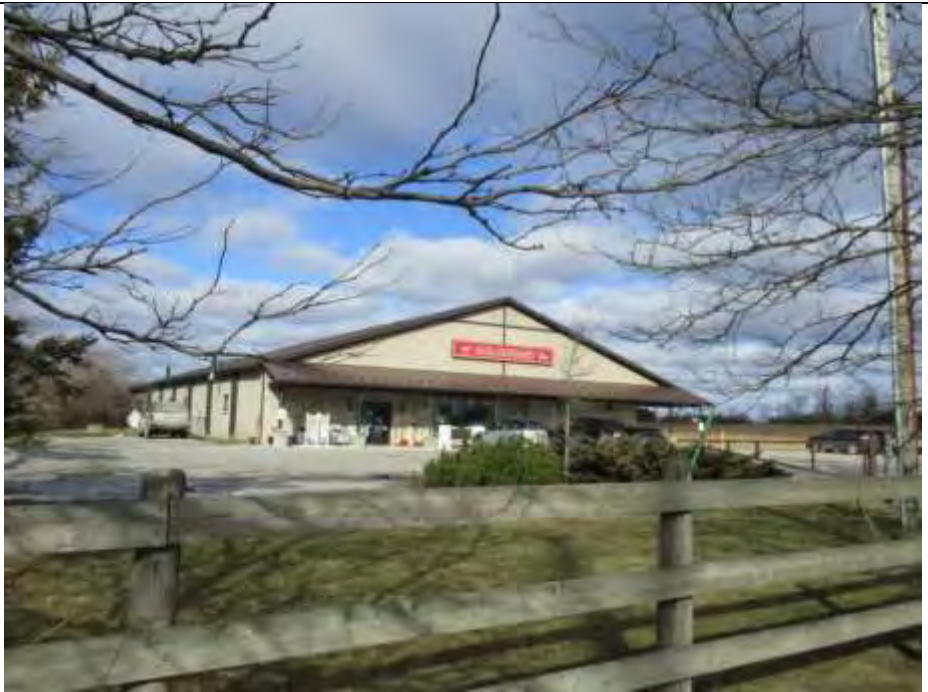
<p>CHL 10</p>	<p>13329 Steeles Avenue</p>	<p>Commercial  Hornby Historic Settlement Area</p>	<p>Identified: Field review and/or review of historical mapping</p>	<p><i>Existing Conditions:</i></p> <ul style="list-style-type: none"> <li>-Large, single storey structure with a metal end gable roof, clad in metal siding on the east and west elevations.</li> <li>-The south elevation features an entranceway and a large window at ground level, and is clad in a stone façade. The south elevation also features a single-storey roofed verandah, with the gable end clad in metal siding.</li> <li>-Operates as a 'Bahr Saddlery', a commercial facility selling tack and agricultural supplies.</li> <li>-Landscape features include an established entrance drive, large parking area, and fence grass areas, with active agricultural fields to the north.</li> </ul> <p><i>Historical Summary:</i></p> <p>The building is not present in 1954 aerial photo. A building identified in this location in the 1961 aerial, however this building has a different footprint than the current building.</p>

<p>South and west elevation, looking northeast</p>

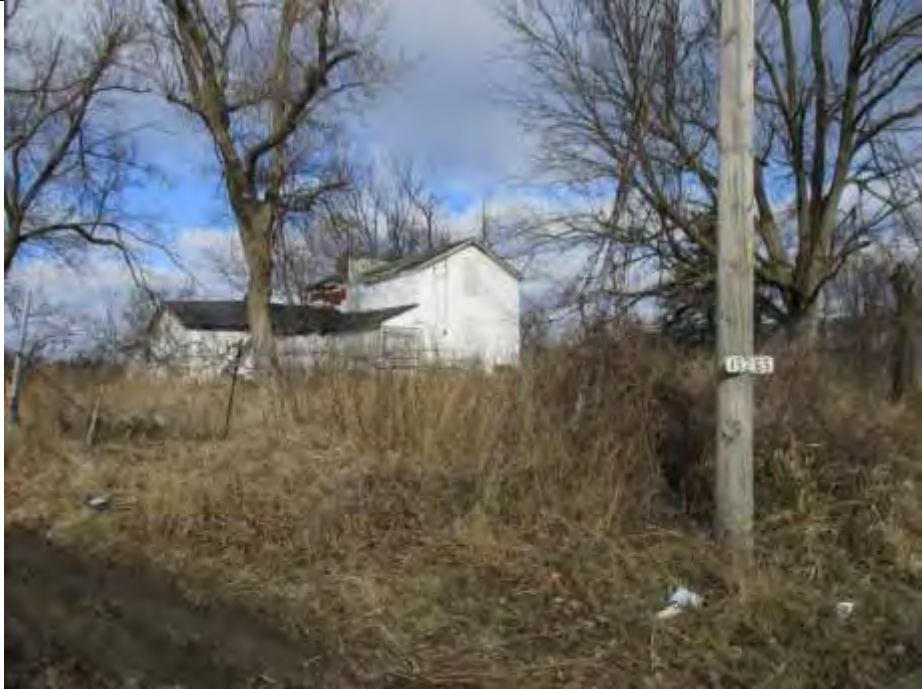
<p>CHL 11</p>	<p>13265 Steeles Ave</p>	<p>Remnant Farmscape</p>	<p>Identified: Field review and/or review of historical mapping</p>	<p><b>Existing Conditions:</b></p> <ul style="list-style-type: none"> <li>-One-and-a-half storey frame residence clad in white siding with multiple additions on the west and north elevations.</li> <li>-Structure was boarded up and for sale at the time of field inspection, with structural damage evident on the roof and walls.</li> <li>-Landscape features include mature trees, an established entrance drive, and overgrown, unmaintained lawn.</li> </ul> <p><b>Historical Summary:</b></p> <p>On the 1858 Tremaine's Map this property is owned by Mrs. J McKenzie, no house is present on the property. On the 1878 Historical Atlas Map, the property is identified as being owned by Samuel Brooks, a farmhouse is present on the property in the same approximate location. On the c. 1955 Tweedsmuir map the property is owned by Frank Chisholm. The intact farmstead is visible in the 1954 aerial photography. In the 1973 NTS topographic mapping the farmscape is still present.</p> <p>The Hornby Drill Shed was moved to Frank Chisholm's farm to serve as a barn, the Drill Shed was demolished in 2009.</p>

<p>South elevation, looking northeast</p>

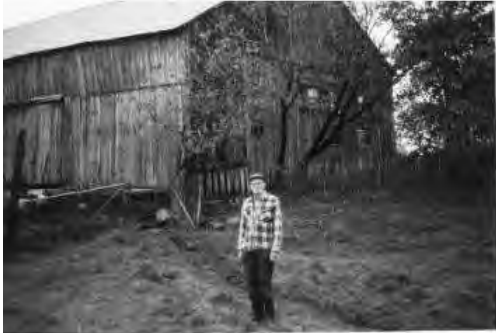
<p><b>Hornby Drill Shed</b></p> <p>The Hornby Drill Shed stood on the north-west corner of Trafalgar and Steeles Avenue, opposite the old Church. It was built in 1866 of white pine. Frank Chisholm (1912-2001) stands in front of the former drill shed which was moved to his farm to serve as a barn.</p>

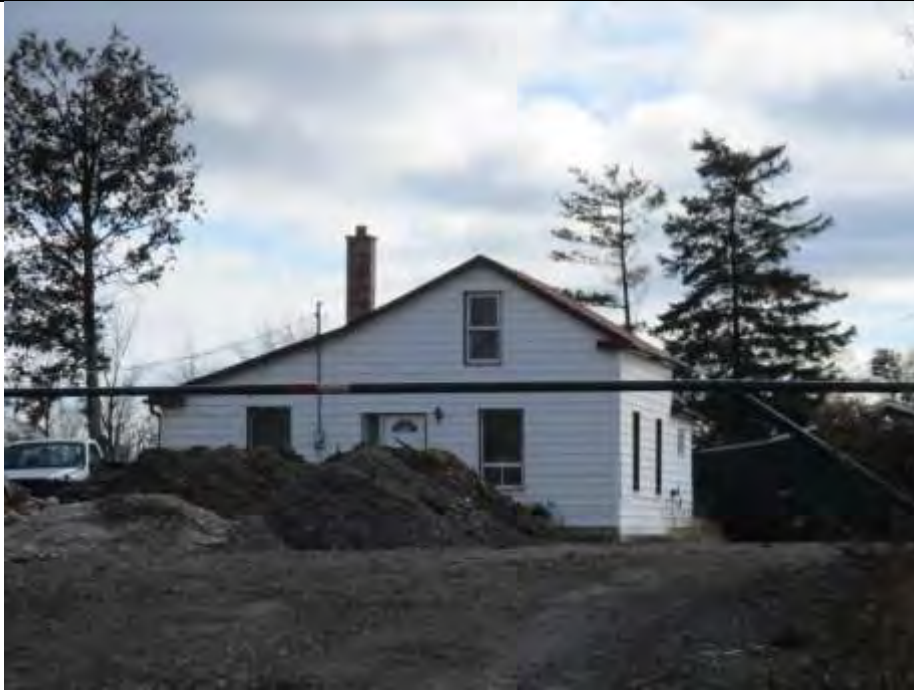
BHR 5	13256 Steeles Avenue	Residential  Hornby Historic Settlement Area	Identified during field review	<p><i>Existing Conditions:</i></p> <ul style="list-style-type: none"> <li>-One-and-a-half storey residence on the south side of Steeles Avenue, clad in white siding with a saltbox roof. The north elevation features a central doorway, with a modern rectangular window on both sides on the main floor, and a single one-over-one sash window under the gable peak on the second floor.-The west elevation features two rectangular windows, while the east elevation features an internal red brick chimney.</li> <li>-Landscape features include an established entrance drive and fenced yard.</li> <li>-The property appears to be either under renovations or operated as an industrial or landscaping business, as there were large piles of earthen fill in front of the structure at the time of field review</li> </ul> <p><i>Historical Summary:</i></p> <p>On the 1858 Tremaine’s Map this property is owned by Peter M. Rowe, no house is present on the property. On the 1878 North Trafalgar Map, identified as being owned by Samuel King, a farmhouse is present on the property. On the c. 1955 Tweedsmuir map the property is owned by R. King. The intact farmstead is visible in the 1954 aerial photography. In the 1973 NTS topographic mapping the farmscape is still present.</p>

<p>North and west elevations, looking south from Steeles Avenue.</p>

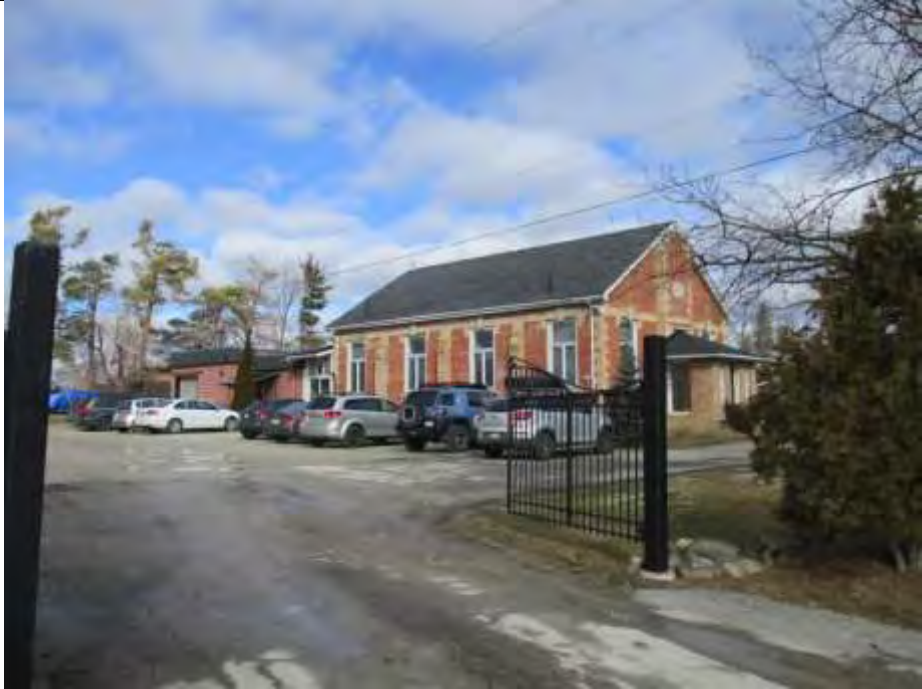
BHR 6	13029 Steeles Avenue	School  Hornby Historic Settlement Area	Identified: Field review and/or review of historical mapping	<p><i>Existing Conditions:</i></p> <ul style="list-style-type: none"> <li>-One storey polychromatic brick structure with an end gabled roof, brick quoins, brick keystone arches, and brick buttresses.</li> <li>-The south elevation features a central doorway which is obscured by a modern single-storey brick addition, with a large rectangular window with yellow brick keystone arches. A central frontspiece is present on the south elevation, which originally supported a projecting spire, as depicted in historical photographs. The spire is absent, but the frontspiece is extant, and features a concrete date stone or plaque above the original doorway.</li> <li>-The west elevation features four evenly-spaced rectangular windows with yellow brick keystone arches, separated by yellow brick buttresses. All windows in the structure appear to be modern casement with fixed rectangular lights above.</li> <li>-The north and east elevations feature a modern, single-storey addition clad in siding.</li> <li>-Landscape features include a gated, established entrance drive, and a parking area.</li> </ul> <p><i>Historical Summary</i></p> <p>The first Hornby school was opened in 1826 in a log cabin next to the Orange Hall. Hornby school became SS#AE Hornby in 1848. This brick school was built in 1870. It closed in 1963 with the opening of Pineview School at 5 Sideroad. It is now the office of a geomatics company.</p> <p>On the 1858 Tremaine's Map this property is owned by Mrs. J McKenzie, no school house is present on the property. On the 1878 Historical Atlas Hornby Town Map, the property is identified as a school. A schoolhouse is present on the property in the same location as the current building. On the c. 1955 Tweedsmuir map the schoolhouse is identified in the same location. The school is visible in the 1954 aerial photography and in the 1973 NTS topographic mapping.</p>

<p>South and west elevations, looking northeast</p>

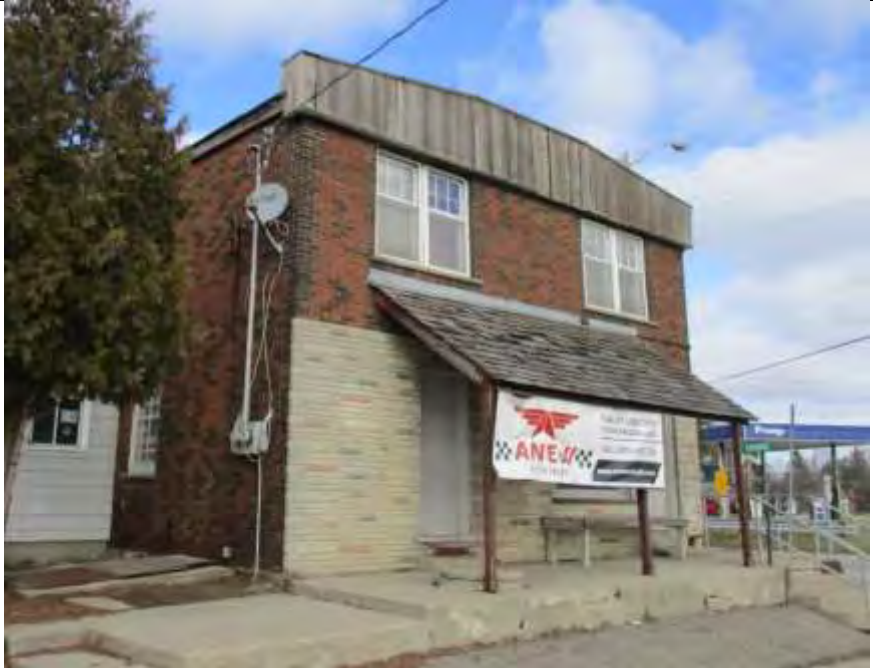
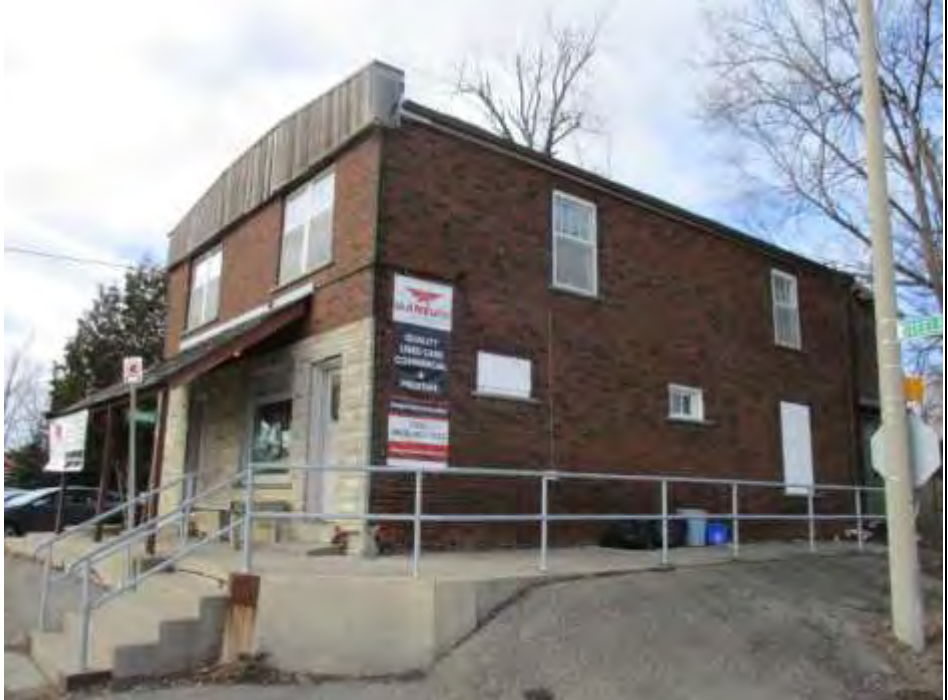
BHR 7	12933 Steeles Ave	Commercial/ General Store  Hornby Historic Settlement Area	Identified: Field review and/or review of historical mapping	<p><i>Existing Conditions:</i></p> <ul style="list-style-type: none"> <li>- Two storey red brick commercial structure with a flat roof and on the south elevation, located at the northwest corner of Hornby Road and Steeles Avenue.</li> <li>-The south elevation features a boomtown or false front roof made of vertical boards, a cut stone façade at ground level, and a single storey roofed porch over a central display window on the main floor. The second floor features two paired six-over-one sash windows with concrete sills. The main entrance is located on the east portion of the south elevation.</li> <li>-The east elevation features one large rectangular window on the north portion which is boarded up, and two small rectangular windows on the ground level, with the southernmost one also boarded up.</li> <li>-The second floor of the east elevation features two centrally-located eight-over-one sash windows with concrete sills.</li> <li>-The structure currently operates as an automotive sales and repair shop.</li> </ul> <p><i>Historical Summary:</i></p> <p>Hornby Store was established in the early 1900's. The store belonged to a Mr. W. J. Lindsay. He was the postmaster there in 1910. Bill Lindsay was the store owner and postmaster. The original Hornby Store burned down at an unidentified date. The current structure appears in the 1961 birds eye aerial photography.</p> <p>On the 1858 Tremaine's Map this property is owned by James Crawford, no buildings are present on the property, although the area is identified as being within the Upper Hornby historic settlement area. On the 1878 Historical Atlas Map, the property is identified as being within the West Hornby historic settlement area. The Hornby Town map from 1878 shows no building on the property. The store is visible in the 1954 aerial photography. In the 1973 NTS topographic mapping the building is still present.</p>

South elevation, looking northeast.

South and east elevation, looking northwest.

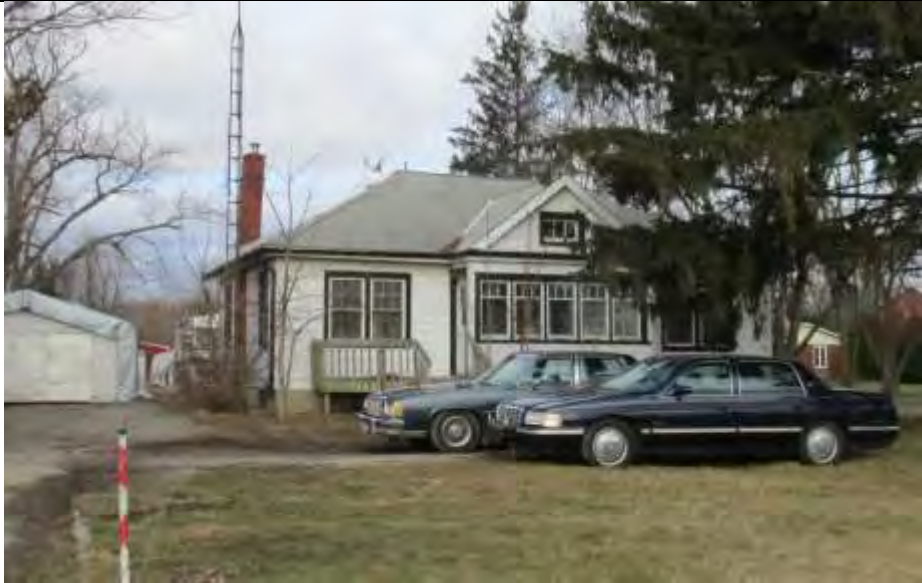
BHR 8	12039 Steeles	Cottage Residential  Hornby Historic Settlement Area	Identified: Field review and/or review of historical mapping	<p><i>Existing Conditions:</i></p> <p>One-and-a-half storey structure clad in white siding with a hipped roof and a gable dormer on the south elevation. The main entrance is located inside an enclosed veranda that features five windows. The south elevation also features two paired six-over-one sash windows on both sides of the central verandah on the main floor, and one three-paned window in the center of the dormer on the second floor.</p> <p>-An external red brick chimney is located in the west elevation.</p> <p>-Landscape features include an established entrance drive, mature trees, large yard, and sever small outbuildings to the rear of the main residence.</p> <p><i>Historical Summary:</i></p> <p>On the 1858 Tremaine's Map this property is owned by D. Fore, no house is present on the property. On the 1878 Historical Atlas Map, the property is identified as being owned by Mrs. Mary A. MacDowell, a farmhouse is present on the property with an orchard but does not align with the location of this property. On the 1921 Guidal Landowners Map the property is owned by T. Learmont. On the c. 1955 Tweedsmuir map the property is owned by Hullman. The building visible in the 1954 aerial photography. In the 1973 NTS topographic mapping the building is present.</p>

<p>South and west elevations, looking north from Steeles Avenue.</p>
