**CULTURAL HERITAGE RESOURCE ASSESSMENT**

**TOWN OF HALTON HILLS PREMIER GATEWAY PHASE 1B EMPLOYMENT AREA SECONDARY PLAN  
LOTS 1 AND 2, CONCESSIONS 7 AND 8, FORMER TOWNSHIP OF ESQUESING**

**TOWN OF HALTON HILLS,  
REGIONAL MUNICIPALITY OF HALTON, ONTARIO**

Revised May 2018

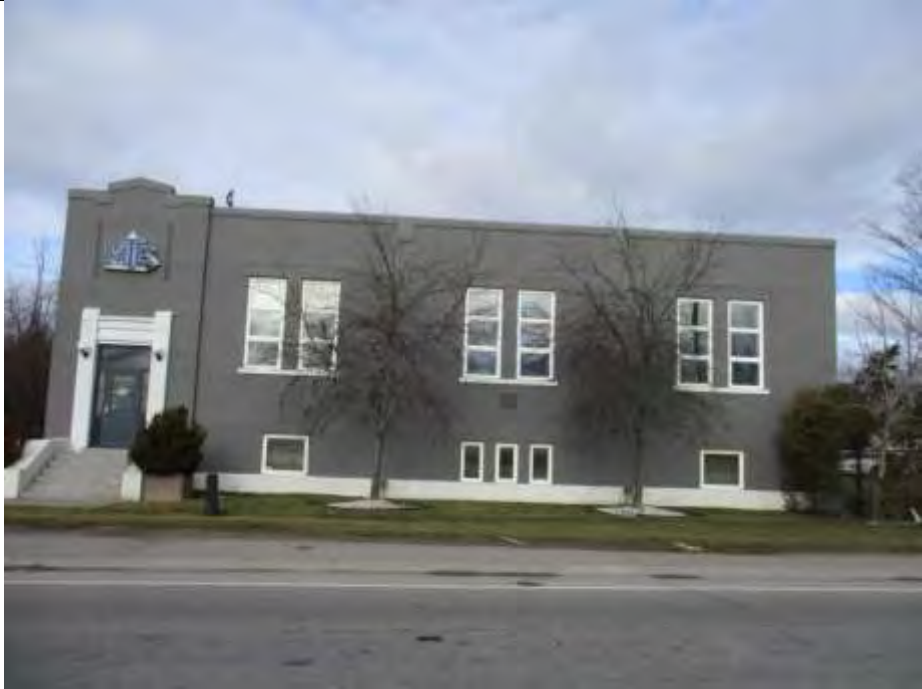
<p>BHR 9</p>	<p>12005 Steeles  Hornby Repeater Station</p>	<p>Institutional</p>	<p>Identified: Field review and/or review of historical mapping</p>	<p><i>Existing Conditions:</i></p> <ul style="list-style-type: none"> <li>-Two storey industrial painted red brick structure with a flat roof, and concrete foundations.</li> <li>-South elevation features a main entranceway on the western portion, raised above grade by a flight of stairs, bordered by decorative brick pilasters and topped with a pediment. Basement windows are above grade, and consist of three small rectangular fixed windows at center, with a larger rectangular window on both the east and west portions of the south elevation. The main floor windows are large, and consist of three pairs of three-pane fixed windows symmetrically arranged on the south elevation.</li> <li>-The south elevation features decorative brickwork, although it is difficult to see due to the paint applied over it.</li> <li>-The west elevation features one centrally located rectangular window in the basement, and two rectangular, three-paned windows on the second floor. An external brick chimney is also located on the west elevation.</li> <li>-Landscape features include a parking lot, decorative plantings, and rock features.</li> </ul> <p><i>Historical Summary:</i></p> <p>Hornby Repeater Station on Steeles Ave. and the 6th Line was designed by Frederick John McNab, Chief Architect, Bell Canada, in 1929 and built in 1930. It has some interesting ornamental detail around the windows, and is in quite good shape. It was used by Bell Telephone as a repeater station to boost phone signals between Toronto and Windsor, until 1995.  <a href="http://dictionaryofarchitectsincanada.org/node/2127">http://dictionaryofarchitectsincanada.org/node/2127</a></p> <p>On the 1858 Tremaine's Map this property is owned by D. Fore, no house is present on the property. On the 1878 Historical Atlas Map, the property is identified as being owned by Mrs. Mary A. MacDowell, a farmhouse is present on the property with an orchard but does not align with the location of this property. On the 1921 Guidal Landowners Map the property is owned by T. Learmont. On the c. 1955 Tweedsmuir map the property is identified as a separate lot. The building visible in the 1954 aerial photography. In the 1973 NTS topographic mapping the building is present.</p>

<p>South elevation, looking north.</p>

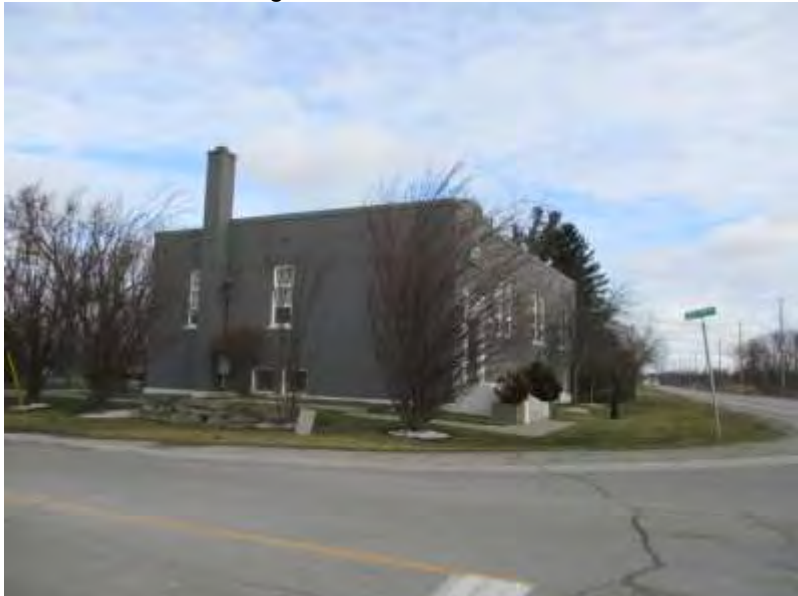
<p>West elevation, looking east.</p>

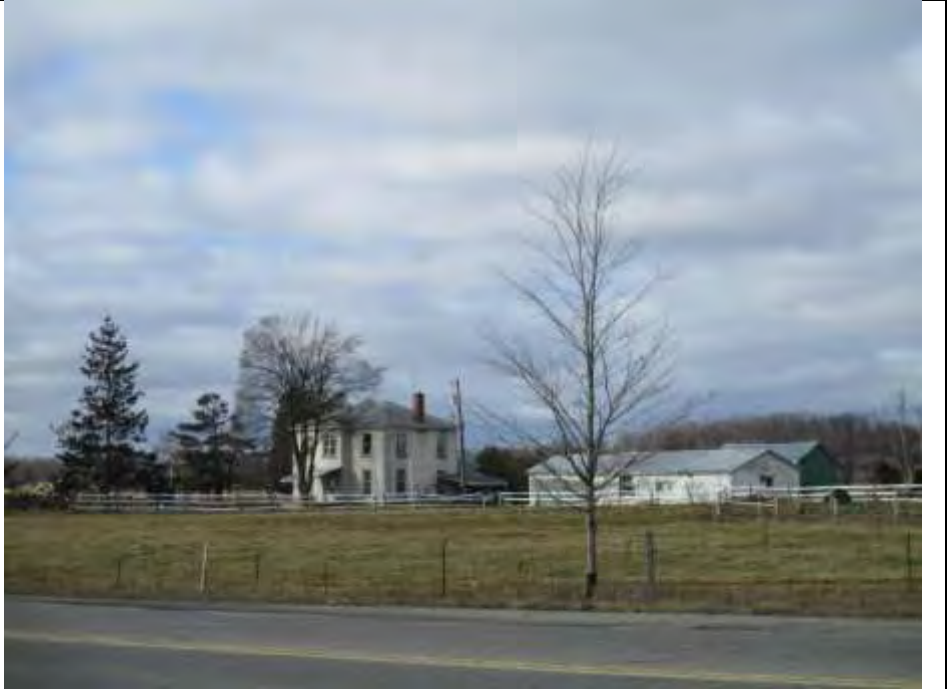
<p>CHL 15</p>	<p>12689 Steeles Avenue, Lot 1 Con 7</p>	<p>Farmscape</p>	<p>Identified during field review</p>	<p><i>Existing Conditions:</i></p> <ul style="list-style-type: none"> <li>- Large, active farmscape north of Steeles Avenue.</li> <li>-Residence is a two storey rectangular structure clad in yellow brick with a hipped roof and parged concrete foundation.</li> <li>-The south elevation features a two-storey central frontpiece with a gable roof, that features the main entranceway and roofed porch on the main floor, and paired three-over-three sash window with segmental arches and transom lights on the second floor.</li> <li>-The south elevation features six-over-six sash windows with concrete sills on the east and west of the frontpiece, on both the main and second floors.</li> <li>-The east elevation features two six-over-six sash windows with concrete sills on the main floor, and an additional two on the second floor. There is also an internal red brick chimney on the east elevation.</li> <li>-Landscape features include several gable roof barns and outbuildings, a silo, established circulations routes, fenced agricultural fields, and mature treelines.</li> </ul> <p><i>Historical Summary:</i></p> <p>On the 1858 Tremaine's Map this property is owned by James Crawford, no house is present on the property. On the 1878 Historical Atlas Map, the property is identified as being owned by Thos. Howson, a farmhouse is present on the property with an orchard. On the c. 1955 Tweedsmuir map the property is owned by Ella. The building and supporting farmscape features are visible in the 1954 aerial photography. In the 1973 NTS topographic mapping the farmstead is still present.</p>

<p>South and east elevation, looking northwest from Steeles Avenue.</p>

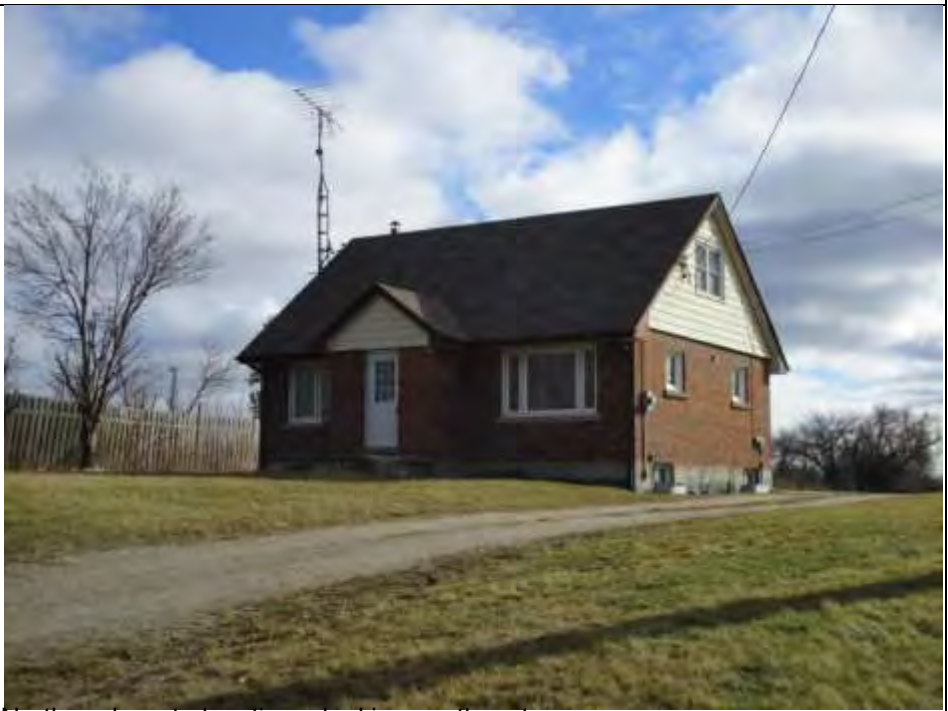
<p>BHR 10</p>	<p>13238 Steeles Avenue</p>	<p>Residence</p>	<p>Identified during field review</p>	<p><i>Existing Conditions:</i></p> <ul style="list-style-type: none"> <li>-One-and-a-half storey red brick residence with a side gabled roof and parged concrete block foundation.</li> <li>-North elevation features a central entrance with a gabled dormer, with a fixed rectangular window flanked by rectangular casement windows on the east side, and paired rectangular casement windows on the west side.</li> <li>-The west elevation features two small windows in the basement below grade level, two small rectangular windows on the main floor, and one large rectangular window on the second floor below the gable peak. The gable end on the west elevation is clad in siding.</li> <li>-Landscape features include a large yard and an established entrance drive.</li> </ul> <p><i>Historical Summary:</i></p> <p>On the 1858 Tremaine's Map this property is owned by Peter M. Rowe, no house is present on the property. On the 1878 North Trafalgar Map, identified as being owned by Samuel King. On the c. 1955 Tweedsmuir map the property is owned by R. King. The intact farmstead is visible in the 1954 aerial photography. In the 1973 NTS topographic mapping the building is still present.</p>

<p>North and west elevations, looking southeast.</p>

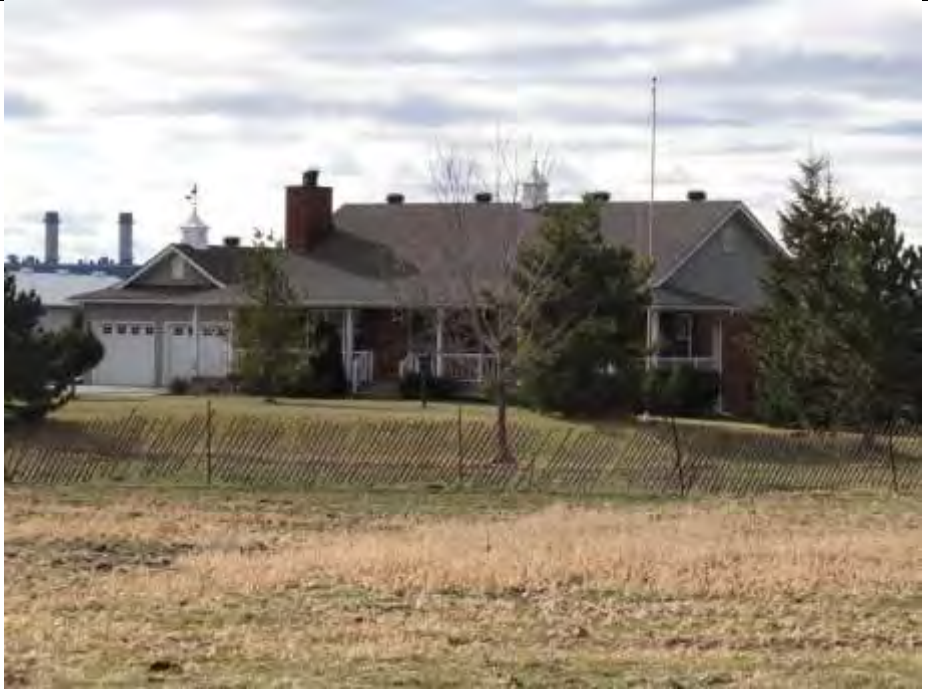
<p>CHL 16</p>	<p>8150 Trafalgar Road</p>	<p>Farmscape</p>	<p>Identified during field review</p>	<p><i>Existing Conditions:</i></p> <ul style="list-style-type: none"> <li>-One storey red brick residence with side gabled roof, verandah on the east elevation, and attached two car garage on the south elevation.</li> <li>-Large, internal red brick chimney on the south elevation of the main structure adjacent to garage.</li> <li>-Peaked roof monitor with a finial on the center of the main structure, with a matching monitor on the garage roof featuring a weather vane.</li> <li>-Large outbuilding present to the southwest of the residence, accessed by the main entrance drive.</li> <li>-Landscape features include a long entrance drive west of Trafalgar Road, large grass lawns, internal circulation routes, and active agricultural fields.</li> </ul> <p><i>Historical Summary:</i></p> <p>Not depicted in 1954 aerial photograph.</p>

<p>East elevation, looking west.</p>

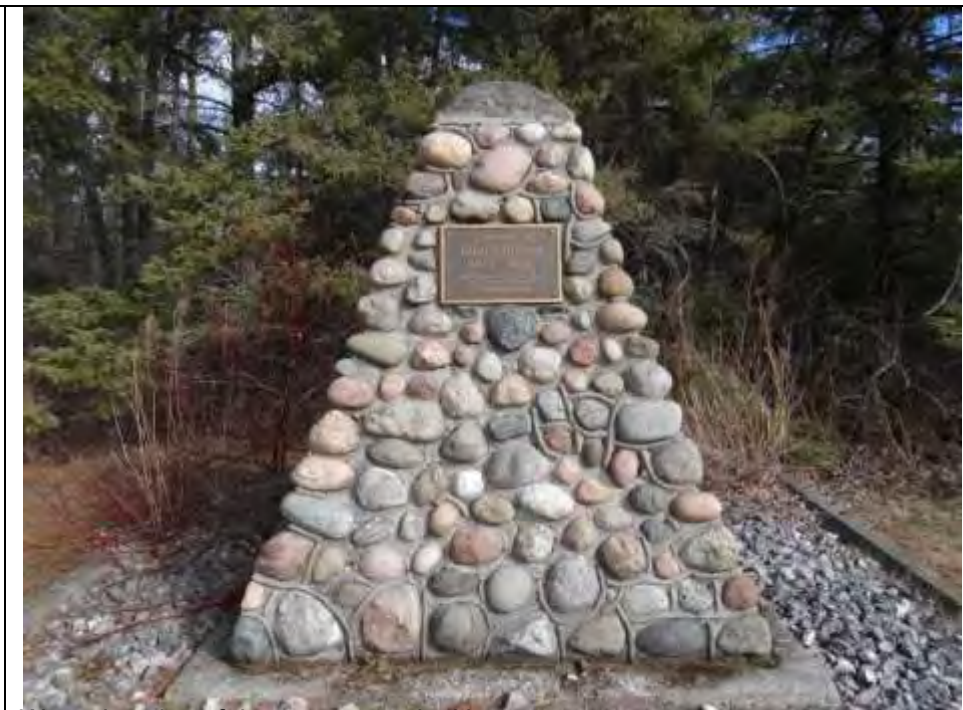
CHL 19	8315 Hornby Road Memorial	Memorial	Listed in the Town of Halton Hills Municipal Heritage Register	<p><i>Existing Conditions:</i></p> <p>-Memorial cairn and plaque to John Coulson, who donated his farmland to the Regional Municipality of Halton for reforestation, now known as the Coulson Regional Forest Tract.</p> <p>-Monument constructed of rounded stones bound with concrete, with a bronze plaque affixed.</p> <p>- Area around monument is landscaped grass, and bordered by mature treelines on all sides except the west, which is bordered by Hornby Road.</p> <p><i>Historical Summary:</i></p> <p>This area is part of the Coulson Regional Forest Tract. The property was primarily reforested with white pine. On the 1858 Tremaine's Map this property is owned by Geo. Beckwith, no farmhouse is present on the property. On the 1878 Historical Atlas map the property is owned by Jas. Boyd, no farmhouse is present on the property. On the 1917 Guidal Landowners Map the property is owned by J. Coulson. John Coulson, (1871-1956) bequeathed 95 acres of the property to Halton County as a Reforestation Tract in 1956. On the c. 1955 Tweedsmuir map the property is owned by Coulson.</p>

West elevation of the monument, looking east.

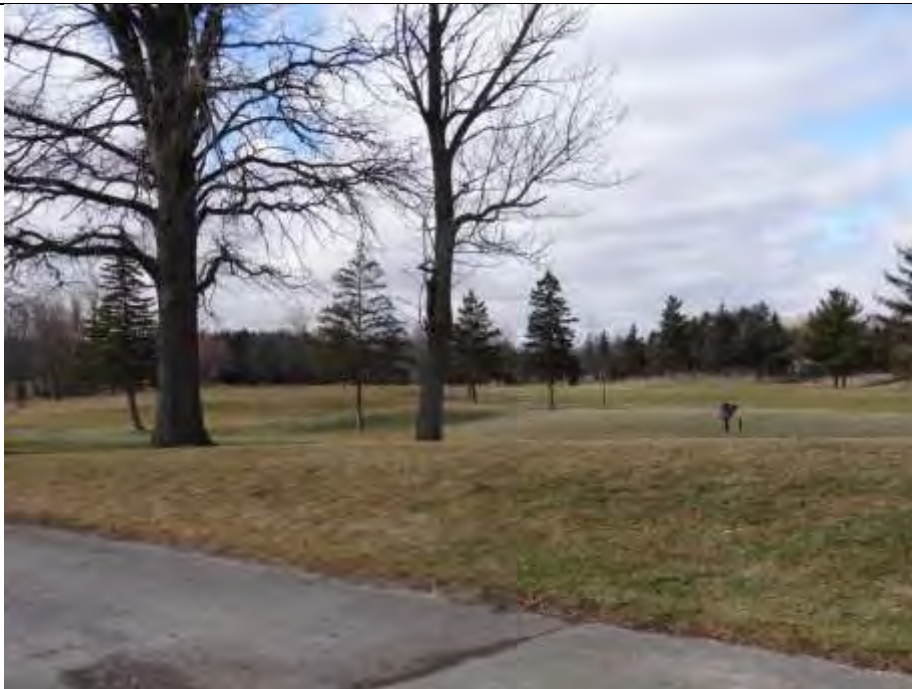
<p>CHL 20</p>	<p>8286 Hornby Rd</p>	<p>Recreational</p>	<p>Identified: Field review and/or review of historical mapping</p>	<p><i>Existing Conditions:</i></p> <p>Hornby Glen Golf Course consists of large tracts of heavily landscaped planned recreational areas, a clubhouse and associated outbuildings, and a large parking area.</p> <p>-Bordered by on the east by fencing and a mature tree line fronting on the Hornby Road right-of-way, residences on the northeast and southeast, and agricultural fields on all other sides.</p> <p><i>Historical Summary:</i></p> <p>The golf course opened in 1965.</p> <p>On the 1858 Tremaine's Map this property is owned by Robert S. Hall, no houses are present on the property. On the 1878 Historical Atlas Map the property is identified as being owned by Robert S. Hall, three farmhouses and two orchards with two laneways are identified. On the 1921 Guidal Landowners Map the property is identified as being owned by F. Wigglesworth. On the c. 1955 Tweedsmuir map the property is owned by C. Wigglesworth. The intact historic farmstead is visible in the 1954 aerial photography. In the 1973 NTS topographic mapping the property has been converted to a golf course.</p>

View northwest of the golf course from the parking lot.

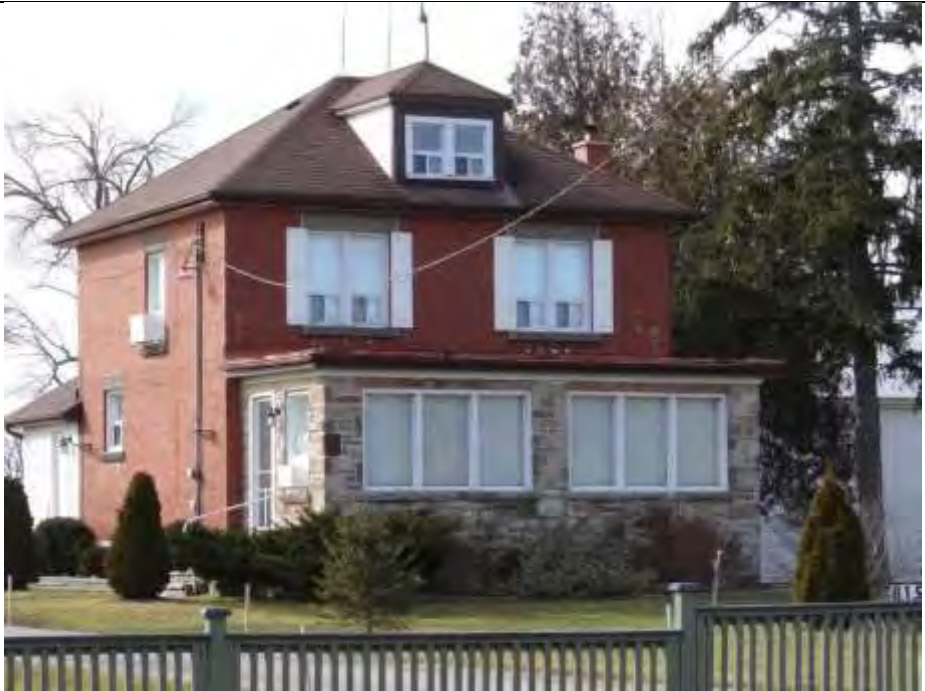
BHR 12	8156 Hornby Road	Residential  Hornby Historic Settlement Area	Identified: Field review and/or review of historical mapping	<p><i>Existing Conditions:</i></p> <p>Residence is a two-storey red brick Foursquare style, with rectangular massing, a hipped-pyramidal roof, and an enclosed verandah on the east elevation.</p> <ul style="list-style-type: none"> <li>-The east elevation also features a hipped roof dormer with a central window.</li> <li>-Windows consist of six modern, fixed windows on the main floor of the east elevation, with two symmetrically-located, paired windows with concrete lintels and sills and louvered shutters.</li> <li>-Landscape features include mature trees, fenced lawn yard, and established entrance drive.</li> </ul> <p><i>Historical Summary:</i></p> <p>On the 1858 Tremaine's Map this property is owned by James Crawford, no houses are present on the property. On the 1878 Historical Atlas Map the property is identified as being owned by Thos. Howson, just south of the church property owned by T. Wyley and Dr. A. Fox no farmhouses are identified. On the c. 1955 Tweedsmuir map the property is owned by Thompson. The home is visible in the 1954 aerial photography. In the 1973 NTS topographic mapping the property remains.</p>

<p>East elevation, looking west.</p>

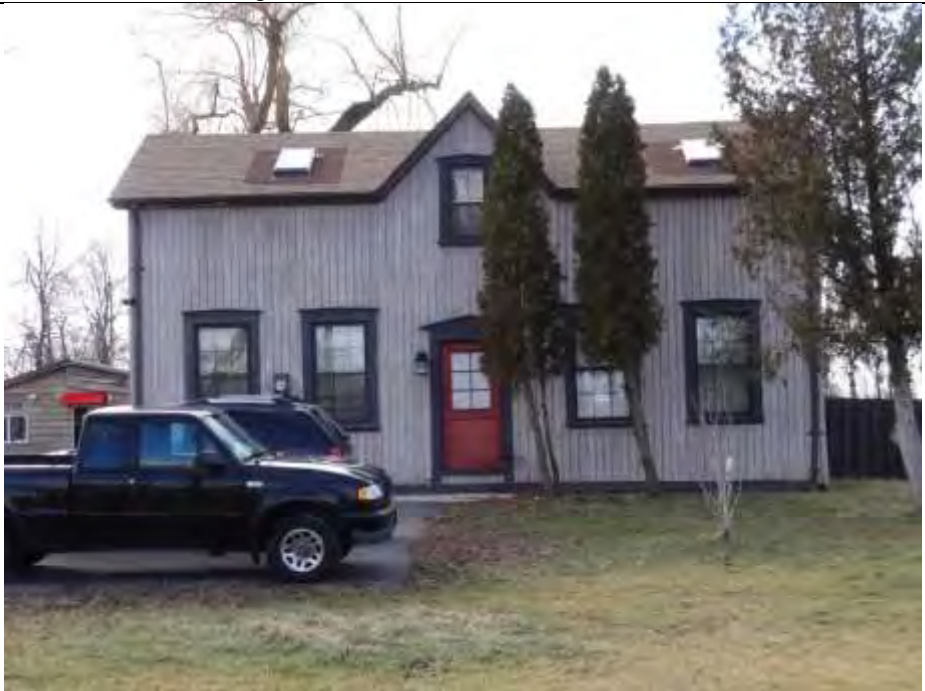
BHR 13	8140 Hornby Road	Residential  Hornby Historic Settlement Area	Identified: Field review and/or review of historical mapping	<p><i>Existing Conditions:</i></p> <p>One-and-a-half storey Ontario Gothic Cottage clad in vertical shiplap siding with a central intersecting gable roof.</p> <ul style="list-style-type: none"> <li>-Windows on the east elevation include six-over-six sash and feature decorative trim and modest pediments, with one centrally located on the second floor, and two on both sides of a central doorway on the main floor.</li> <li>-Doorway is central to the east elevation, and consists of a six-paned panel door with pilasters and a pediment.</li> <li>- An outbuilding is located to the south west of the main structure, with a modern addition on the west elevation of the main structure.</li> <li>-Landscape features include mature trees and an established entrance drive.</li> </ul> <p><i>Historical Summary:</i></p> <p>On the 1858 Tremaine's Map this property is owned by James Crawford, no houses are present on the property. On the 1878 Historical Atlas Map the property is identified as being owned by Thos. Howson, just south of the church property owned by T. Wyley and Dr. A. Fox, no farmhouses are identified. On the c. 1955 Tweedsmuir map the property is owned by Thompson. The home is visible in the 1954 aerial photography. In the 1973 NTS topographic mapping the property remains.</p>

<p>East elevation, looking west.</p>

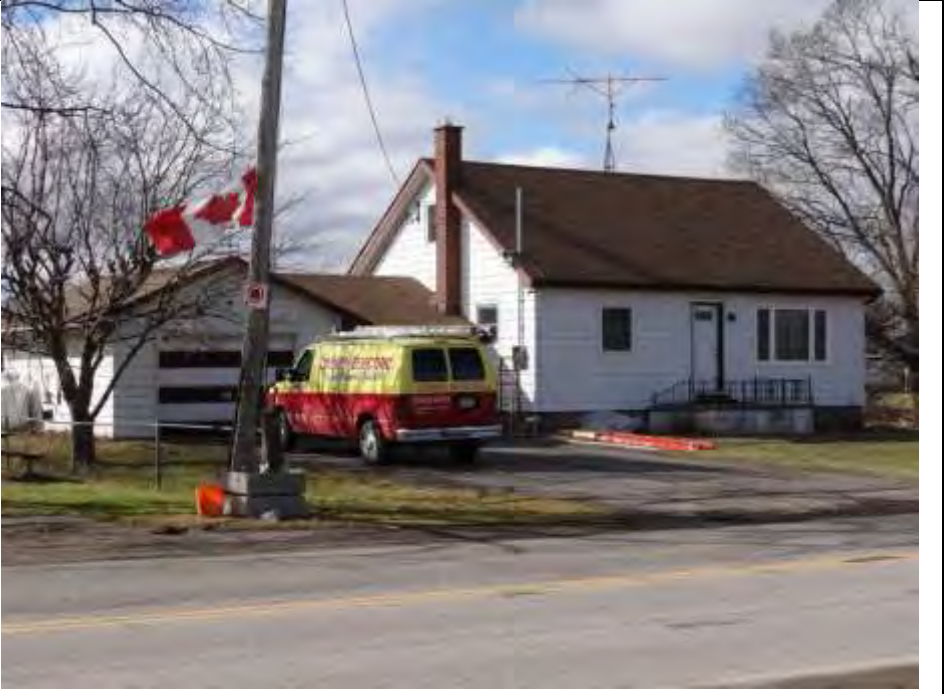
BHR 16	8032 Hornby Road	Residential  Hornby Historic Settlement Area	Identified: Field review and/or review of historical mapping	<p><i>Existing Conditions:</i></p> <p>One-and-a-half storey residential structure with a side-gable roof, clad in siding, with an attached one-car garage.</p> <p>-The east elevation features a centrally-located doorway, with a large rectangular casement window on the north of the door, and a smaller rectangular one-over-one sash window on the south of the door.</p> <p>-The south elevation features one small one-over-one sash window on the easternmost portion of the main floor, with the rest of the main floor occupied by an addition that connects the main house to the garage. The south elevation of the second floor features a centrally-located window that is partially obscured from view from Hornby Road by the external red brick chimney on the south elevation.</p> <p>Landscape features include an established entrance drive off Hornby Road, landscaped lawns, and fenced property dividers.</p> <p><i>Historical Summary:</i></p> <p>On the 1858 Tremaine's Map this property is owned by James Crawford, no houses are present on the property. On the 1878 Historical Atlas Map the property is identified as being owned by Thos. Howson, the property is within the West Hornby Settlement Area. On the c. 1955 Tweedsmuir map the property is owned by Thompson. The building is not identifiable in the 1954 aerial photography.</p> <p>The building is present in the 1973 NTS topographic mapping</p>

<p>East elevation, looking west.</p>

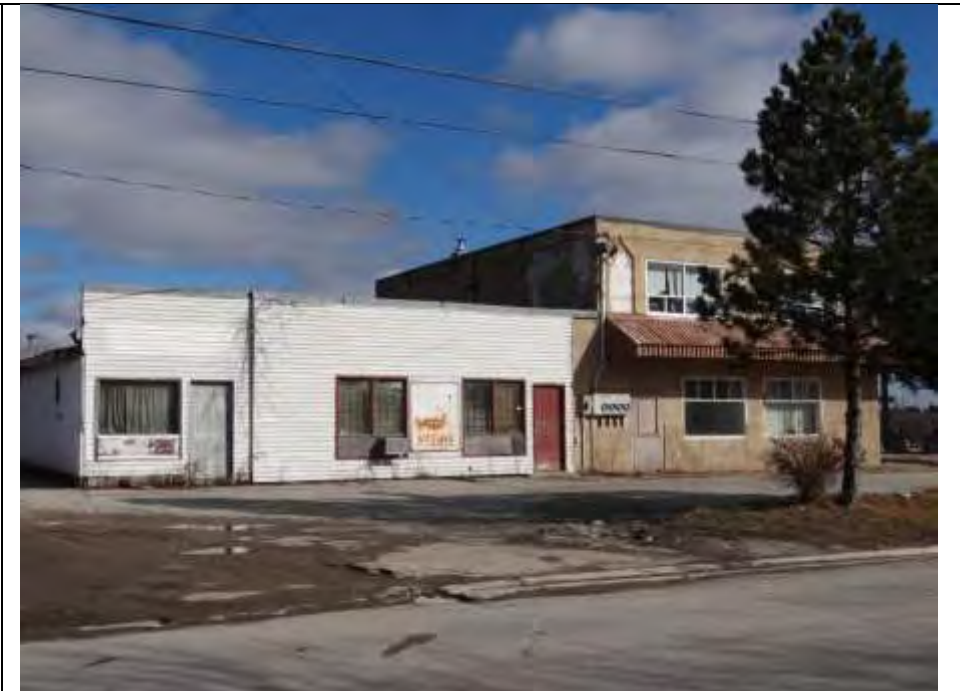
BHR 17	8017 Hornby Road	Commercial  Hornby Historic Settlement Area	Identified: Field review and/or review of historical mapping	<p><i>Existing Conditions:</i></p> <p>Two storey commercial-residential structure with a single-storey addition on the north elevation and a small single-storey addition on the south elevation, at the northeast corner of Hornby Road and Steeles Avenue.</p> <p>-The main structure is a two-storey rectangular building with large rectangular windows on both the main and second floors on the west elevation. The west elevation also features a simple doorway on the northern portion, and a single-storey awning.</p> <p>-The northern addition is a single storey structure clad in white siding with a false front on the west elevation, and features three large rectangular windows and two doorways.</p> <p>-The southern addition is the most recent, and is a stucco-clad, single storey structure associated with the operational gas station present on the site.</p> <p>-Associated features include gas pumps, large parking area, and several entrances from Hornby Road and Steeles Avenue.</p> <p><i>Historical Summary:</i></p> <p>Identified as the Brigden Service Station. The home of Alfred Brigden formerly was located at the front of the lot towards Steeles Ave. The building served the automotive traffic travelling north-south on Hornby Road.</p> <p>On the 1858 Tremaine's Map this property is owned by Mrs. J MacKenzie, no houses are present on the property the property is located within the Upper Hornby historic settlement area. On the 1878 Historical Atlas Map the property is identified as being owned by Samuel Brooks, the property is within the West Hornby Settlement Area. The building can be seen in the 1954 aerial photography. The building is present in the 1973 NTS topographic mapping.</p>

North and west elevation, looking east.

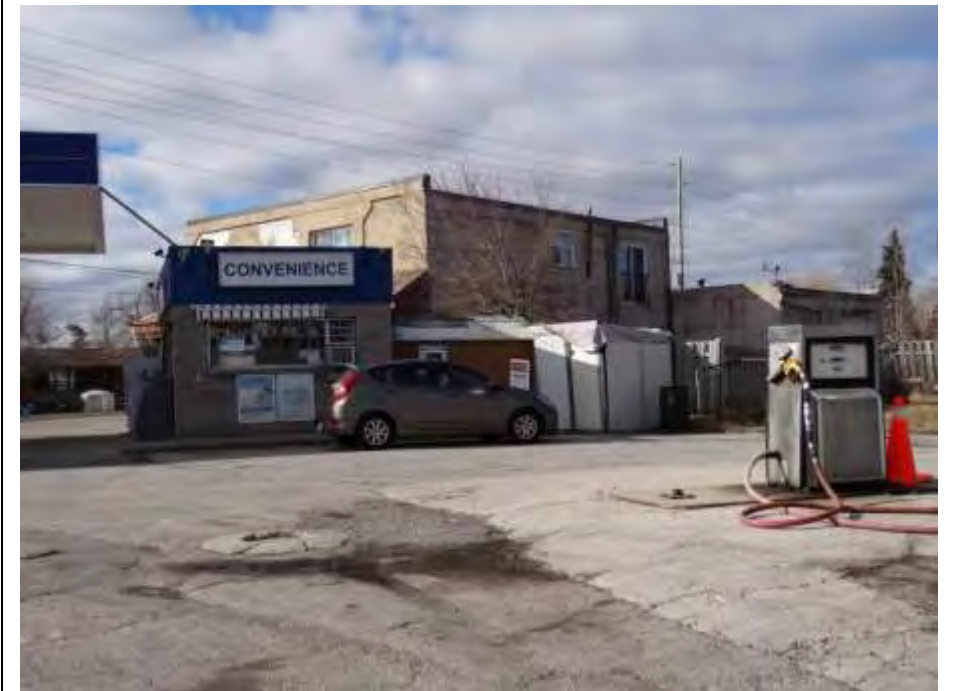
East elevation, looking northwest.

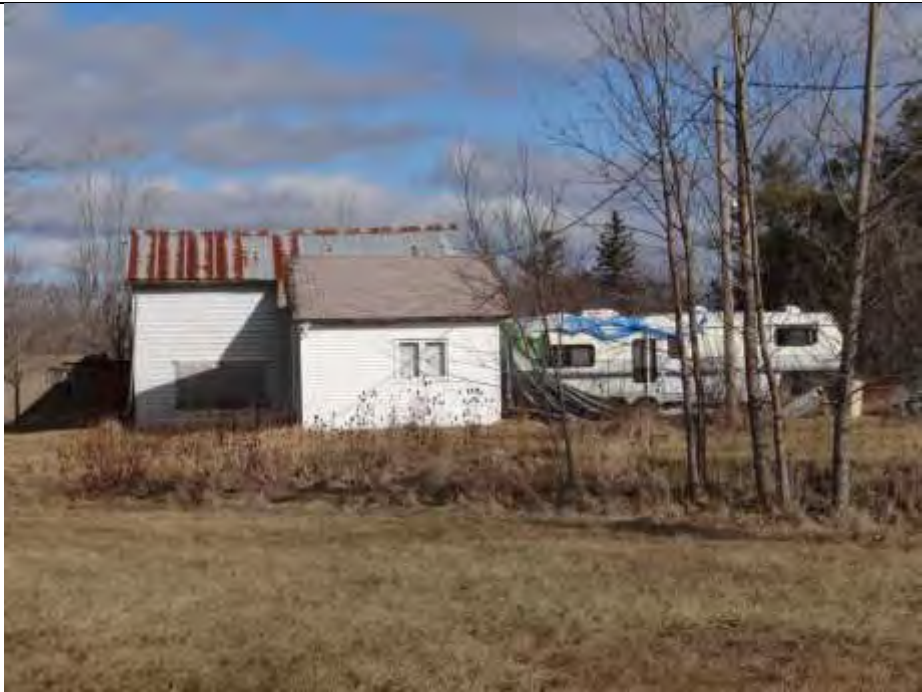
<p>CHL 21</p>	<p>8029-8049 Hornby Road</p>	<p>Remnant Farmscape  Hornby Historic Settlement Area</p>	<p>Identified: Field review and/or review of historical mapping</p>	<p><i>Existing Conditions:</i></p> <ul style="list-style-type: none"> <li>-Property features two small attached structures, with the easternmost featuring a corrugated metal gable roof and clad in white siding, and the westernmost featuring an asphalt gable roof clad in white siding. Both structures appeared to be in poor repair at the time of inspection.</li> <li>-A large motor home was parked on site at the time of the field inspection</li> <li>-Landscape features include established treelines and overgrown lawns.</li> </ul> <p><i>Historical Summary:</i></p> <p>On the 1858 Tremaine's Map this property is owned by Mrs. J MacKenzie, no houses are present on the property the property is located within the Upper Hornby historic settlement area. On the 1878 Historical Atlas Map the property is identified as being owned by Samuel Brooks, the property is within the West Hornby Settlement Area. The building can be seen in the 1954 aerial photography. The building is present in the 1973 NTS topographic mapping.</p>

<p>West elevation, looking east.</p>

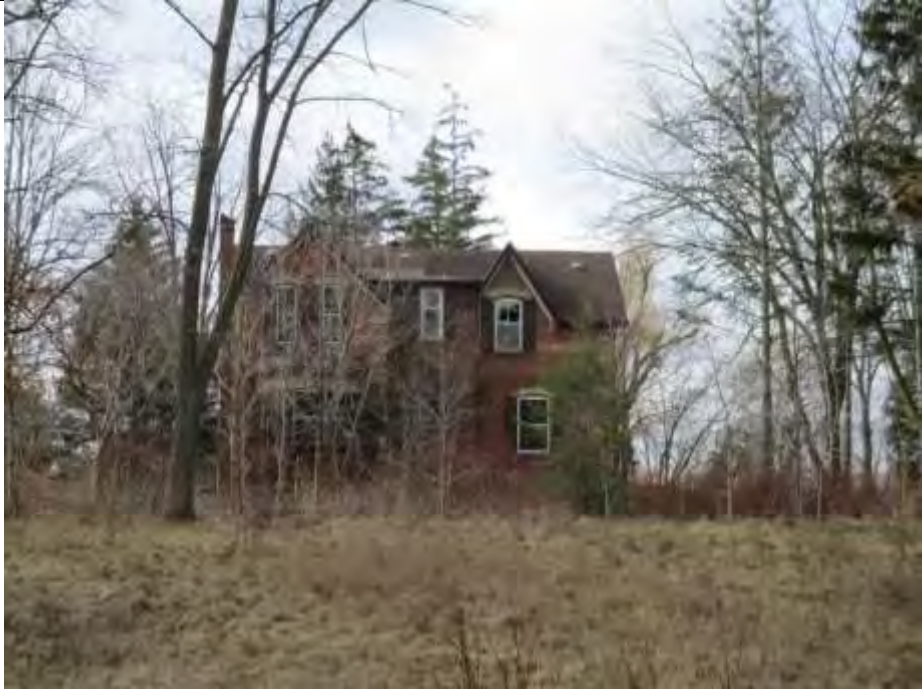
<p>CHL 22</p>	<p>7974 Sixth Line</p>	<p>Farmscape</p>	<p>Identified: Field review and/or review of historical mapping</p>	<p><i>Existing Conditions:</i></p> <ul style="list-style-type: none"> <li>-Details are obscured due to heavy tree coverage</li> <li>-Large, two storey polychromatic brick Victorian Vernacular residence with multiple intersecting gabled dormers, and yellow brick decorative elements and quoins.</li> <li>-The east elevation was the only one visible during the field review, which features a projecting frontpiece on the southern portion with a large bay window on the main floor, two one-over-one sash windows with yellow brick segmental arches and brown louvered shutters on the second floor.</li> <li>-The main floor features two one-over-one sash windows, the northernmost with yellow brick segmental arches and louvered shutters, and the central one with red brick segmental arch and louvered shutters.</li> <li>-The south elevation features an external red brick chimney.</li> <li>-The property exhibits a broken window on the second floor, and the landscape appears unmaintained, suggesting the property has fallen from use.</li> <li>-Landscape features include matures trees, large fenced yard.</li> </ul> <p><i>Historical Summary:</i></p> <p>Identified as the T.J. Chisholm Farmstead. On the 1858 Tremaine's Map this property is owned by Thom Chisholm, no houses are present on the property. On the 1878 Historical Atlas Map the property is identified as being owned by T.J. Chisholm a farmhouse and orchard is identified. The building can be seen in the 1954 aerial photography. The building is present in the 1973 NTS topographic mapping. Farm outbuildings were demolished in 2009/2010</p> <p>Historic Photo at right taken in front of the farmhouse at the corner of 6th Line and Steeles Avenue across from Hornby Park. Pictured are, in back row from left to right: Rebecca Chisholm, the "hired girl" Alice Ward and Thomas Chisholm. In the front row are the Chisholm children, Will, Gordon, Dempsey, Annie and Joe.</p> <p><i>Notes:</i></p> <p>Alice Ward listed on the 1891 census as a domestic residing with the Thomas Chisholm family. She was aged 17 years at the time. According to the same census, she was from England. Presumably she was a Home Child.</p>

<p>East elevation of residence, looking west from Sixth Line</p>

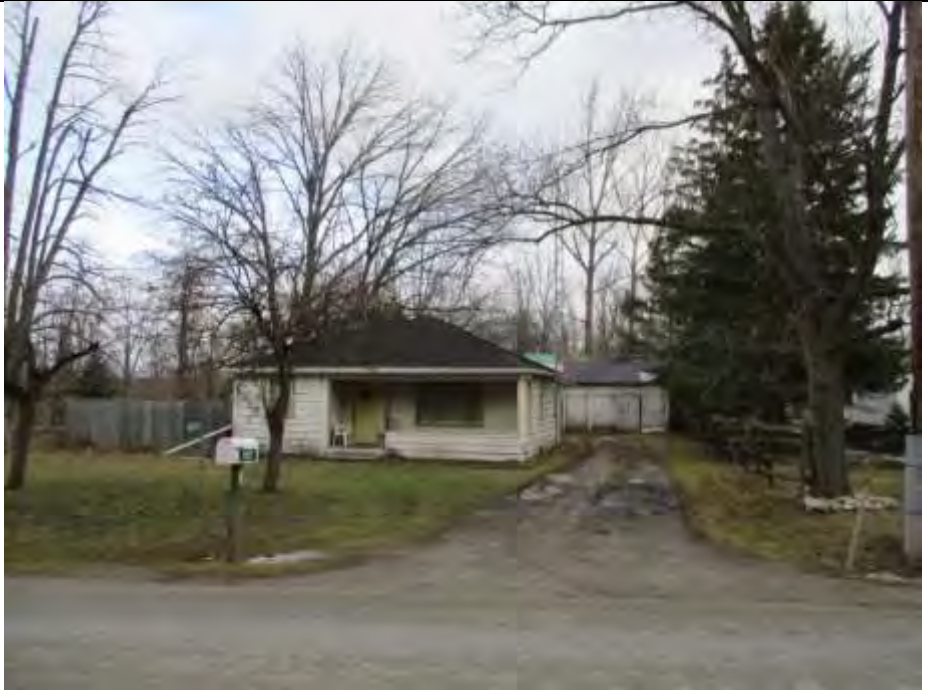
BHR 18	8087 Sixth Line	Residential	Identified: Field review and/or review of historical mapping	<p><i>Existing Conditions:</i></p> <ul style="list-style-type: none"> <li>-One storey frame cottage clad in siding with a hipped roof and concrete foundation.</li> <li>-West elevation features a central main entrance and a large rectangular window flanked by a four-over-four sash window on both sides. The southern portion of the west elevation includes a roofed verandah, while the northern portion features a four-over-four sash window. The south elevation features two symmetrically-located windows, and the east elevation features a red brick chimney.</li> <li>-Landscape features include an established entrance drive, outbuildings, fenced yard, and trees.</li> </ul> <p><i>Historical Summary:</i></p> <p>On the 1858 Tremaine's Map this property is owned by D. Fore, no house is present on the property. On the 1878 Historical Atlas Map, the property is identified as being owned by Mrs. Mary A. MacDowell, a farmhouse is present on the property with an orchard but does not align with the location of this property. On the 1921 Guidal Landowners Map the property is owned by T. Learmont. On the c. 1955 Tweedsmuir map the property is owned by Hullman. The building visible in the 1954 aerial photography. In the 1973 NTS topographic mapping the building is present.</p>

<p>West elevation, looking east.</p>

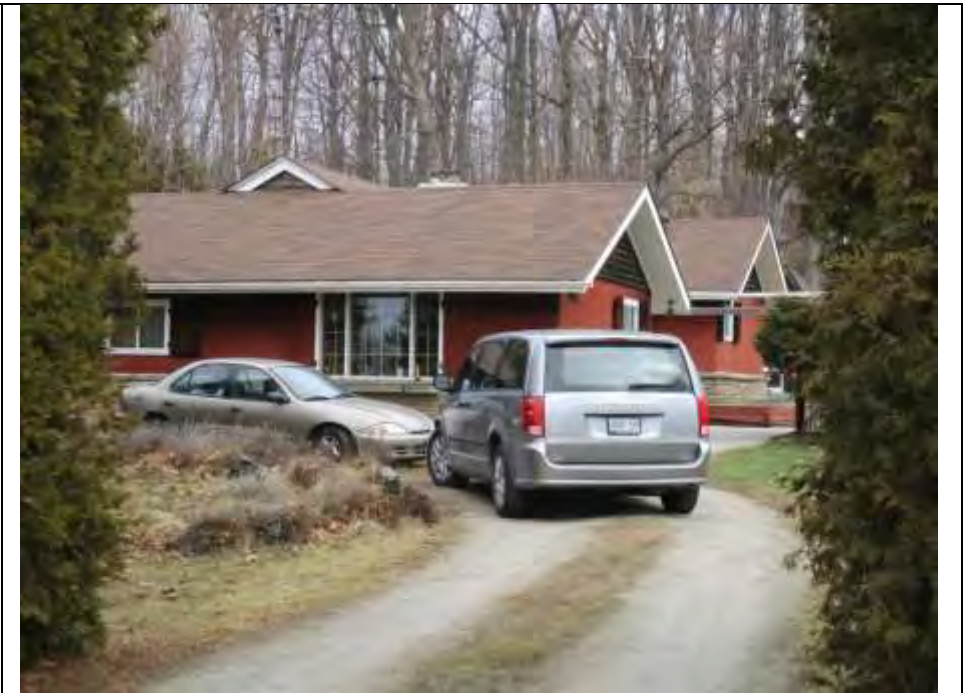
BHR 19	8381 Sixth Line	Residential	Identified: Field review and/or review of historical mapping	<p><i>Existing Conditions:</i></p> <p>Entire property is heavily obscured from view by a dense cedar privacy hedge along Sixth Line, with very few architectural details visible. Satellite imagery was utilized to determine many details of the structure and landscape.</p> <p>-The property features a one-and-a-half storey, multi-pitched roof structure. The west elevation and parts of the south elevation were visible from Sixth Line, and feature end gabled roof with asphalt shingles and horizontal boards on the gable ends, walls clad in vertical painted boards, and a cut stone façade on the foundation.</p> <p>-Windows appear to be modern, although the view was too obscured to be certain.</p> <p><i>Historical Summary:</i></p> <p>On the 1858 Tremaine's Map this property is owned by Robert S. Hall, no houses are present on the property. On the 1878 Historical Atlas Map the property is identified as being owned by Robert S. Hall, three farmhouses and two orchards with two laneways are identified. On the 1921 Guidal Landowners Map the property is identified as being owned by F. Wrigglesworth. On the c. 1955 Tweedsmuir map the property is owned by C. Wrigglesworth. The intact historic farmstead is visible in the 1954 aerial photography. The building is not identifiable in the 1954 aerial photography.</p> <p>The building is present in the 1973 NTS topographic mapping</p>

West and south elevations, looking east.

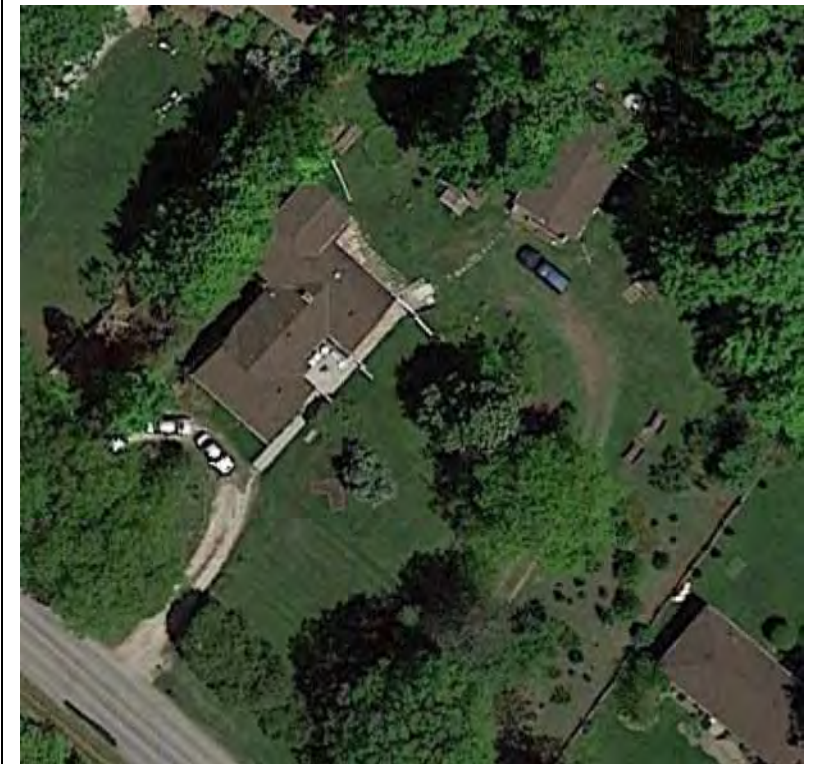
Satellite image of the subject property, courtesy of Google Earth.

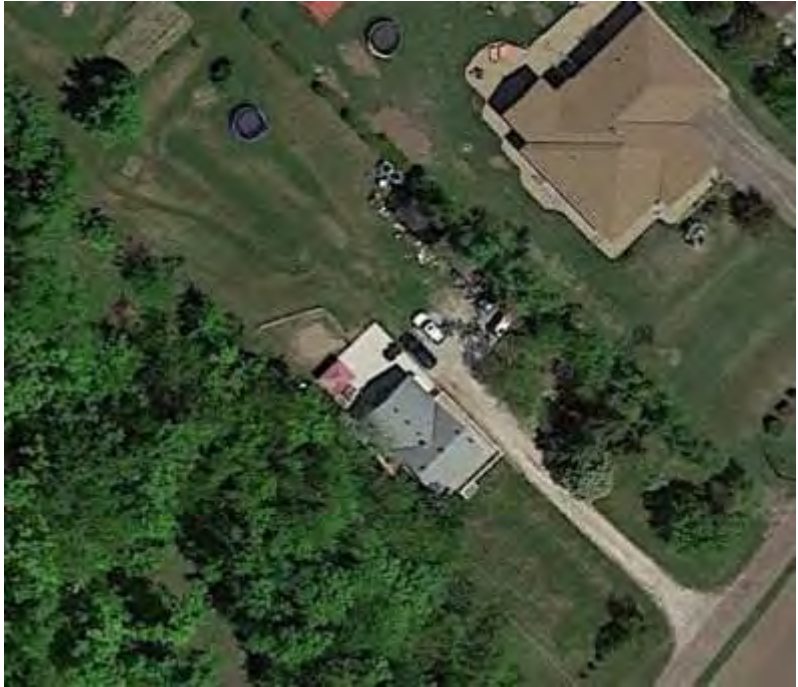
<p>CHL 25</p>	<p>8299 6th Line Lane</p>	<p>Farmhouse</p>	<p>Identified: Field review and/or review of historical mapping</p>	<p><i>Existing Conditions:</i></p> <ul style="list-style-type: none"> <li>- Not visible from publicly-accessible Sixth Line right-of-way.</li> <li>-Subject property features an intersecting gable roof residence, established entrance drive, mature treelines, large yard, and several outbuildings.</li> </ul> <p><i>Historical Summary:</i></p> <p>On the 1858 Tremaine’s Map this property is owned by Robert S. Hall, no houses are present on the property. On the 1878 Historical Atlas Map the property is identified as being owned by Robert S. Hall, three farmhouses and two orchards with two laneways are identified. On the 1921 Guidal Landowners Map the property is identified as being owned by F. Wigglesworth. On the c. 1955 Tweedsmuir map the property is owned by C. Wigglesworth. The intact historic farmstead is visible in the 1954 aerial photography. The building is identifiable in the 1954 aerial photography. Landscape feature present in the approximate area in 1954 aerial photograph.</p>

<p>Satellite image of subject property, courtesy of Google Earth</p>

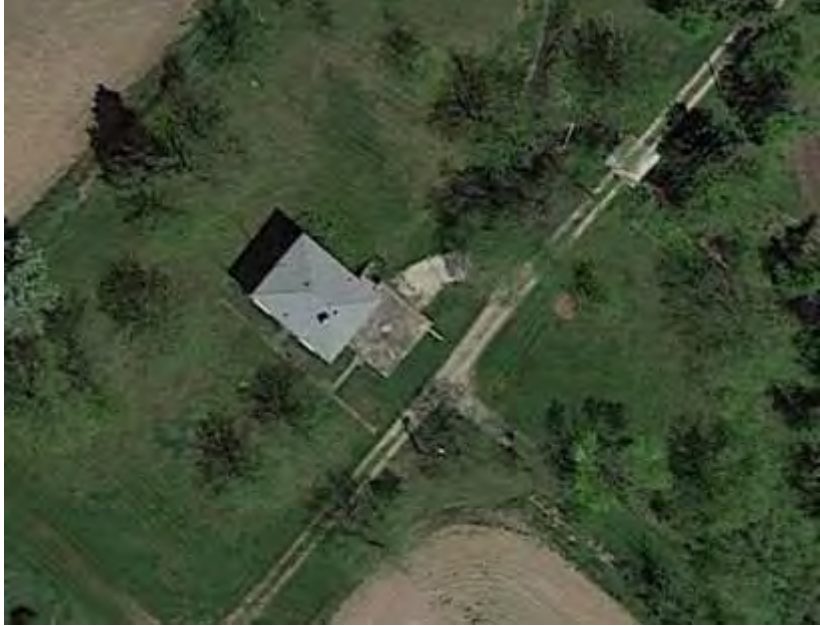
<p>CHL 26</p>	<p>8466 6<sup>th</sup> Line</p>	<p>Farmhouse</p>	<p>Identified: Field review and/or review of historical mapping</p>	<p><i>Existing Conditions:</i></p> <ul style="list-style-type: none"> <li>-Obscured from view due to distance from roadway.</li> <li>-Landscape features include a residence and a long tree-lined drive, located 450 metres west of Hornby Road.</li> <li>-Surrounded by active agricultural land and mature trees.</li> </ul> <p><i>Historical Summary:</i></p> <p>On the 1858 Tremaine’s Map this property is owned by Robert S. Hall, no houses are present on the property. On the 1878 Historical Atlas Map the property is identified as being owned by Robert S. Hall, three farmhouses and two orchards with two laneways are identified. On the 1921 Guidal Landowners Map the property is identified as being owned by F. Wigglesworth. On the c. 1955 Tweedsmuir map the property is owned by C. Wigglesworth. The intact historic farmstead is visible in the 1954 aerial photography. The building is identifiable in the 1954 aerial photography. Landscape features visible in the 1954 aerial photograph.</p>

<p>Satellite image of subject property, courtesy of Google Earth.</p>

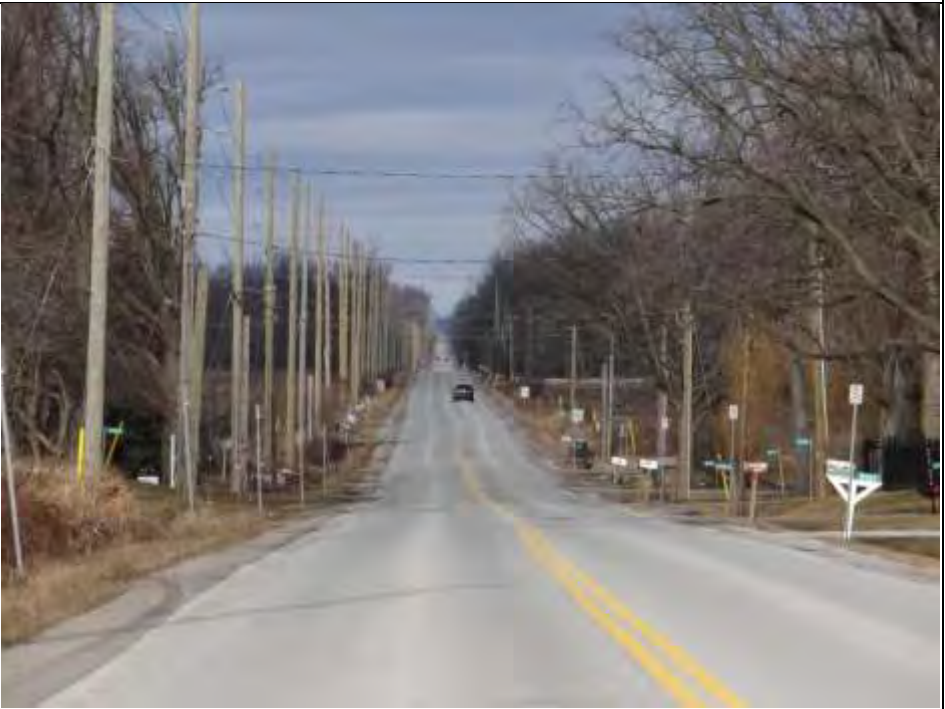
Roadscapes					
CHL 27	Eighth Line	Roadscape	Identified: Field review and/or review of historical mapping.	<p>-Eighth Line consists of two lanes of undivided traffic within the study area, and is bordered by narrow gravel shoulders and drainage ditches in most areas.</p> <p>-Central circulation route to residents of the community of Hornby and to surrounding agricultural areas.</p>

<p>Eighth Line north of Steeles Ave. looking north.</p>
CHL 28	Sixth Line	Roadscape	Identified: Field review and/or review of historical mapping.	<p>-Sixth Line is composed of two lanes of undivided vehicular traffic bordered by drainage ditches on both sides.</p> <p>-Sixth Line is an historically surveyed road that is oriented north-south adjacent to the study area and serves as an important circulation route for residential traffic as well as agricultural production in the area.</p>

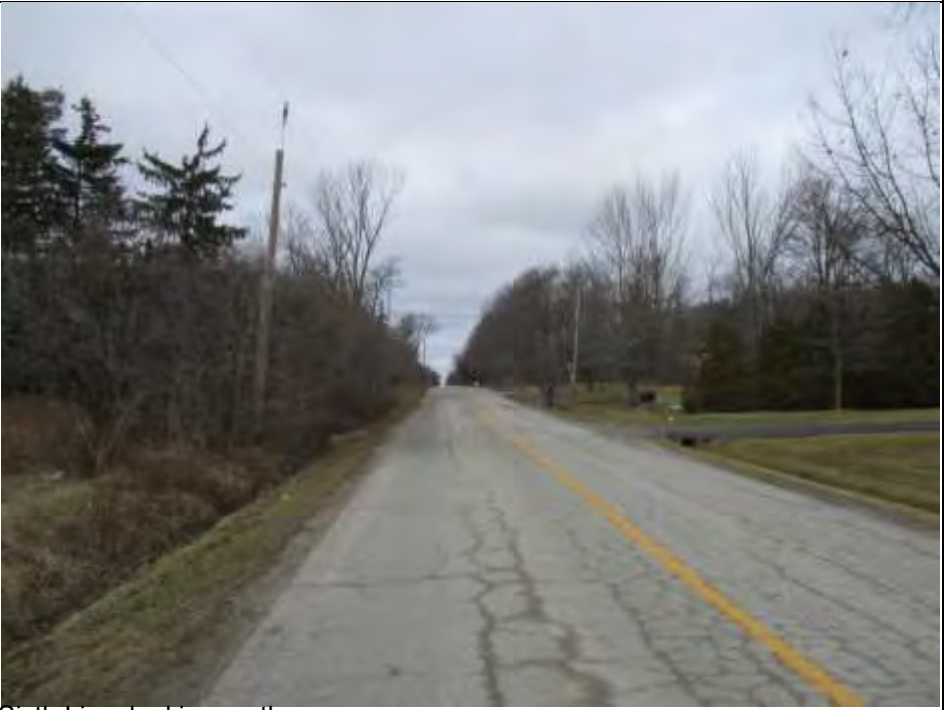
<p>Sixth Line, looking north.</p>

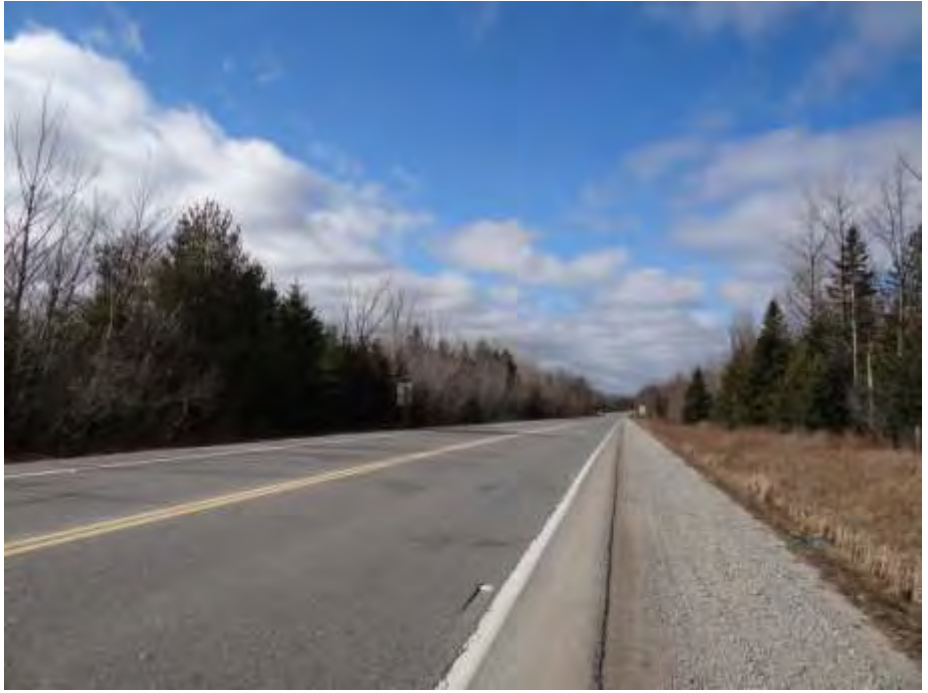
<p>CHL 29</p>	<p>Trafalgar Road</p>	<p>Roadscape</p>	<p>Identified: Field review and/or review of historical mapping.</p>	<p>-Trafalgar Road is composed of two lanes of undivided vehicular traffic bordered by narrow gravel shoulders and drainage ditches in most of the study area. The portion of the roadway in the northern section of the study area is bordered by the Coulson Regional Forest Tract, while the southern half is bordered by agricultural lands and commercial establishments.</p> <p>-Trafalgar Road is not an historically surveyed road and was constructed in the latter half of the twentieth century. It is oriented northwest-southeast within the study area, and serves as an important circulation route for residential traffic as well as agricultural production in the area.</p>

<p>Trafalgar Road within the Coulson Regional Forest Tract, looking northwest.</p>
<p>CHL 30</p>	<p>Steeles Avenue</p>	<p>Roadscape</p>	<p>Identified: Field review and/or review of historical mapping.</p>	<p>-Steeles Avenue is primarily composed of two lanes of undivided vehicular traffic throughout the study area, with the majority bounded by cement curbs and lacking shoulders. The southeastern portion of the study area adjacent to the Toronto Premium Outlets, however, is composed of four lanes of undivided vehicular traffic, with additional left and right turn lanes and concrete medians to improve vehicular traffic to and from the shopping center.</p> <p>-Steeles Avenue is an historically surveyed road that is oriented east-west adjacent to the study area, and serves as an important circulation route for residential, commercial, and agricultural traffic in the area. It is the historical boundary between Esqueving Township to the north, and Trafalgar Township in the south.</p>

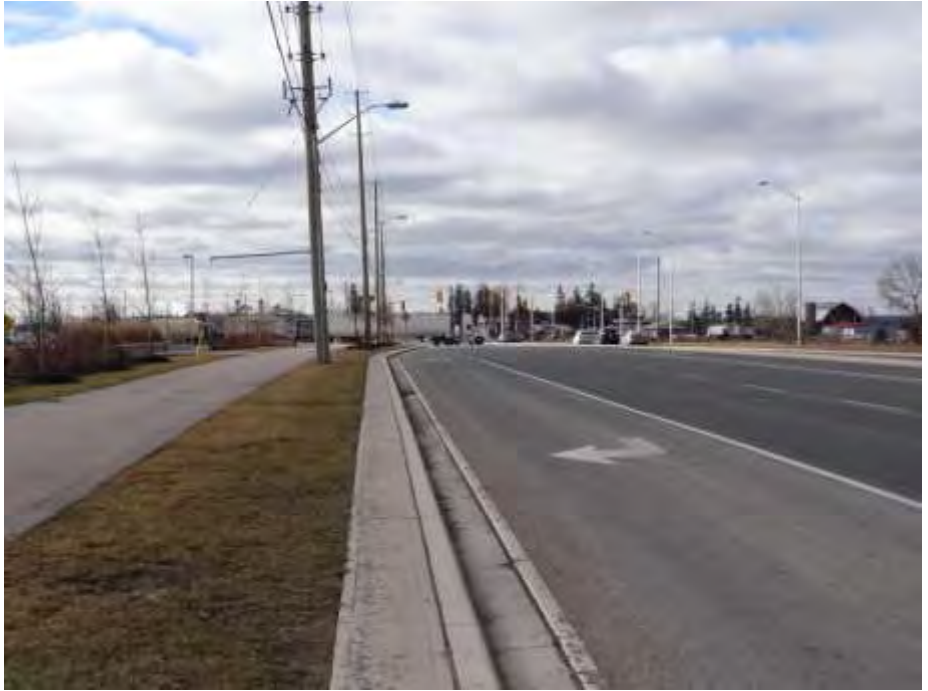
<p>Steeles Avenue, looking west from the southwestern corner of Steeles Avenue and Eighth Line</p>
