**CULTURAL HERITAGE RESOURCE ASSESSMENT**

**TOWN OF HALTON HILLS PREMIER GATEWAY PHASE 1B EMPLOYMENT AREA SECONDARY PLAN  
LOTS 1 AND 2, CONCESSIONS 7 AND 8, FORMER TOWNSHIP OF ESQUESING**

**TOWN OF HALTON HILLS,  
REGIONAL MUNICIPALITY OF HALTON, ONTARIO**

Revised May 2018

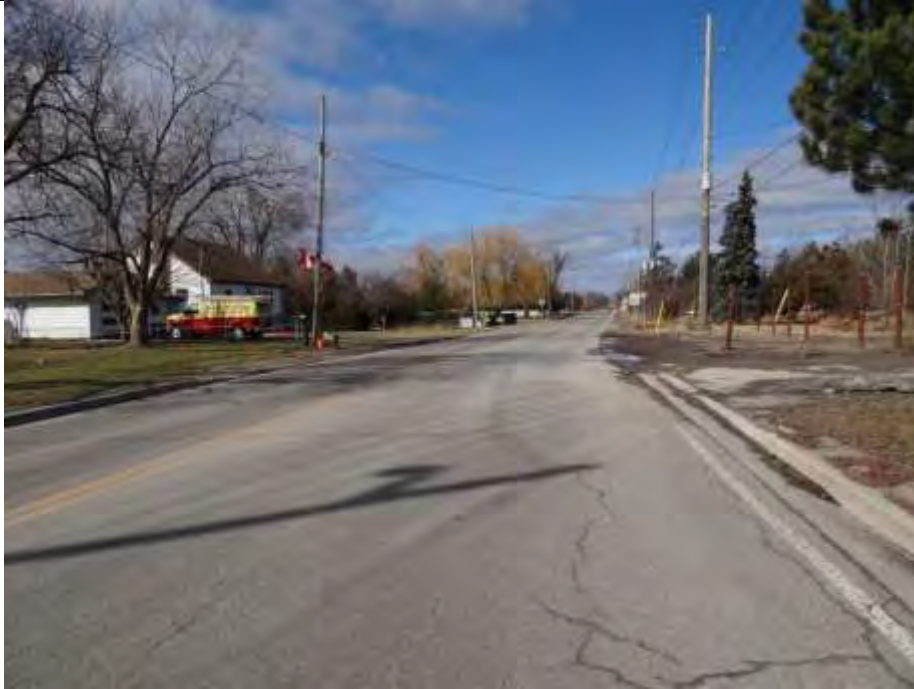
<p>CHL 31</p>	<p>Hornby Road</p>	<p>Roadscape</p>	<p>Identified: Field review and/or review of historical mapping.</p>	<p>-Hornby Road is composed of two lanes of undivided vehicular traffic bordered by narrow gravel shoulders and drainage ditches in most of the study area. The portion of the roadway in the northern section of the study area is bordered by the Coulson Regional Forest Tract and Hornby Glen Golf Course, while the southern half is bordered by the residences of the hamlet of Hornby.</p> <p>-Hornby Road is an historically surveyed road that is oriented north-south adjacent to the study area and serves as an important circulation route for residential traffic as well as agricultural production in the area.</p>

<p>Hornby Road, looking north from Steeles Avenue</p>
<p>BHR 20</p>	<p>Sixth Line Creek Bridge</p>	<p>Bridge</p>	<p>Identified: Field Review, Sixteen Mile Creek Watershed</p>	<p>-Concrete bridge that allows Sixth Line Creek, a tributary of Sixteenth Mile Creek Watershed, to pass under Sixth Line adjacent to the study area.</p> <p>-Bridge features metal railing along the limits of the right-of-way.</p>

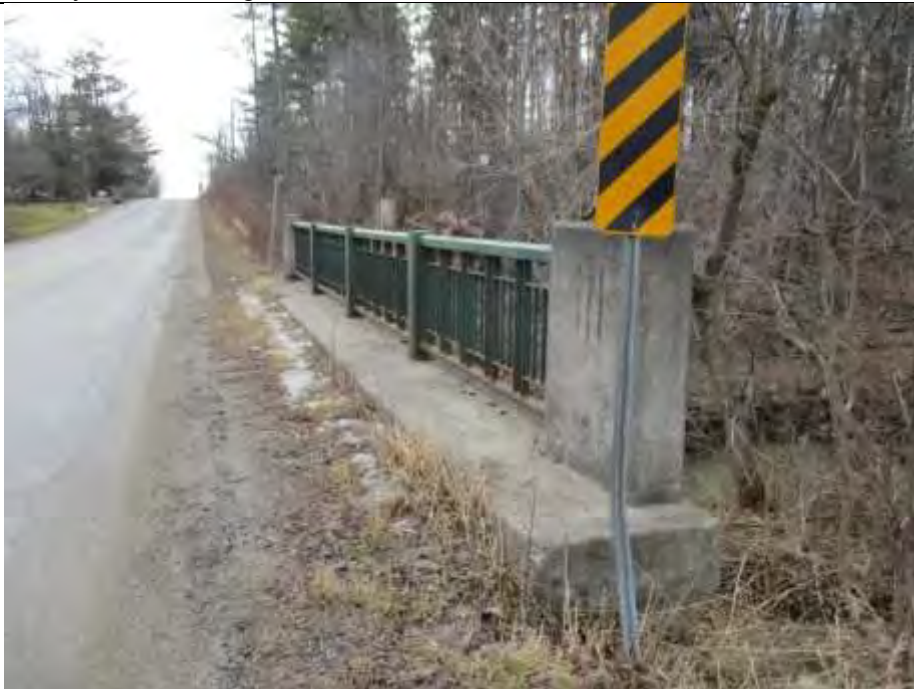
<p>Six Mile Creek Bridge, looking south from Sixth Line.</p>

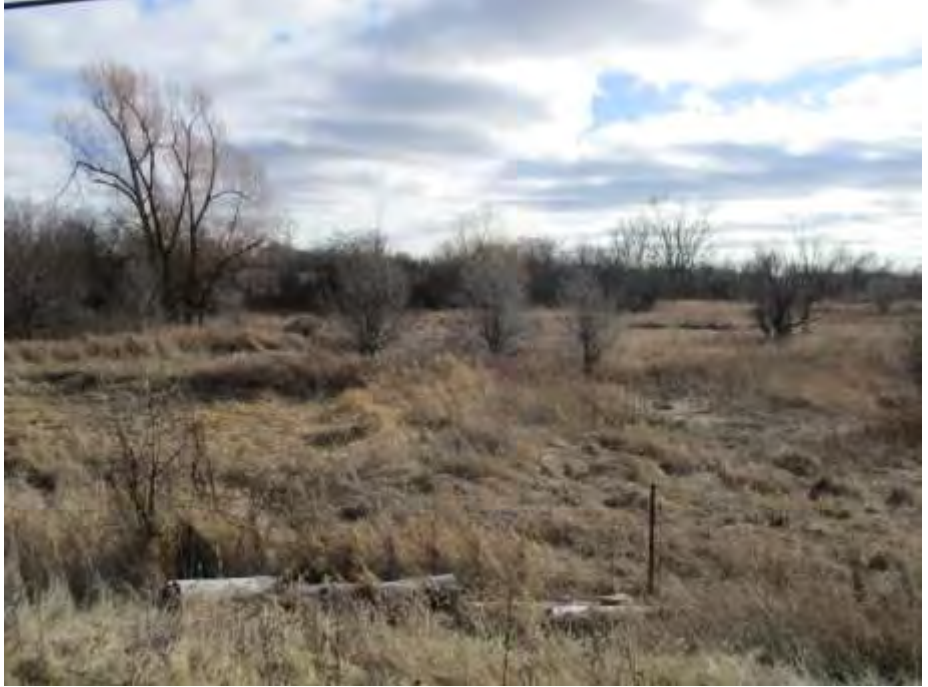
Watercourses					
CHL 32	Steeles Creek East of Hornby Road	Watercourse	Identified: Field Review, Sixteen Mile Creek Watershed	<p>-Low lying, scrub brush and grass area south of Steeles Avenue adjacent to Steeles Creek.</p> <p><i>Historical Summary</i></p> <p>This location was dammed in the fall to make a skating rink, and was the location of the Hornby Hockey Club.</p> <p>From Halinet: <i>“Organized hockey was played in the area since the turn of the century; first on Brain’s Brewery pond, and then on land leased from Stewart Robertson. The rink was on the south side of Steeles, across from Hornby school and beside the creek.</i></p> <p><i>There was a nice clubhouse at the east end of the rink, and wooden boards round the sides of the rink, the same as the rinks in town. In the fall of the year, a dam would be put in the creek to ensure enough water was always available to flood the rink.</i></p> <p><i>The dressing room was in the west corner next to the road. It was a separate room, heated by a stove. In the other half of the clubhouse the front opened up, and there was a screen so the pucks wouldn’t fly in. You could watch the game from inside the clubhouse, where it was warm. Eventually the boards wore out, and by that time Stewart was gone. They got a bulldozer to put mounds of soil around the sides, but it was never as good. The clubhouse was sold to Joe Ferrier to build his house, but pupils from Hornby School made use of it at noon hour, and even in the 1940’s it was a great place for young people to meet on Sunday for a game of shinny.”</i></p>

<p>Low lying area directly west of Steeles Creek, location of former ice rink, looking south from Steeles Avenue.</p>

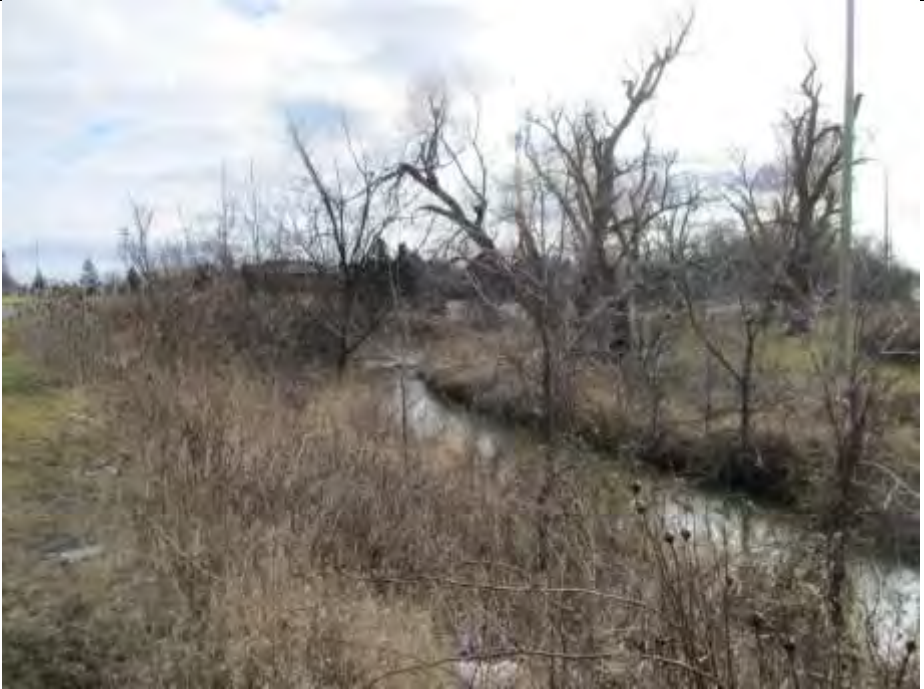
<p>CHL 35</p>	<p>Steeles Creek West of 6<sup>th</sup> Line and Hornby Park</p>	<p>Watercourse</p>	<p>Identified: Field Review, Sixteen Mile Creek Watershed</p>	<p>- Steeles Creek, a tributary of Sixteenth Mile Creek Watershed, is oriented generally north-south where it crosses under Steeles Avenue.</p>

<p>Steeles Creek adjacent to Hornby Park, looking south.</p>
<p>CHL 36</p>	<p>Trafalgar Stream and Culvert South</p>	<p>Watercourse</p>	<p>Identified: Field Review, Sixteen Mile Creek Watershed</p>	<p>-Trafalgar stream is oriented generally northeast to southwest within the study area.                  -Trafalgar Stream diverted under Trafalgar Road by a large concrete box culvert.</p>

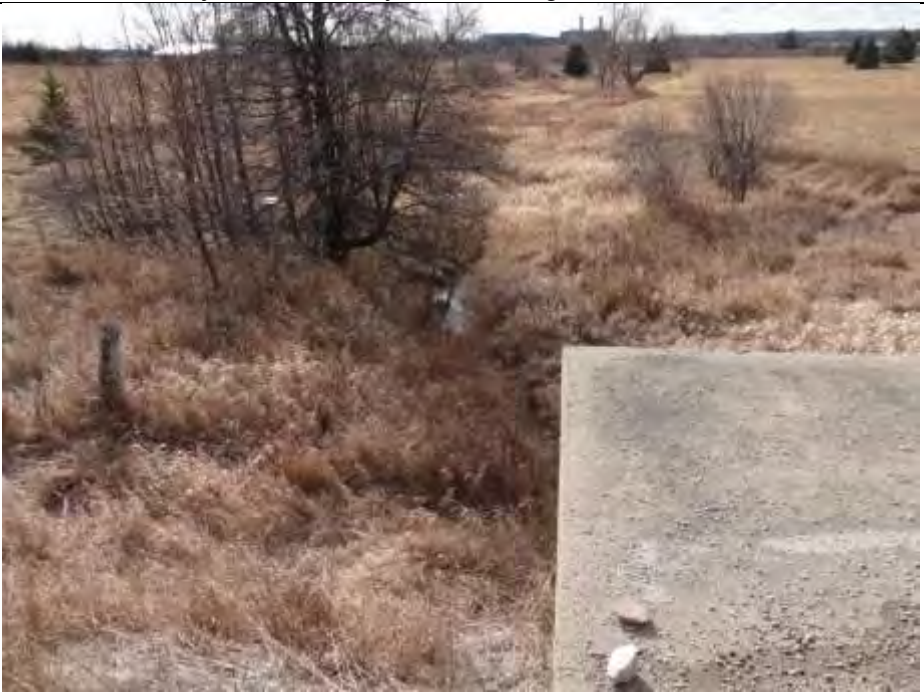
<p>Trafalgar Creek passing through a box culvert under Trafalgar Road, looking southwest from Trafalgar Road.</p>

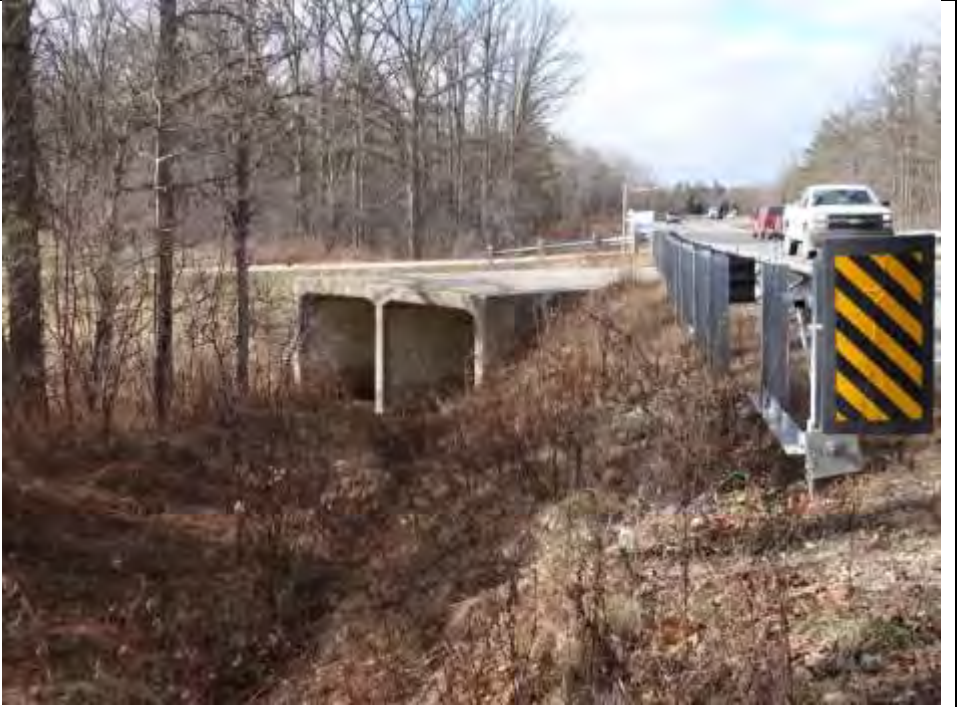
<p>Trafalgar Creek passing under Trafalgar Road through two concrete box culverts, looking north from Trafalgar Road.</p>
<p>CHL 38</p>	<p>8471 Trafalgar Road</p>	<p>Farmscape</p>	<p>Identified during field review</p>	<p><i>Existing Conditions:</i></p> <ul style="list-style-type: none"> <li>-Farmscape includes a residence, several barns and outbuildings, two silos, and other landscape features, located at the end of a long entrance drive east of Trafalgar Road, making the evaluation of property details difficult.</li> <li>-Residence is a single-storey frame structure clad in siding with an end gable roof and parged concrete foundations. The west elevation features the main entrance is enclosed by a roofed porch supported by square posts, and several modern windows. The south elevation features an external red brick chimney.</li> <li>Landscape features include a long entrance drive, mature treelines, internal circulation routes, and active agricultural fields</li> </ul> <p><i>Historical Summary:</i></p> <p>On the 1858 Tremaines Map this property is owned by Robert S. Hall Esq., no farmhouse is present on the property. On the 1878 Historical Atlas map the property is owned by C. Taylor, a farmhouse, laneway and orchard is present on the property. On the 1917 Guidall Landowners Map the property is owned by J.W. Cantelon. The farmstead is visible in the 1954 aerial photography. In the 1973 NTS topographic mapping, the farmscape and house is present.</p>

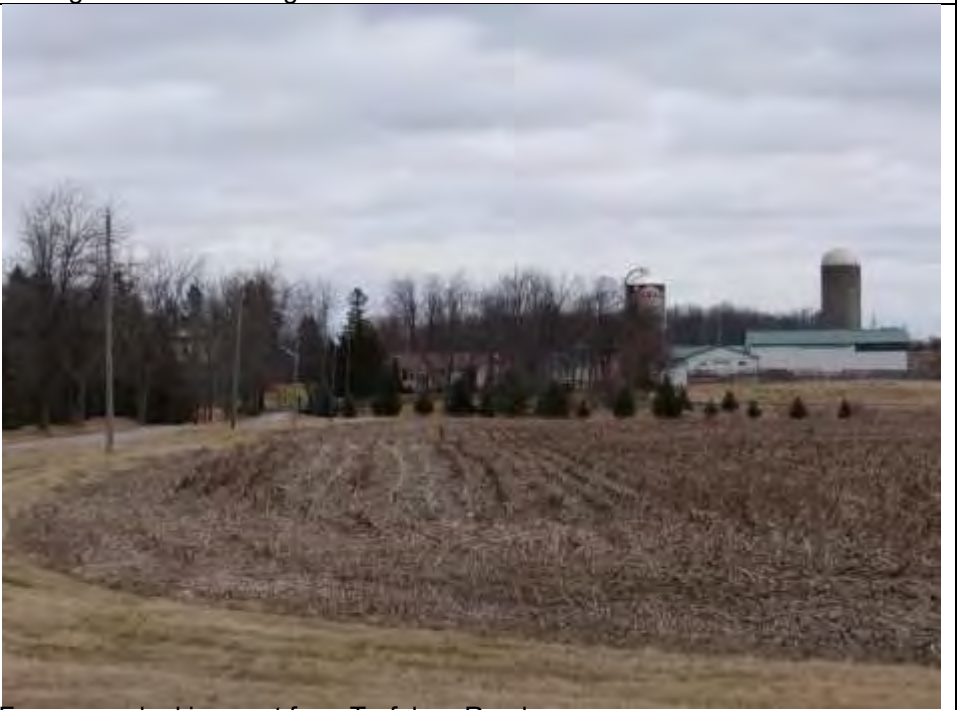
<p>Farmscape looking east from Trafalgar Road</p>
