November 13, 2019

**Re: Glen Williams Subdivision – Confederation Street and Bishop Court
Tree Assessment Report**

Tree Assessment Sketch

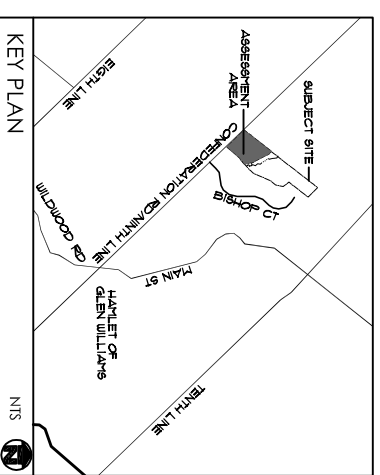
Of the trees deemed suitable for retention based on species and condition, Figure 1 illustrates those that can be potentially retained with the proposed draft plan development. It is also possible to preserve portions of the west and north plantations as sections occur in the open space block.
