Appendix D

Fluvial Geomorphology

APPENDIX D-2
Headwater Drainage Feature Assessment Memo
June 3, 2016

Subject: Results of Headwater Drainage Feature Assessment for Premier Gateway Scoped Subwatershed Study

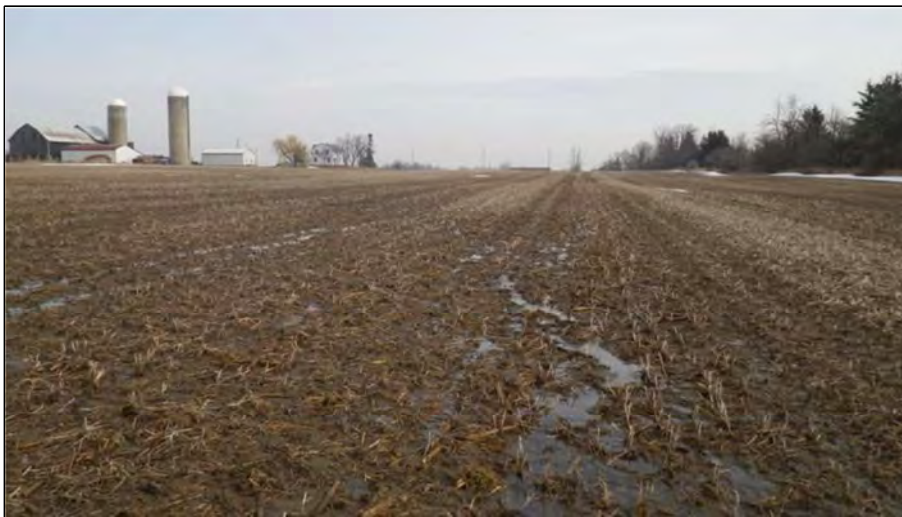
5. **HT -2b -3b.** Area where feature would be located facing upstream. Feature type is swale, flow condition is dry. **Management recommendation: No Management**

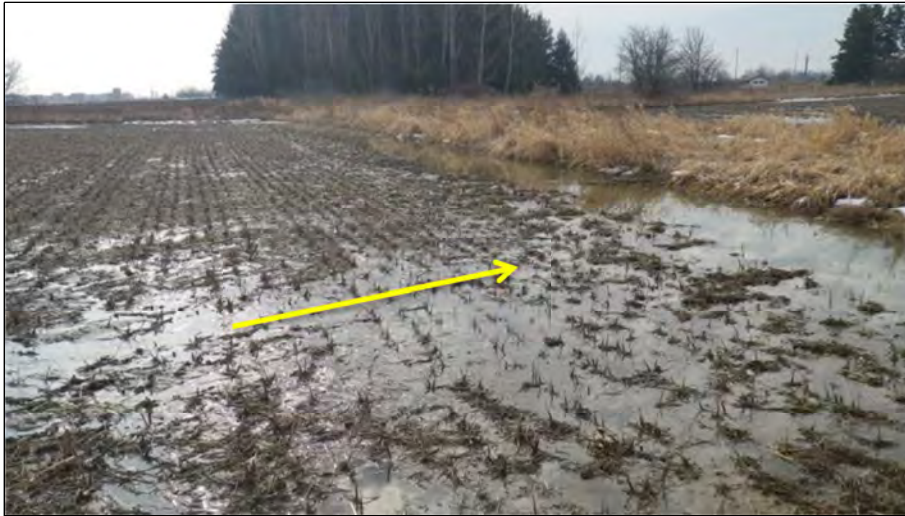
8. **HT -2b -3a.** Approaching downstream end, facing upstream. Flow becomes more defined as it approaches confluence with HT -2b -3. Feature type is swale and flow condition is standing water.

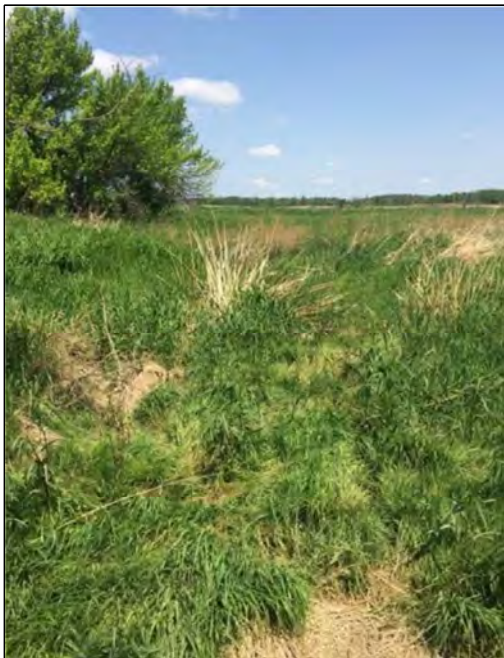
23. HT -2b -2 (Segment 1). Upstream end of feature, facing downstream from property boundary. No defined depression or flow path, no water present. Feature type is multi -thread and flow condition is no surface water.

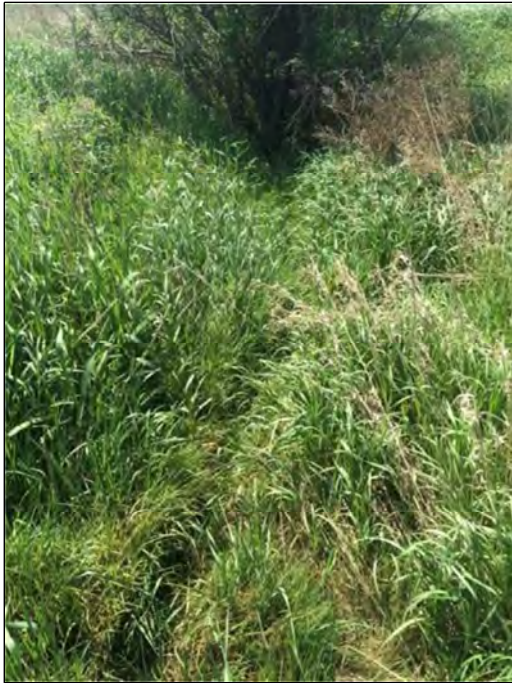
30. HT -2b -2 (Segment 2). Within Segment, facing upstream. Note dead grass indicative of swale depression. Feature type is swale and flow condition is no surface water.

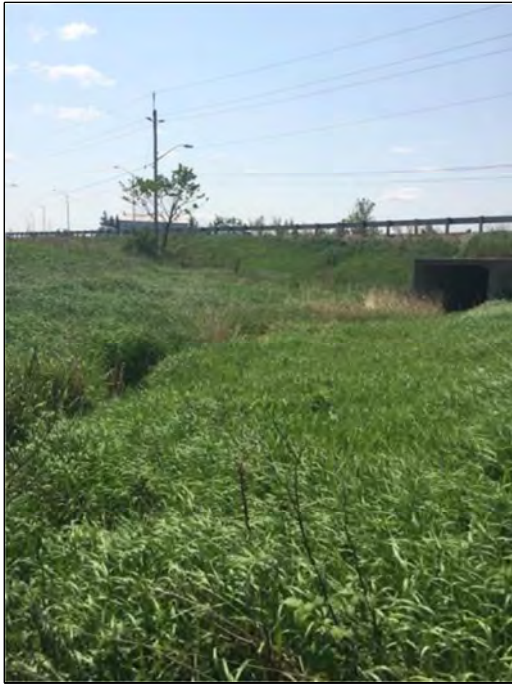
36. HT -2b -2 (Segment 3). Upstream end of feature at tree where channel bed becomes defined. The feature is primarily dry through the length of the Segment with some very isolated standing water. Feature type is defined natural channel (visible banks); flow condition is no surface water.

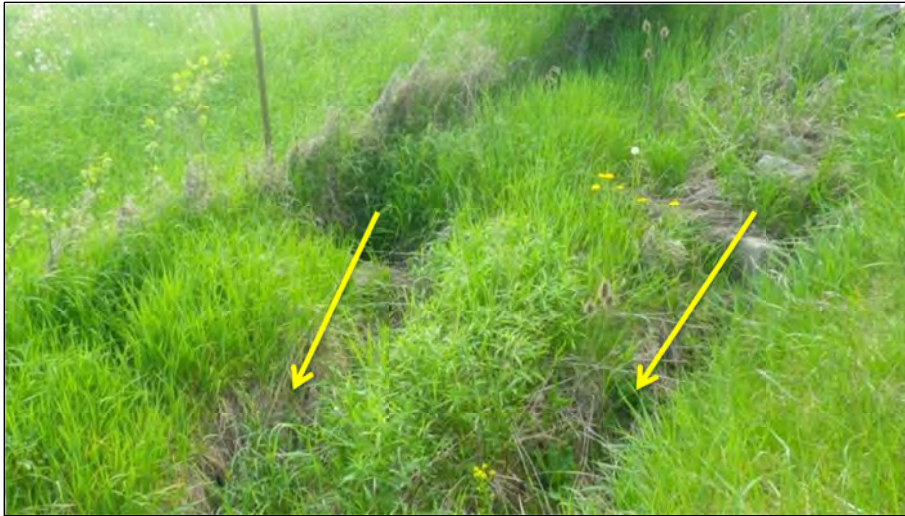
56. Roadside ditch adjacent to **HT -2b -4**, facing downstream towards Trafalgar Road culvert. Feature was dry.

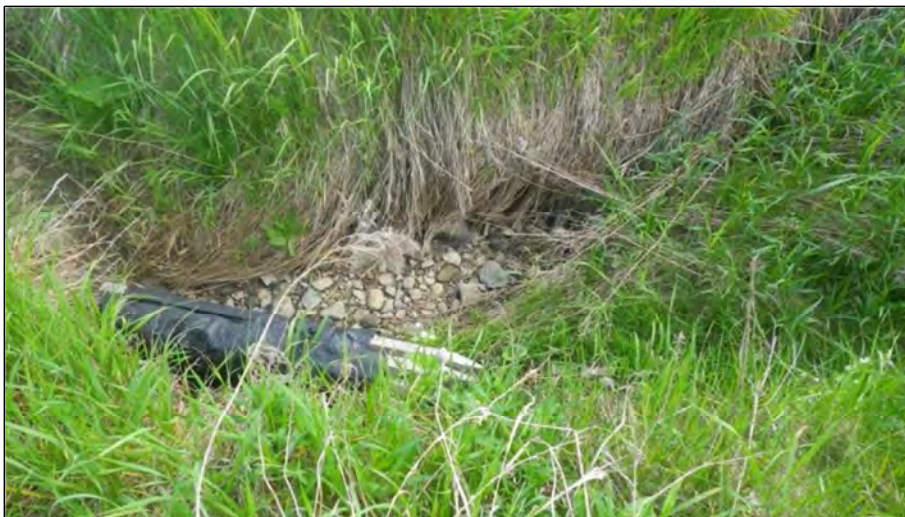
57. Area where **HT -2b -4 (Segment 1)** and roadside ditch converge upstream of Trafalgar Road culvert. **HT -2b -4 (Segment 1)** is on the left, roadside ditch is on the right. **Management recommendation:**
No Management

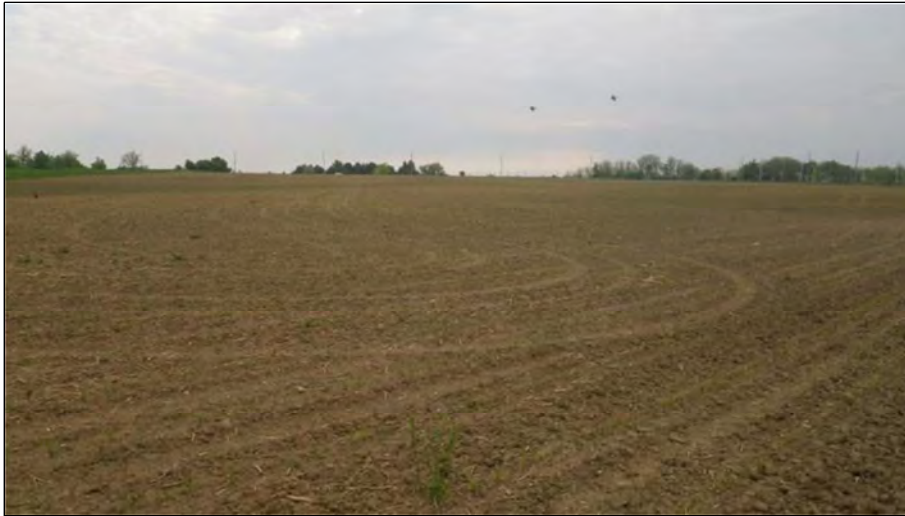
60. HT -2b -4a. Feature added after observation in field on first visit. Facing upstream from downstream end. Feature looks to be cut as a furrow by farmer. Feature type is channelized (modified agricultural) and flow condition is standing water.

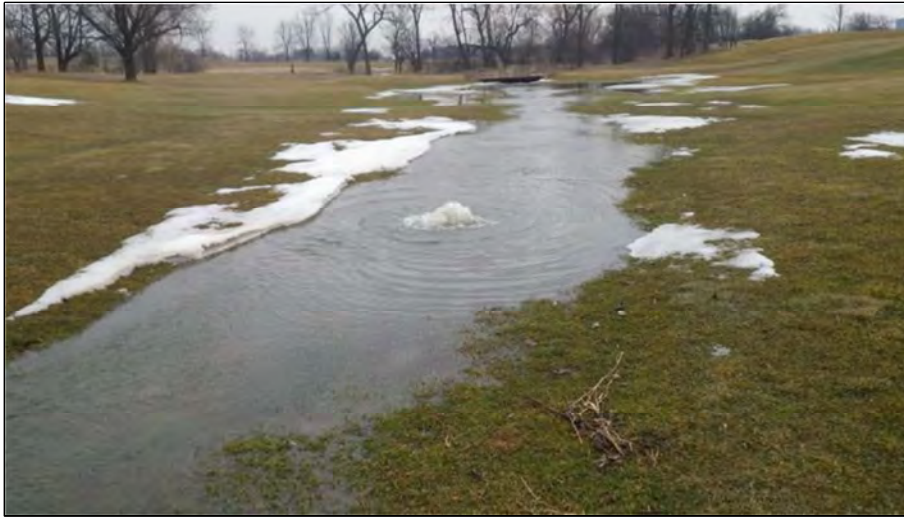
72. E -T1 -4 (Segment 1). Facing downstream towards fourth cart path crossing. Water flows at surface after outletting from pipe. Feature type is classified as tiled drainage (buried stream/pipe) because the feature is primarily piped through the extent of the golf course. Flow condition is surface flow substantial.

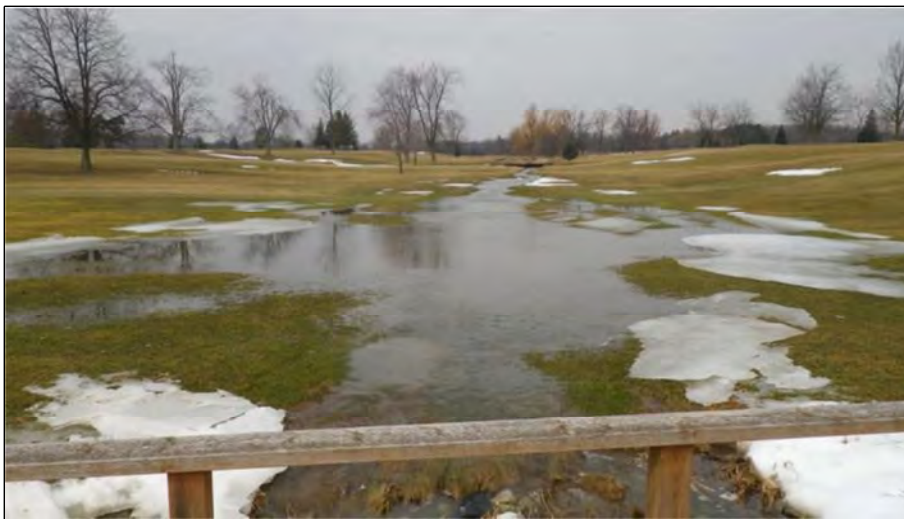
73. E -T1 -4 (Segment 1). Facing downstream towards fifth cart path crossing. Overland flow through piped section downstream of fourth cart path crossing. Hole in pipe as indicated by bubbling water in photo. Feature type is classified as tiled drainage (buried stream/pipe) because the feature is primarily piped through the extent of the golf course. Flow condition is surface flow substantial.

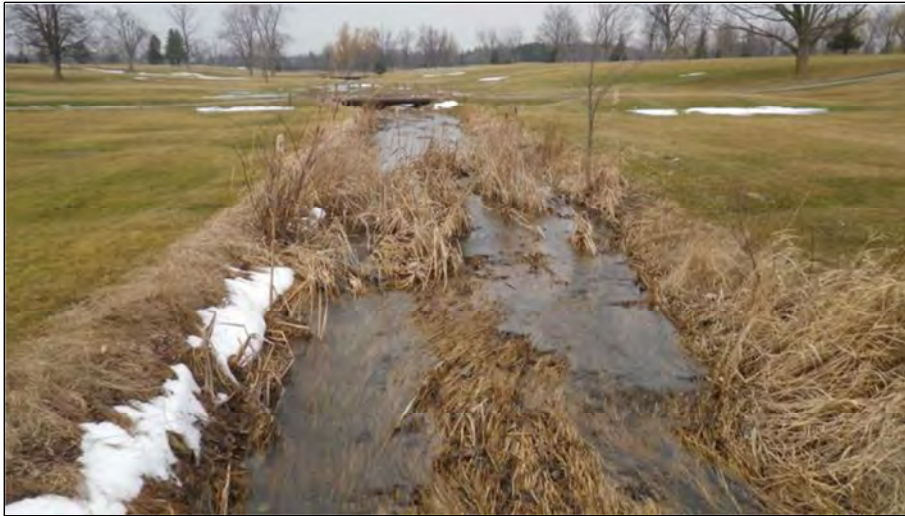
74. E -T1 -4 (Segment 1). Facing upstream from fifth cart path crossing, wide area of water pooling due to broken pipe. Two pipe outlets upstream of cart path crossing. Feature type is classified as tiled drainage (buried stream/pipe) because the feature is primarily piped through the extent of the golf course. Flow condition is surface flow substantial.

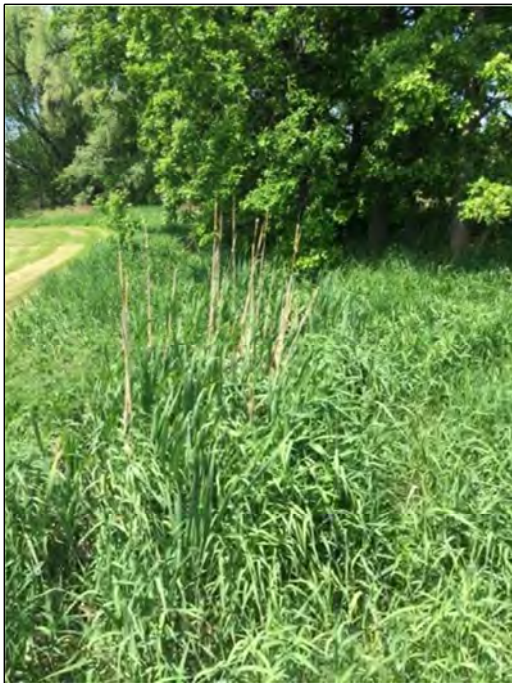
75. E -T1 -4 (Segment 1). Facing upstream towards fifth cart path crossing where feature appears to be open to surface, wetted width approximately 3.5m. Feature type is classified as tiled drainage (buried stream/pipe) because the feature is primarily piped through the extent of the golf course. Flow condition is surface flow substantial.

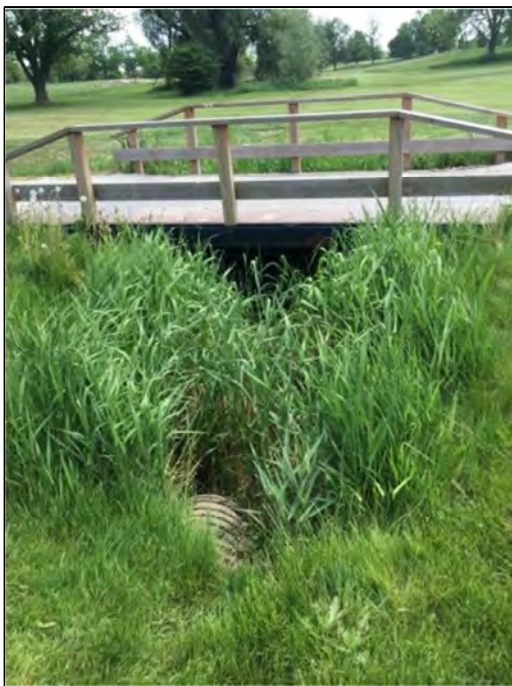
77. E -T1 -4 (Segment 1). Facing upstream towards first cart path crossing, feature is piped, no surface flow. Feature type is classified as tiled drainage; flow condition is no surface water.

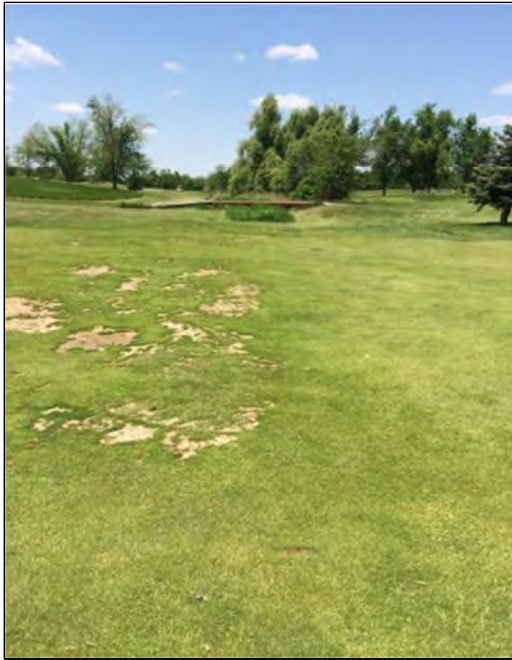
80. E -T1 -4 (Segment 1). Facing downstream towards third cart path crossing, where feature is at surface. Feature type is classified as tiled drainage; flow condition is no surface water.

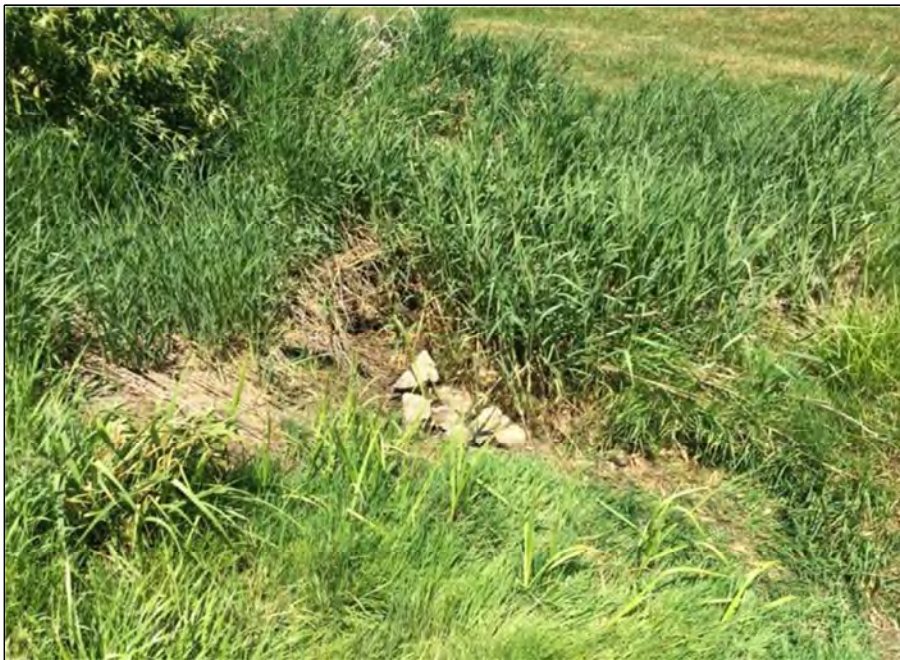
81. E -T1 -4 (Segment 1). Facing upstream to third cart path crossing, feature is piped beneath fairway. Feature type is classified as tiled drainage; flow condition is no surface water.

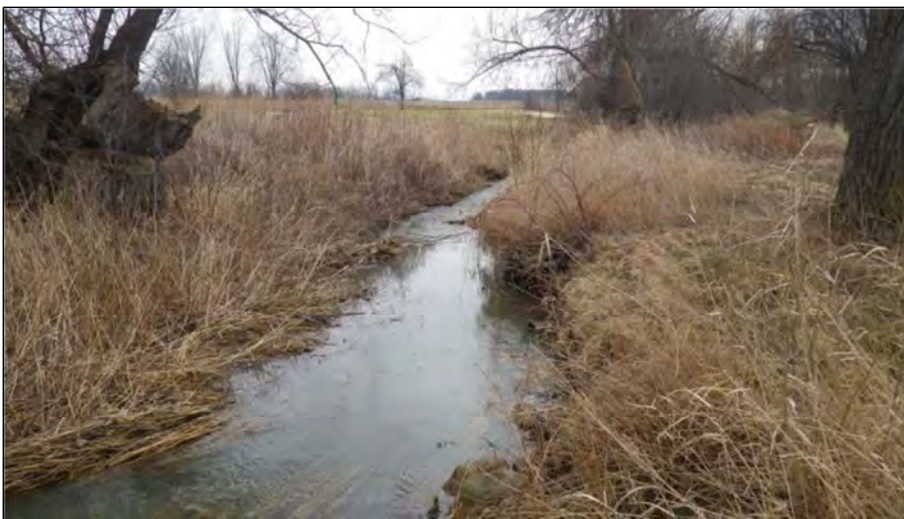
85. E -T1 -4 (Segment 1). Facing downstream from fifth cart path crossing where feature is at surface. Feature type is classified as tiled drainage; flow condition is no surface water. **Management Recommendation: Conservation**

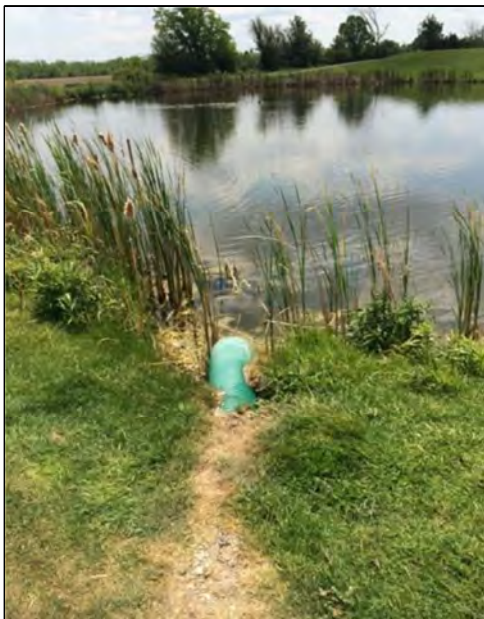
- 104. HDF -4.** Downstream end of feature outletting to pond. Feature is piped through last Segment. Feature type is swale and flow condition is no surface water. **Management recommendation: No management required**

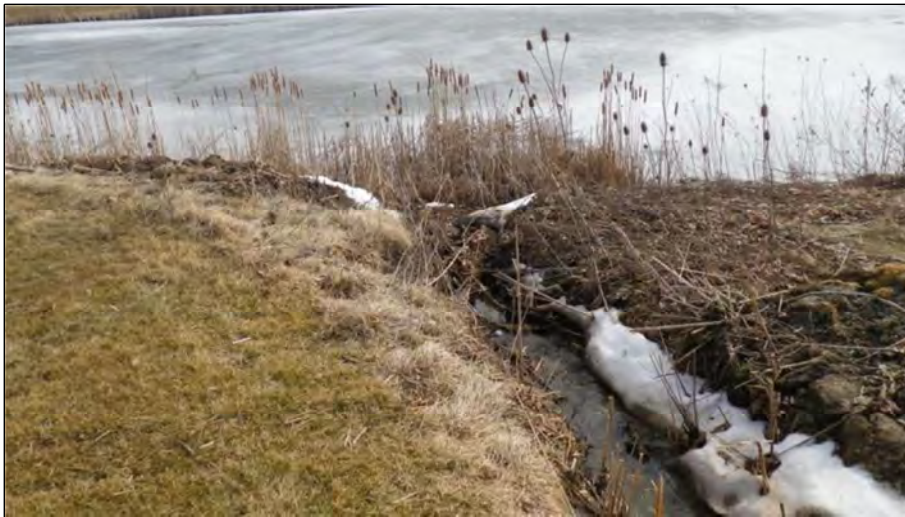
110. HDF -3. Downstream end of feature at golf course pond. Feature type is swale, flow condition is standing water.

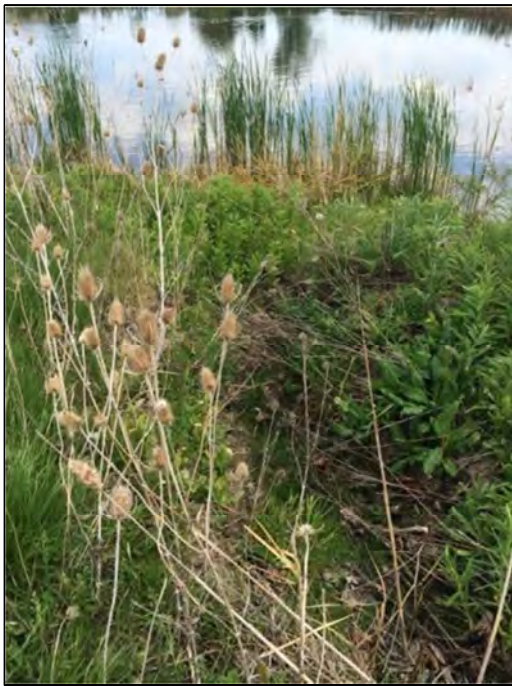
112. HDF -3. Downstream end of feature at golf course pond. Feature type is swale; flow condition is no surface water. **Management Recommendation: No management required.**

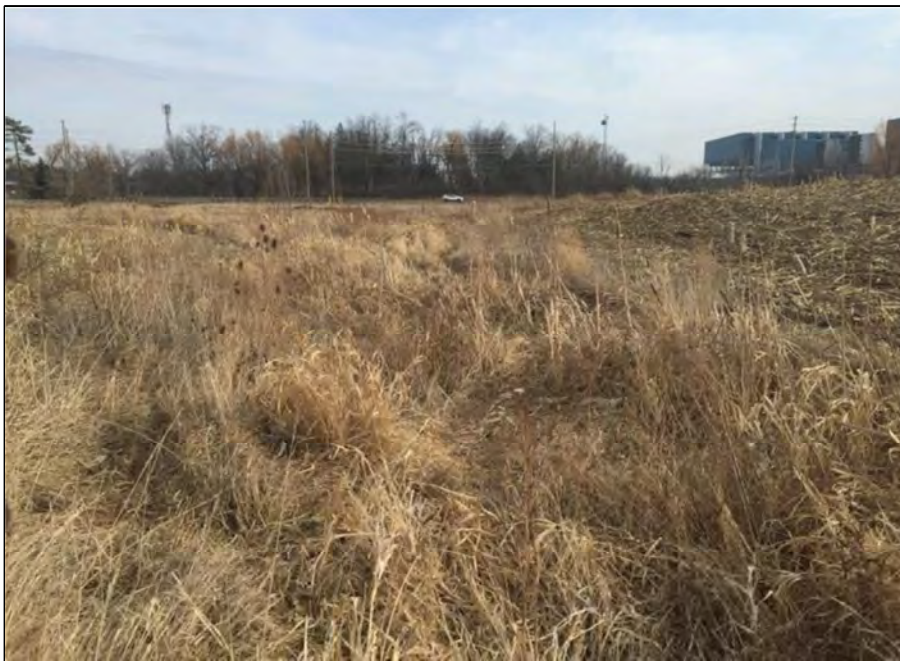
125. HDF -1 (Segment 2). Facing downstream within Segment. Water becomes more concentrated between crops and grasses. Feature type is swale and flow condition is surface flow minimal.

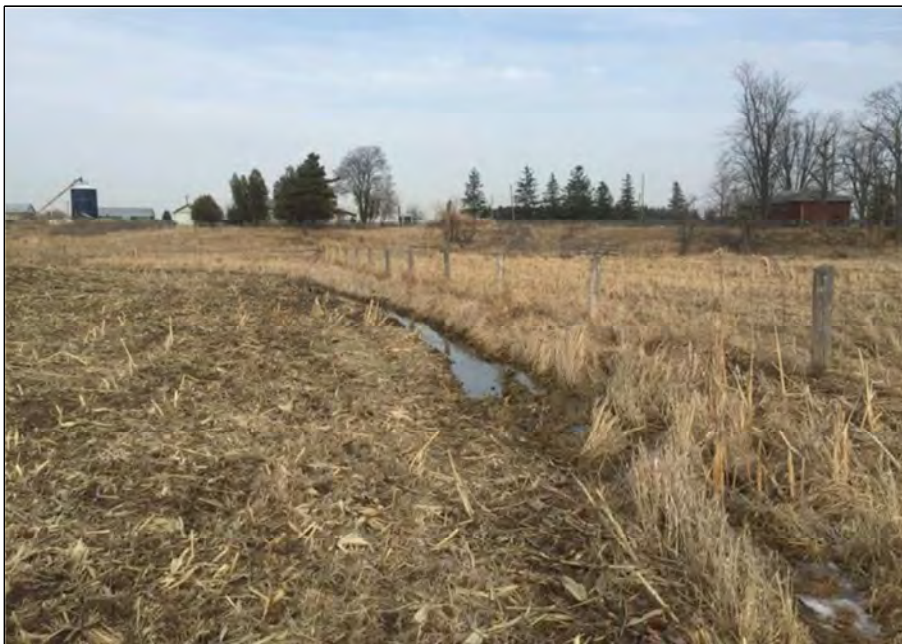
127. HDF -1 (Segment 2). Facing downstream towards E -T1 -2. Definition is lost approaching E -T1 -2. Feature type is swale and flow condition is surface flow minimal.

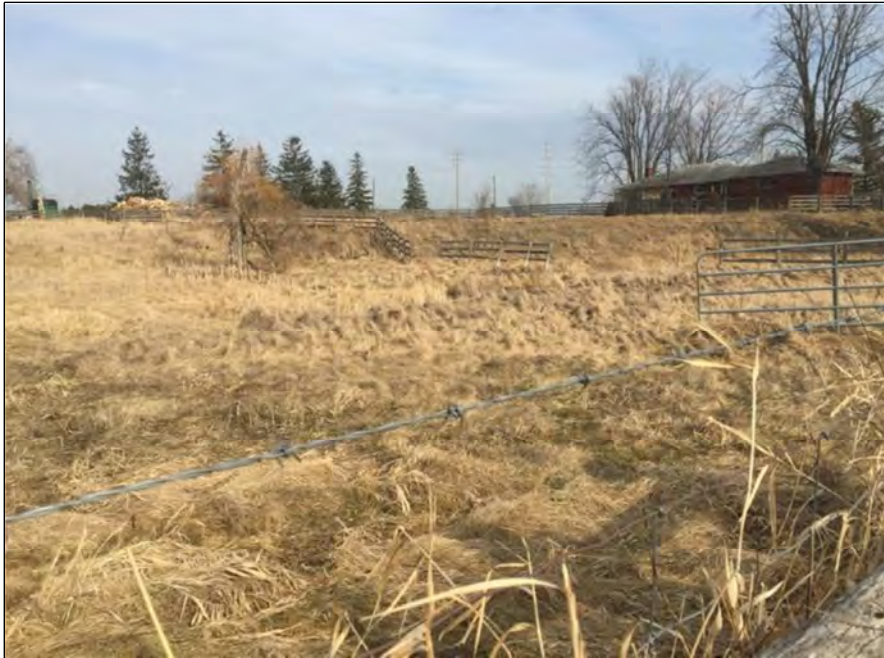
128. HDF -1 (Segment 2). Looking towards confluence location with E -T1 -2. Flow discontinues in this area, a confluence could not be identified in the field based on presence of flow or topography. Feature type is swale and flow condition is surface flow minimal.
