June 3, 2016

Matrix 21510-522

**Subject: Results of Headwater Drainage Feature Assessment for Premier Gateway Scoped Subwatershed Study**

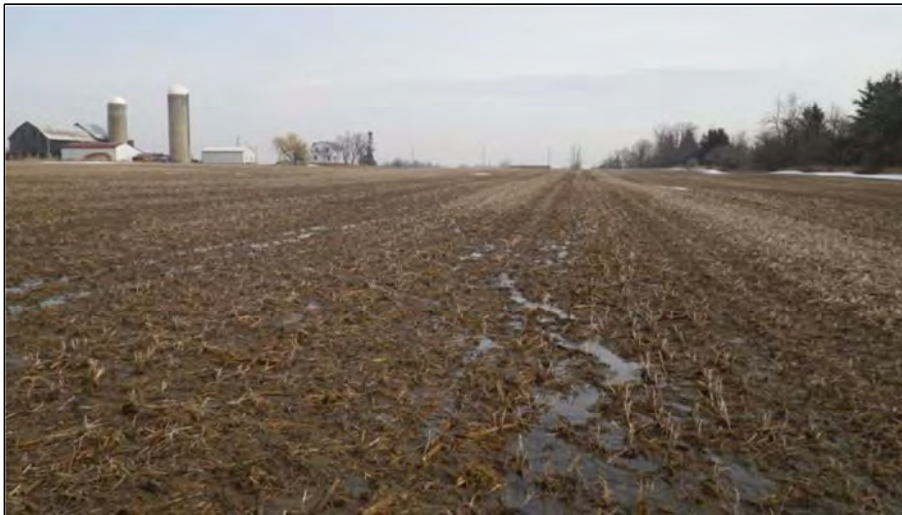
6. **HT -2b -3a.** Upstream end of feature, facing upstream. Feature type is swale and flow condition is standing water.

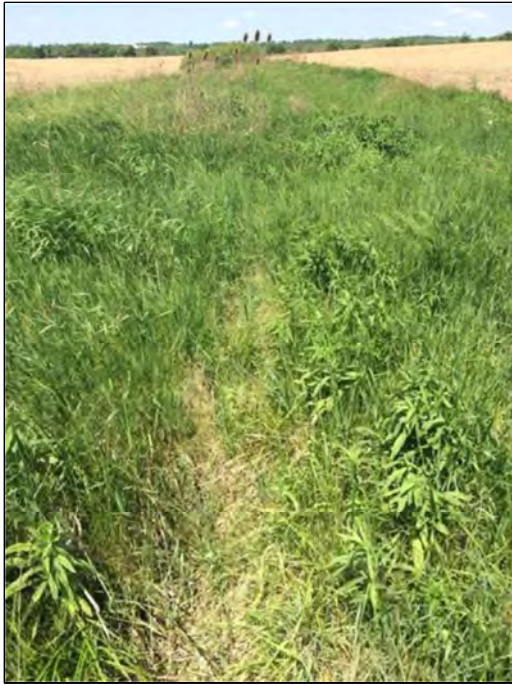
**17. HT -2b -3.** Facing upstream, within vegetated area. Note narrow depression in center of photo. Feature type is no defined feature (overland flow only) and flow condition is no surface water.

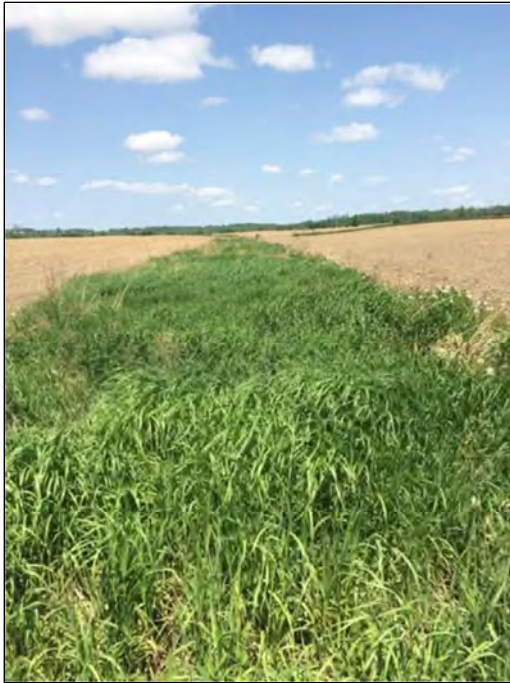
19. **HT -2b -3.** Facing upstream and downstream extent of feature. Feature type is no defined feature (overland flow only) and flow condition is no surface water. **Management Recommendation:**  
**Mitigation**

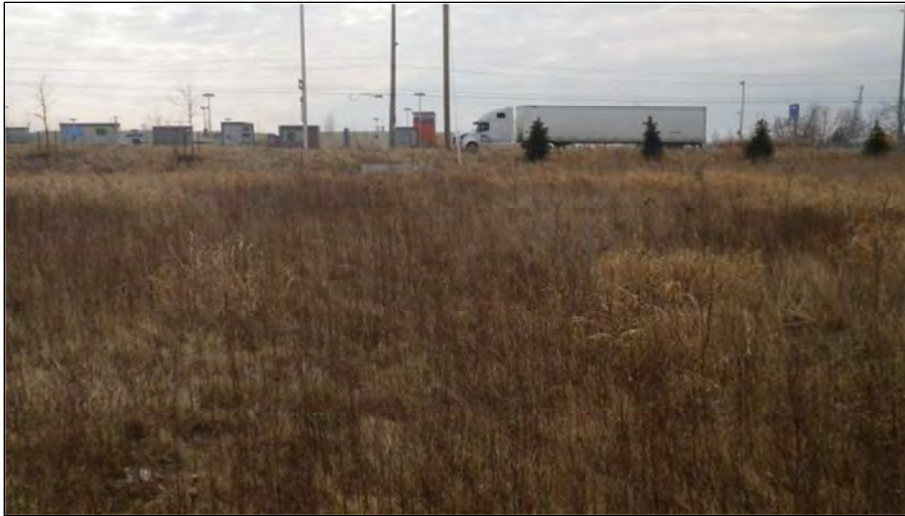
**43. HT -2b -4 (Segment 1).** Facing upstream towards Steeles Avenue. Lack of flow or well -defined single flow path. Feature type is no defined feature (overland flow only) and flow condition is standing water.

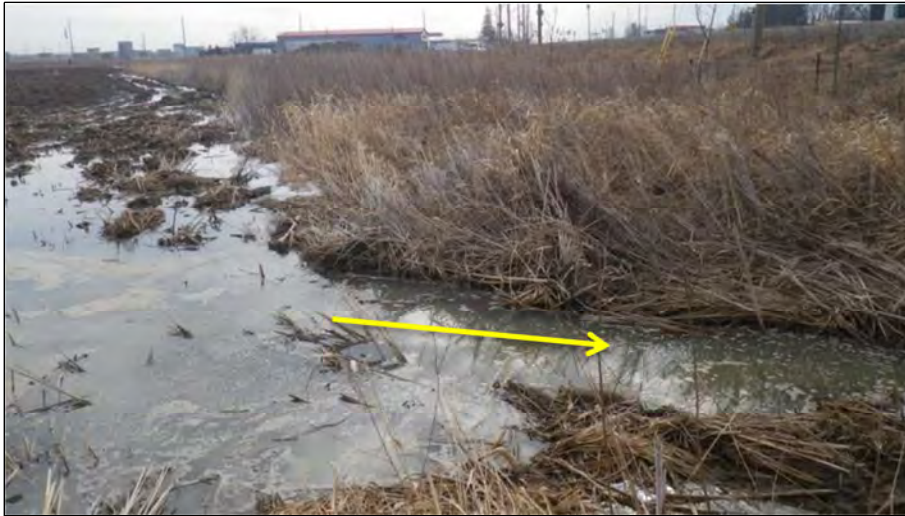
**47. HT -2b -4 (Segment 1).** Facing upstream, ponded water draining off the fields toward roadside ditch. Feature type is no defined feature (overland flow only); flow condition standing water.

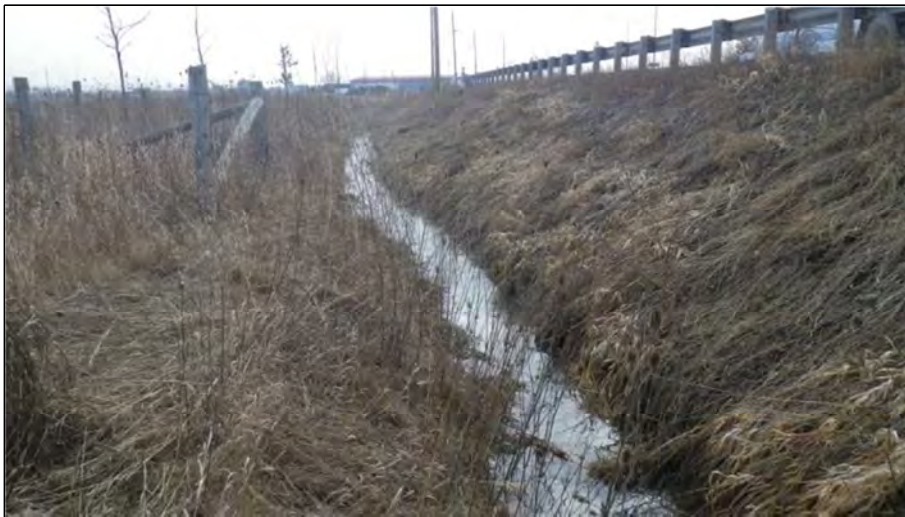
**48.** Roadside ditch along Trafalgar adjacent HT -2b -4 (Segment 1). Standing water.

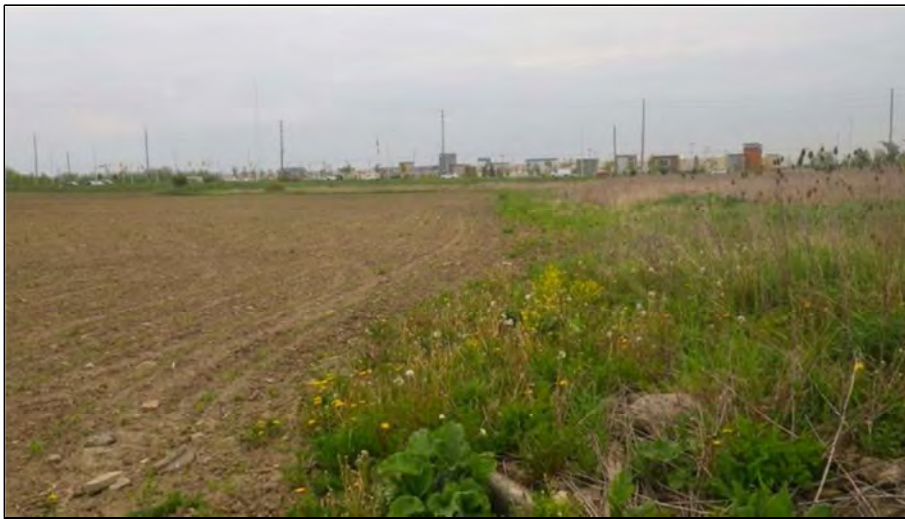
**52. HT -2b -4 (Segment 1).** Facing upstream towards Steeles Avenue in agricultural field. Feature type is no defined feature (overland flow only); flow condition is no surface water.

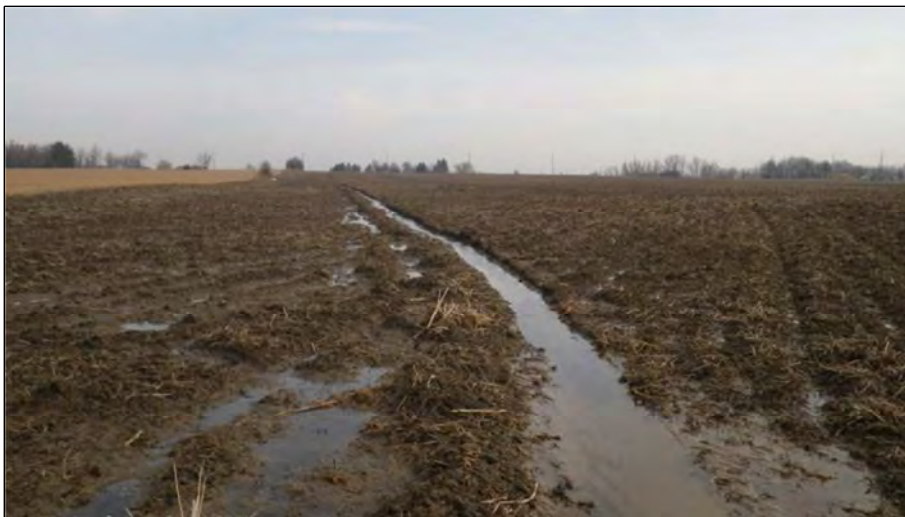
**61. HT -2b -4a.** Looking eastward across field where feature was previously located. Feature is no longer visible as field appears to have been reworked. Flow condition is dry, feature type is channelization (modified agricultural). **Management Recommendation: No management required.**

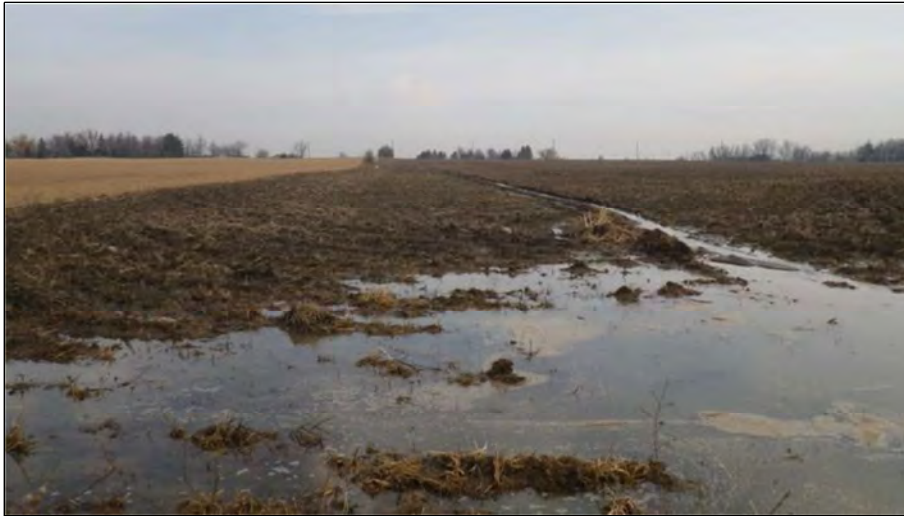
**62. HT -2b -4b.** Feature added after identification in the field at time of first visit. Facing upstream from downstream end. Feature appears to be cut as a furrow by farmer. Feature type is channelization (modified agricultural) and flow condition is standing water.

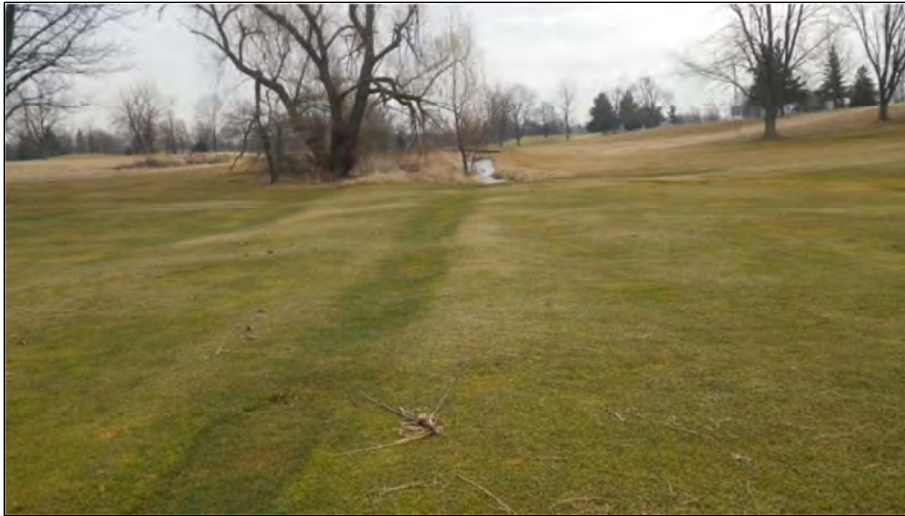
**68. E -T1 -4 (Segment 1).** Downstream side of second cart path crossing. Water flows out of pipe upstream of cart path crossing and then again drains into pipe to traverse another fairway. Feature type is classified as tiled drainage (buried stream/pipe) because the feature is primarily piped through the extent of the golf course. Flow condition is surface flow substantial.

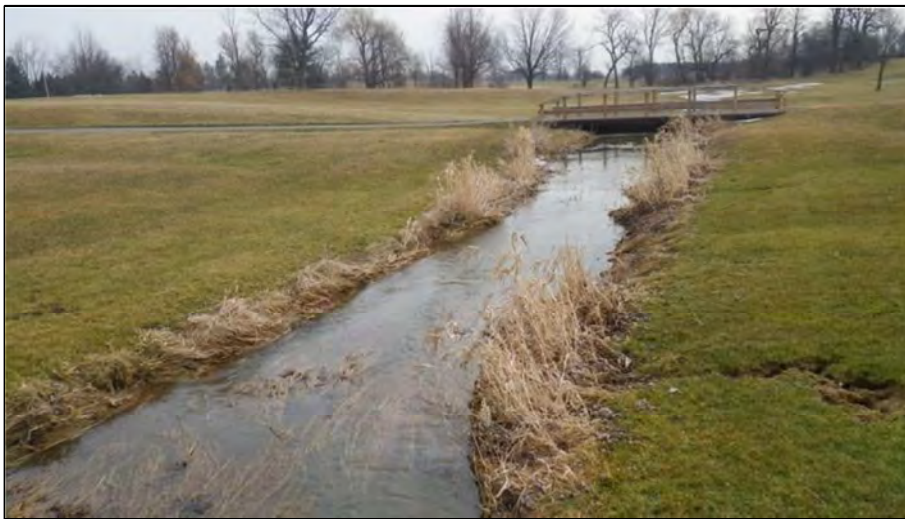
**71. E -T1 -4 (Segment 1).** Facing upstream towards third cart path crossing. In background of photo water is pooling at surface where it has overwhelmed the pipe. In foreground, pipe outlets into grasses area, where flow is relatively fast and erosion has occurred around the outlet. Wetted depth is 14cm. Feature type is classified as tiled drainage (buried stream/pipe) because the feature is primarily piped through the extent of the golf course. Flow condition is surface flow substantial.

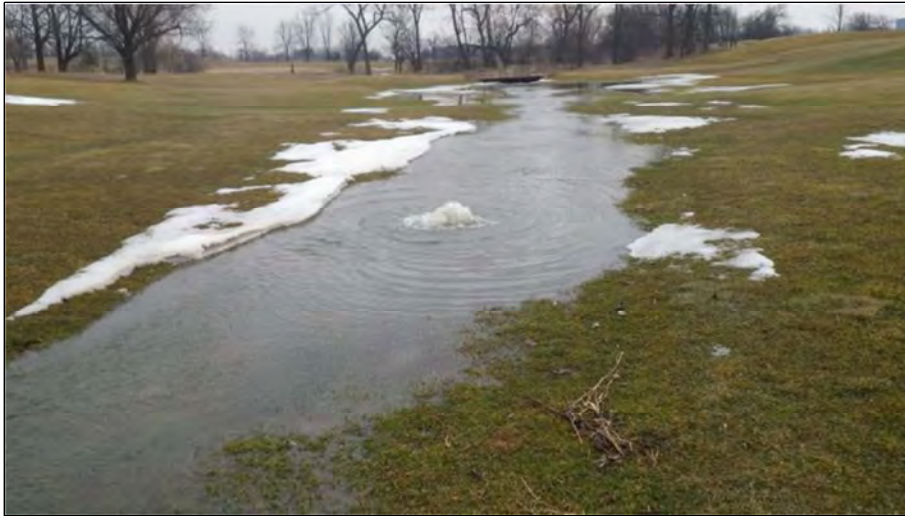
**72. E -T1 -4 (Segment 1).** Facing downstream towards fourth cart path crossing. Water flows at surface after outletting from pipe. Feature type is classified as tiled drainage (buried stream/pipe) because the feature is primarily piped through the extent of the golf course. Flow condition is surface flow substantial.

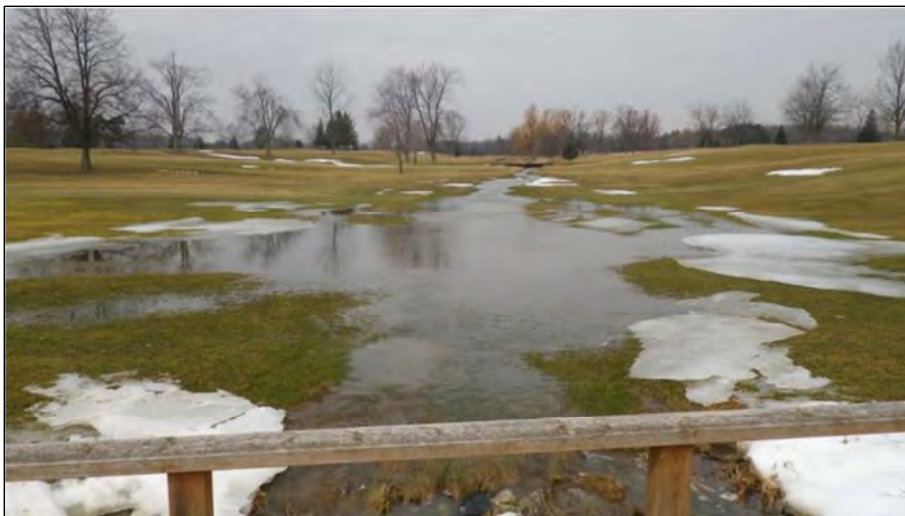
**73. E -T1 -4 (Segment 1).** Facing downstream towards fifth cart path crossing. Overland flow through piped section downstream of fourth cart path crossing. Hole in pipe as indicated by bubbling water in photo. Feature type is classified as tiled drainage (buried stream/pipe) because the feature is primarily piped through the extent of the golf course. Flow condition is surface flow substantial.

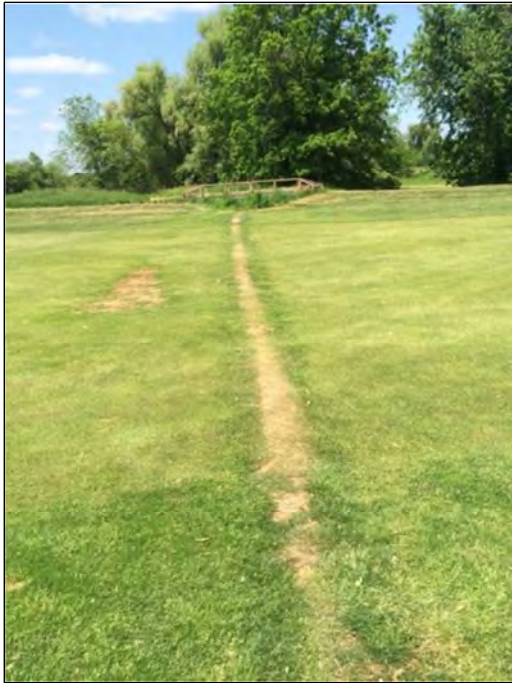
**76. E -T1 -4 (Segment 1).** Facing upstream at upstream end of golf course. No water or standing water only noted. Feature type is classified as tiled drainage; flow condition is no surface water.

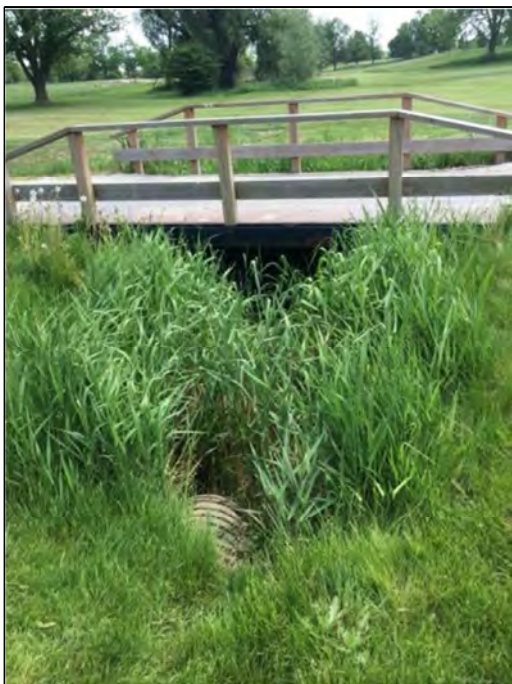
**77. E -T1 -4 (Segment 1).** Facing upstream towards first cart path crossing, feature is piped, no surface flow. Feature type is classified as tiled drainage; flow condition is no surface water.

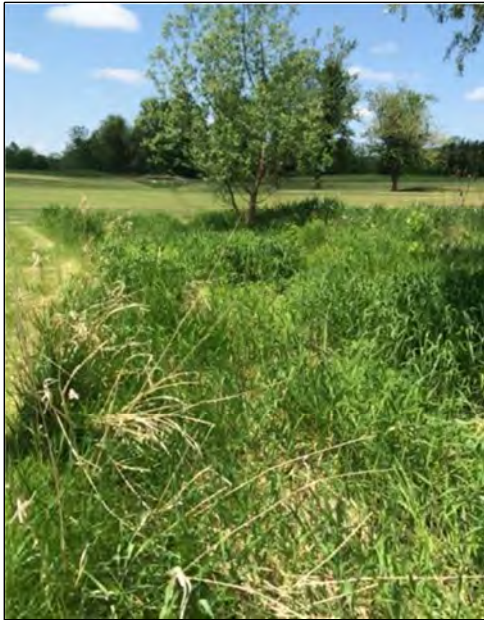
**78. E -T1 -4 (Segment 1).** Pipe outlet at second cart path crossing, facing downstream. No water noted. Feature type is classified as tiled drainage; flow condition is no surface water.

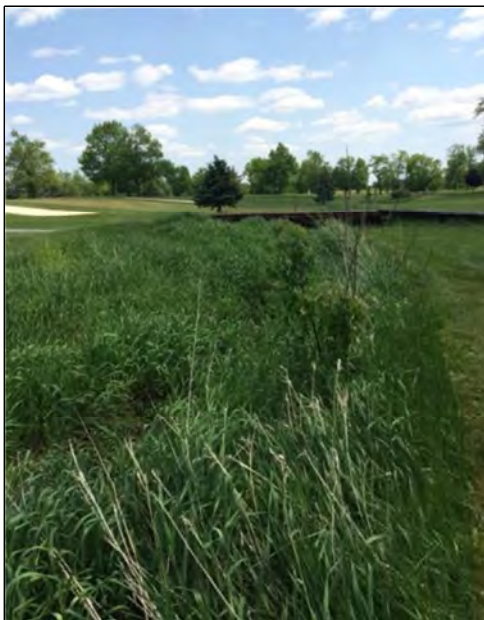
**79. E -T1 -4 (Segment 1).** Facing upstream towards second cart path crossing, within area where pipe outlets to surface. Standing water noted at the outlet only. A depression bare of grass was noted indicating previous flows. Feature type is classified as tiled drainage; flow condition is no surface water.

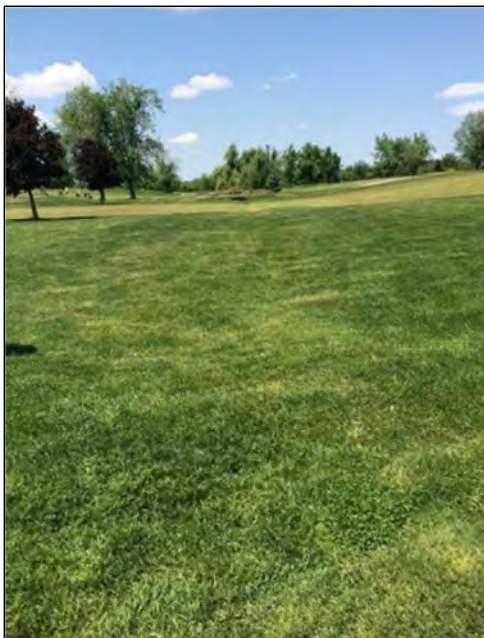
**83. E -T1 -4 (Segment 1).** Facing downstream towards fourth cart path crossing. Dry defined depression, evidence of previous flows from pipe outlet. Feature type is classified as tiled drainage; flow condition is no surface water.

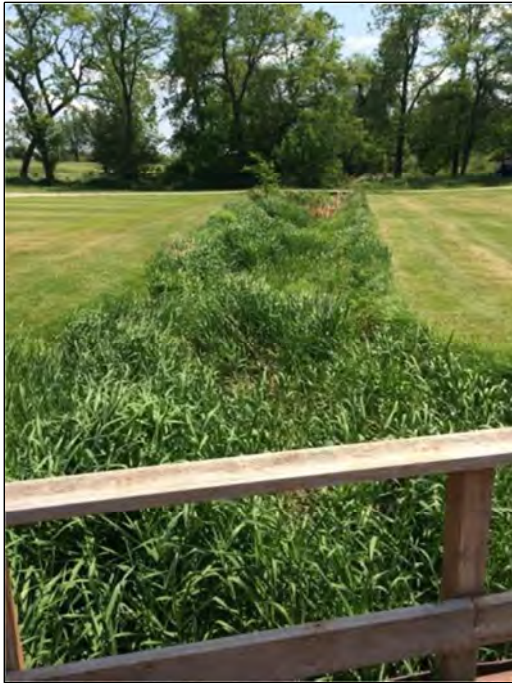
**84. E -T1 -4 (Segment 1).** Facing upstream towards fourth cart path crossing. Feature piped beneath fairways. Feature type is classified as tiled drainage; flow condition is no surface water.

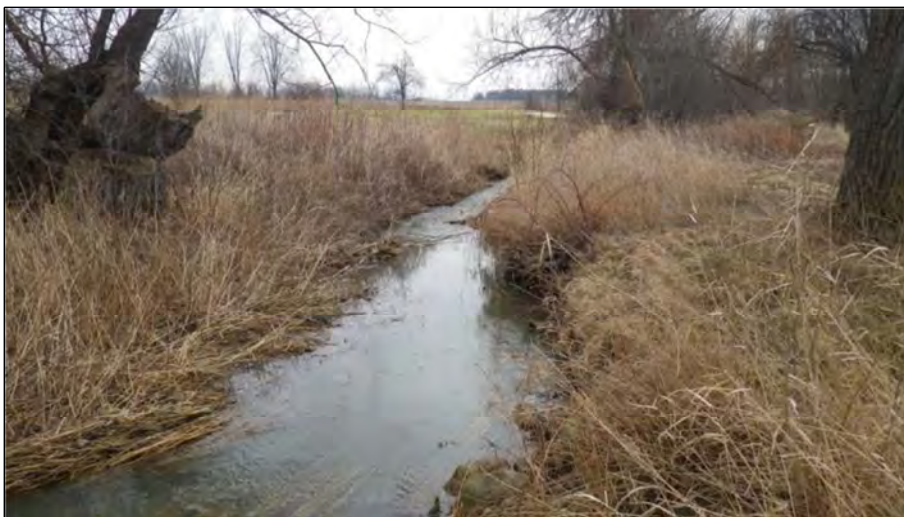
**85. E -T1 -4 (Segment 1).** Facing downstream from fifth cart path crossing where feature is at surface. Feature type is classified as tiled drainage; flow condition is no surface water. **Management Recommendation: Conservation**

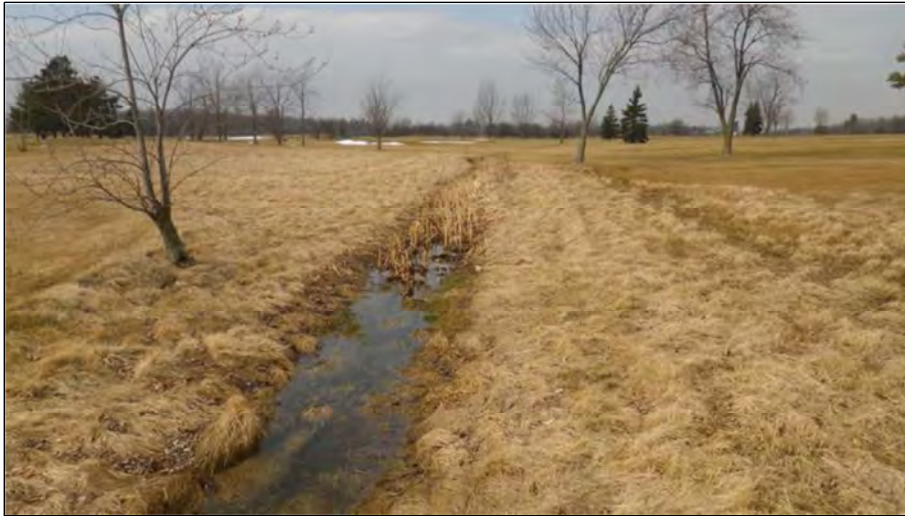
**90. HDF -4.** At upstream end of feature where flow initiates. Feature type is swale and flow condition is surface flow minimal.

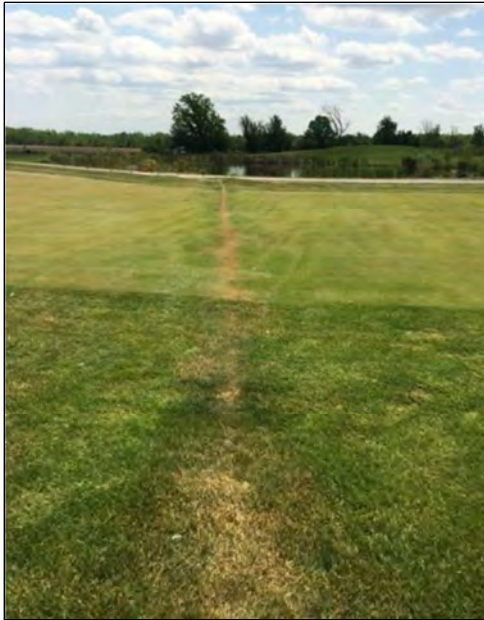
**102. HDF -4.** Facing downstream, feature runs along edge of manicured golf course green. Feature type is swale and flow condition is no surface water.

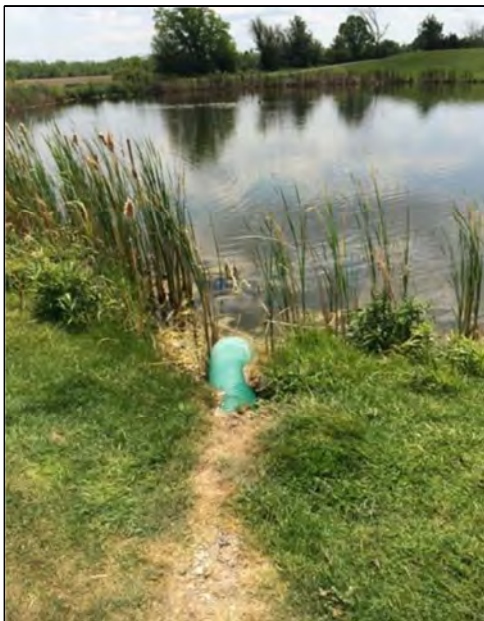
- 103. HDF -4.** Facing downstream towards golf course pond at downstream end. Feature is piped through last Segment. Feature type is swale and flow condition is no surface water.

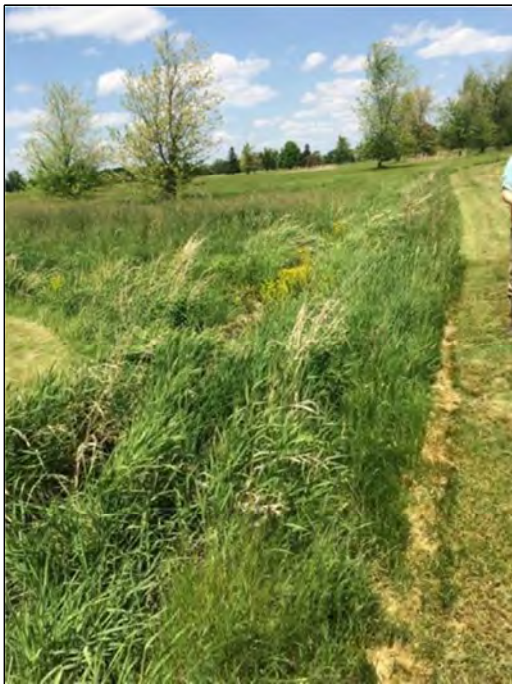
**105. HDF -4a.** Facing upstream from confluence with HDF -4. Feature type is swale and flow condition is standing water.

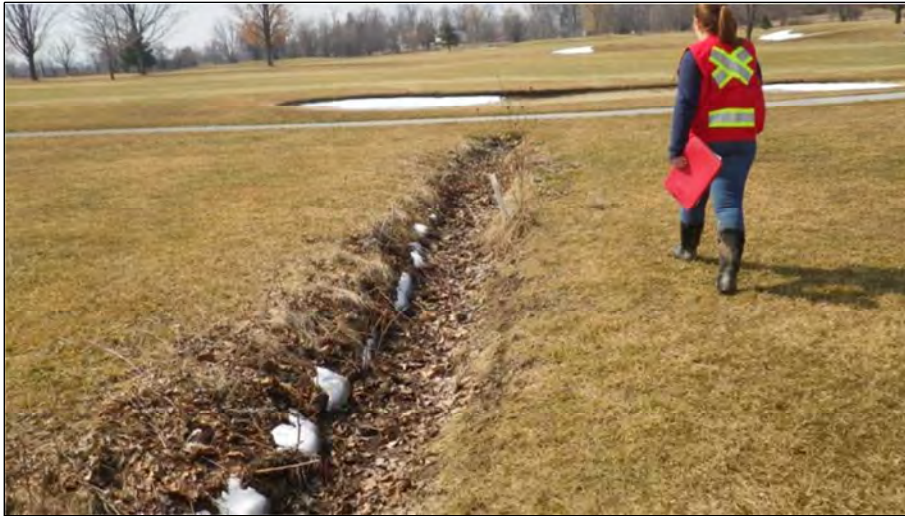
**106. HDF -4a.** Feature at downstream end joining HDF -4. Feature type is swale and flow condition is no surface water. **Management Recommendation: No management required**

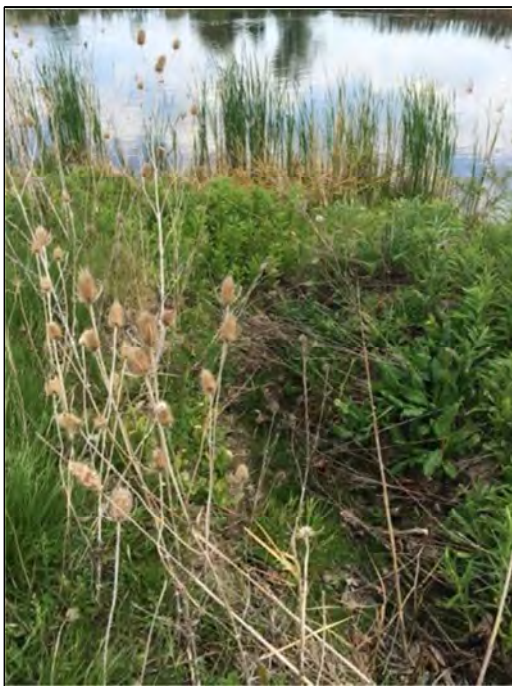
**111. HDF -3.** Facing upstream, near downstream end of feature. Feature heavily vegetated with cattails. Feature type is swale; flow condition is no surface water.

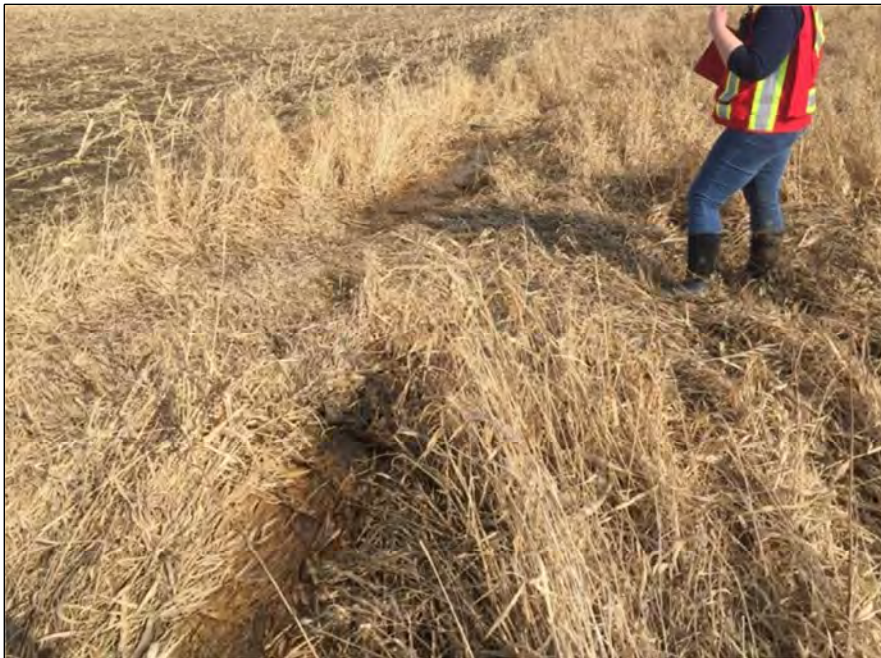
**116. HDF -1 (Segment 1).** At upstream end of feature, facing downstream. Upstream end has more water due to outlet from golf course ponds. Feature type is multi -thread and flow condition is standing water.

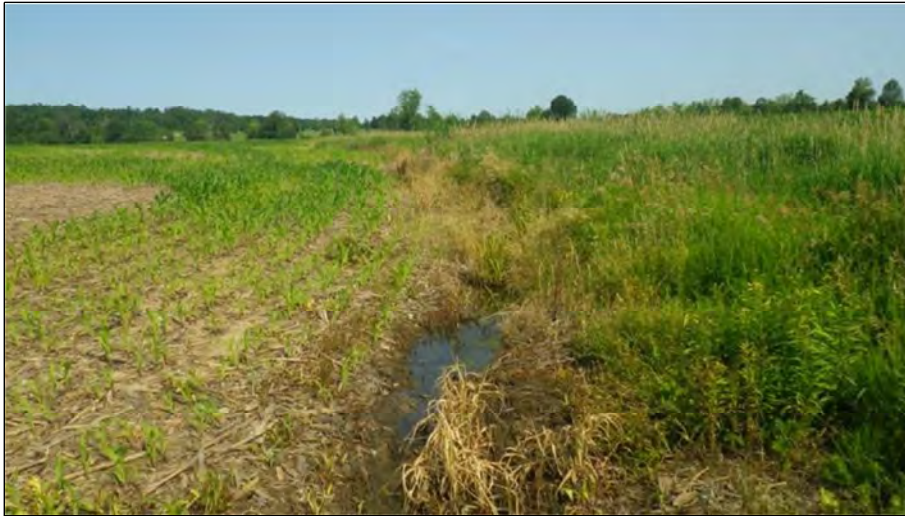
**121. HDF -1 (Segment 1).** Standing water throughout feature up to 20cm. Feature type is multi -thread and flow condition is standing water.

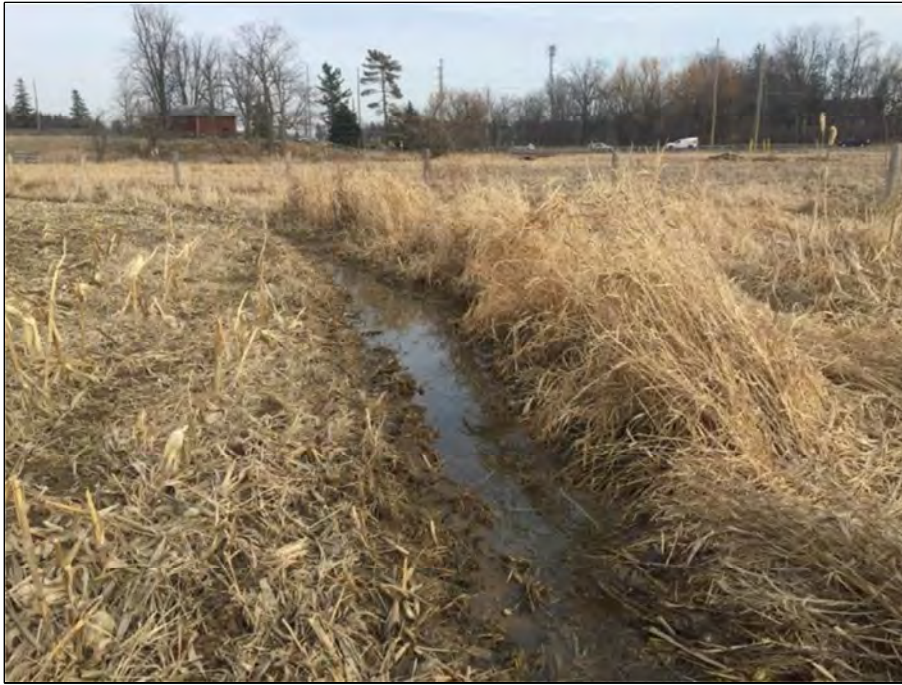
**125. HDF -1 (Segment 2).** Facing downstream within Segment. Water becomes more concentrated between crops and grasses. Feature type is swale and flow condition is surface flow minimal.

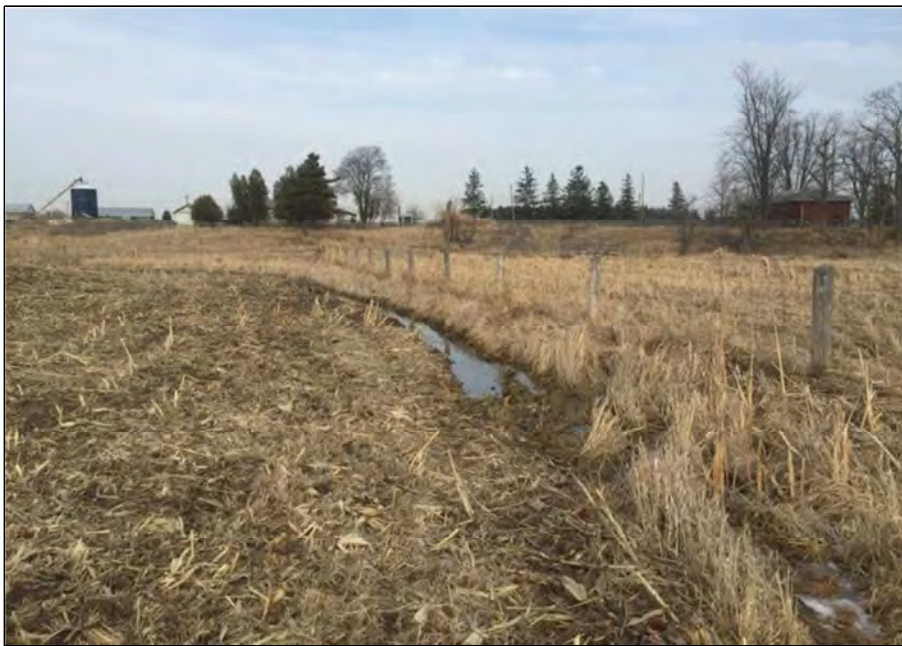
**126. HDF -1 (Segment 2).** Facing downstream, flow path is more defined. Feature type is swale and flow condition is surface flow minimal. Wetted depth is 18 cm.

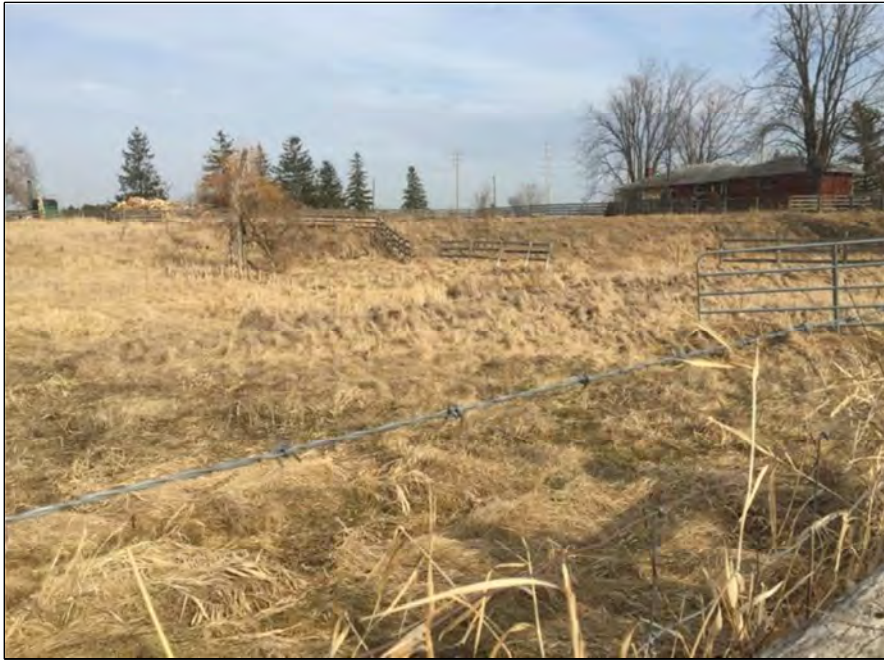
**127. HDF -1 (Segment 2).** Facing downstream towards E -T1 -2. Definition is lost approaching E -T1 -2. Feature type is swale and flow condition is surface flow minimal.

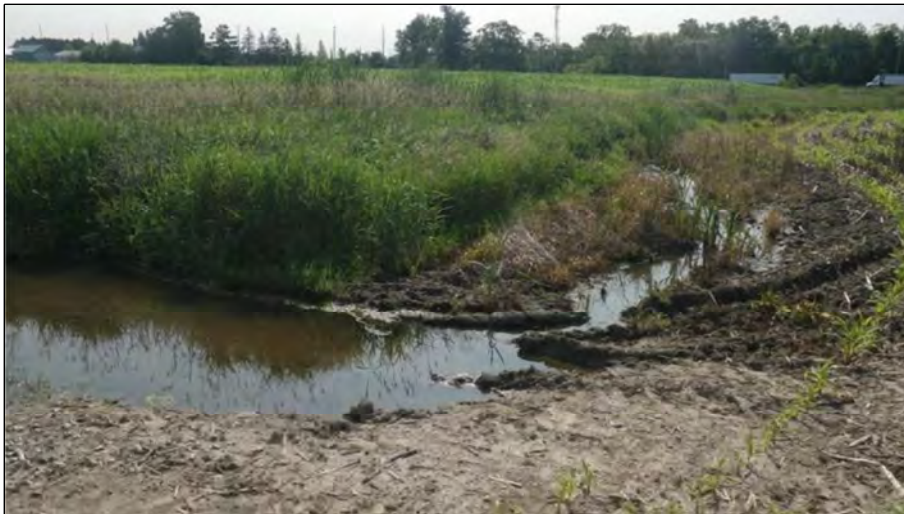
**128. HDF -1 (Segment 2).** Looking towards confluence location with E -T1 -2. Flow discontinues in this area, a confluence could not be identified in the field based on presence of flow or topography. Feature type is swale and flow condition is surface flow minimal.

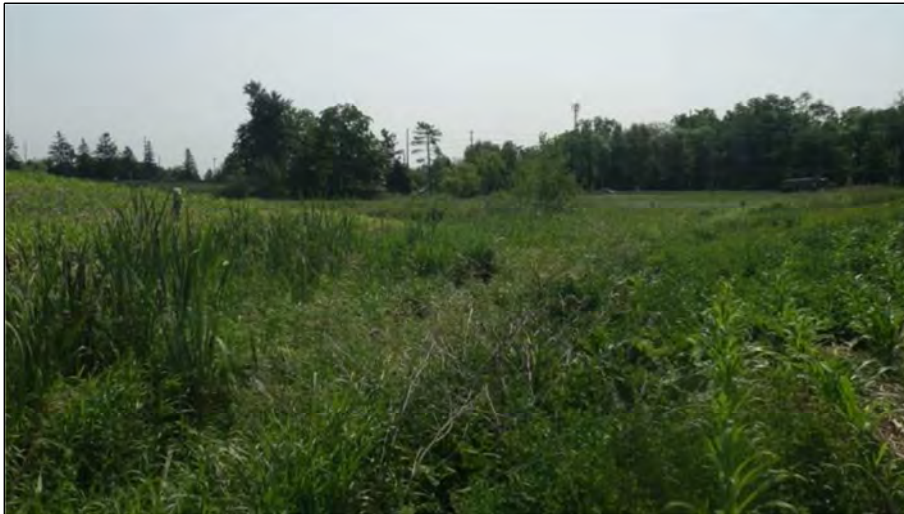
**130. HDF -1 (Segment 2).** Facing downstream, flow concentrated along boundary between cropland and vegetated area. Feature type is swale and flow condition is surface flow minimal.

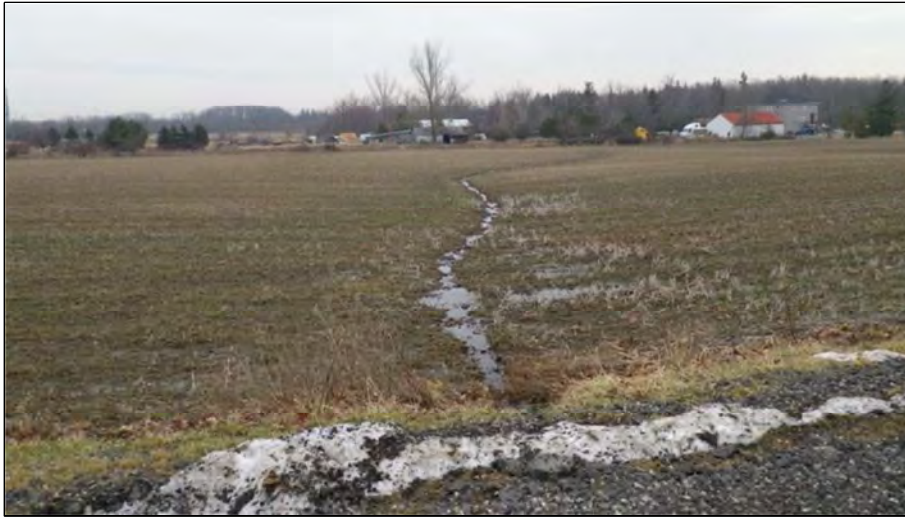
**133. HDF -1 (Segment 2).** At downstream end of feature, feature goes dry and is not able to be identified through tall grass section to confluence with E -T1 -2. Confluence could not be located. Feature type is swale and flow condition is surface flow minimal. **Management Recommendation: Conservation**

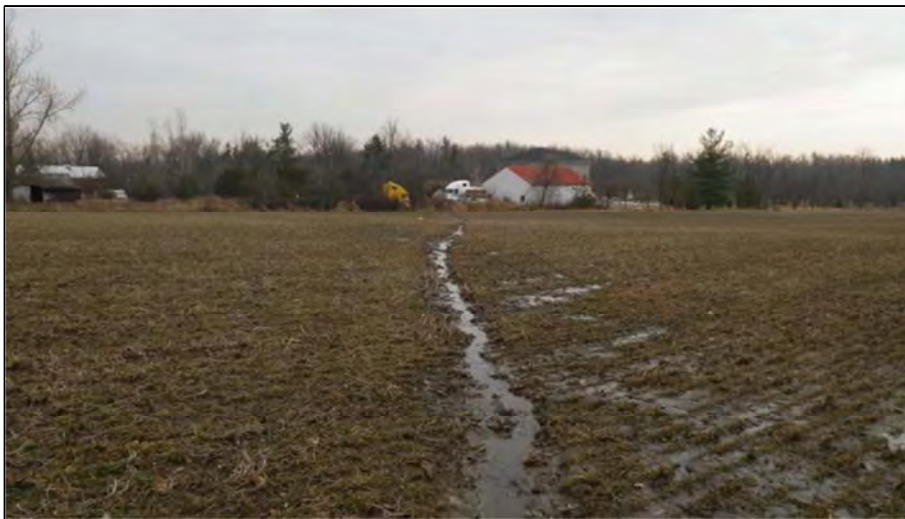
**134. W -T1 -2b (Segment 1).** Upstream end of Segment 1 facing downstream. Feature type is swale and flow condition is surface flow minimal.

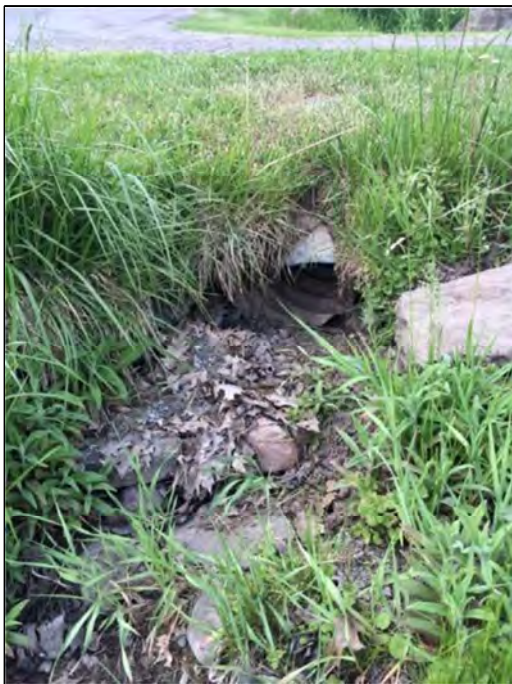
**136. W -T1 -2b (Segment 1).** Downstream end of feature. Feature makes a turn westward and drains towards Sixth line. Feature type is swale and flow condition is surface flow minimal.

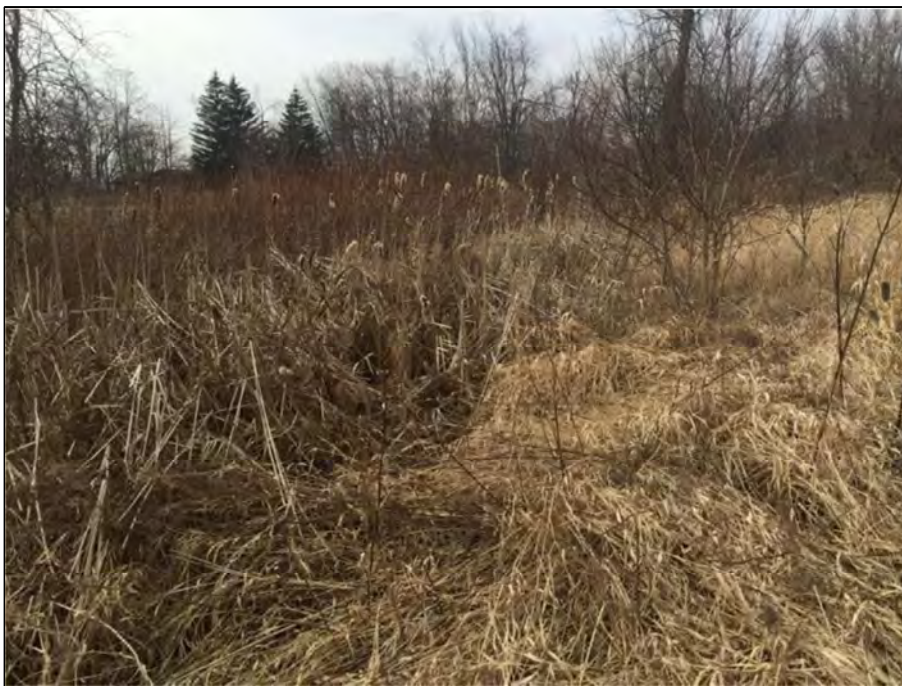
**140. W -T1 -2b (Segment 3).** Within Segment, dense vegetation. Feature type is swale and flow condition is surface flow minimal.
