CULTURAL HERITAGE IMPACT ASSESSMENT

PROPOSED MCGIBBON CONDOMINIUM PROJECT  
69 MAIN STREET SOUTH, 71-77 MAIN STREET SOUTH, 79 MAIN STREET SOUTH, AND 94-96 MILL STREET,  
FORMER ESQUESING TOWNSHIP, HALTON COUNTY  
COMMUNITY OF GEORGETOWN, TOWN OF HALTON HILLS, ONTARIO

ASI File: 15TS-266

February 2016

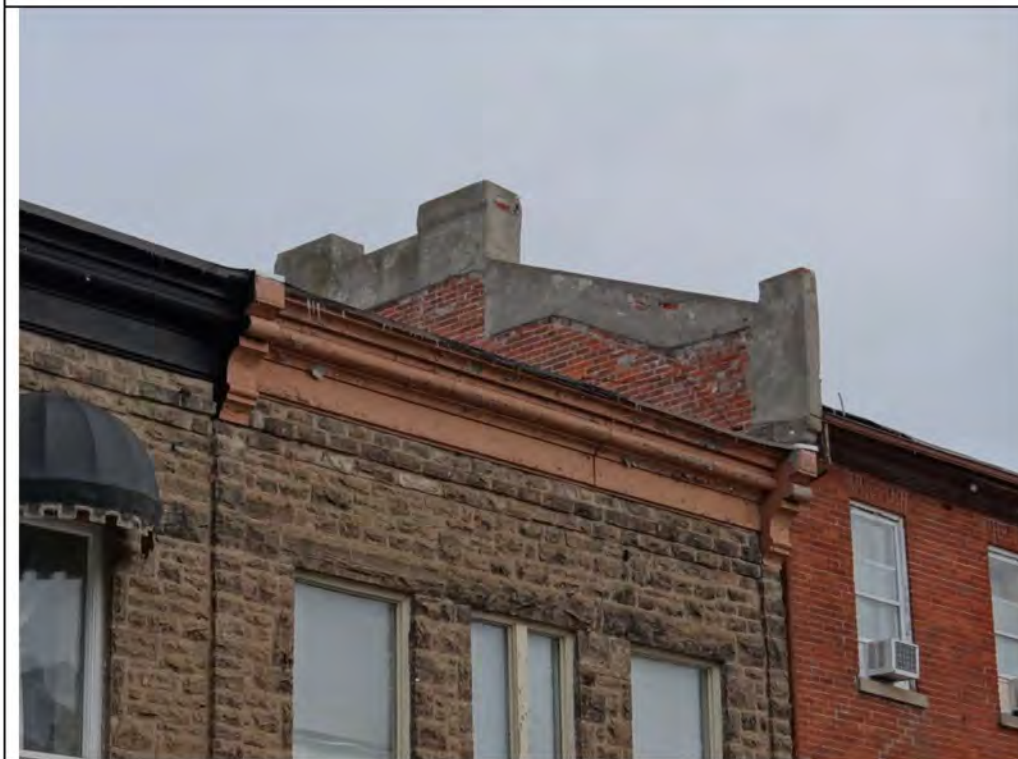
Plate 2: West elevation roof, cornice, and parapet of 69 Main Street South, looking southeast.

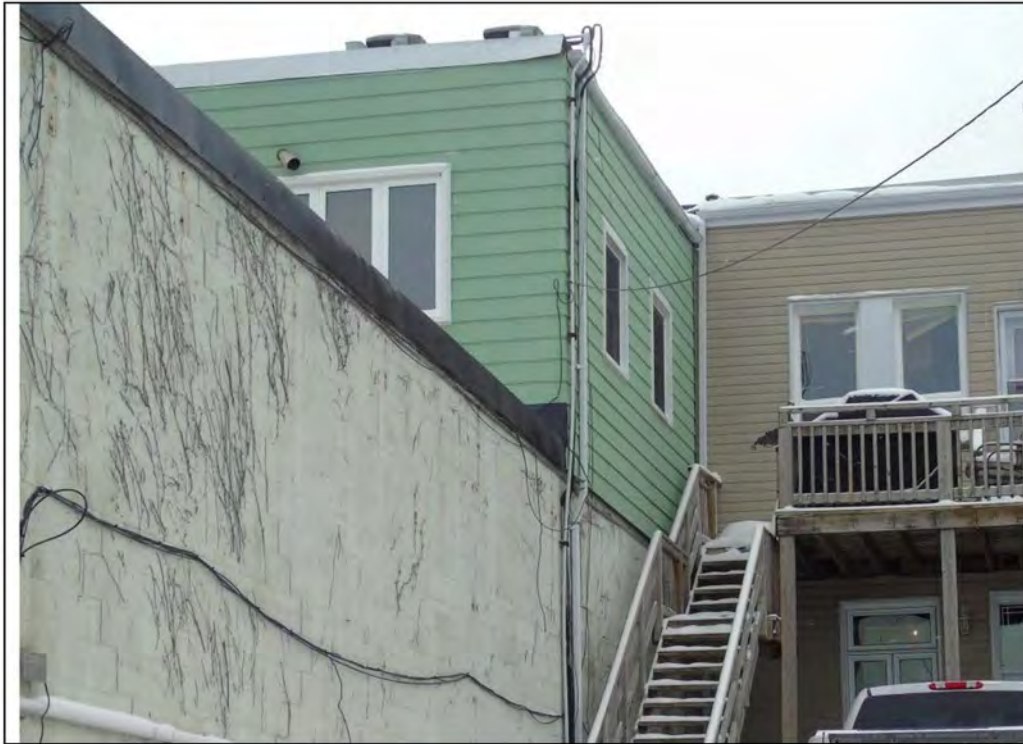
Plate 5: East elevation of the second floor of the modern rear addition at 69 Main Street South, looking southwest.

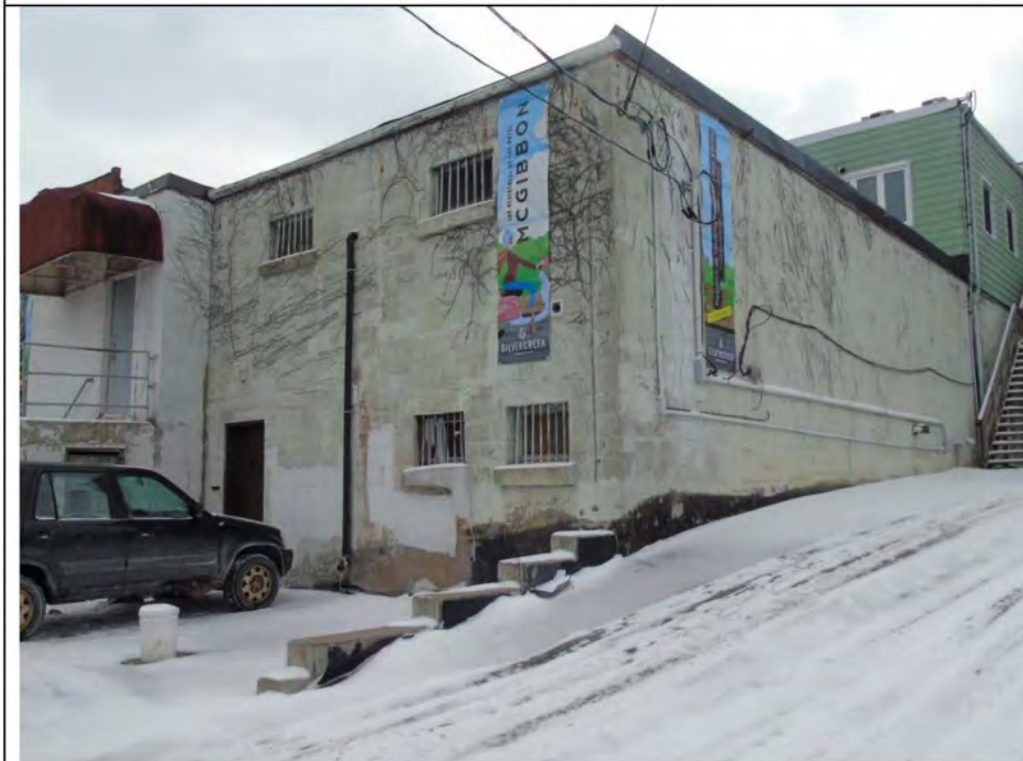
Plate 6: East and north elevations of the concrete block addition at 69 Main Street South, looking southwest.

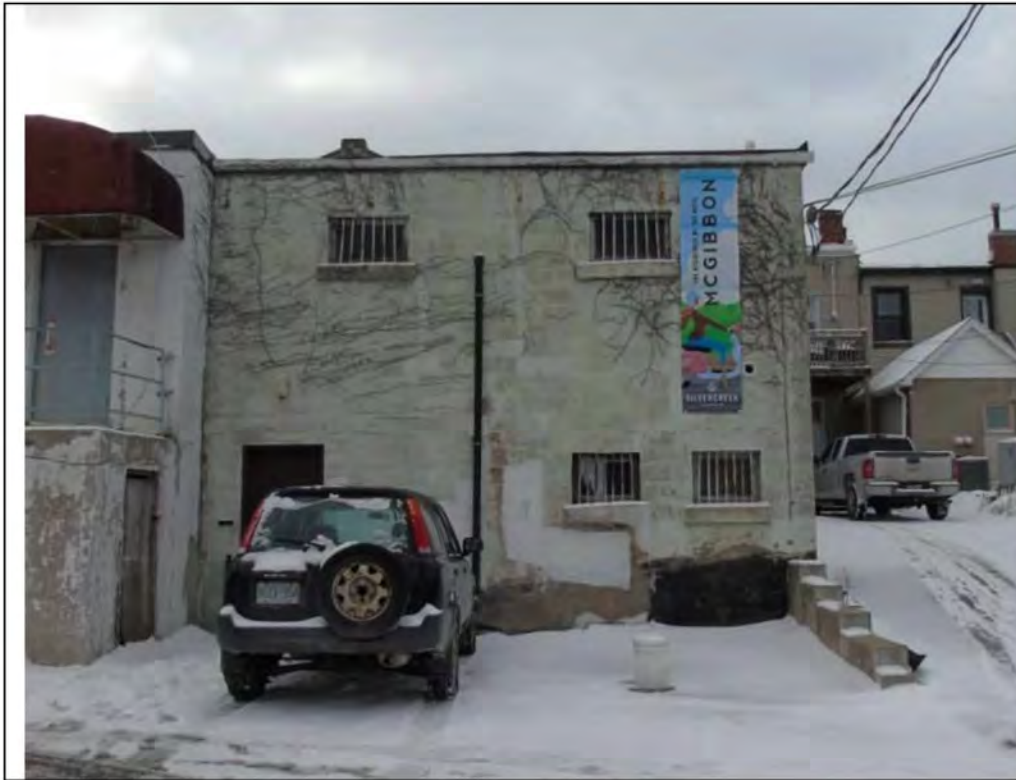
Plate 7: East elevation of the concrete block addition at 69 Main Street South, looking west.

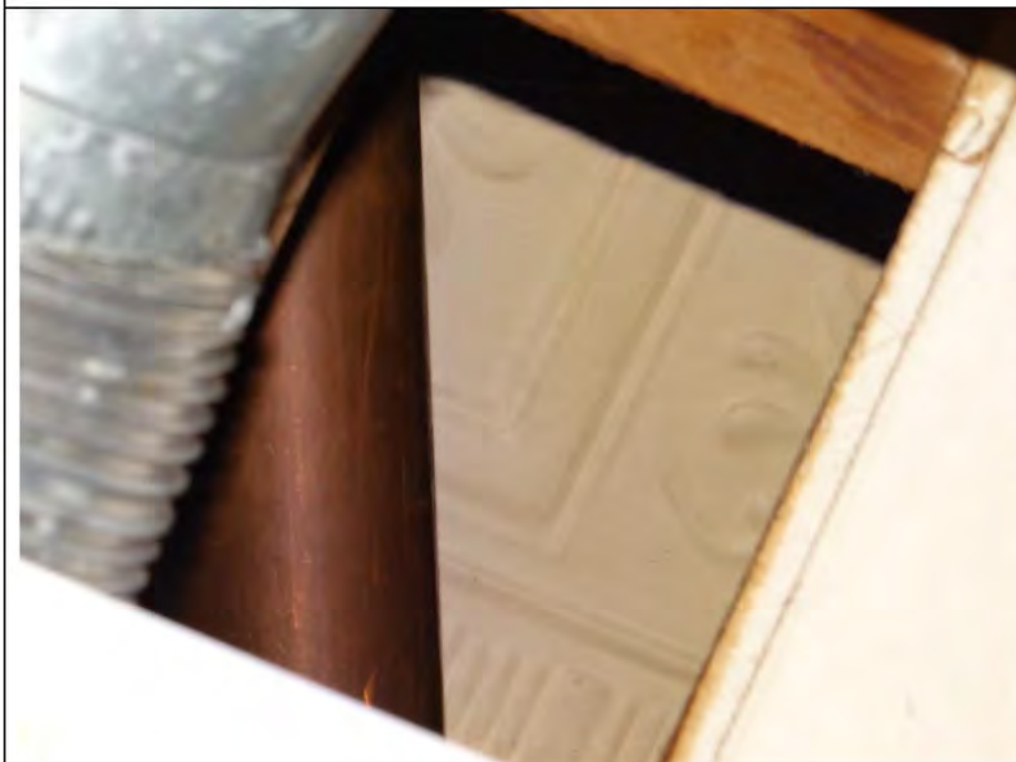
The interior of the original structure has been heavily modified from its original construction and was most recently used as a salon and spa. The interior was completely renovated within the past 20-30 years, leaving no visible heritage elements. Stamped tin ceiling tiles are visible above two successive modern dropped ceilings composed of gypsum tiles on the main floor. These tin ceiling tiles are still visible in-situ on the original ceiling above the modern drop ceiling tiles, and likely represent one of the earlier phases on the buildings use (Plate 8). The floor plan includes a reception area and hair salon area at the front, with spa facilities in the rear (Plates 9-11).

Plate 8: Detail of stamped tin ceiling tiles on original main floor ceiling of 69 Main Street South.

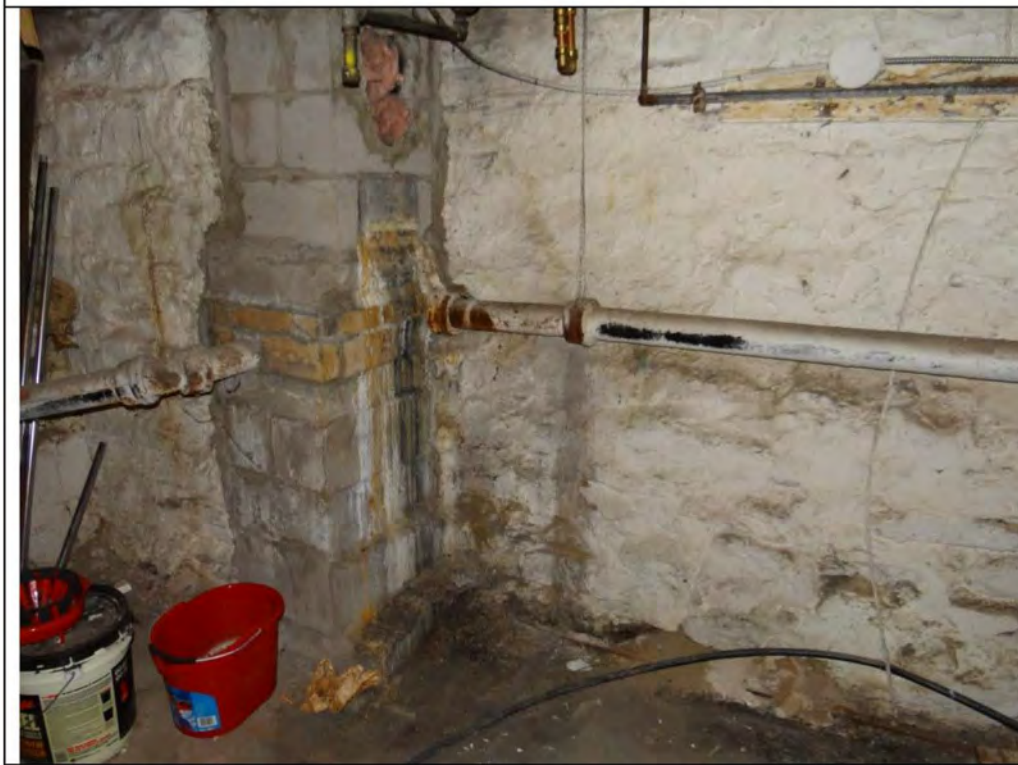
The basement of the original structure features stone foundations, large sawn support beams, plank floorboards, and un-milled timber support poles. Modern renovations and repairs were carried out in a

variety of areas, likely to replace damaged or faulty support elements with more modern, structural elements such as modern timbers, plywood floor sheeting, and cinderblocks. The original vault and heavy steel door is still present in the basement, retained from the original function of the building as the Bank of Hamilton (Plates 12-15). The basement of the concrete block addition features cinder block foundations, modern dimensional lumber floor joists, and drywall, and was used as part of the salon and spa business (Plate 16)

Plate 12: Detail  
of the stone  
foundations in  
the basement of  
69 Main Street  
South.

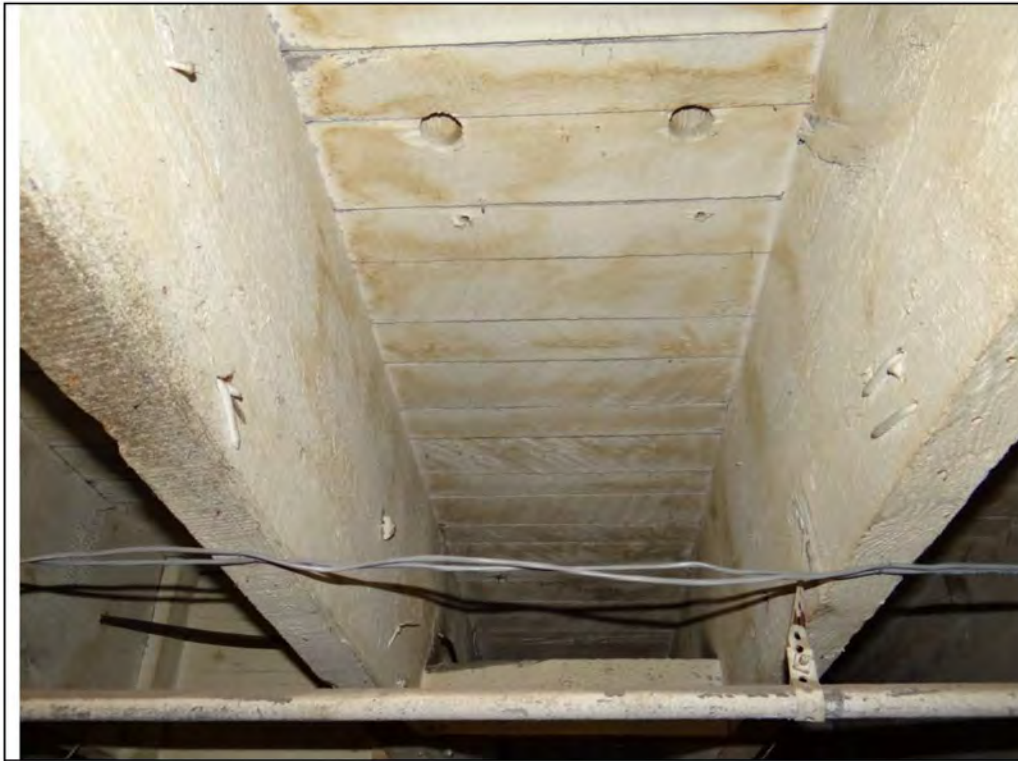
Plate 13: Detail of the sawn floor joists and softwood plank flooring from the basement of 69 Main Street South.

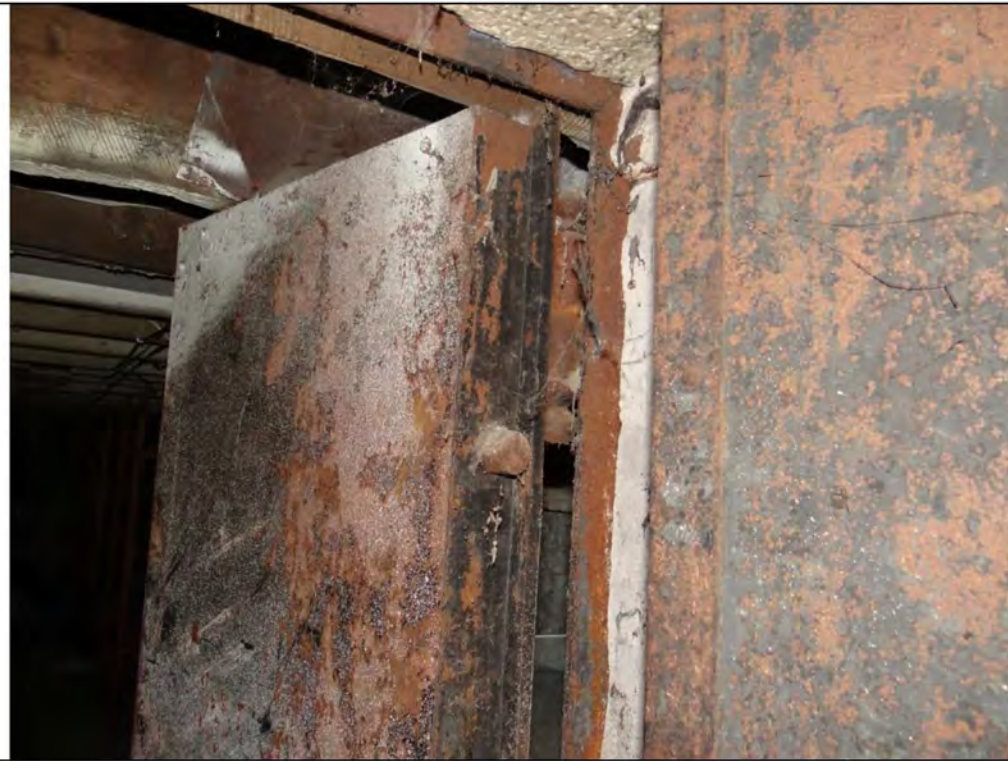
Plate 15: Detail of the Bank of Hamilton vault door in the basement of 69 Main Street South.

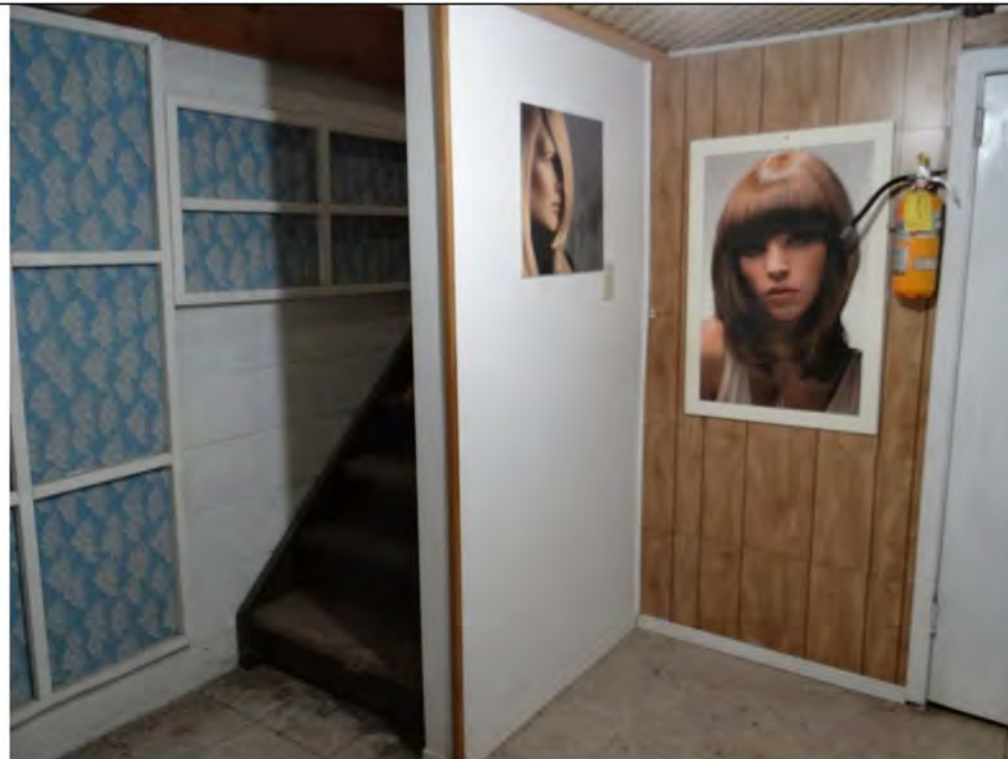
Plate 16: Detail of the finished section of the basement in the concrete block addition at 69 Main Street South.

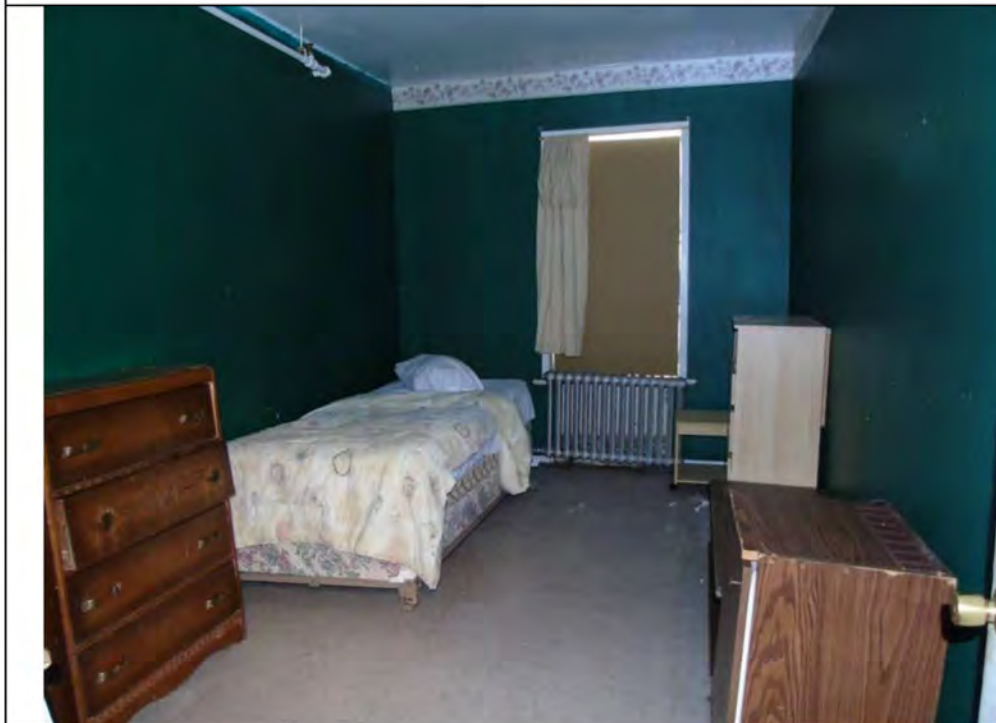
Plate 64: View of a typical room on the third floor.

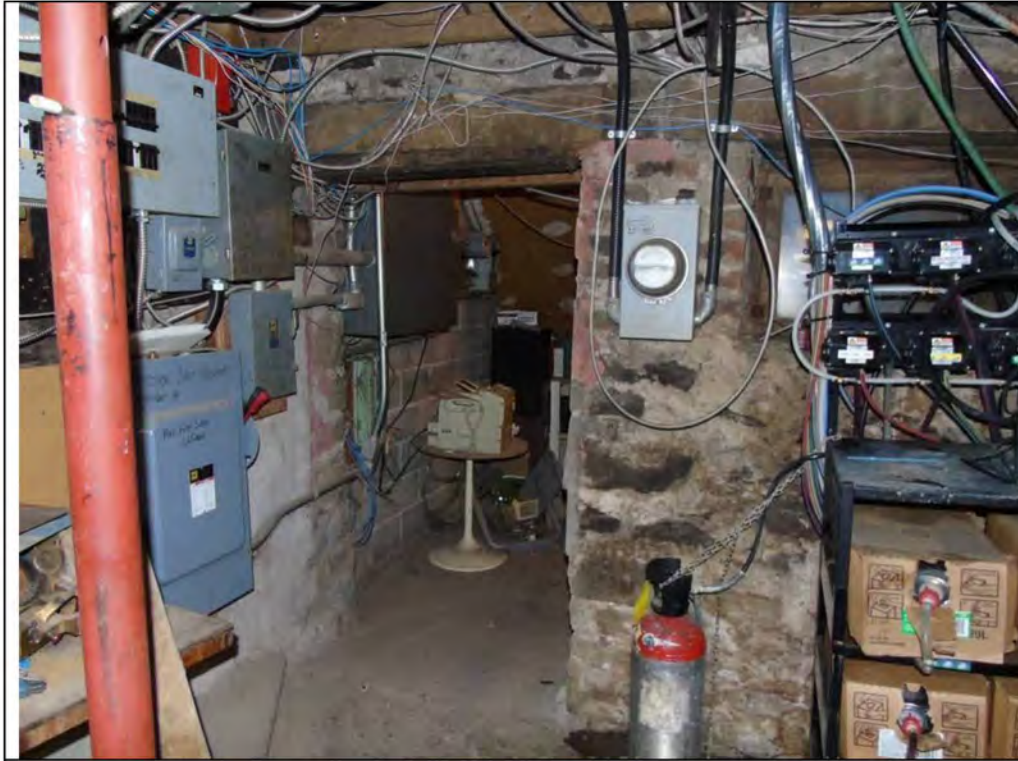
Plate 65:  
Basement of 79  
Main Street  
South, showing  
stone  
foundations,  
hewn beams,  
and modern  
electrical panels.

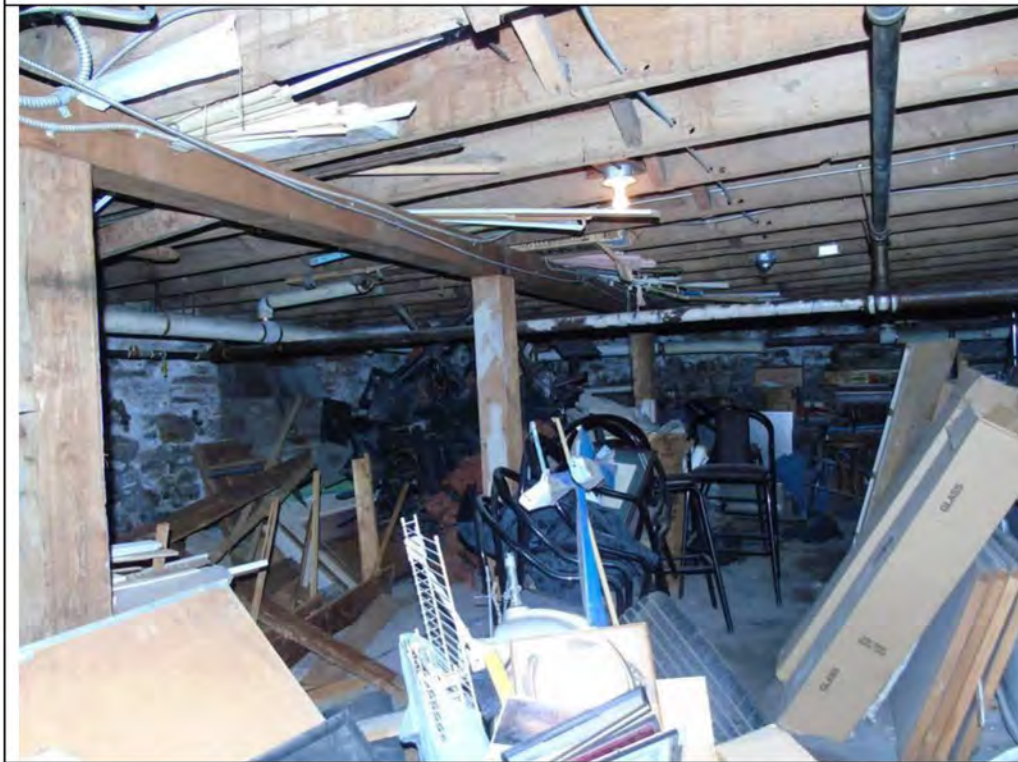
Plate 66:  
Basement of 71-  
77 and 79 Main  
Street South,  
showing stone  
foundations,  
sawn beams,  
and modern  
dimensional  
lumber floor  
joists.

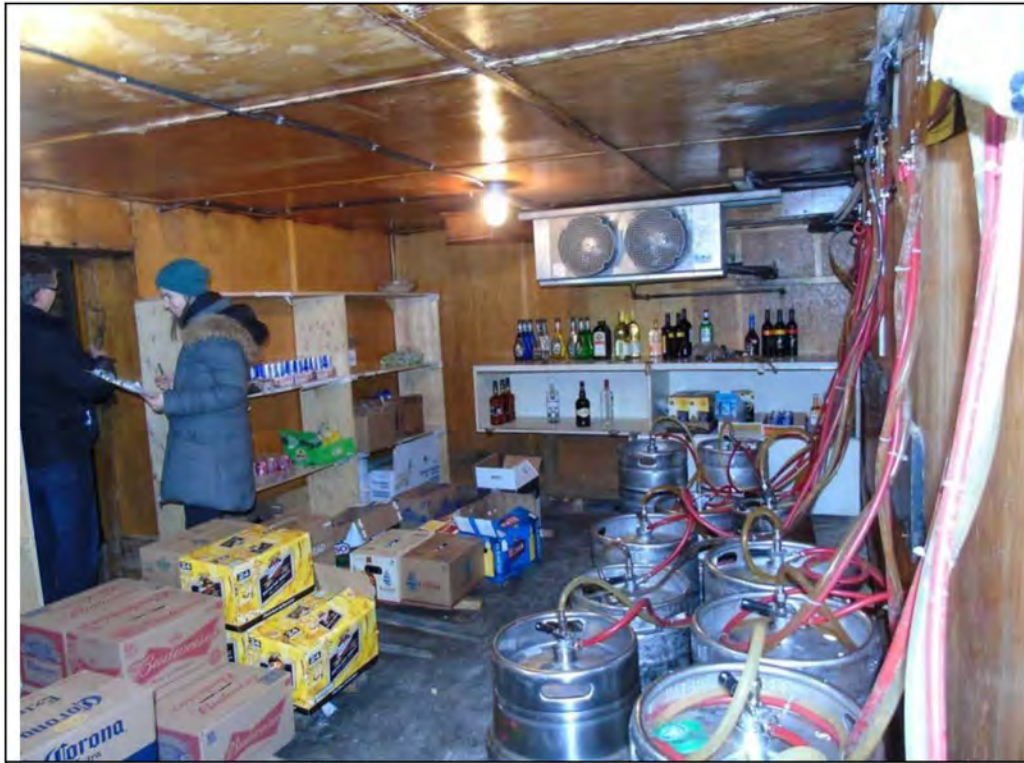
Plate 67:  
Basement of 71-  
77 and 79 Main  
Street South,  
showing modern  
refrigeration  
facilities for the  
restaurant and  
bar.

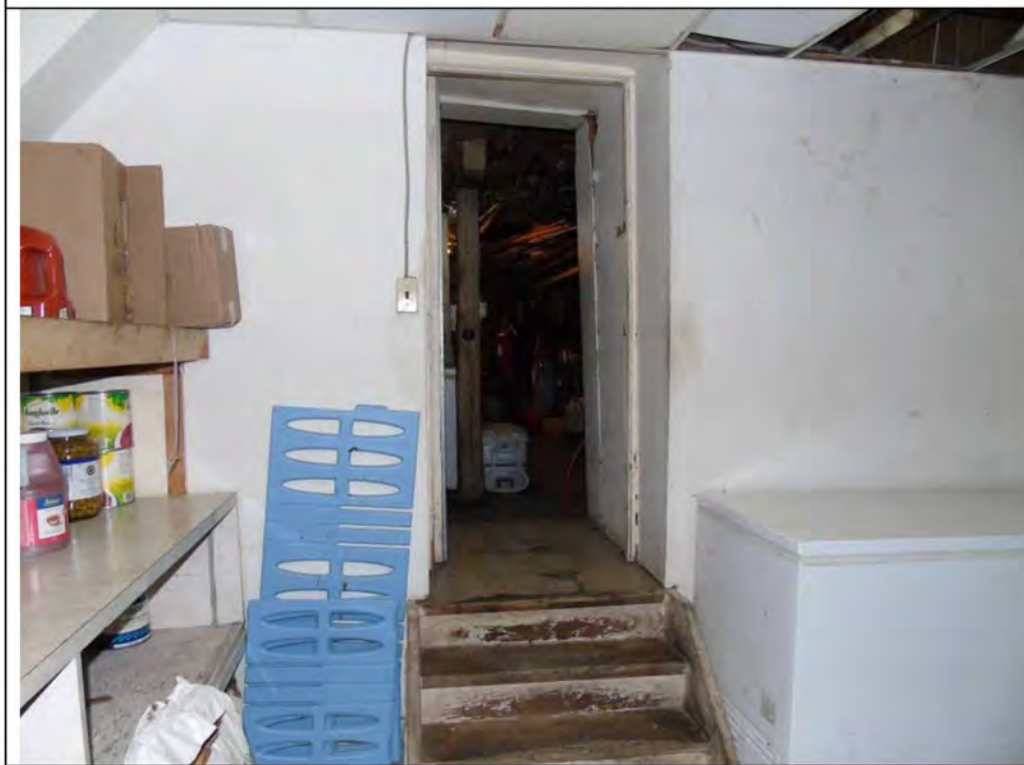
Plate 68:  
Basement of 71-  
77 and 79 Main  
Street South,  
showing modern  
drywall and  
ceiling tiles in a  
food storage  
area.

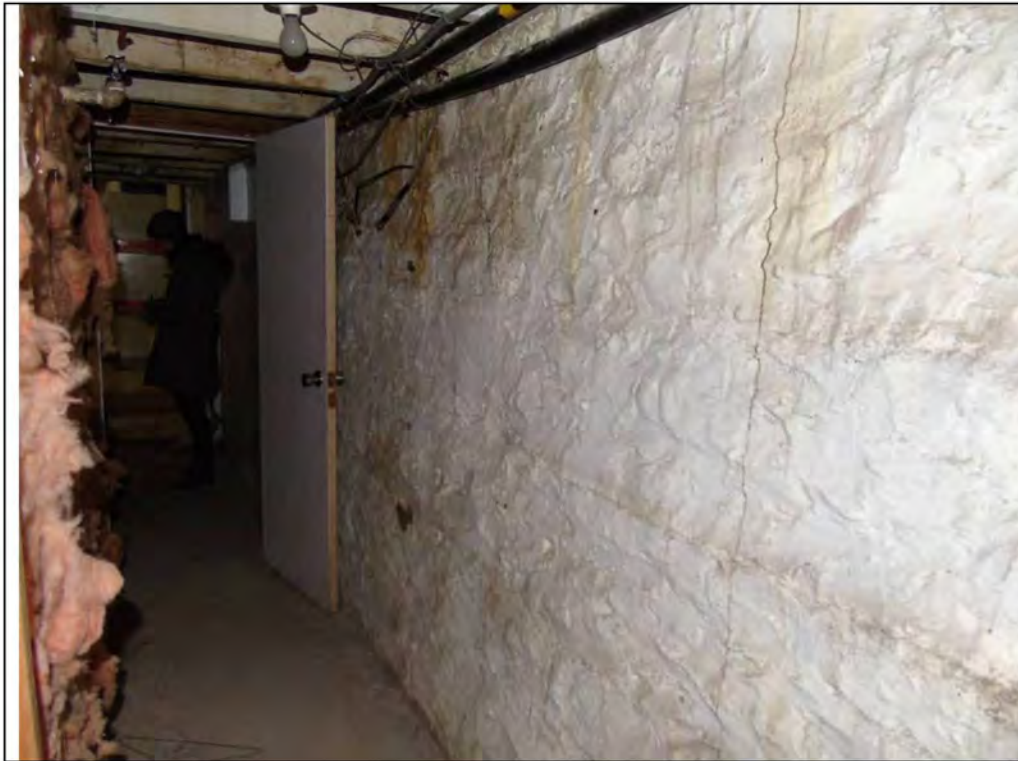
Plate 69:  
Basement of 71-  
77 and 79 Main  
Street South,  
showing painted  
stone  
foundations at  
right, and  
modern  
insulated walls  
at left.

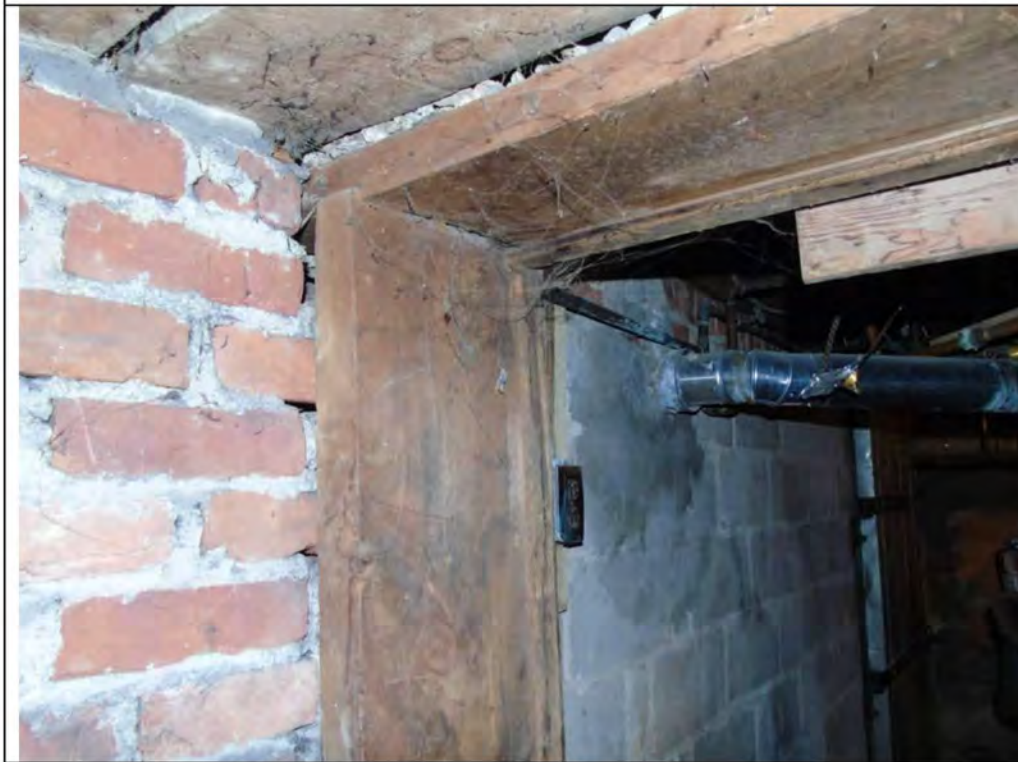
Plate 70:  
Basement of 71-  
77 and 79 Main  
Street South,  
showing red  
brick and cinder  
block  
foundations,  
softwood  
floorboards, and  
modern  
dimensional  
lumber door  
framing.

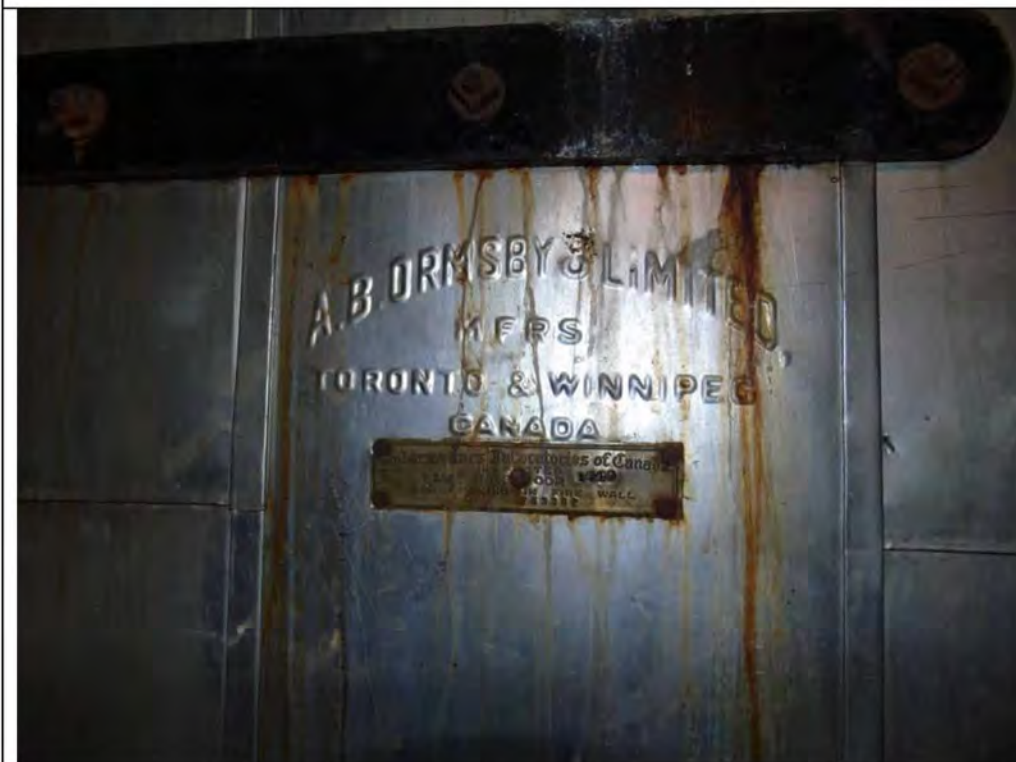
Plate 72:  
Basement of 71-  
77 and 79 Main  
Street South,  
showing heavy  
metal boiler  
room door.

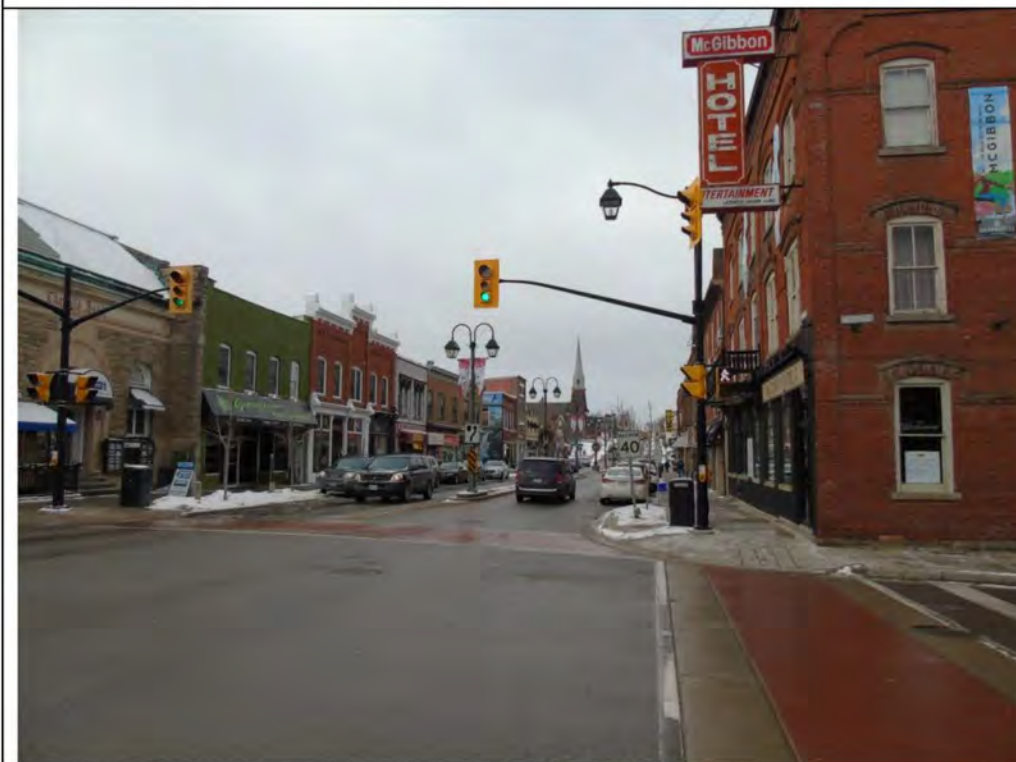
Plate 74: View  
from the  
intersection of  
Main Street  
South and Mill  
Street, looking  
north on Main  
Street.

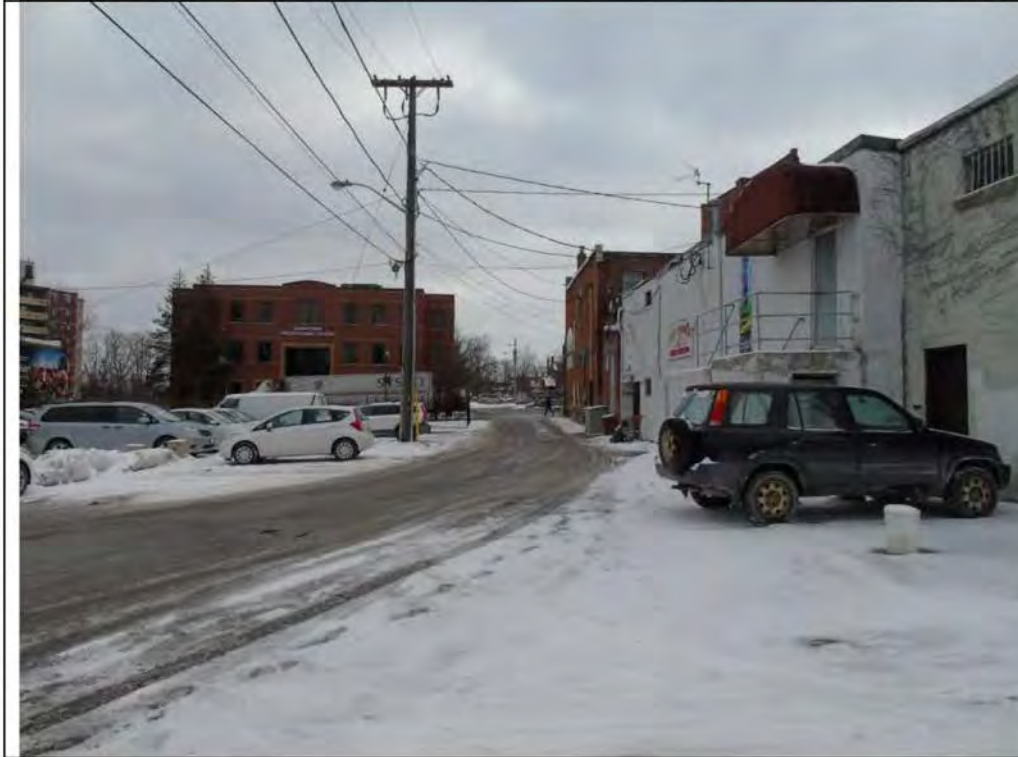
Plate 76: View of parking lot at the northeast section of the study area, looking south to Mill Street.

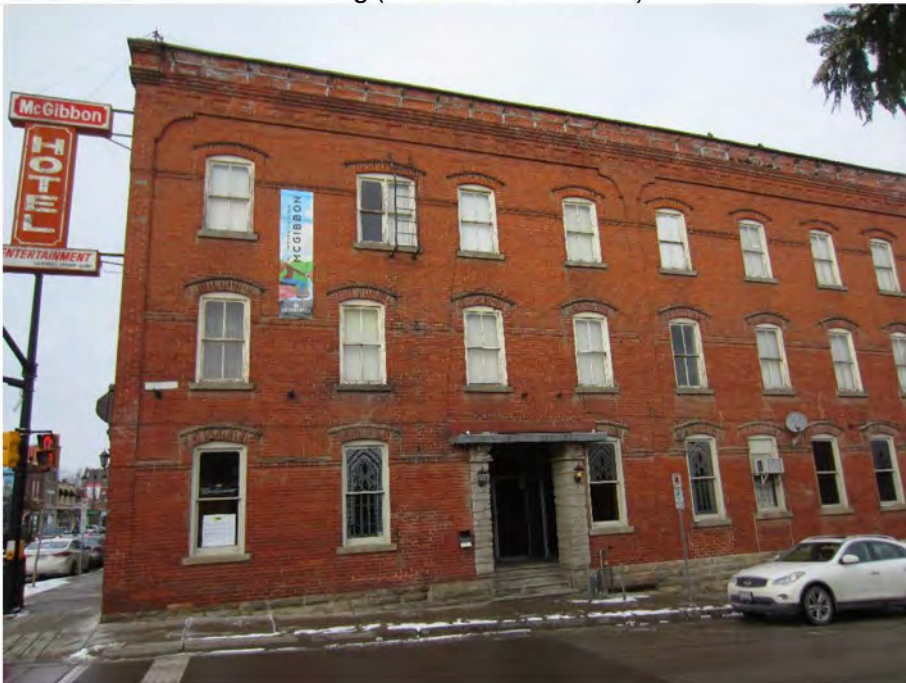
Photo #2: Side of the building (on Mill Street)

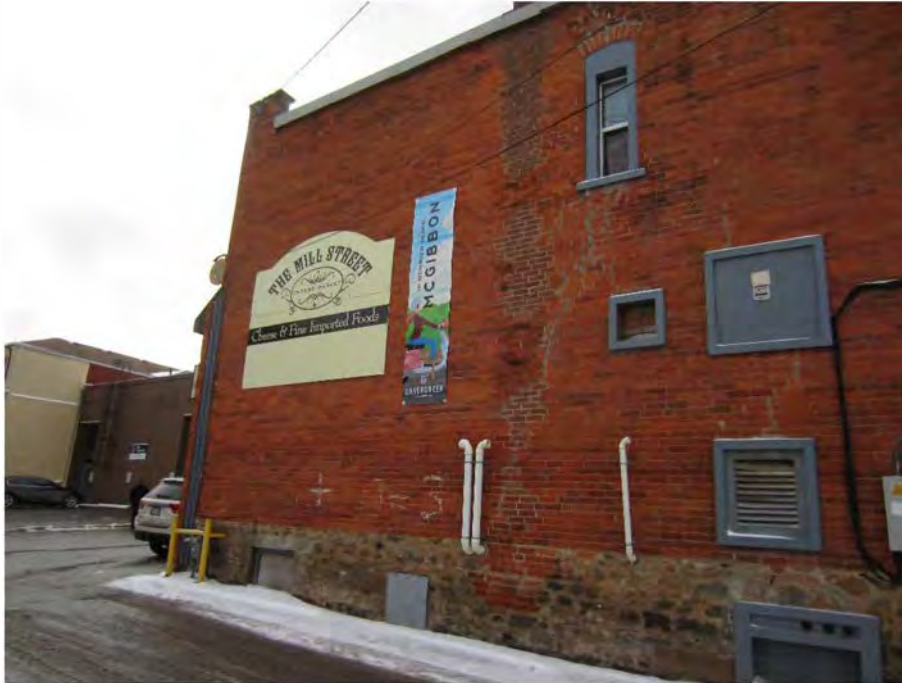
Photo #3: Back of the building

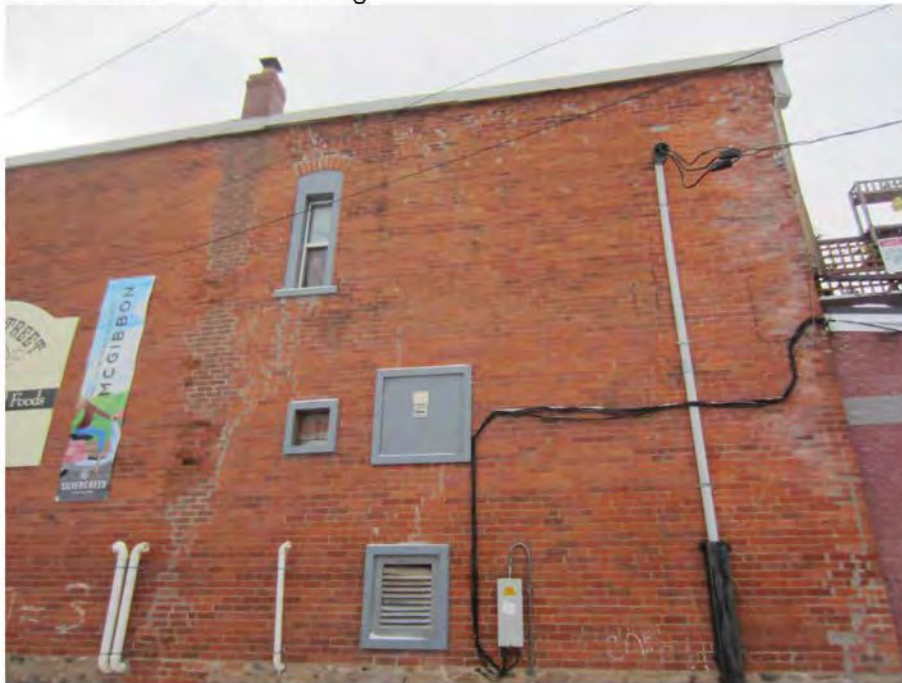
Photo #4: Back of the building

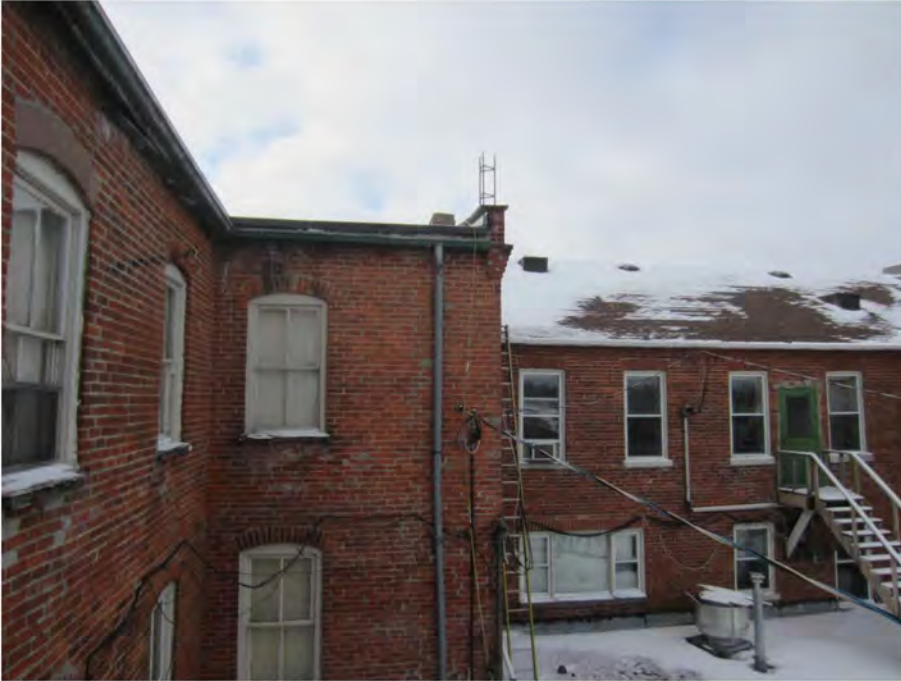
Photo #5: Side of the building

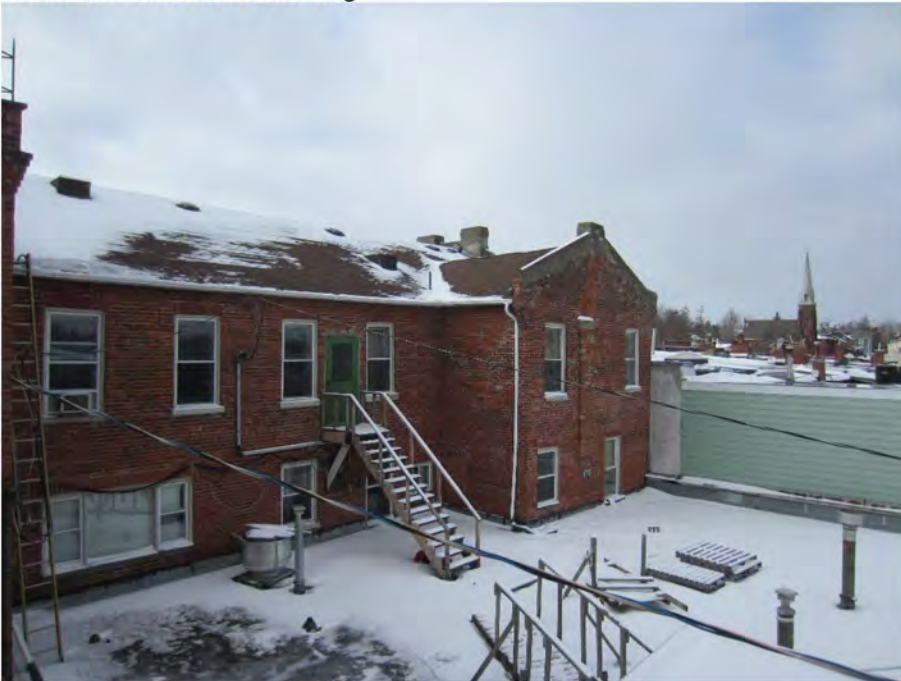
Photo #6: Side of the building

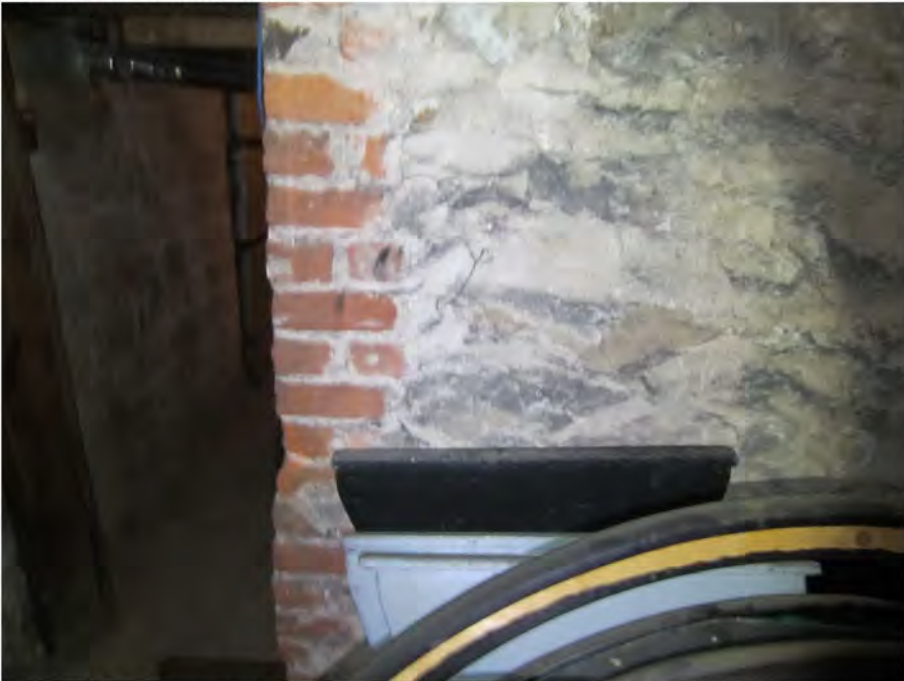
Photo #12: Basement brick foundation
