Appendix F

Stream Morphology

Project: Premier Gateway SWS: HT-1 Detailed Site

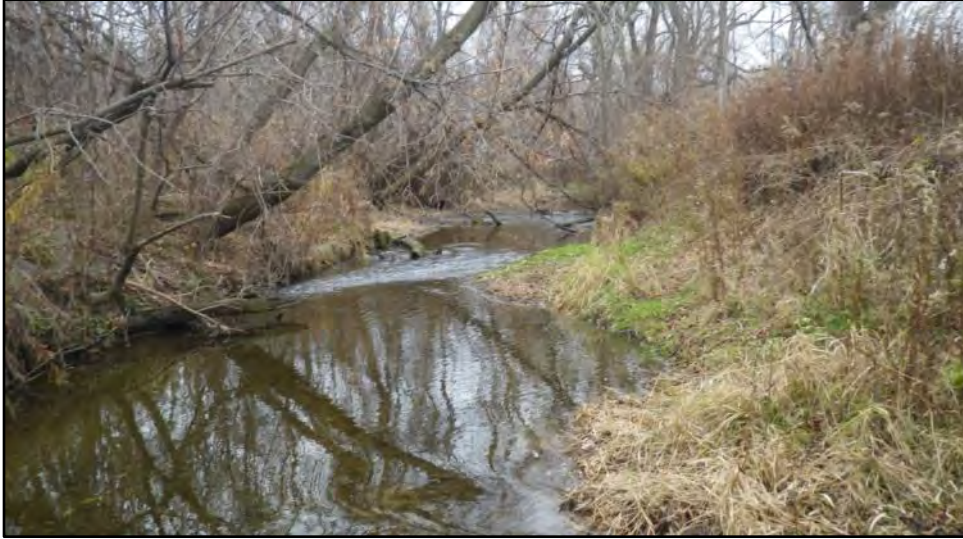
1. W-T1-3 Riffle and lateral bar formation along right bank

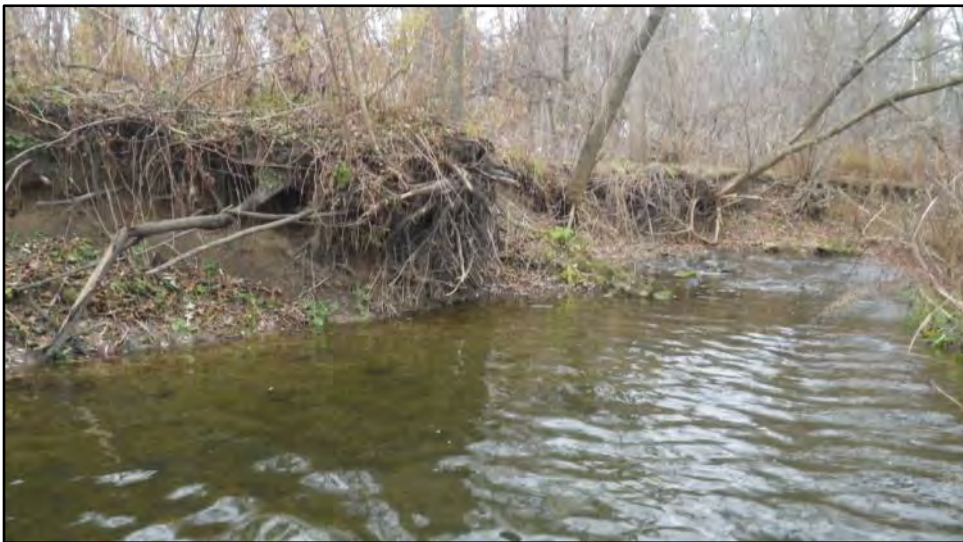
2. W-T1-3 erosion on bank causing leaning trees

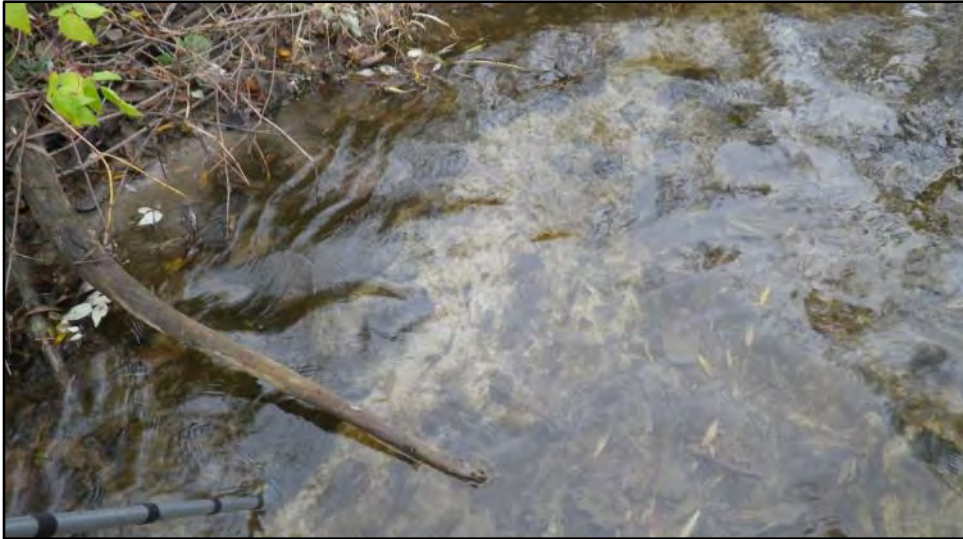
3. W-T1-3 Exposed clay on bed

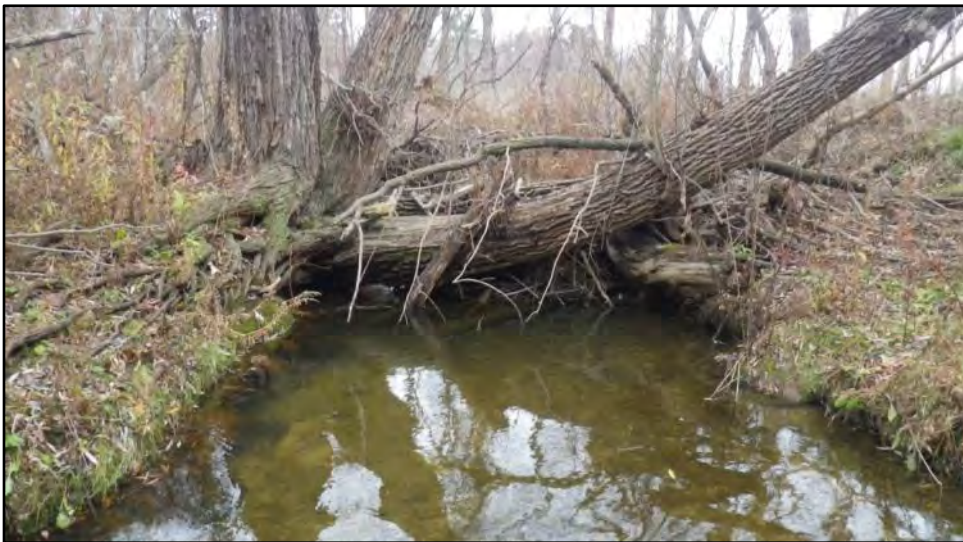
4. W-T1-3 Major woody debris jam at upstream end of reach

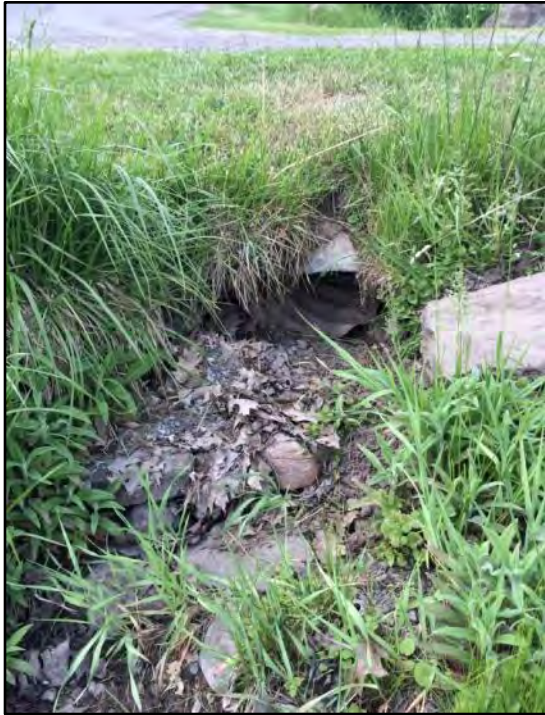
5. W-T1-2b CSP under driveway at far upstream end of reach.

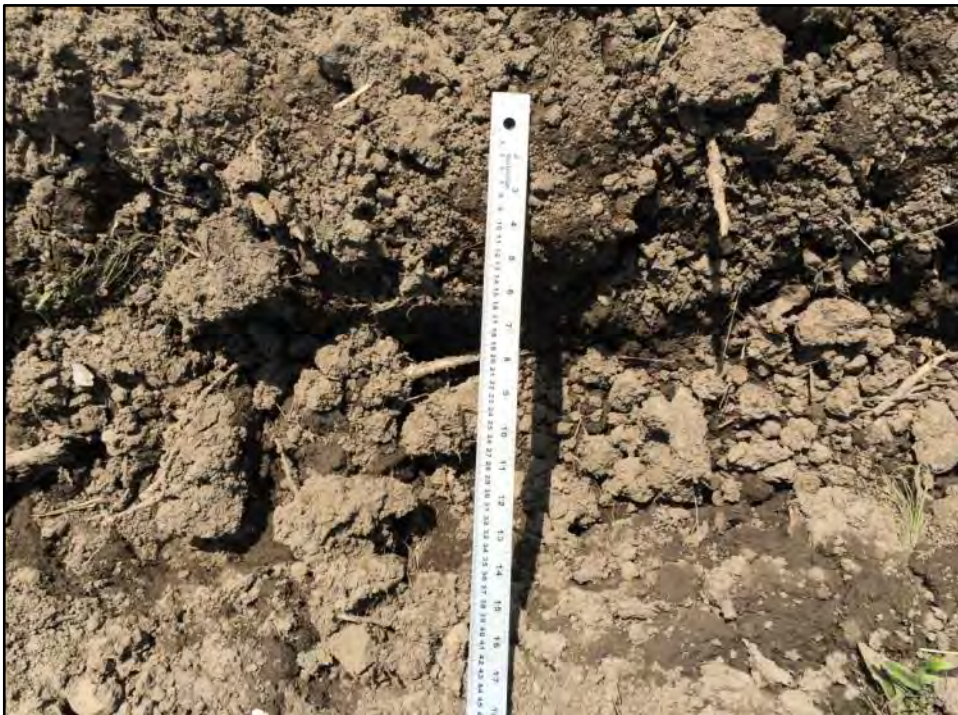
6. W-T1-2b width of channel (approximately 24cm) at far upstream end of reach.

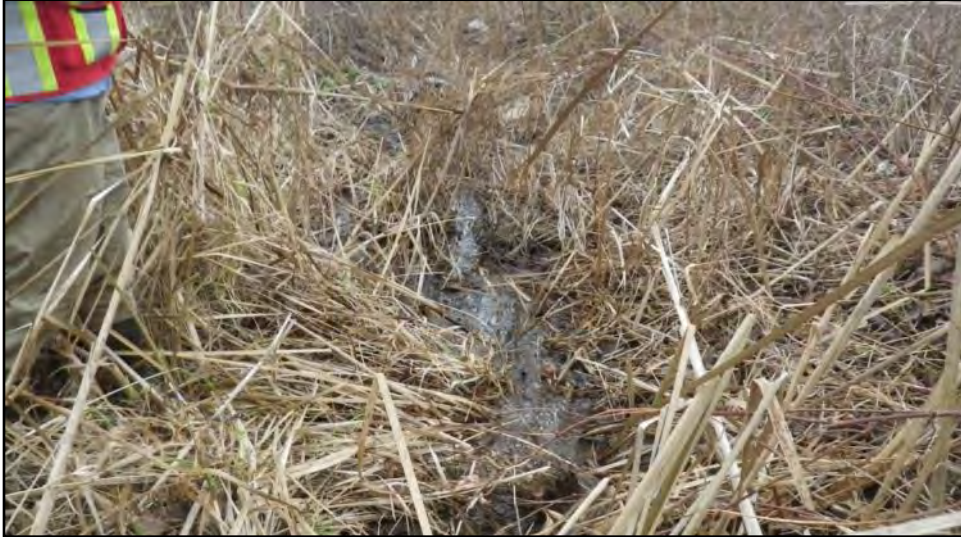
7. W-T1-2b facing downstream. Flow path through tall grasses at downstream end of reach.

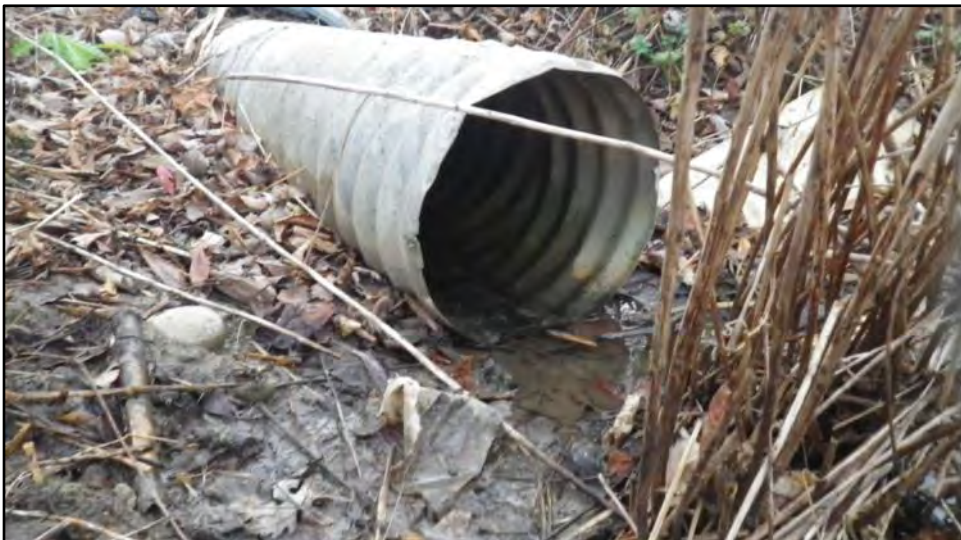
8. W-T1-2b facing downstream. Flow into CSP located under farm lane.

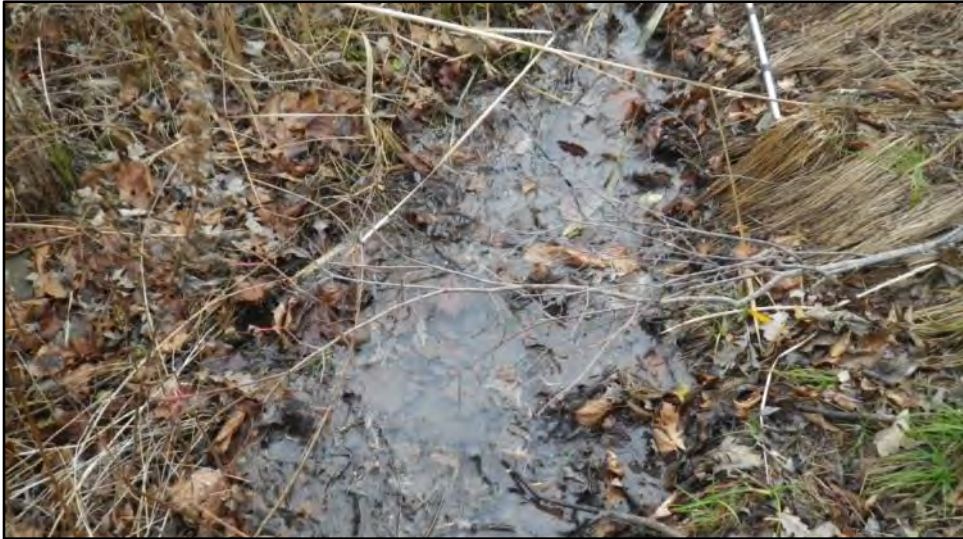
9. W-T1-2a Channel flowing out of phragmites patch which widens downstream.

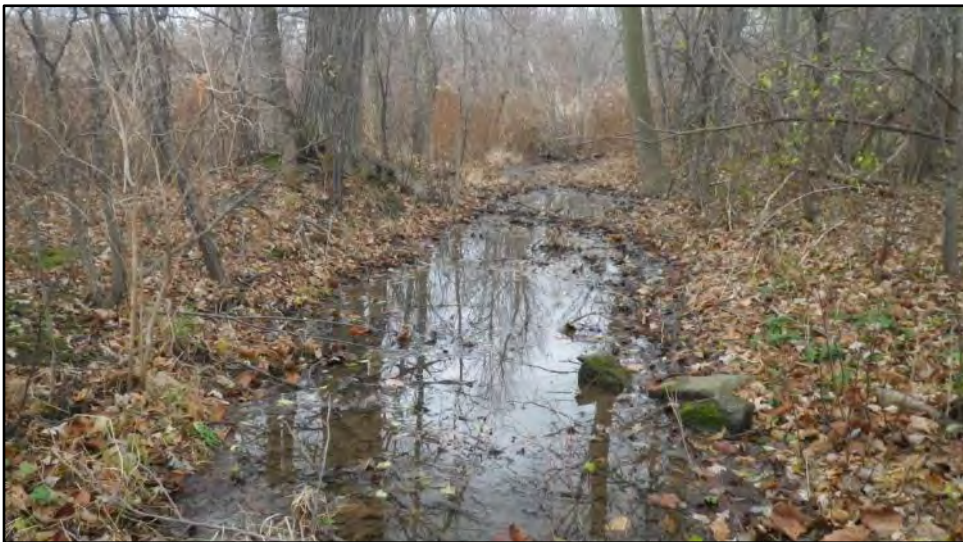
10. W-T1-2a facing downstream through treed section. Shallow wetted width and low banks.

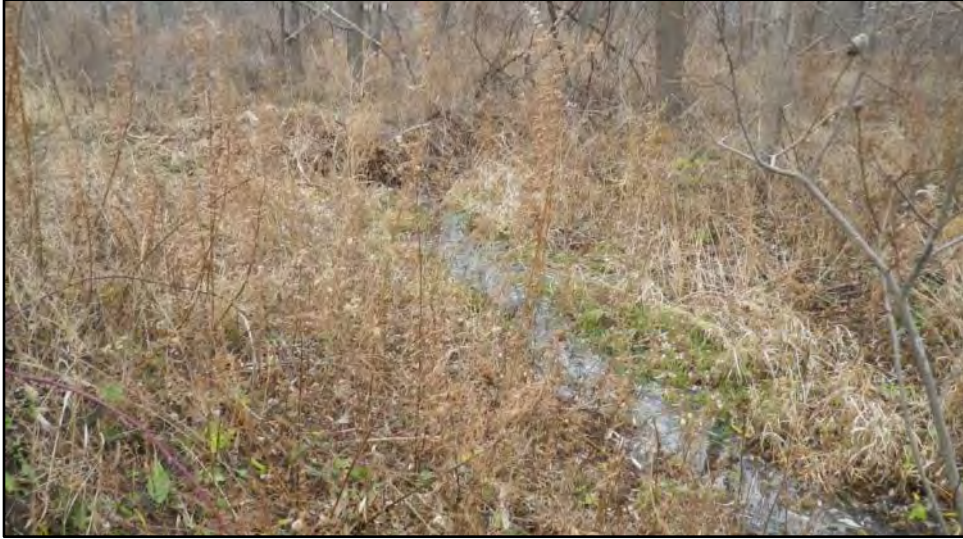
11. W-T1-2a facing downstream. Channel more narrow and less defined as it travels through grasses.

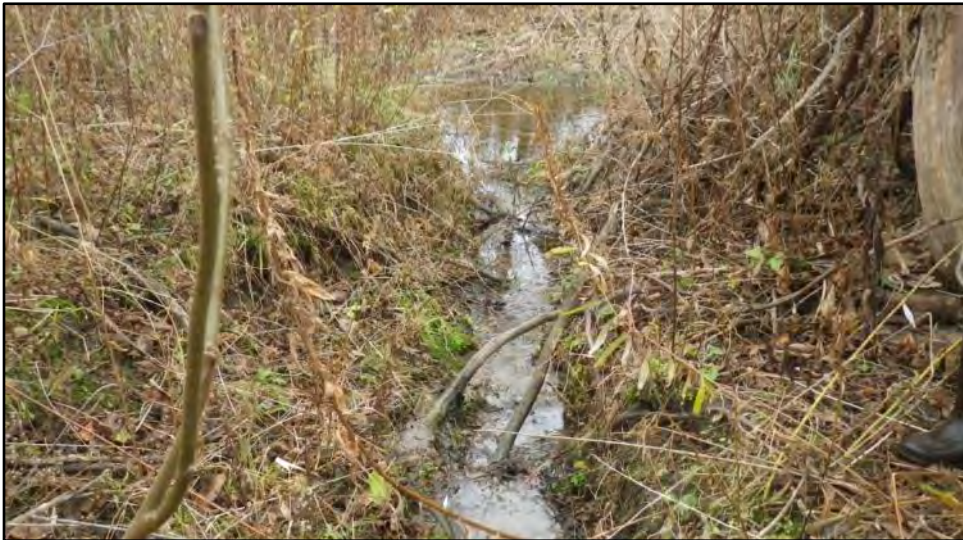
12. W-T1-2a facing downstream. Channel is very narrow at the confluence with the main channel.

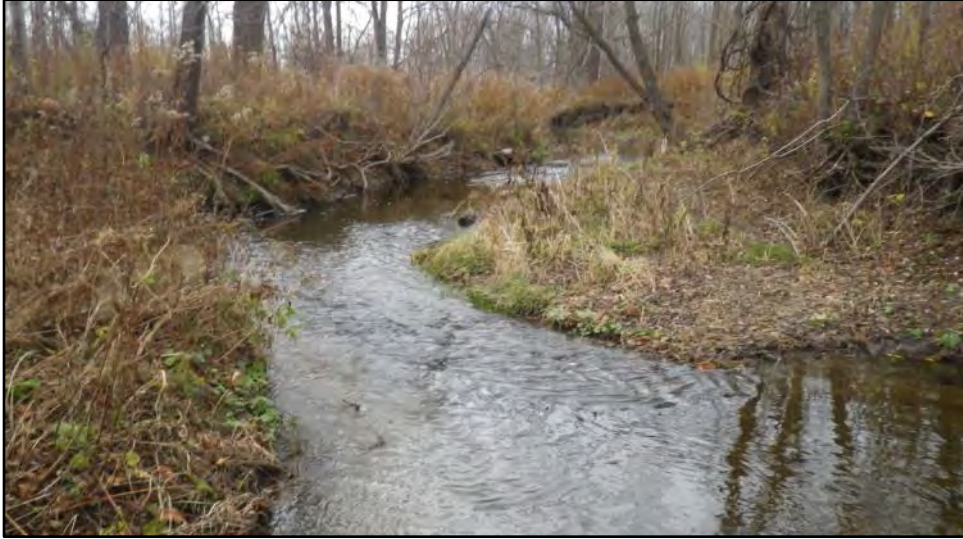
27. W-T1-3 facing downstream. Large vegetated lateral bars inducing sinuosity.

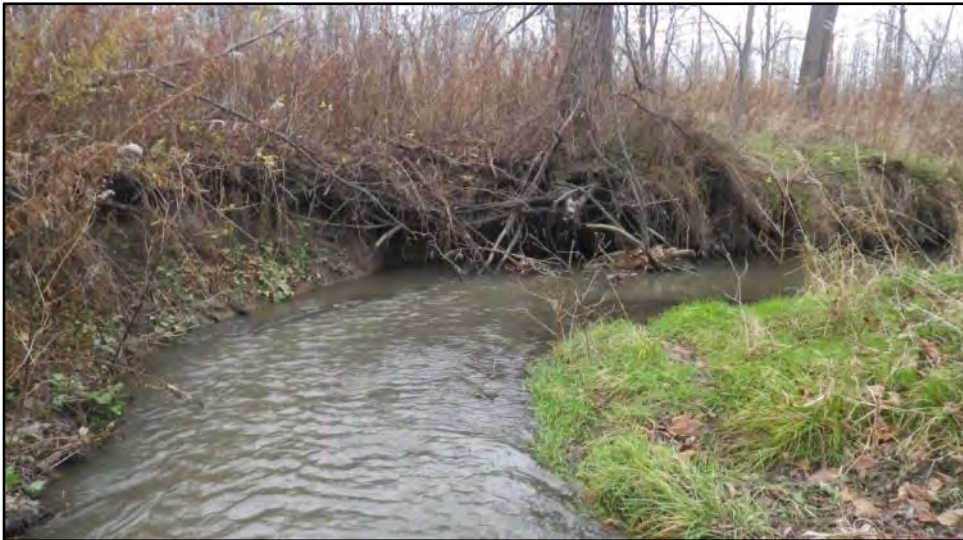
28. W-T1-3 Banks experiencing erosion opposite of bars producing bank slumping and undercutting which exposes roots.

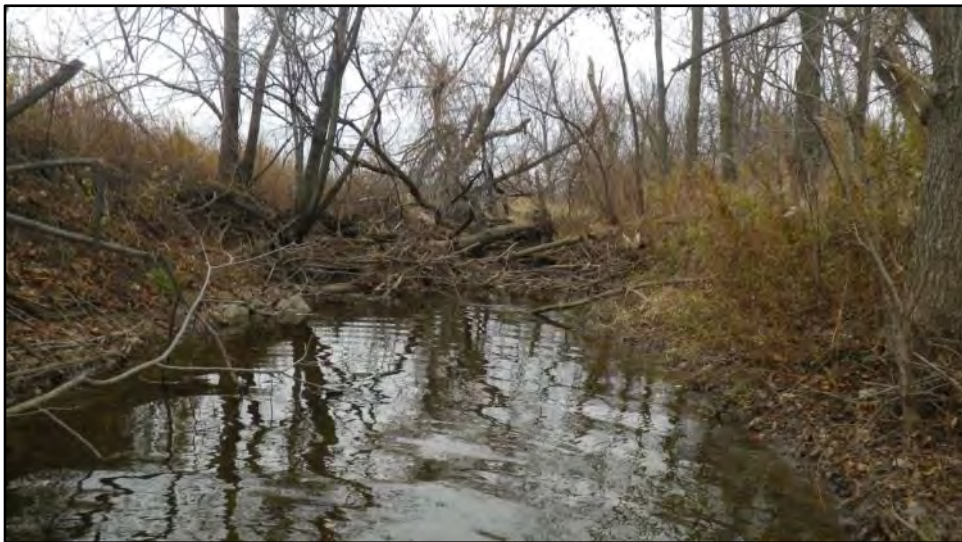
30. W-T1-2 Large woody debris jam at upstream end

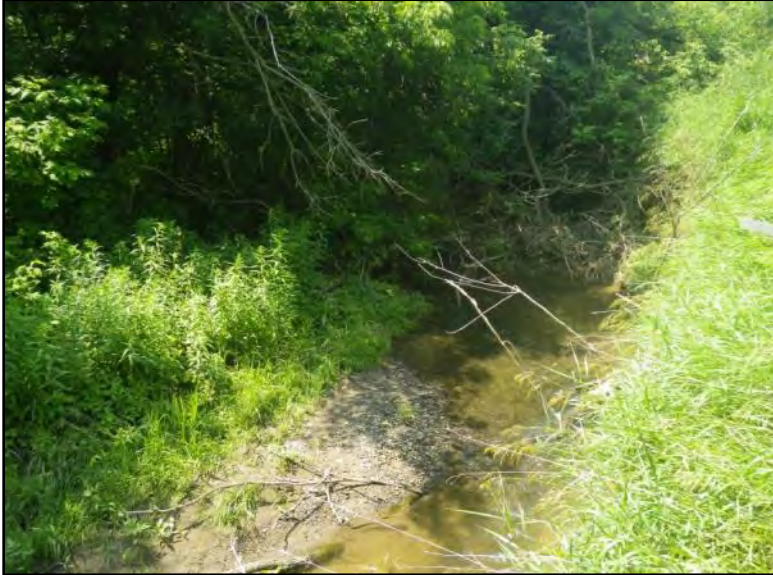
31. W-T1-2 gravel bar accumulation along inner bank.

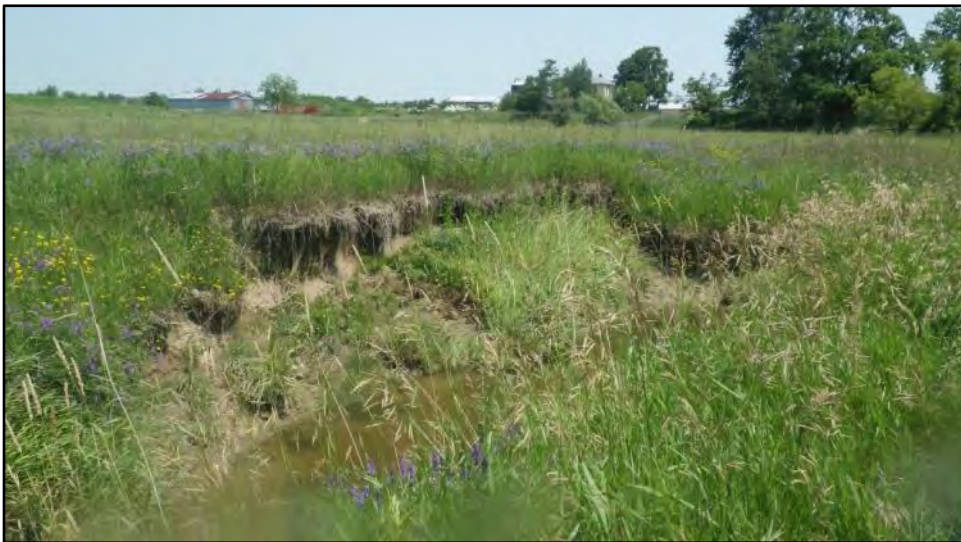
32. W-T1-1 calving of bank material.

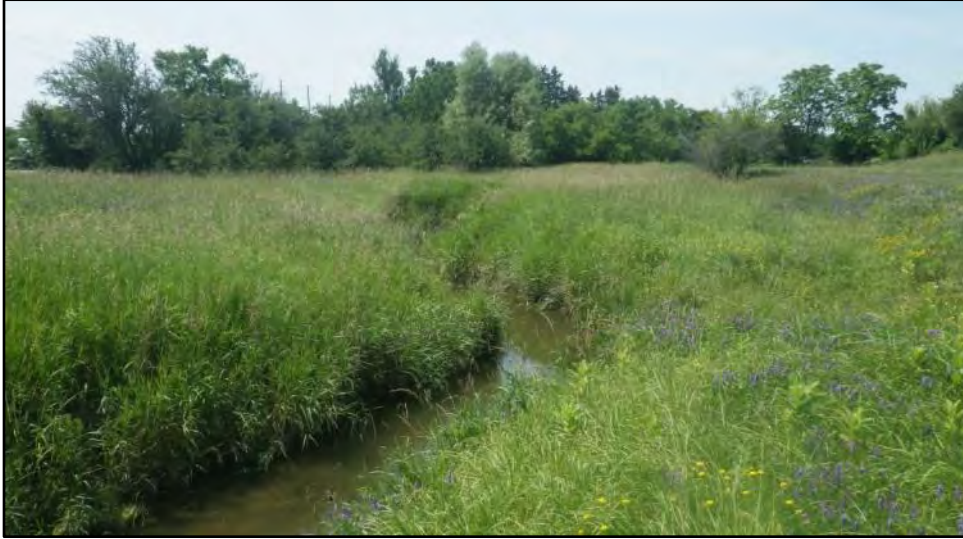
33. W-T1-1 Channel flows through dense meadow vegetation.

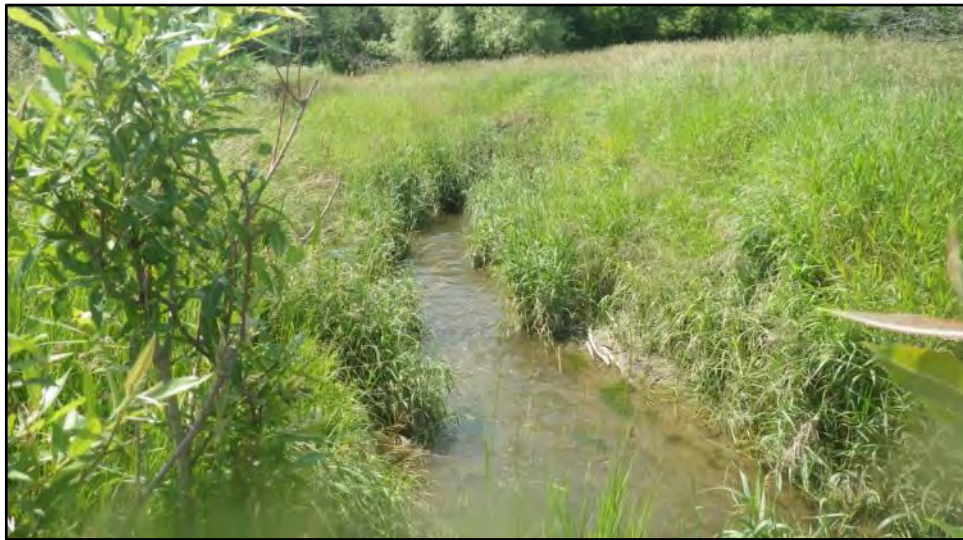
34. W-T1-1 Narrowing of wetted width due to dense grass vegetation.

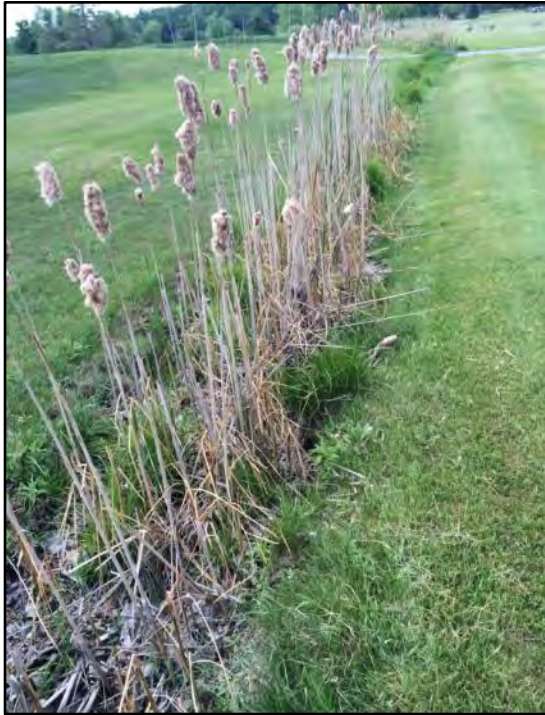
35. HDF-3 channel with cattails in channel and manicured lawn banks.

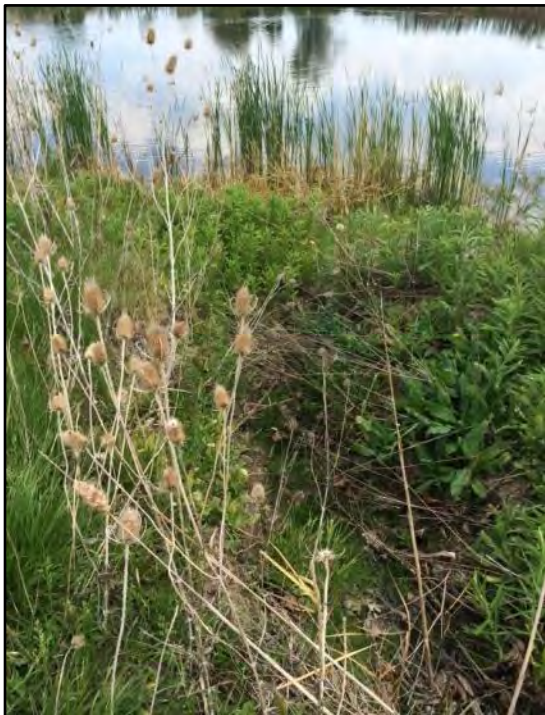
36. HDF-3- channel confluence into pond.

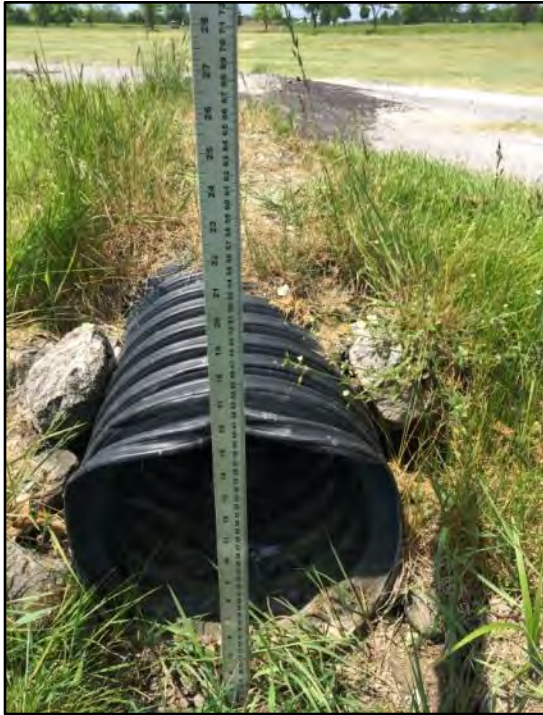
37. HDF-4 culvert under golf course trail.

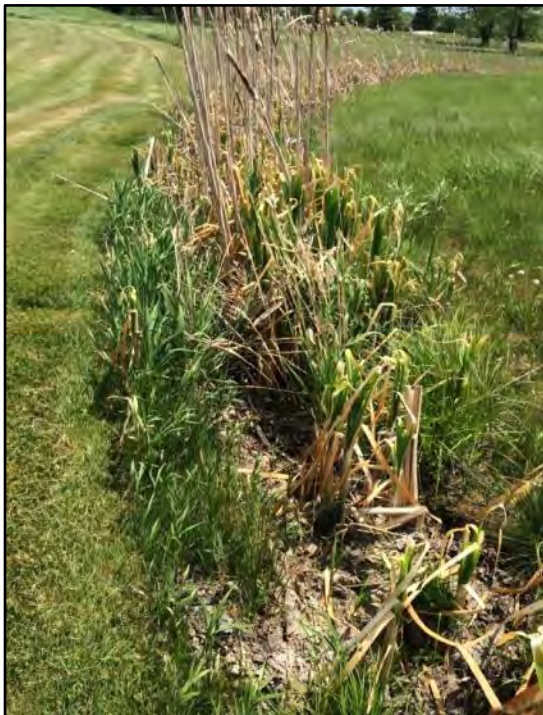
38. HDF-4 dry channel dry at time of photo.

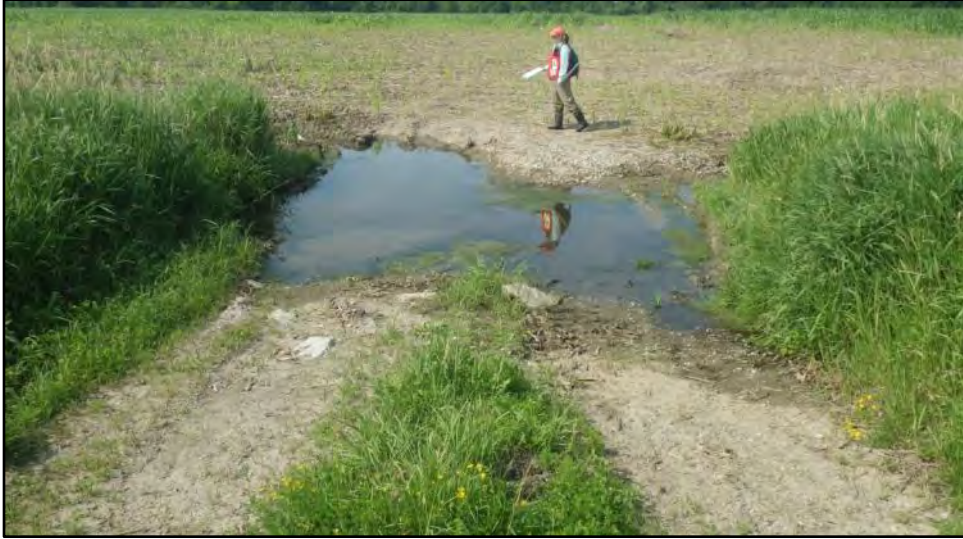
39. HDF-1- ponded area at farm lane.

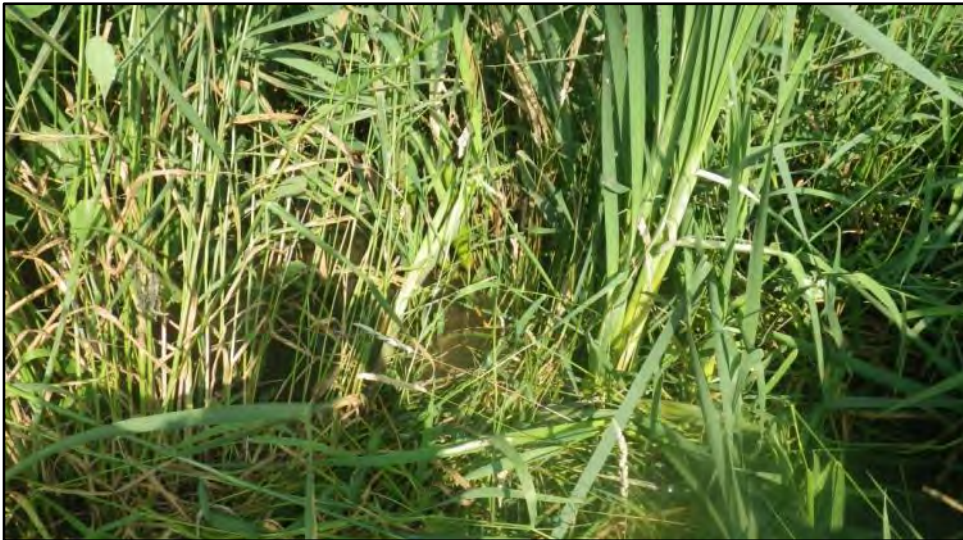
40. HDF-1- Stagnant water located in grass channel undefined.

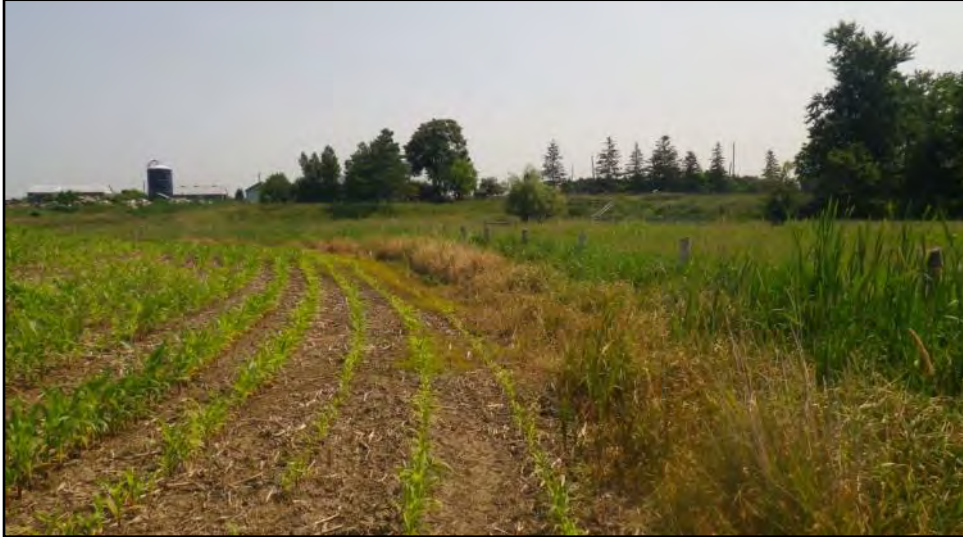
41. HDF-1 Channel flows as drainage ditch along fenceline (right side of photograph)

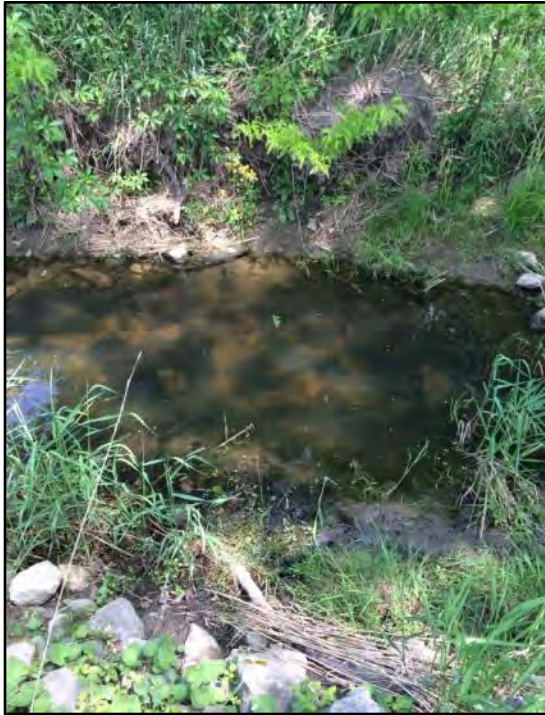
42. E-T1-4 Standing water in trapezoidal shaped channel at downstream extent of RGA/RSAT analysis

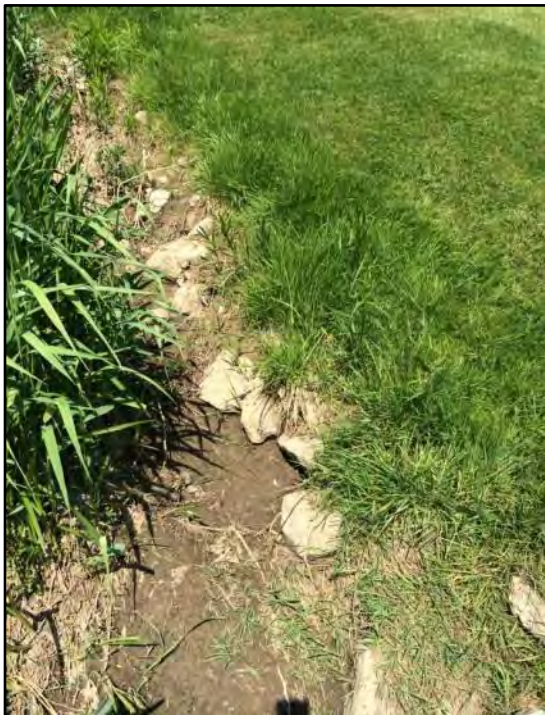
43. E-T1-4 Channel is dry and armouring placed along left bank placed to prevent erosion along fairway boundary.

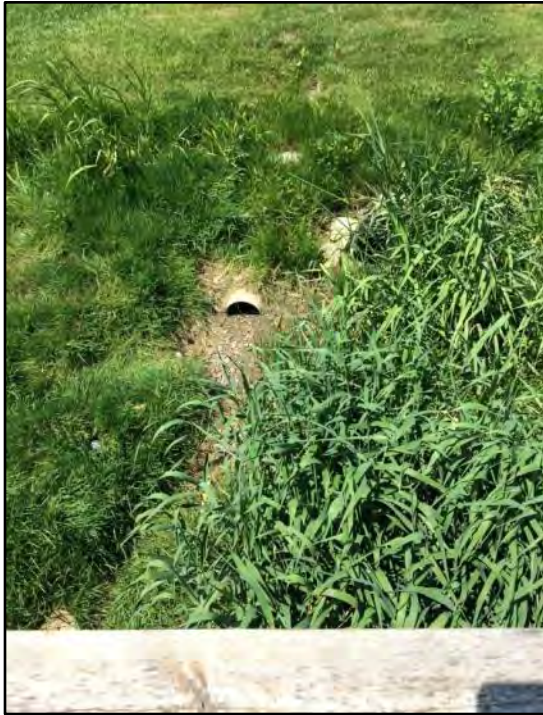
44. E-T1-4 Channel alternates between being piped under golf course fairways (as seen in this photograph) and being a grassed trapezoidal channel.

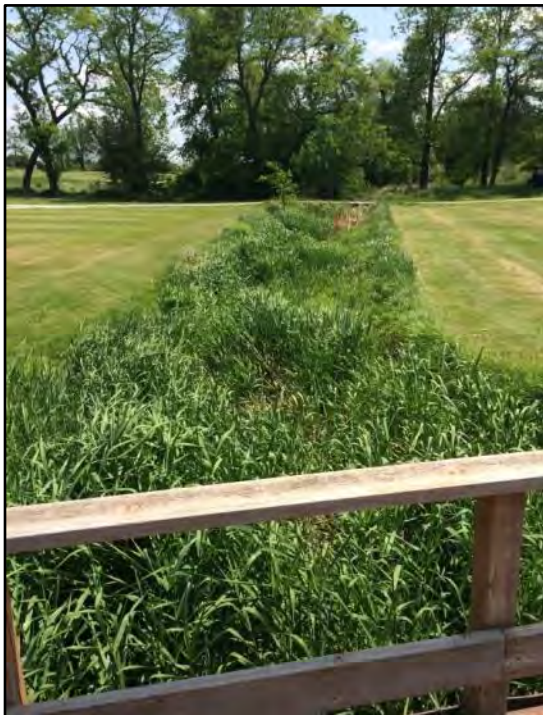
45. E-T1-4 Channel alternates between being piped under golf course fairways and being an intermittent grassed trapezoidal channel (as seen in this photograph).

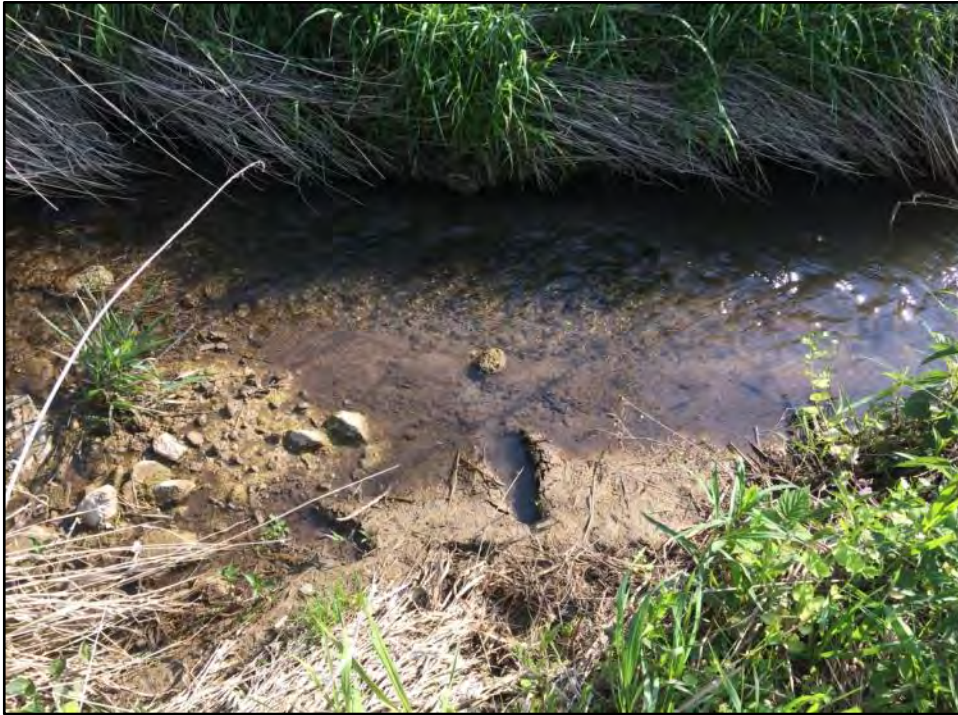
46. E-T1-3 Small pebbles and gravel through thalweg and silt accumulation (10-15cm) in other areas.

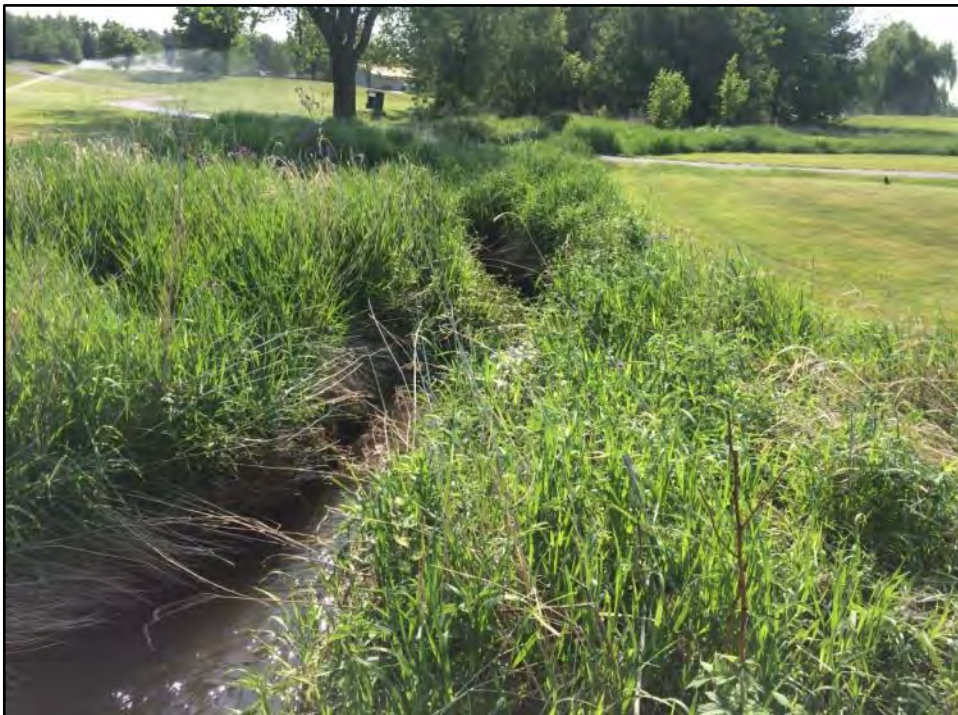
47. E-T1-3 Good grass riparian buffer between the channel and golf course.

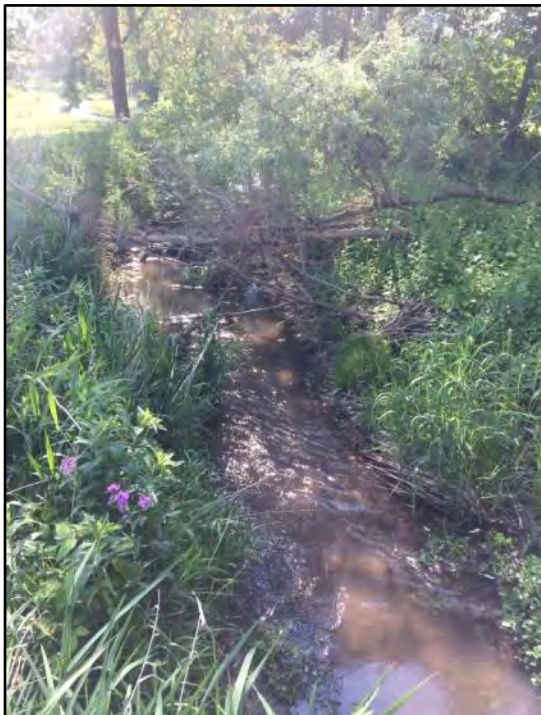
49. E-T1-3 Channel runs through woodlot as it approaches clubhouse.

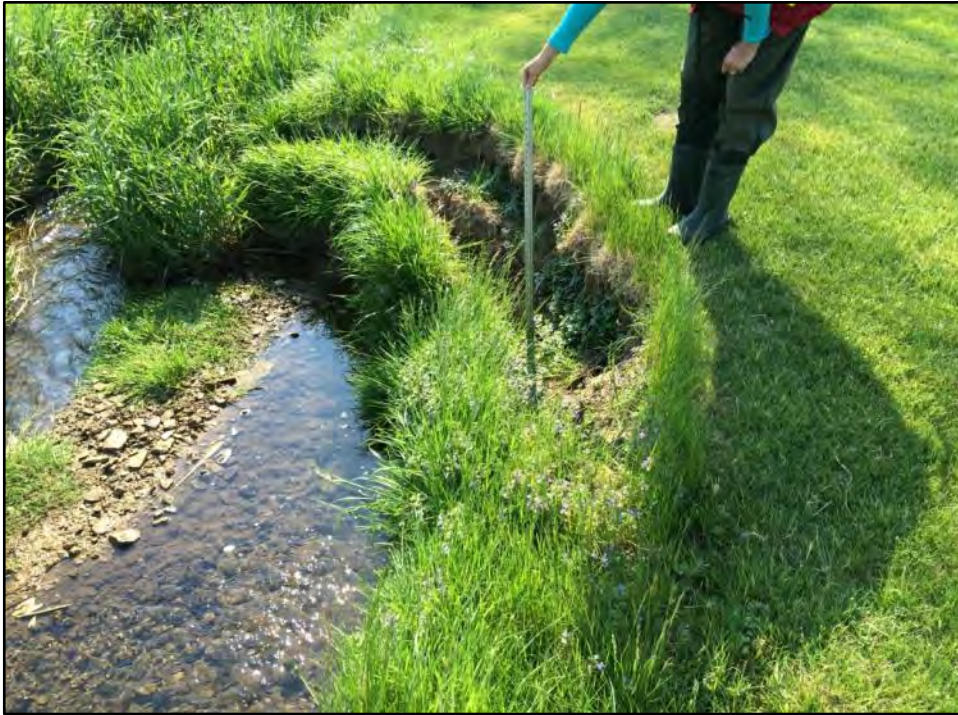
50. E-T1-3 Manicured lawn next to putting green is slumping.

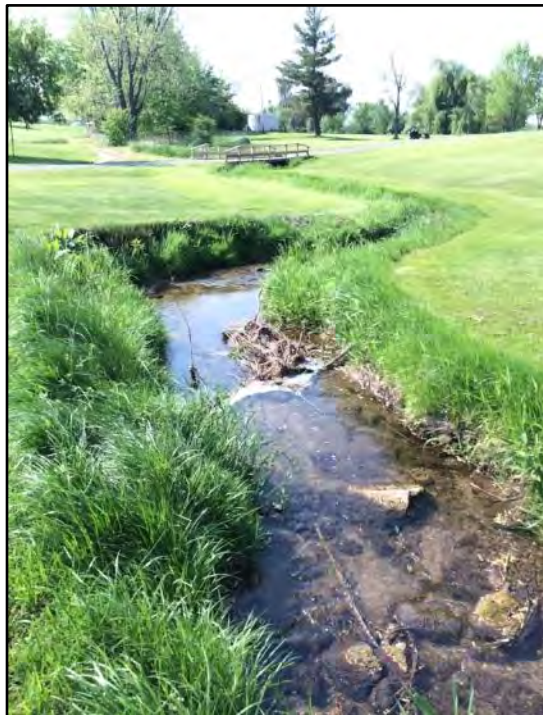
51. E-T1-3 riparian zone decreases in width.

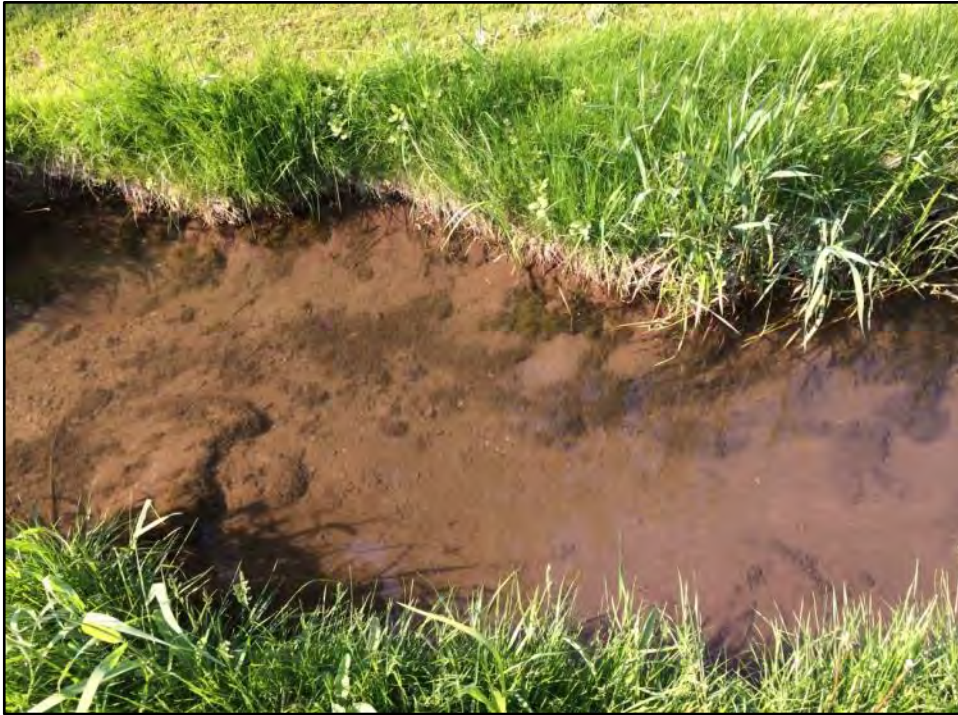
52. E-T1-3 Silt accumulation in multiple areas of the channel.

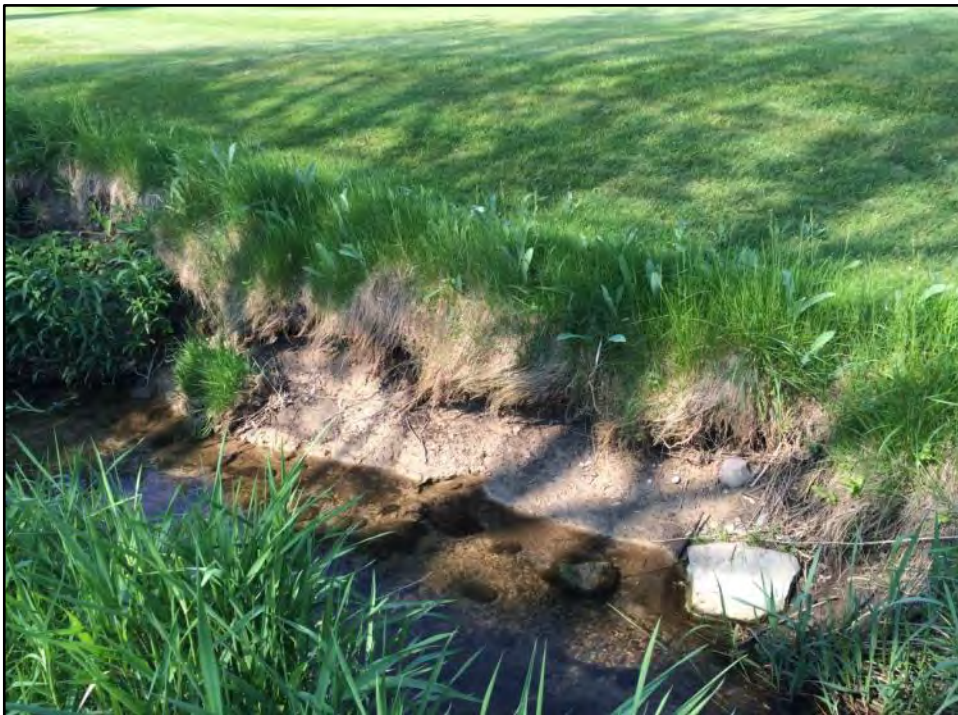
53. E-T1-3 Area of active erosion in areas lacking riparian buffer.

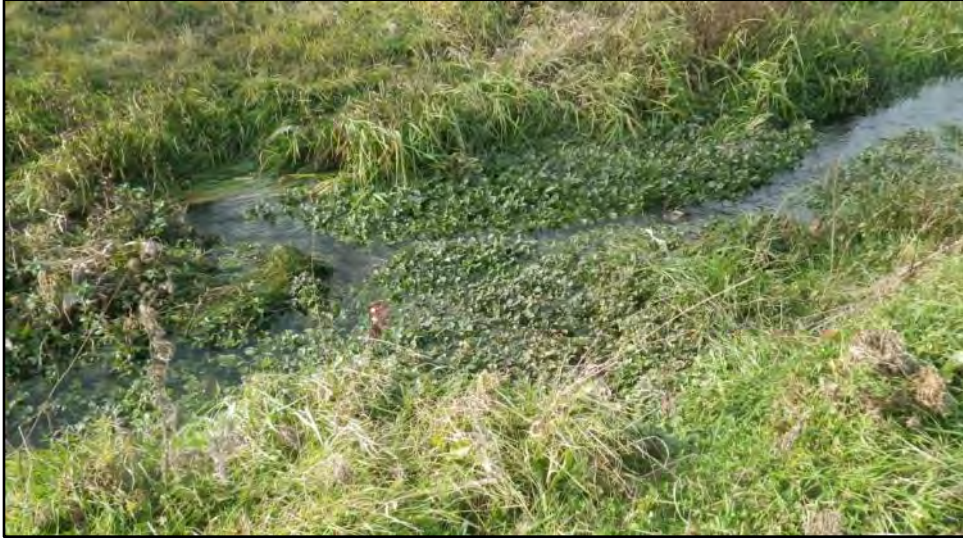
54. E-T1-2 Dense emergent aquatic vegetation, including algae (not seen in photograph).

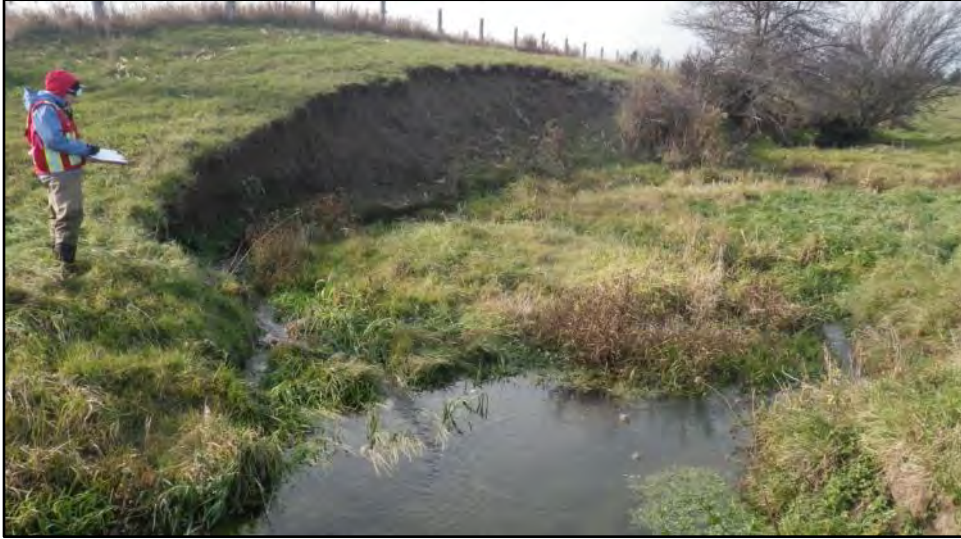
56. E-T1-2 Flow splits due to large island formation in center of channel.

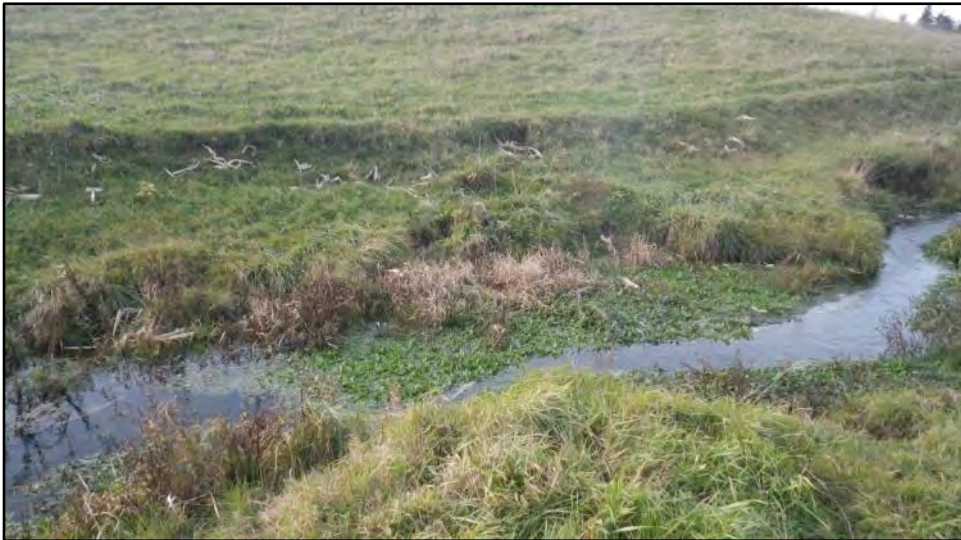
57. E-T1-2 Channel wetted width varies throughout reach.

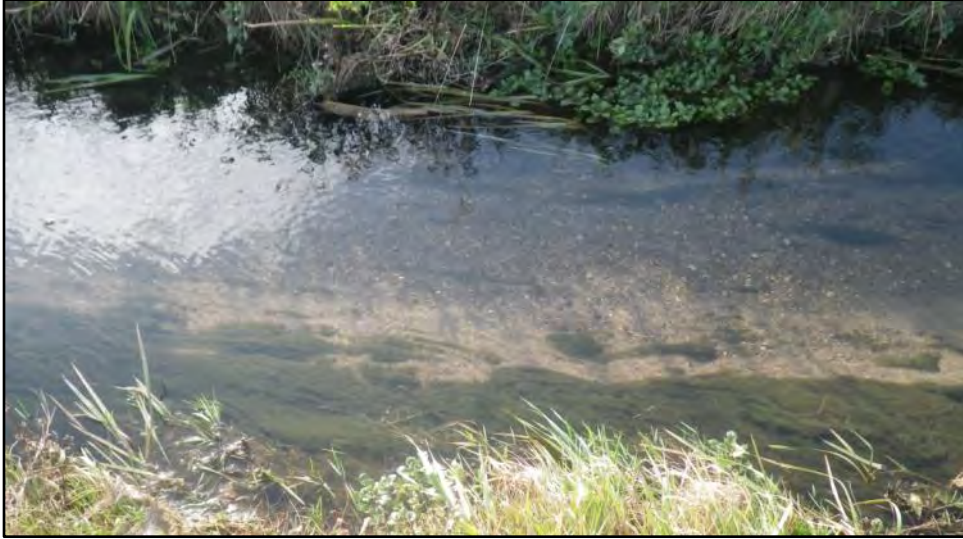
58. E-T1-2 Substrate upstream is more firm consisting of sands and gravel, as opposed to silt downstream.

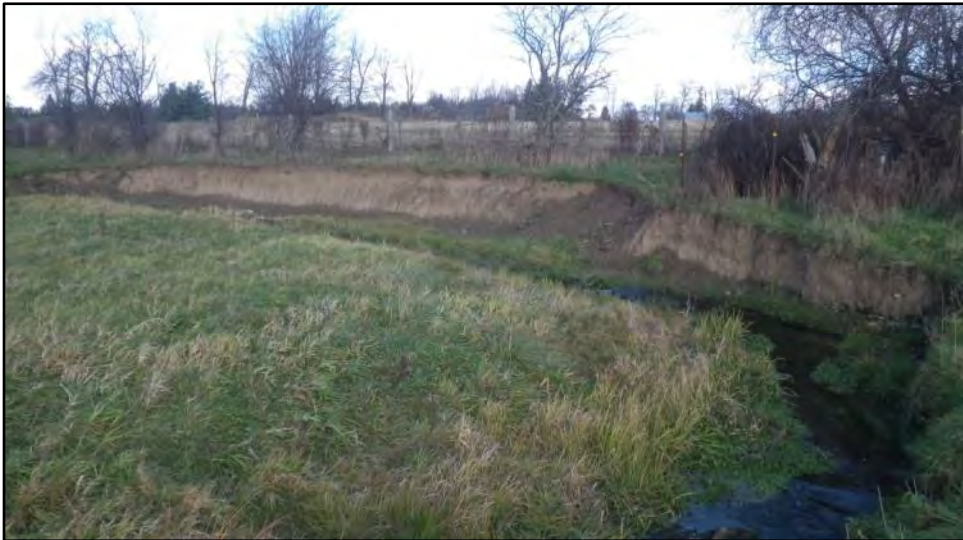
59. E-T1-2 Long eroding exposed bank face at upstream extent of reach walk. Bank height approximately 1.5-2m in height.

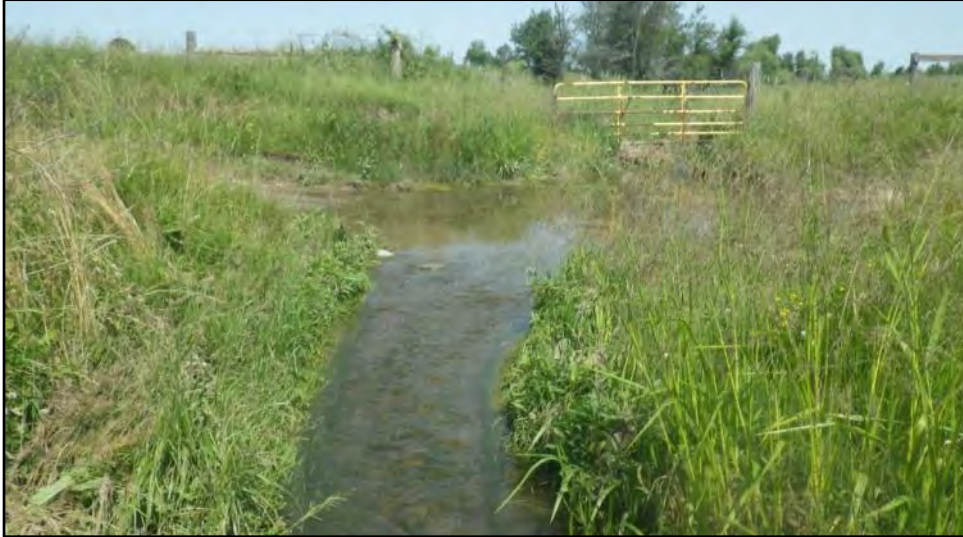
74. E-T1-1 Channel crossing farm lane with no CSP.

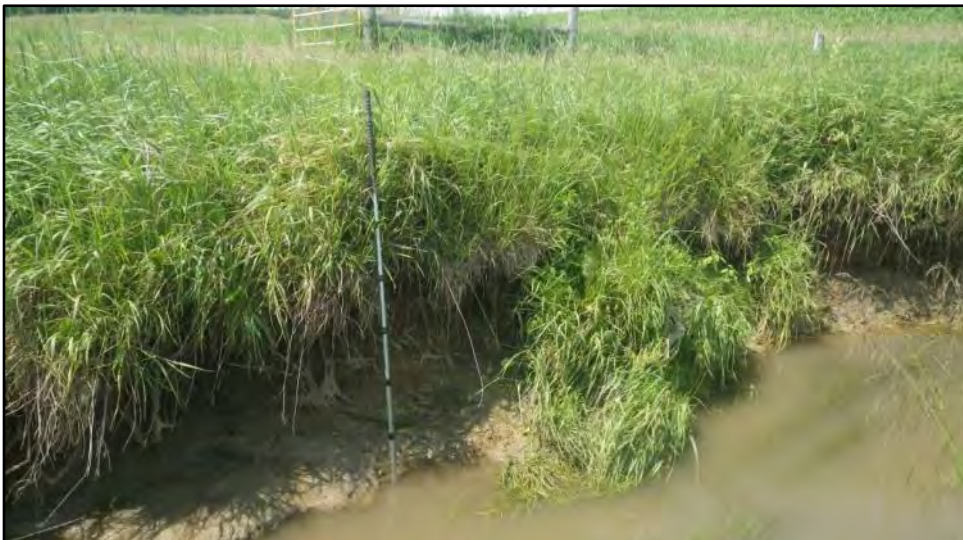
75. E-T1-1 Active erosion and undercutting on outside bend of reach downstream of farm lane.
