Appendix F

Stream Morphology

Project: Premier Gateway SWS: HT-1 Detailed Site

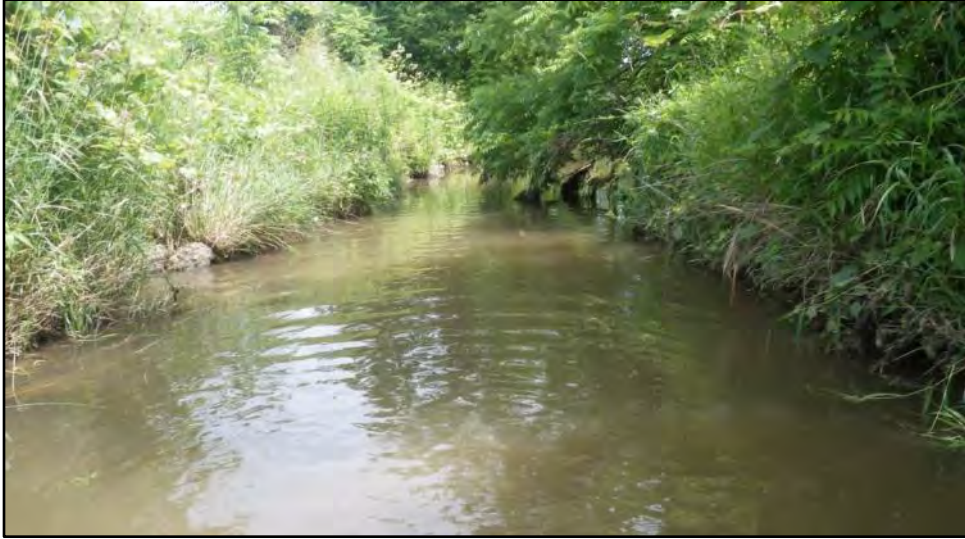
76. T1 Low gradient and slow moving flow with slight erosion on banks hidden by overhanging vegetation.

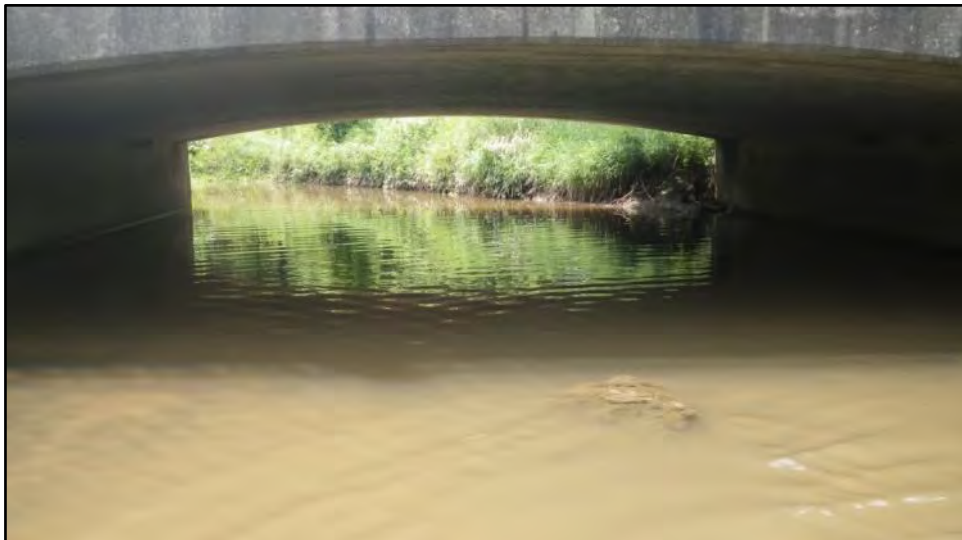
77. T1 Bridge crossing is quite low with major siltation underneath the structure.

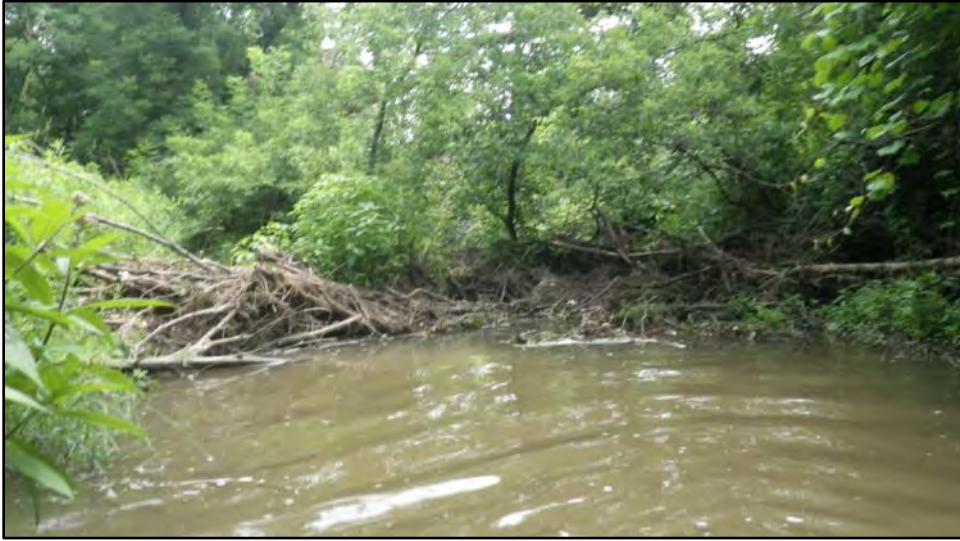
78. T1 Woody debris jam.

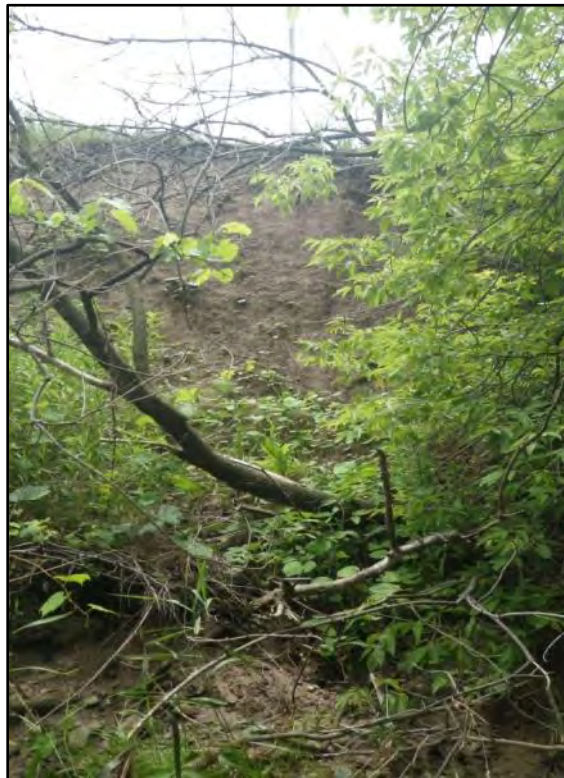
79. T1 Erosion being experienced on embankment that meets road. Some places embankment has become concave (not shown in photograph).

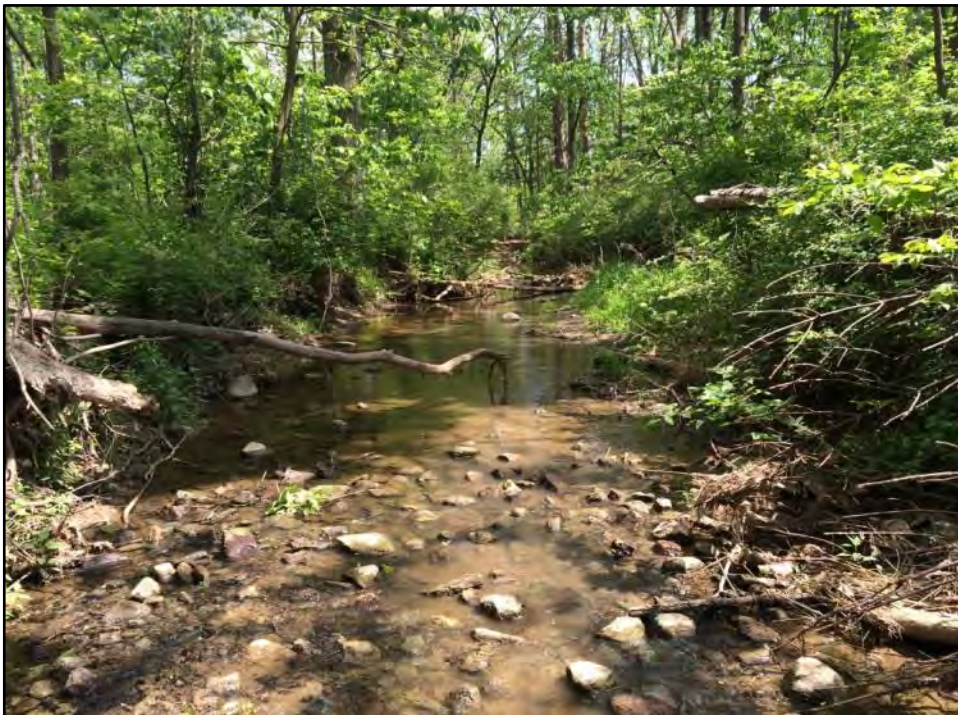
80. HT-2a-2 Erosion and undercutting along right bank. Two small riffle in channel just upstream of double box culvert at Trafalger Rd.

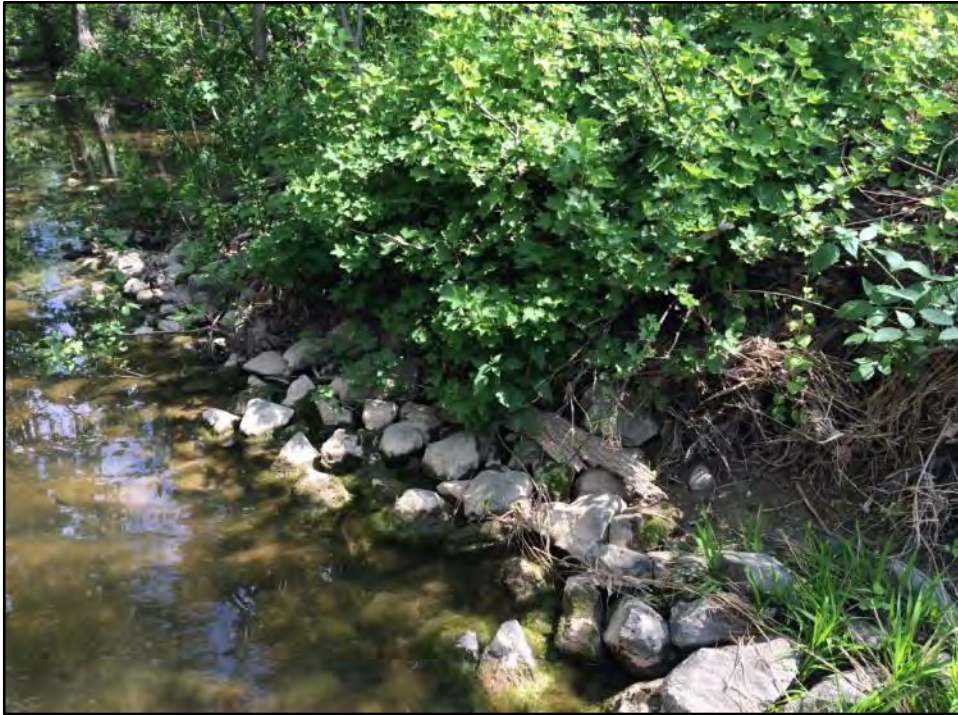
81. HT-2a-2 Erosion along both banks with leaning trees over channel (elevated). Large angular riffle material.

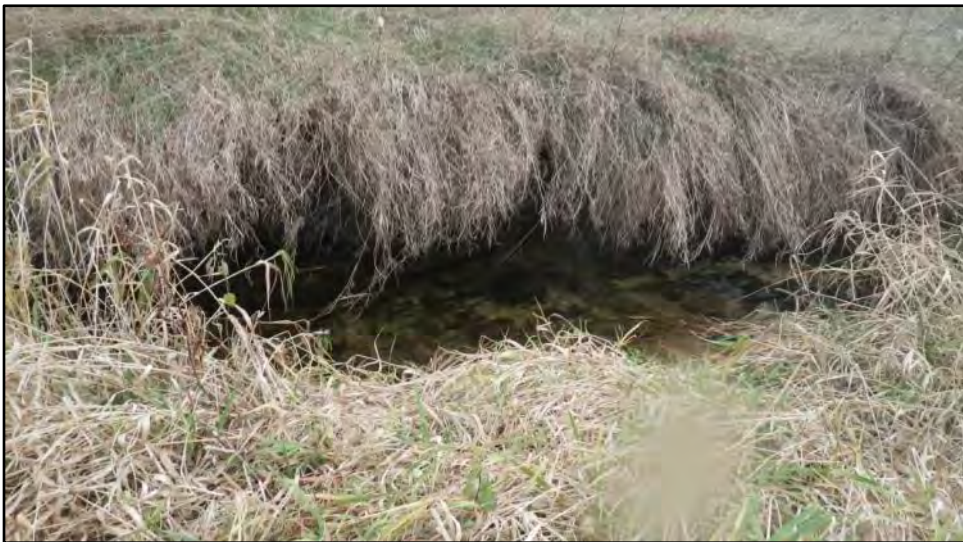
86. HT-2a-1 Exposed clay along bed at toe of bank.

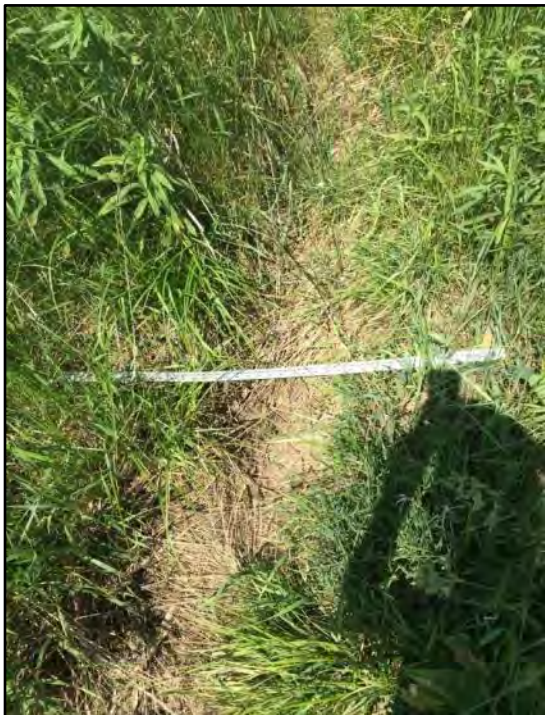
88. HT-2b-3 Dry at time of visit, localized depression on an agricultural property.

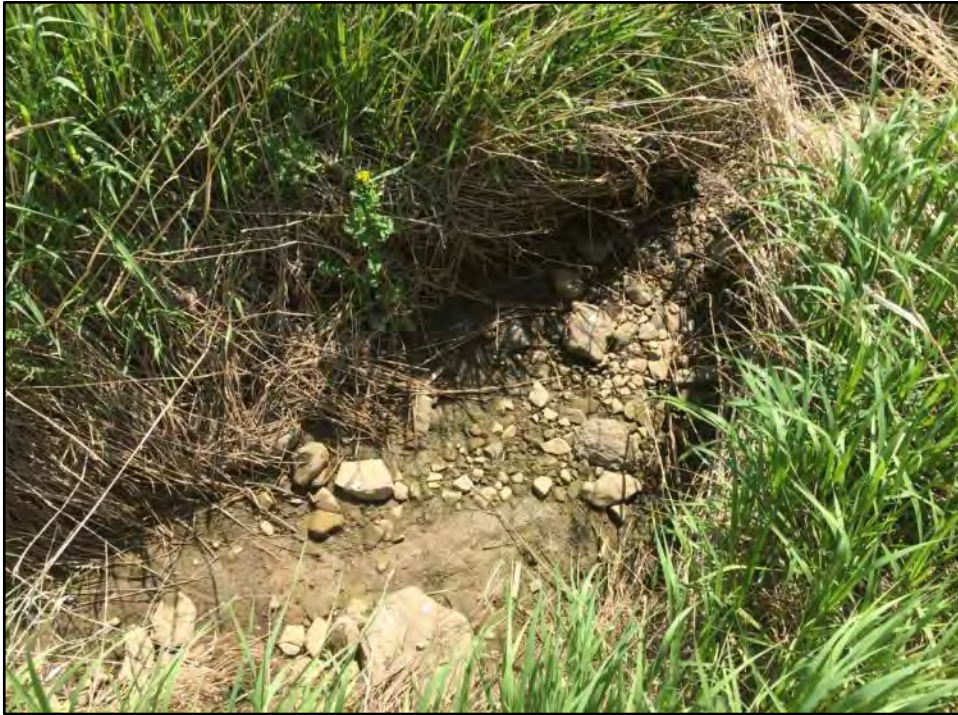
89. HT-2b-3 Depression is approximately 0.5m in width and 0.15m in depth.

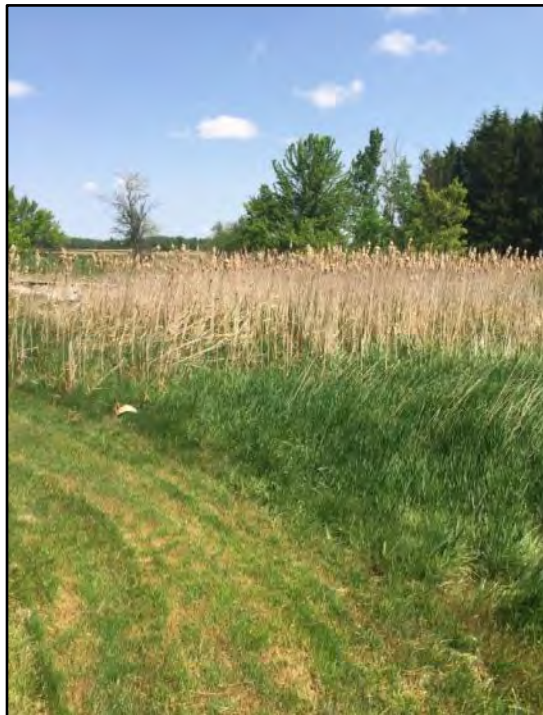
90. HT-2b-2 Feature dry but well defined with signs of riffle features.

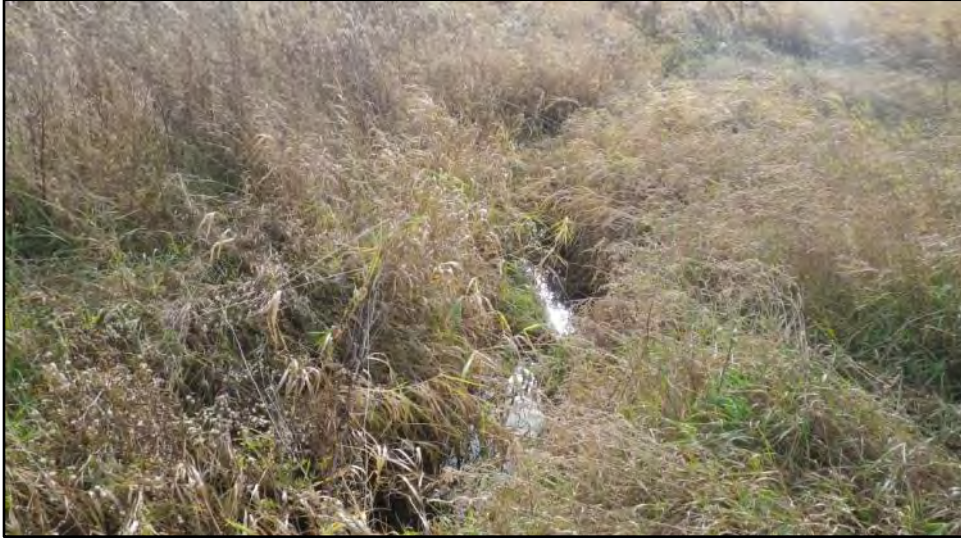
91. HT-2b-2 Feature disperses into cattail marsh.

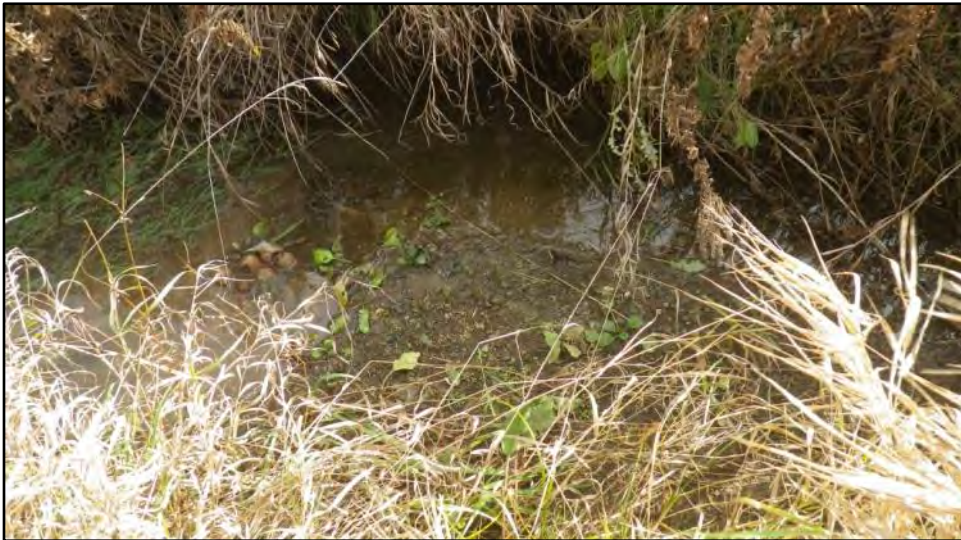
92. HT-2b-1 Narrow channel with dense overhanging grasses.

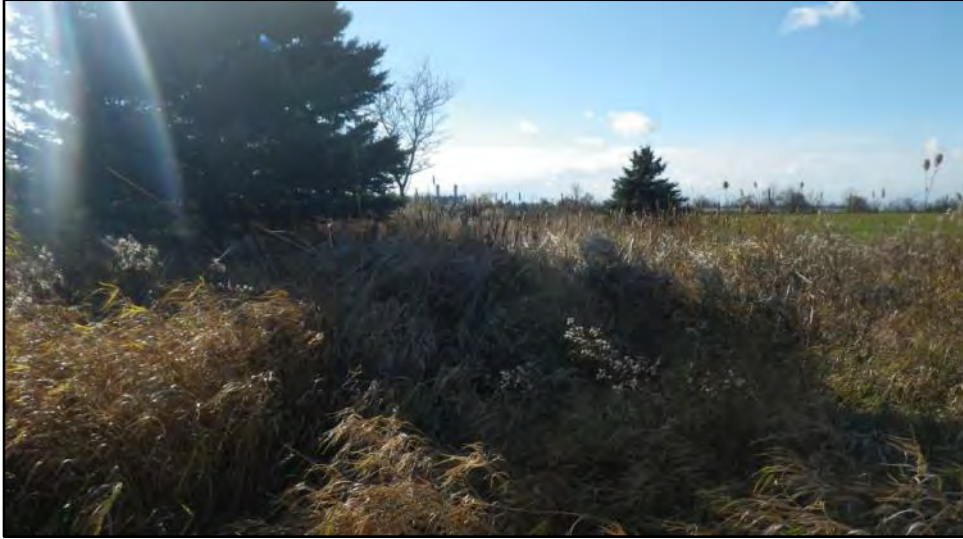
93. HT-2b-1 Lateral bar formation on right bank. Primarily consisting of 1cm particles, pebbles and fine.

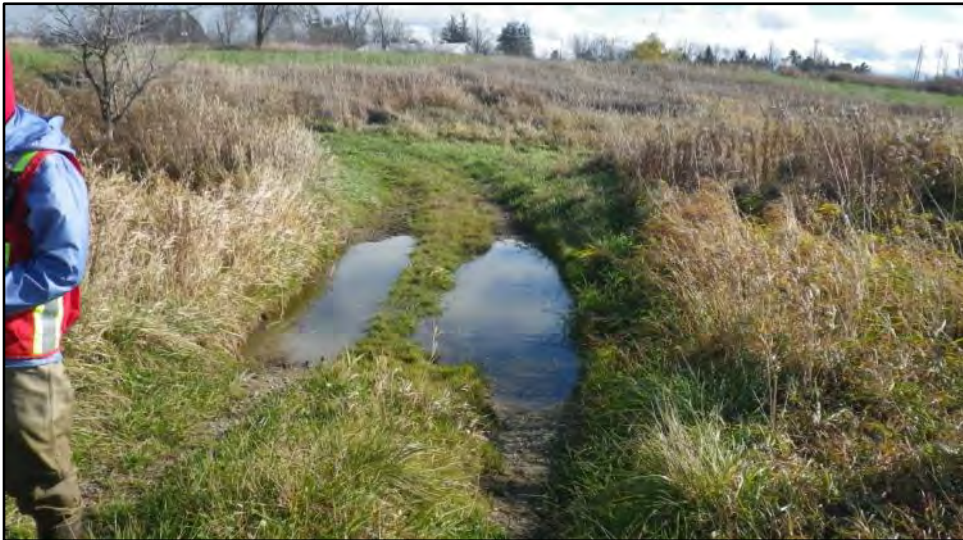
94. HT-2b-1 Channel becomes undefined through cattail patch.

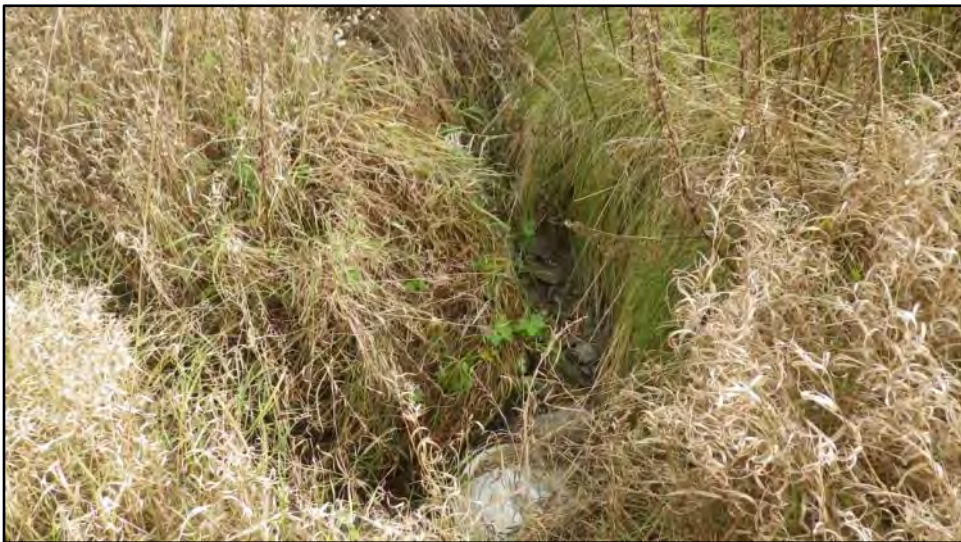
96. HT-2b-1 Severe undercutting found at parts of the reach. Up to 0.30m of undercutting observed.

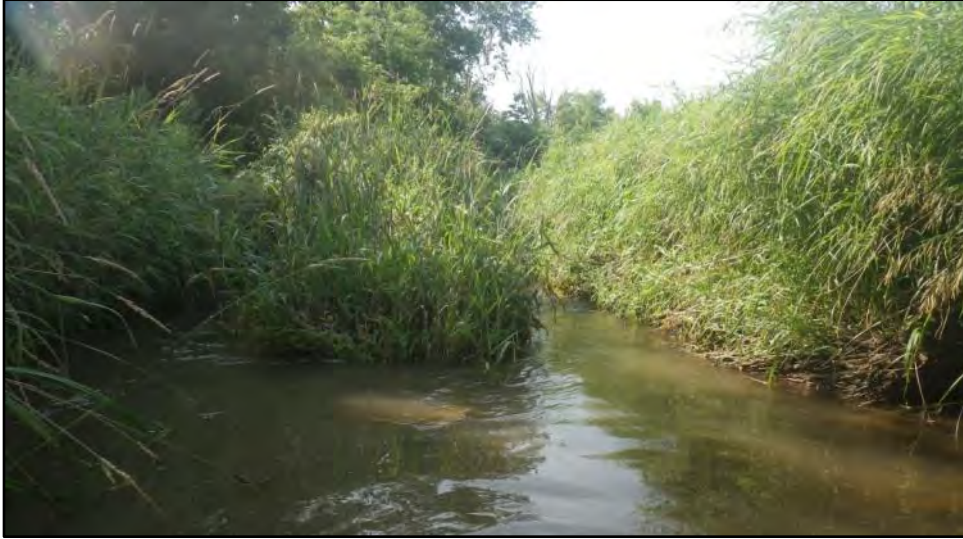
111. HT-1 Cross-section facing downstream

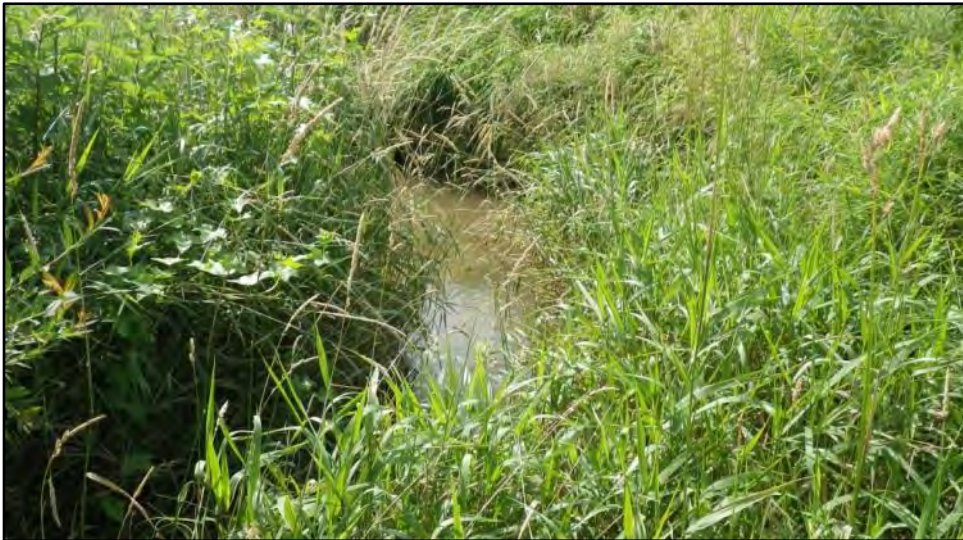
112. HT-1 Material that has slumped off bank has created island causing the flow to split.

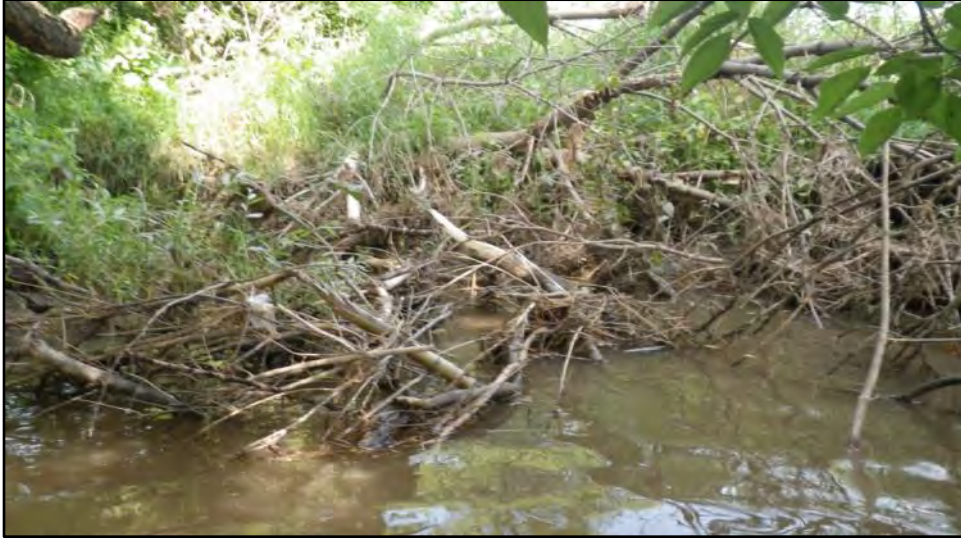
113. HT-1 Channel narrows in multiple areas to a wetted width of approximately 1m.

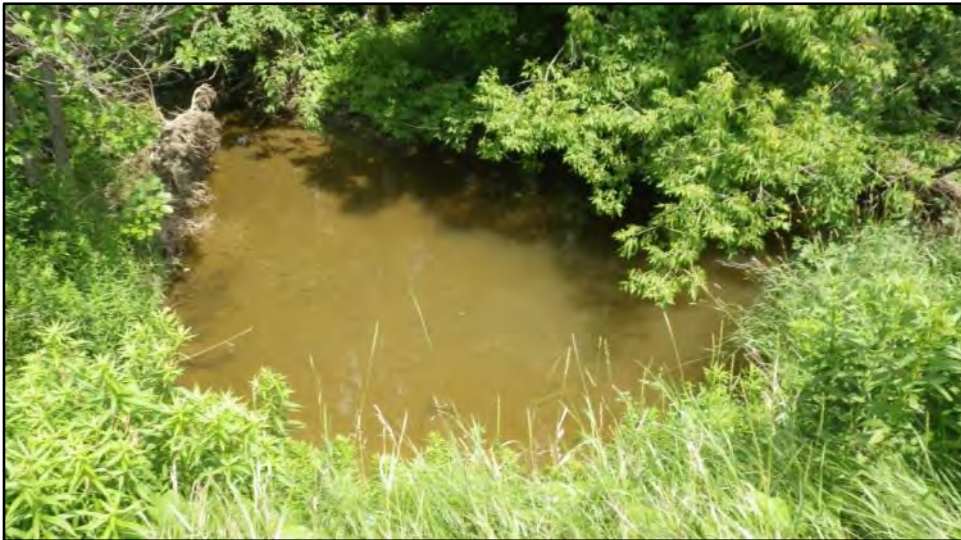
114. HT-1 Woody debris causing obstacles for regular flow patterns.

115. HT-1 downstream extent of reach is more sinuous than further upstream. Bends become over widened with evidence of planform adjustment.

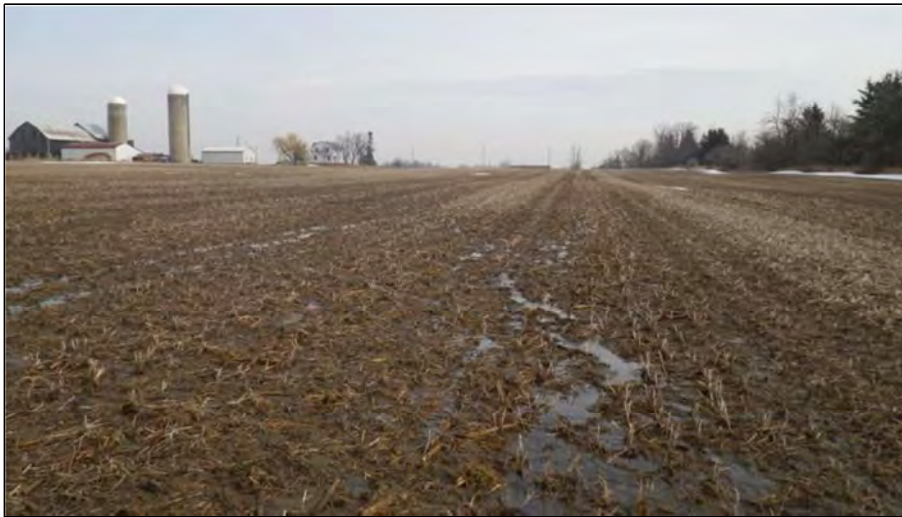
5. **HT -2b -3b.** Area where feature would be located facing upstream. Feature type is swale, flow condition is dry. **Management recommendation: No Management**

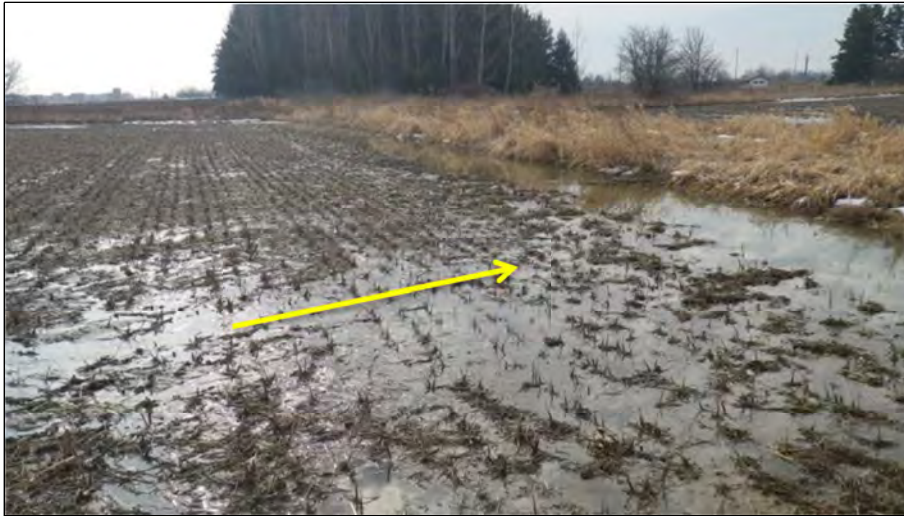
8. **HT -2b -3a.** Approaching downstream end, facing upstream. Flow becomes more defined as it approaches confluence with HT -2b -3. Feature type is swale and flow condition is standing water.

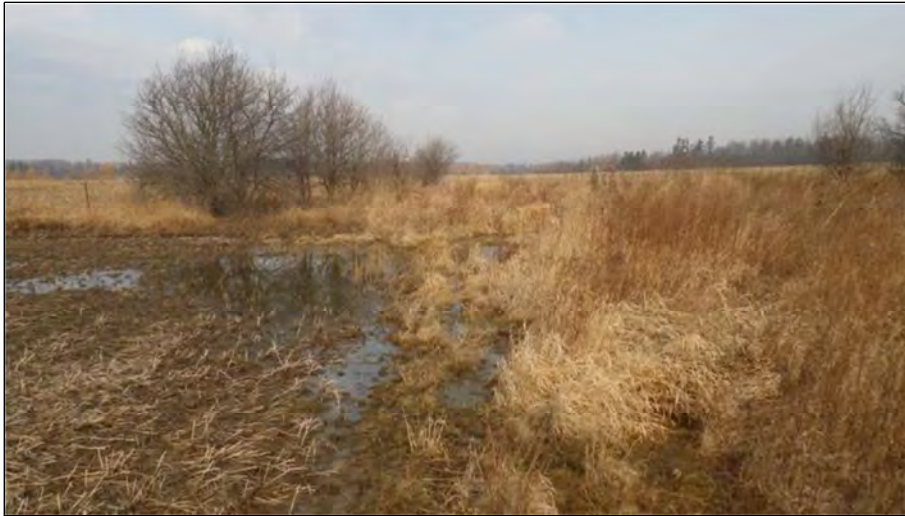
10. **HT -2b -3a.** Facing upstream in vicinity of feature. No depression was visible. Flow condition was no surface water and feature type was swale. **Management Recommendation: No management required.**

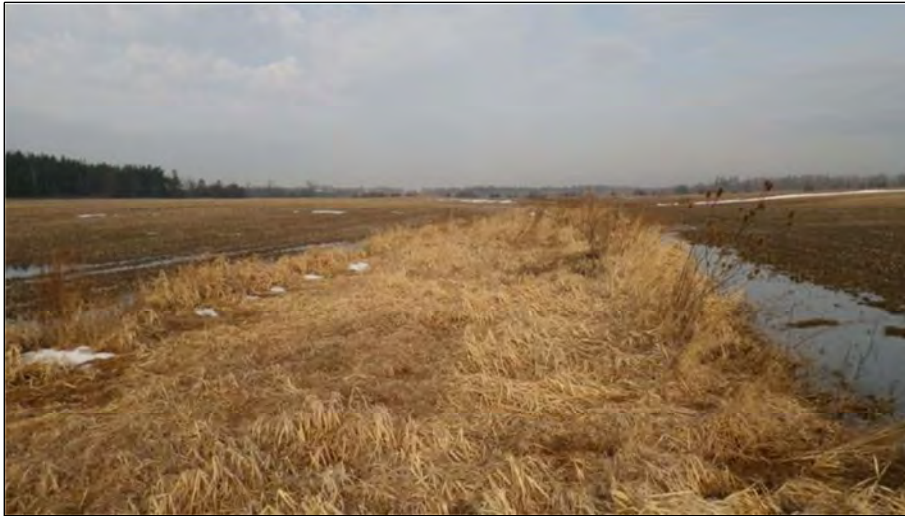
14. HT -2b -3. Near downstream end of feature, facing upstream. Flow is more spread out over flatter area. Feature type is no defined feature (overland flow only) and flow condition is surface flow minimal.

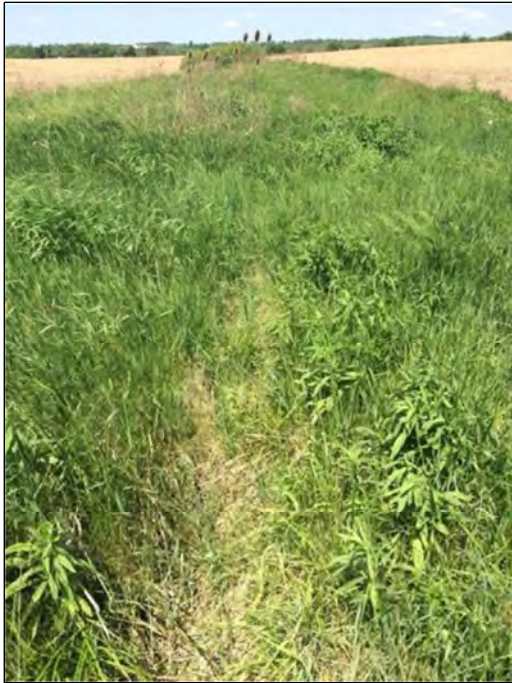
16. HT -2b -3. Near upstream end of feature, facing upstream. Vegetated buffer area between two crop fields. Feature type is no defined feature (overland flow only) and flow condition is no surface water.

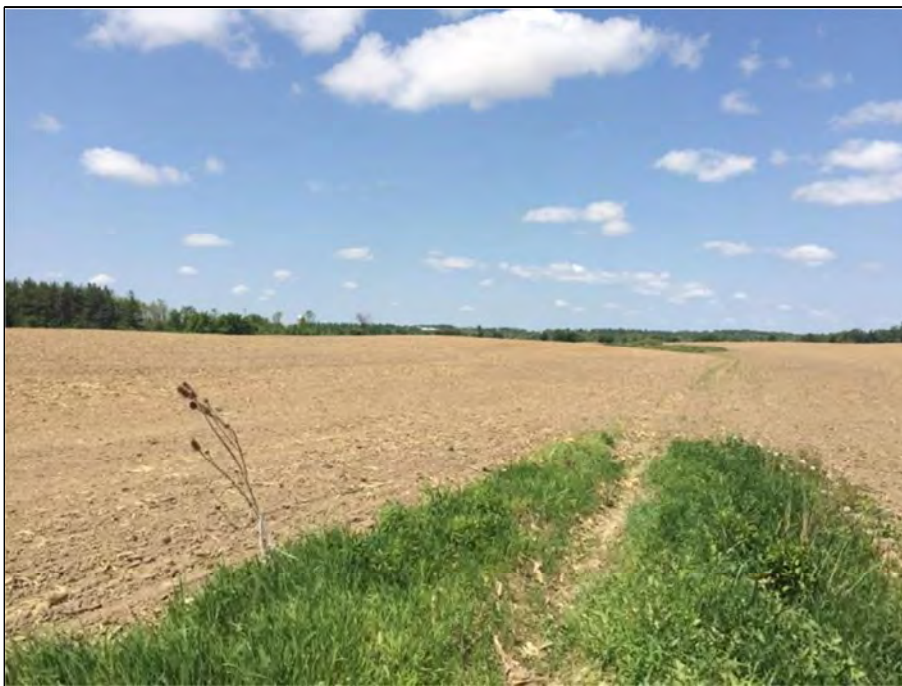
17. HT -2b -3. Facing upstream, within vegetated area. Note narrow depression in center of photo. Feature type is no defined feature (overland flow only) and flow condition is no surface water.

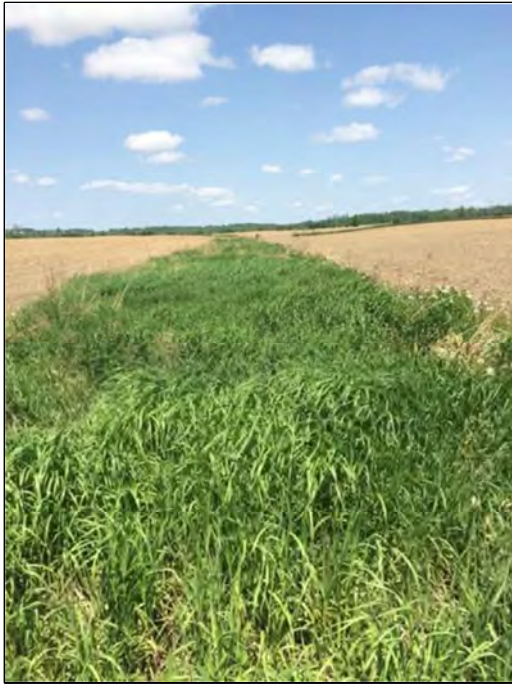
18. HT -2b -3. Facing upstream, near downstream end of feature. Feature type is no defined feature (overland flow only) and flow condition is no surface water.

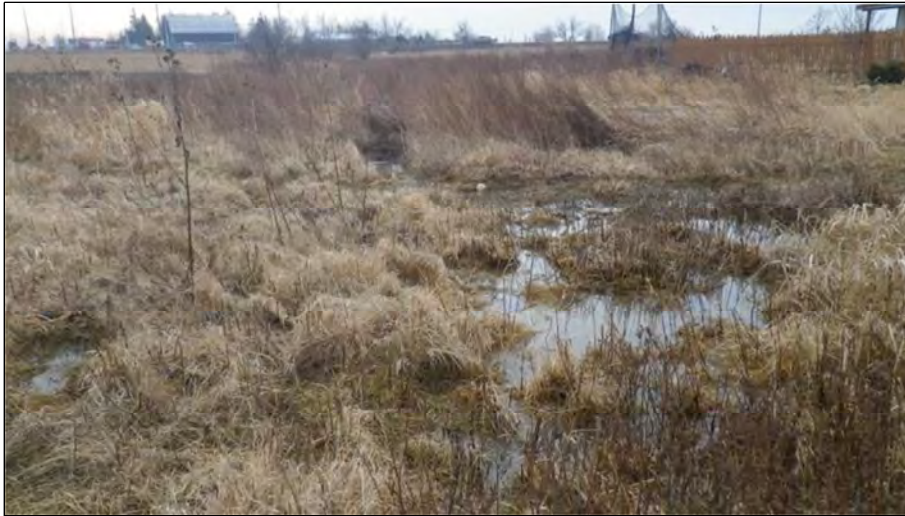
20. **HT -2b -2 (Segment 1).** At upstream end of feature where water flows off agricultural fields upstream. Maximum water depth was at upstream end where water was pooling in several locations (max depth approx. 20cm). Feature type is multi -thread and flow condition is surface flow substantial.

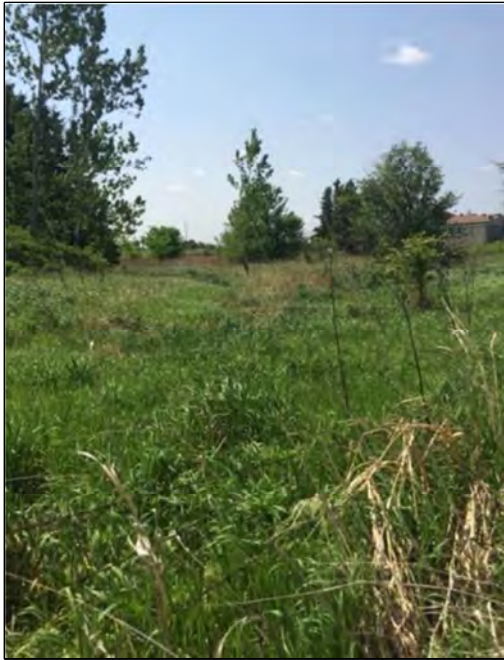
22. HT -2b -2 (Segment 1). Facing upstream at downstream end of Segment. Multiple poorly defined flow paths upstream of small pedestrian boardwalk on property. Feature type is multi -thread and flow condition is surface flow substantial.

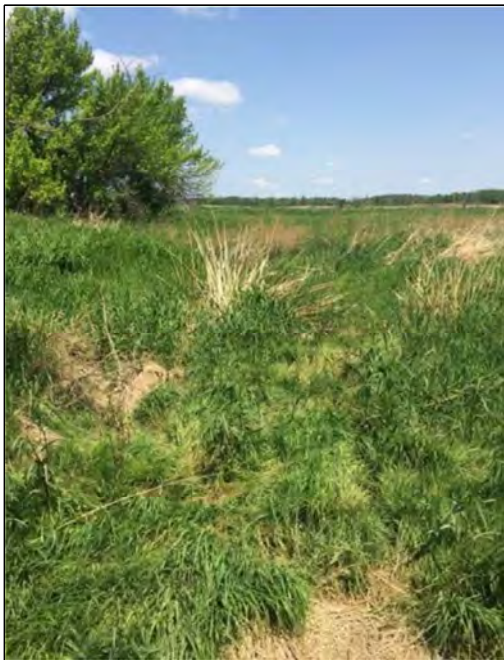
23. HT -2b -2 (Segment 1). Upstream end of feature, facing downstream from property boundary. No defined depression or flow path, no water present. Feature type is multi -thread and flow condition is no surface water.

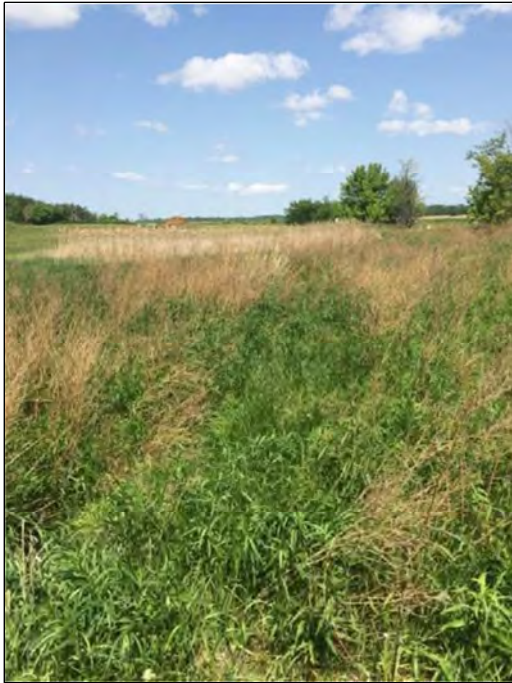
24. HT -2b -2 (Segment 1). Facing upstream within feature. Note dead grass patches indicating previous flow paths. Feature type is multi -thread and flow condition is no surface water.

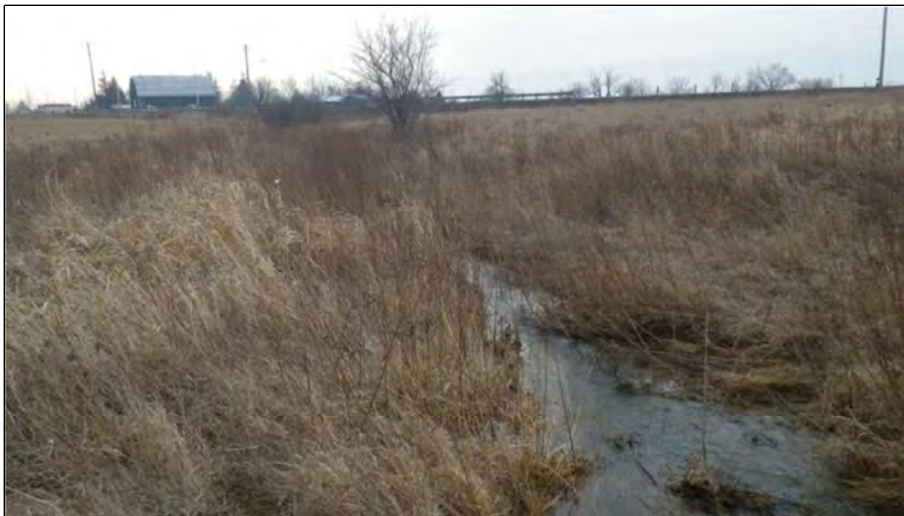
- 25. HT -2b -2 (Segment 1).** Facing upstream from downstream end of Segment towards area of wetland vegetation (cattails). Numerous depressions indicative of multi -thread flow during spring freshet. Feature type is multi -thread and flow condition is no surface water. **Management Recommendation: Conservation (based on riparian vegetation)**

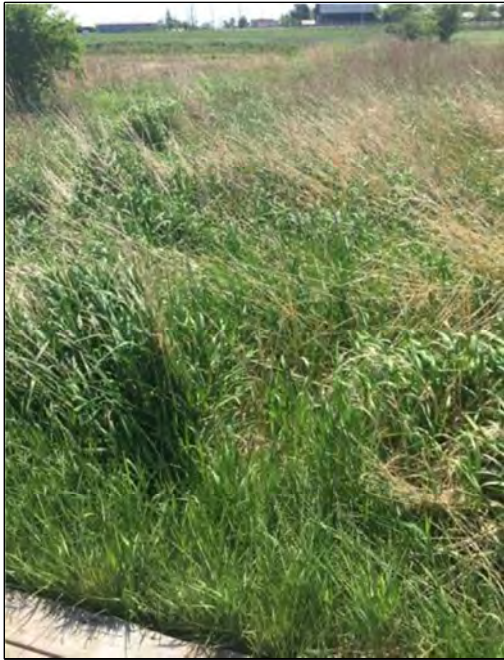
28. HT -2b -2 (Segment 2). Facing downstream at end of Segment. Feature type is swale and flow condition is surface flow substantial.

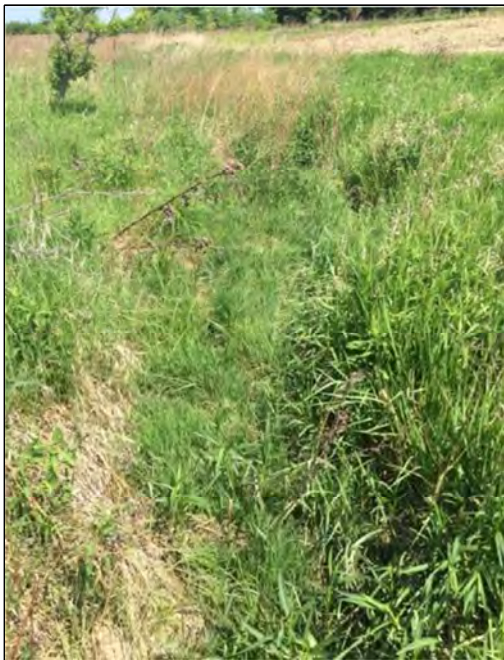
29. HT -2b -2 (Segment 2). Upstream end of Segment located at small boardwalk. Visible depression through this Segment. Feature type is swale and flow condition is no surface water.

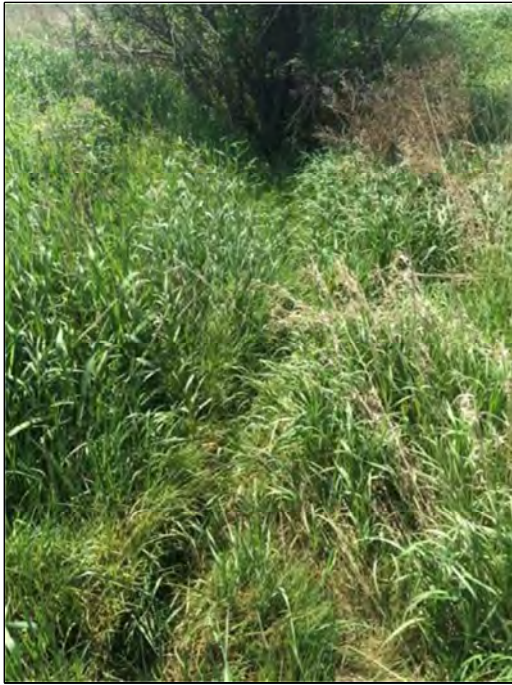
30. HT -2b -2 (Segment 2). Within Segment, facing upstream. Note dead grass indicative of swale depression. Feature type is swale and flow condition is no surface water.

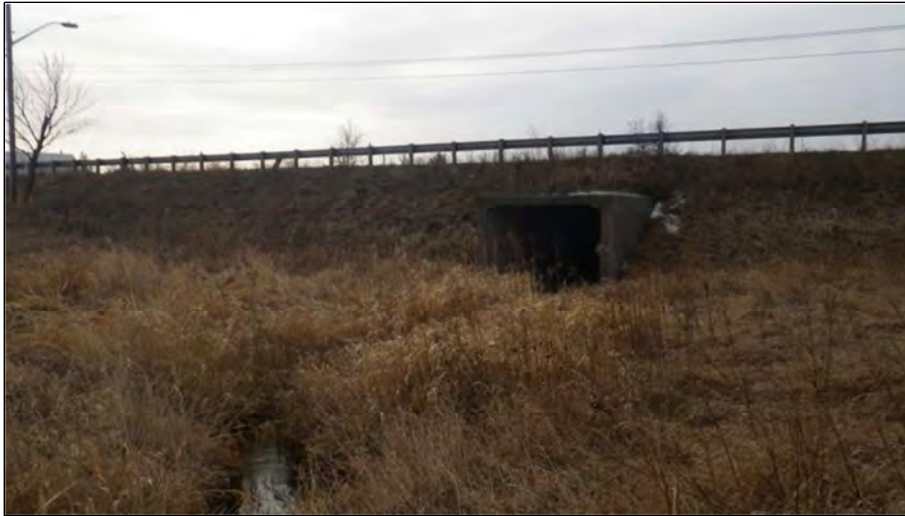
32. HT -2b -2 (Segment 3). Upstream end of Segment where feature transitions into feature type defined natural channel (visible banks). Flow condition is surface flow substantial.

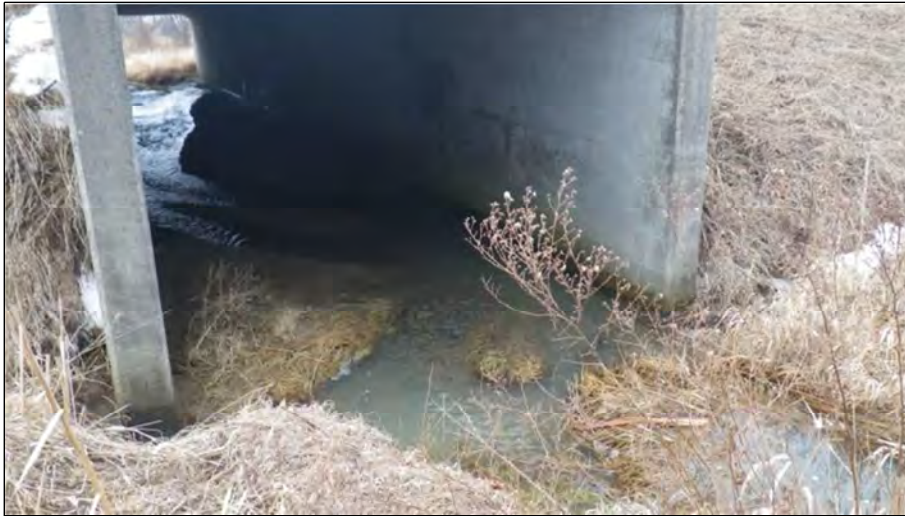
34. HT -2b -2 (Segment 3). Facing downstream to culvert at Trafalgar Road, note well -defined channel banks. Feature type is defined natural channel (visible banks); flow condition is surface flow substantial.

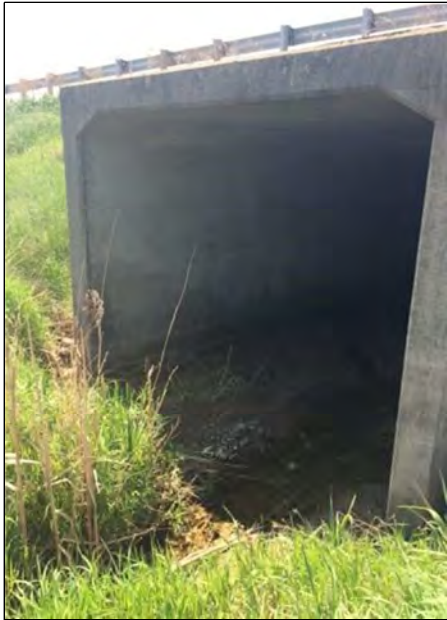
40. HT -2b -2 (Segment 3). Standing water was only noted at downstream end of Segment immediately upstream of culvert. Feature type is defined natural channel (visible banks); flow condition is no surface water.

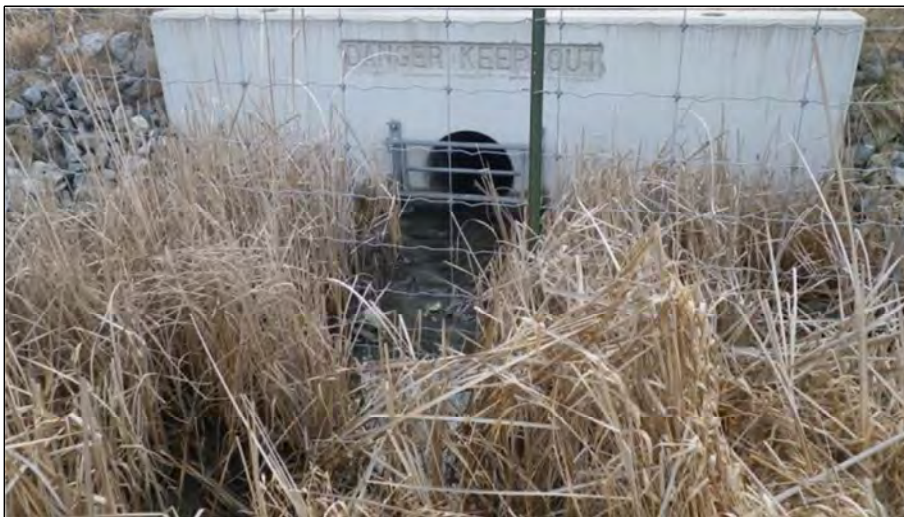
41. HT -2b -2 (Segment 3). Standing water in culvert, downstream end of Segment. Feature type is defined natural channel (visible banks); flow condition is no surface. **Management Recommendation: None. Feature is classified as a Watercourse**

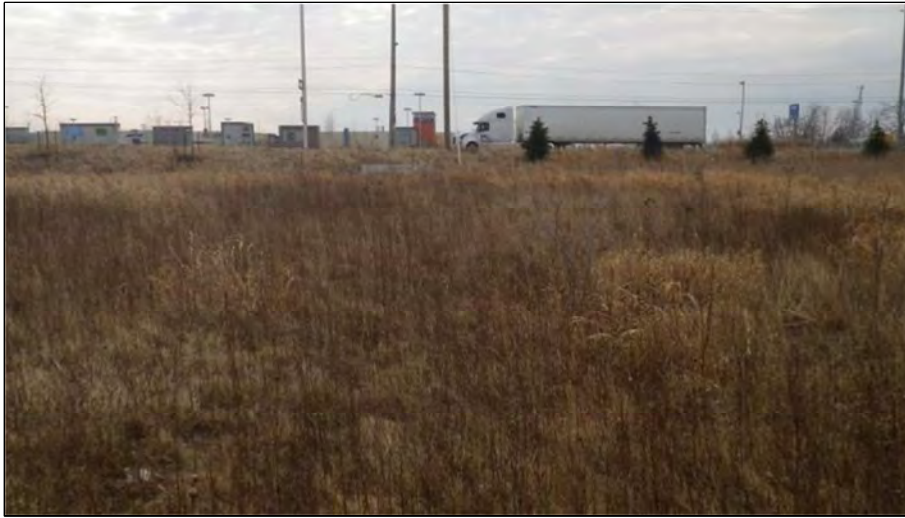
42. HT -2b -4 (Segment 1). Culvert at Steeles Avenue upstream end of feature. Feature type is no defined feature (overland flow only); flow condition was standing water.

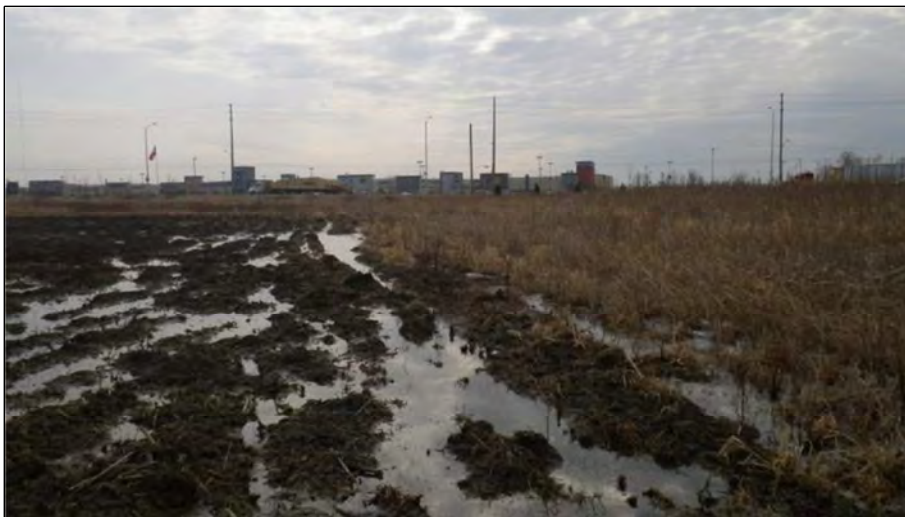
43. HT -2b -4 (Segment 1). Facing upstream towards Steeles Avenue. Lack of flow or well -defined single flow path. Feature type is no defined feature (overland flow only) and flow condition is standing water.

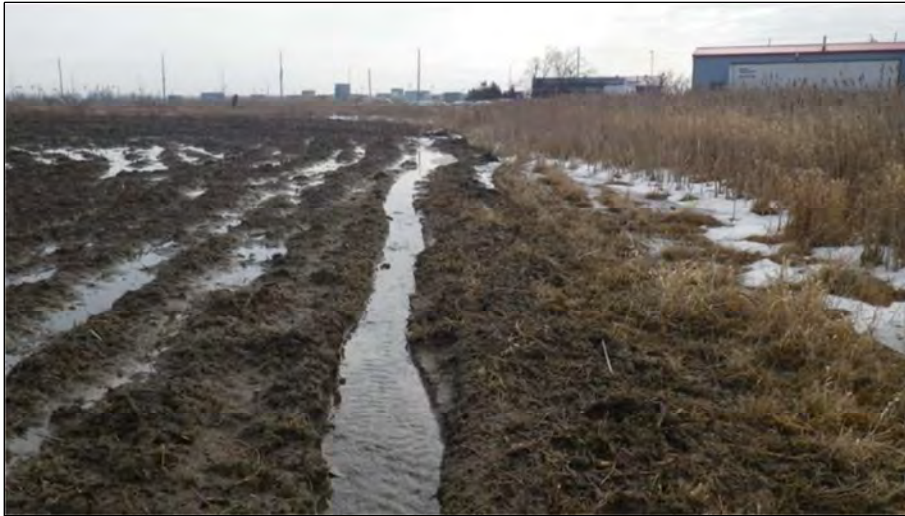
44. HT -2b -4 (Segment 1). Standing at base of agricultural field where water had ponded facing Steeles Avenue. Feature type is no defined feature (overland flow only) and flow condition is standing water.

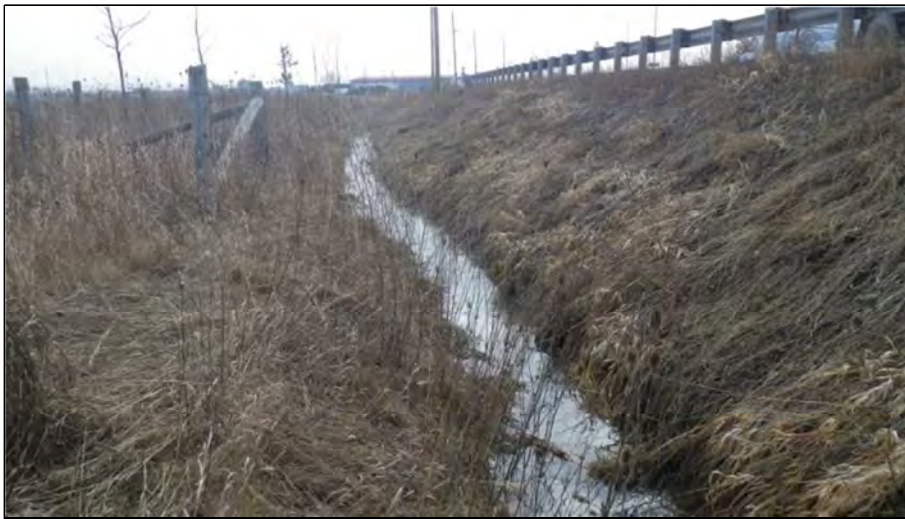
47. HT -2b -4 (Segment 1). Facing upstream, ponded water draining off the fields toward roadside ditch. Feature type is no defined feature (overland flow only); flow condition standing water.

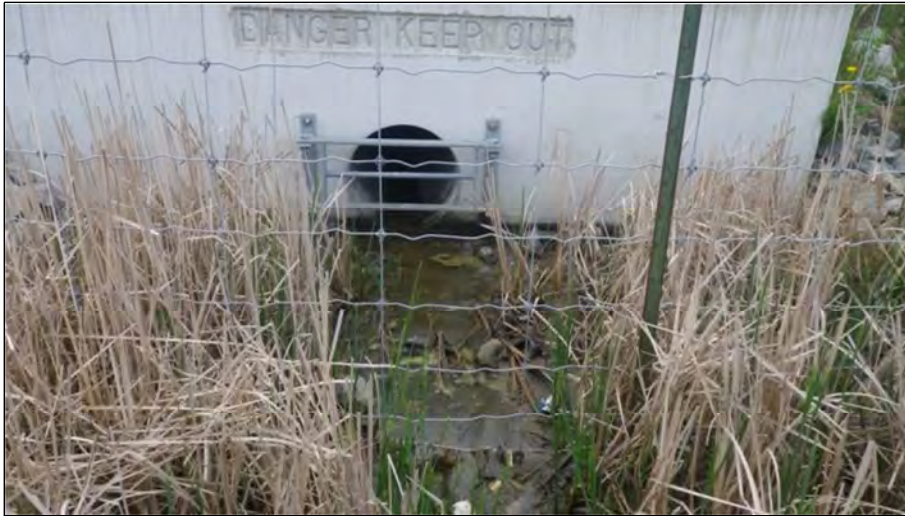
48. Roadside ditch along Trafalgar adjacent HT -2b -4 (Segment 1). Standing water.

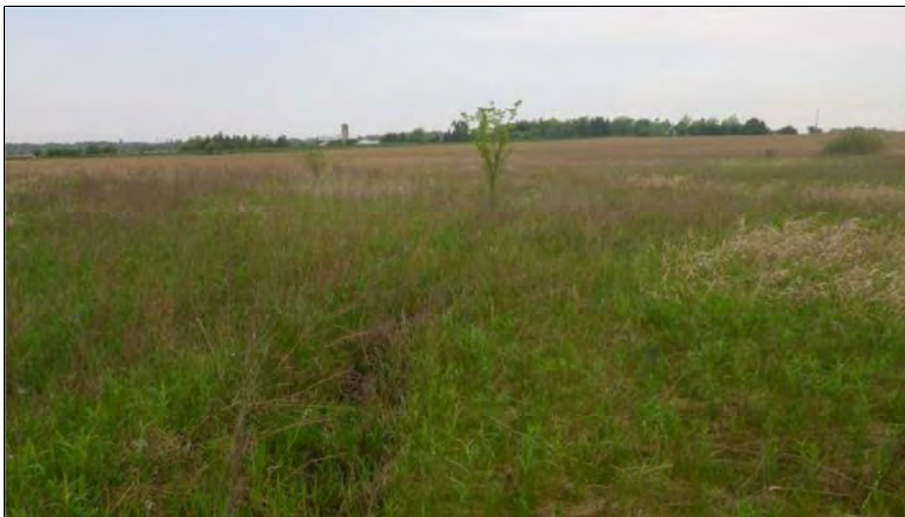
49. HT -2b -4 (Segment 1). Upstream end of feature at Steeles Avenue culvert. Standing water was noted at the culvert only, and not within feature. Feature type is no defined feature (overland flow only); flow condition is no surface water.

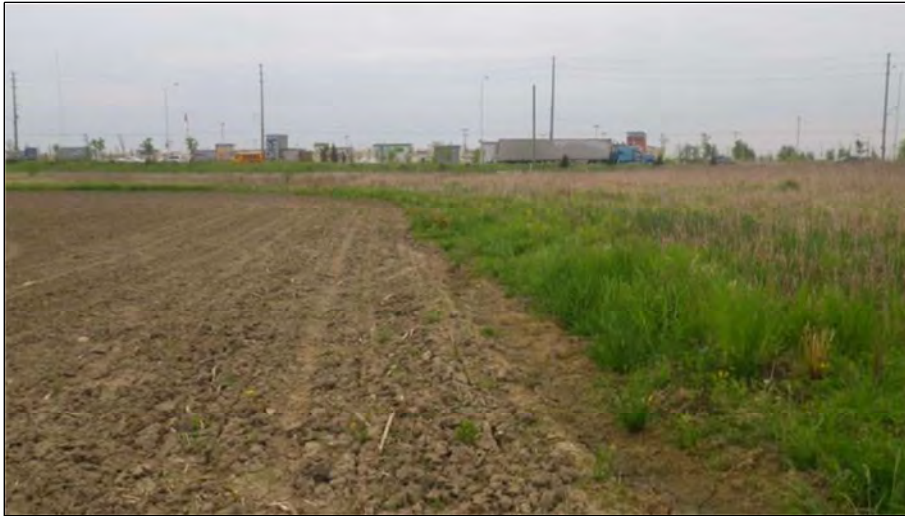
50. HT -2b -4 (Segment 1). Facing downstream towards agricultural fields. Several depressions no singular flow path. Feature type is no defined feature (overland flow only); flow condition is no surface water.
