Appendix F

Stream Morphology

Project: Premier Gateway SWS: HT-1 Detailed Site

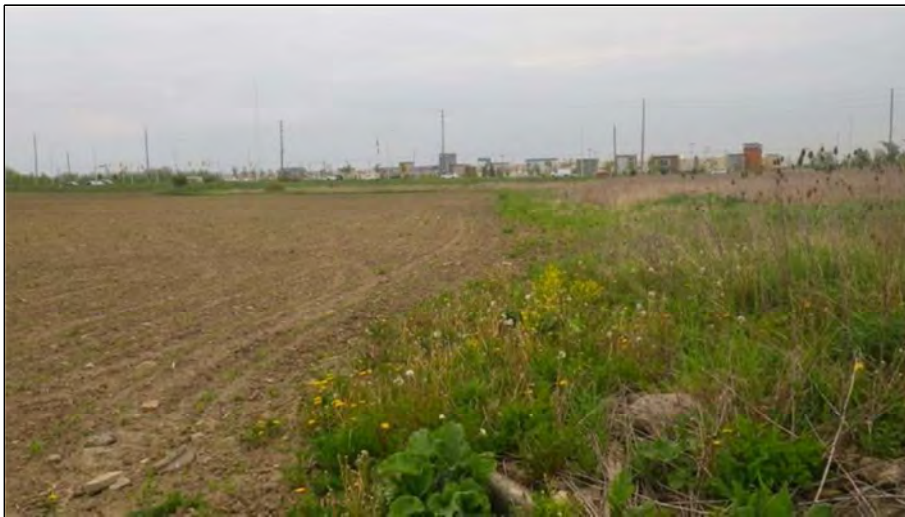
51. HT -2b -4 (Segment 1). Facing upstream towards Steeles Avenue from agricultural field. Feature type is no defined feature (overland flow only); flow condition is no surface water.

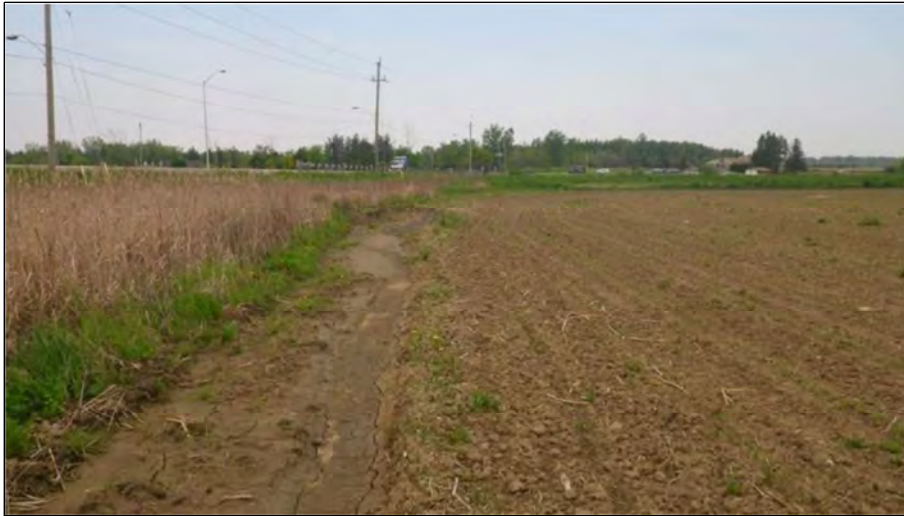
52. HT -2b -4 (Segment 1). Facing upstream towards Steeles Avenue in agricultural field. Feature type is no defined feature (overland flow only); flow condition is no surface water.

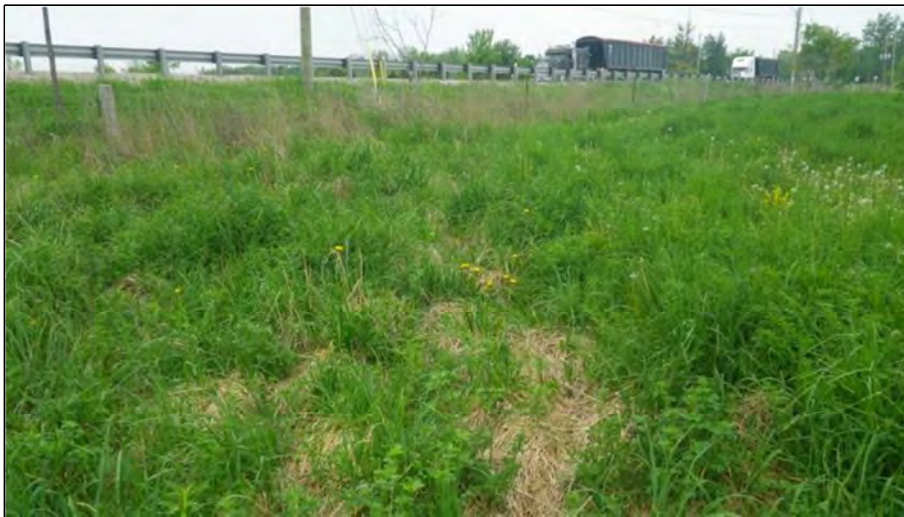
53. HT -2b -4 (Segment 1). Facing downstream towards Trafalgar Road where water was ponded during first visit. Feature type is no defined feature (overland flow only), flow condition is no surface water.

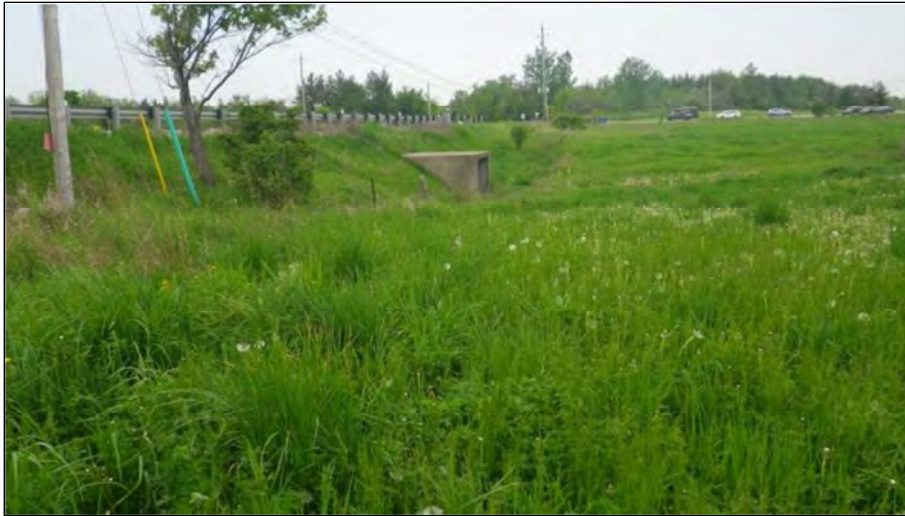
54. HT -2b -4 (Segment 1). Facing downstream towards Trafalgar Road where water drains off agricultural field towards roadside ditch. Feature type is no defined feature (overland flow only), flow condition is no surface water.

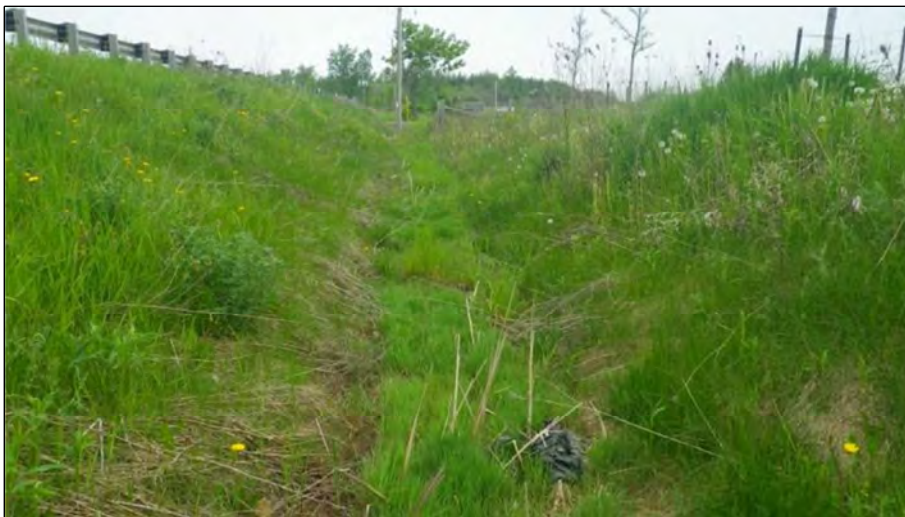
55. HT -2b -4 (Segment 1). Facing downstream towards Trafalgar Road, feature drains toward roadside ditch. During this visit no defined depression noted through this area. Feature type is no defined feature (overland flow only) and flow type is no surface water.

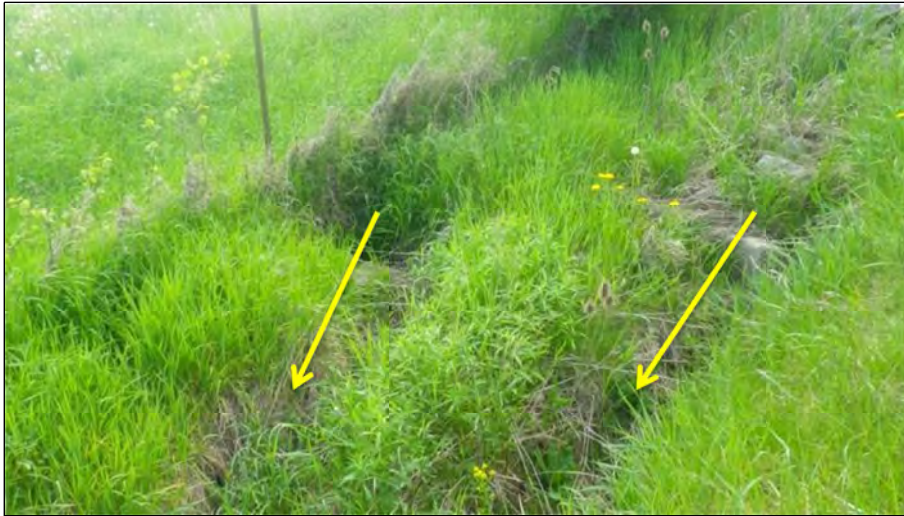
56. Roadside ditch adjacent to **HT -2b -4**, facing downstream towards Trafalgar Road culvert. Feature was dry.

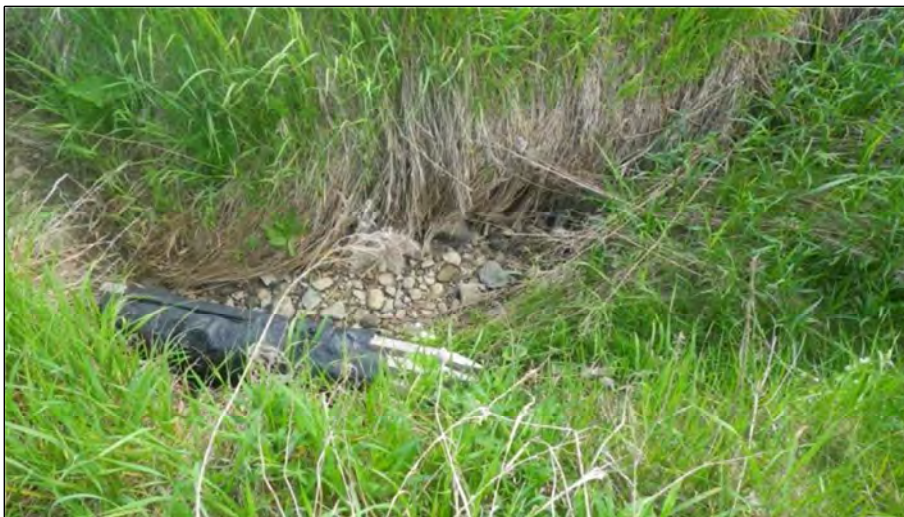
57. Area where **HT -2b -4 (Segment 1)** and roadside ditch converge upstream of Trafalgar Road culvert. **HT -2b -4 (Segment 1)** is on the left, roadside ditch is on the right. **Management recommendation:**
No Management

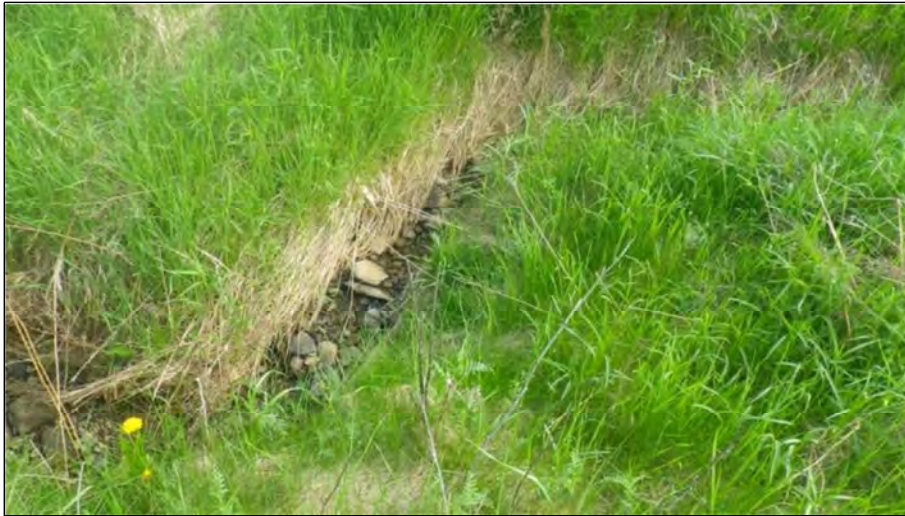
58. **HT -2b -4 (Segment 2)**. Downstream of confluence with roadside ditch, features combine to establish defined bed and banks approaching culvert.

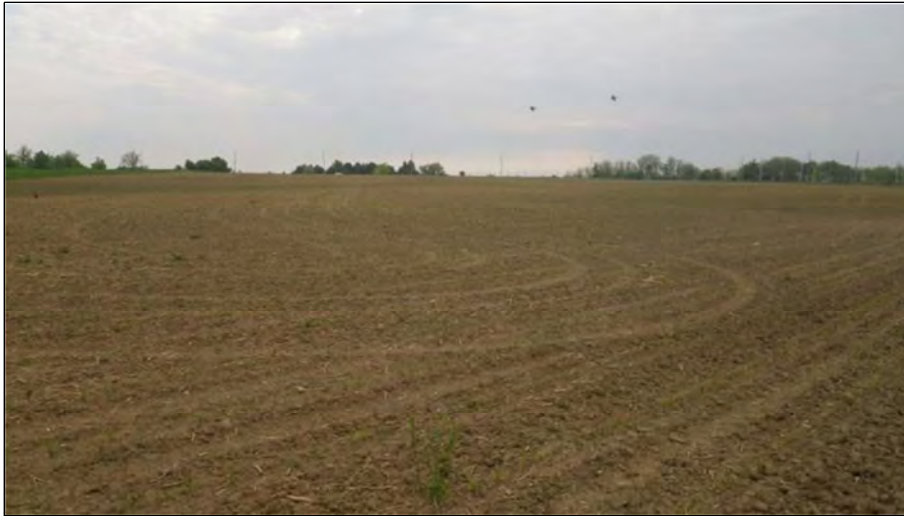
60. HT -2b -4a. Feature added after observation in field on first visit. Facing upstream from downstream end. Feature looks to be cut as a furrow by farmer. Feature type is channelized (modified agricultural) and flow condition is standing water.

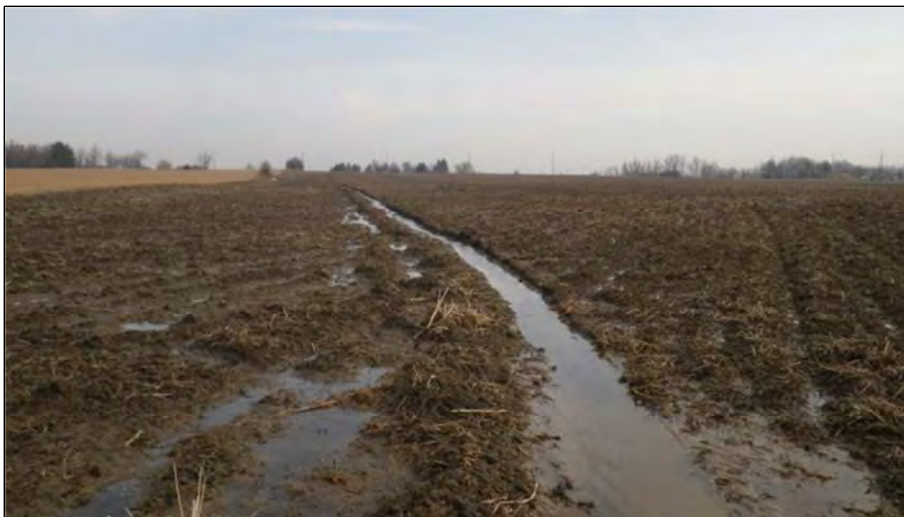
61. HT -2b -4a. Looking eastward across field where feature was previously located. Feature is no longer visible as field appears to have been reworked. Flow condition is dry, feature type is channelization (modified agricultural). **Management Recommendation: No management required.**

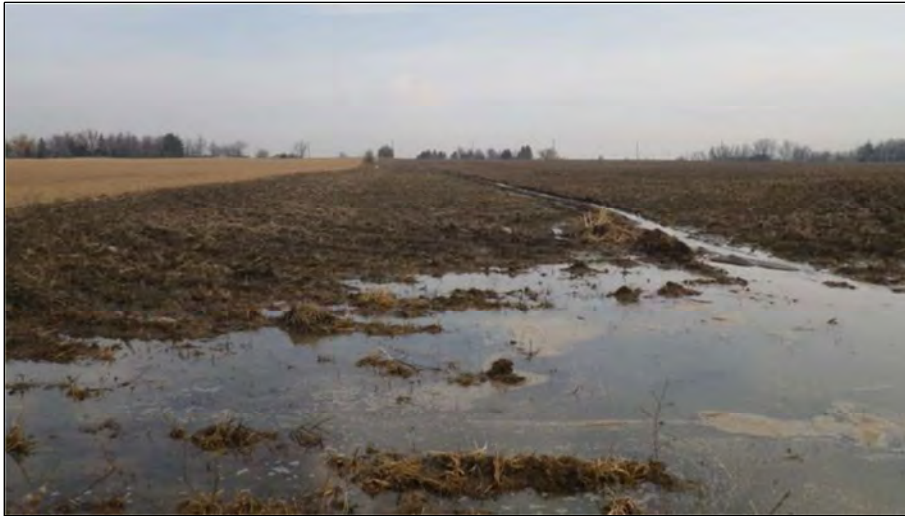
62. HT -2b -4b. Feature added after identification in the field at time of first visit. Facing upstream from downstream end. Feature appears to be cut as a furrow by farmer. Feature type is channelization (modified agricultural) and flow condition is standing water.

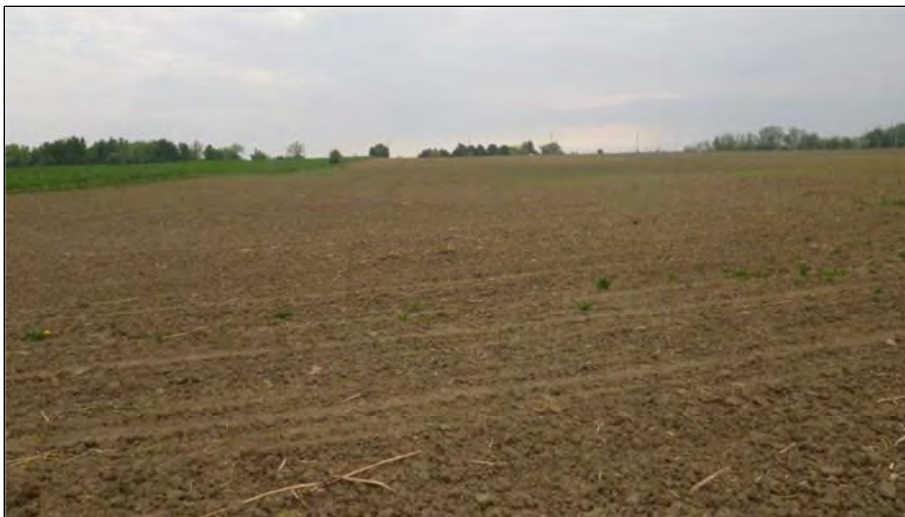
63. HT -2b -4b. Feature drains to large ponded area of HT -2b -4, photo facing upstream. Feature appears to be cut as a furrow by farmer. Feature type is channelization (modified agricultural) and flow condition is standing water.

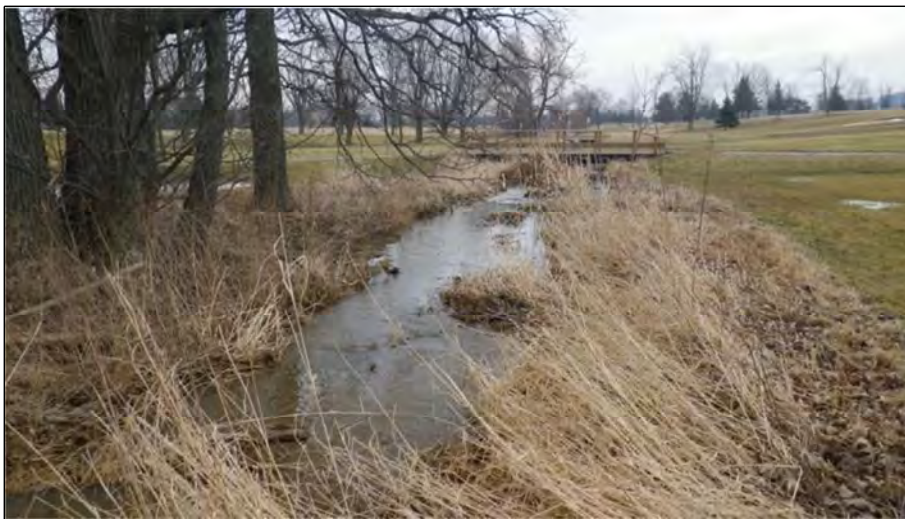
65. E -T1 -4 (Segment 1). At upstream end of golf course facing upstream. Water is standing and pooled, approximately depth of 20 cm. Feature type is classified as tiled drainage (buried stream/pipe) because the feature is primarily piped through the extent of the golf course. Flow condition is surface flow substantial.

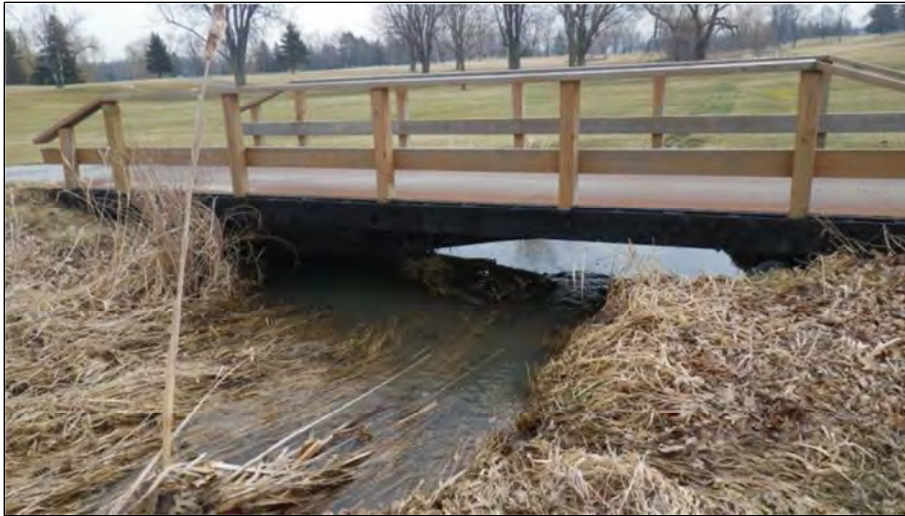
66. E -T1 -4 (Segment 1). At upstream end of golf course, facing downstream towards first cart crossing bridge. Feature type is classified as tiled drainage (buried stream/pipe) because the feature is primarily piped through the extent of the golf course. Flow condition is surface flow substantial.

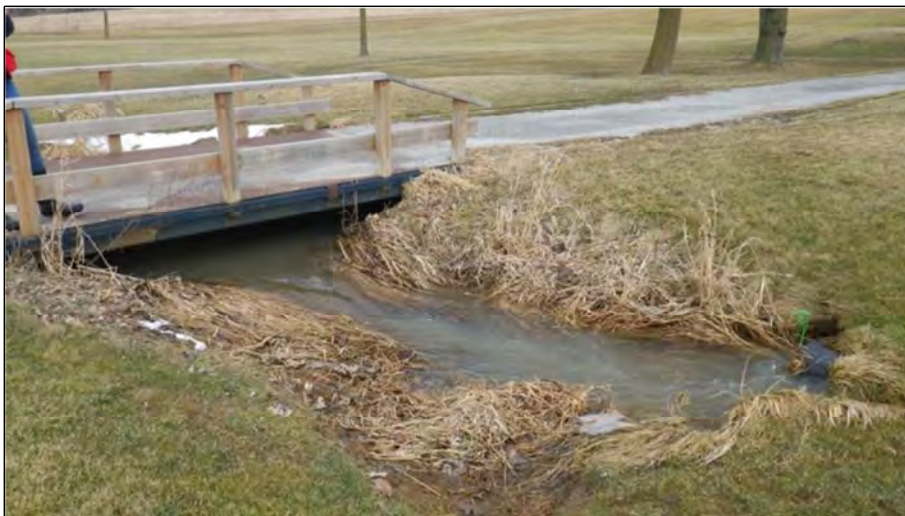
67. E -T1 -4 (Segment 1). At first cart path crossing, facing downstream. Water flows beneath bridge and drains into small pipe across the fairway. Feature type is classified as tiled drainage (buried stream/pipe) because the feature is primarily piped through the extent of the golf course. Flow condition is surface flow substantial.

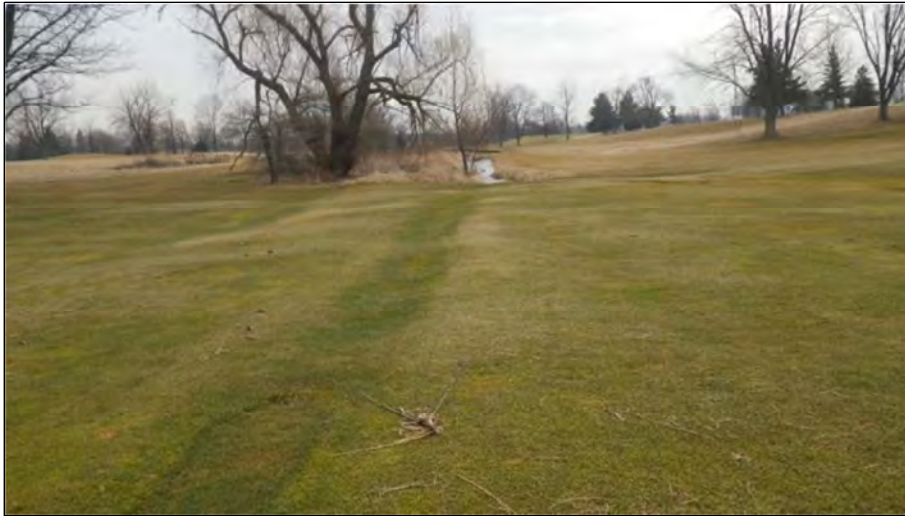
68. E -T1 -4 (Segment 1). Downstream side of second cart path crossing. Water flows out of pipe upstream of cart path crossing and then again drains into pipe to traverse another fairway. Feature type is classified as tiled drainage (buried stream/pipe) because the feature is primarily piped through the extent of the golf course. Flow condition is surface flow substantial.

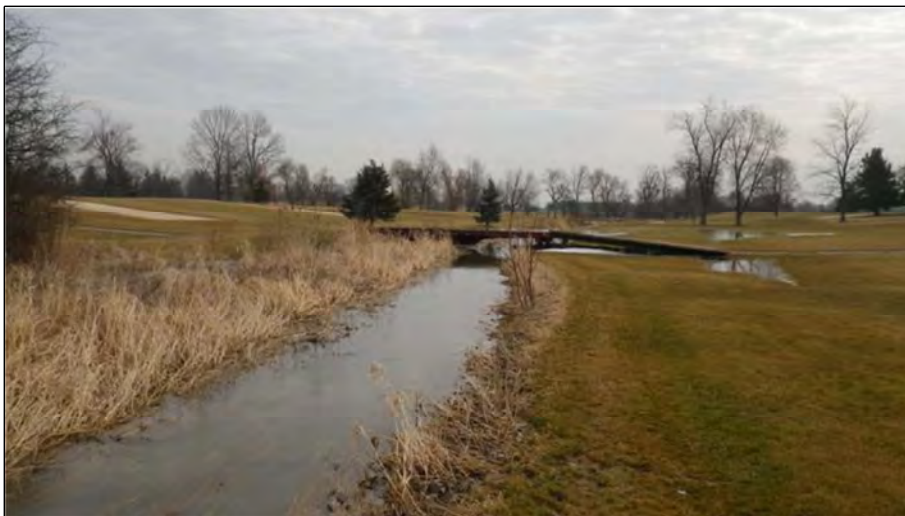
69. E -T1 -4 (Segment 1). Facing downstream of second cart path crossing, no surface water due to piping along fairway, water outlets into grassed area. Feature type is classified as tiled drainage (buried stream/pipe) because the feature is primarily piped through the extent of the golf course. Flow condition is surface flow substantial.

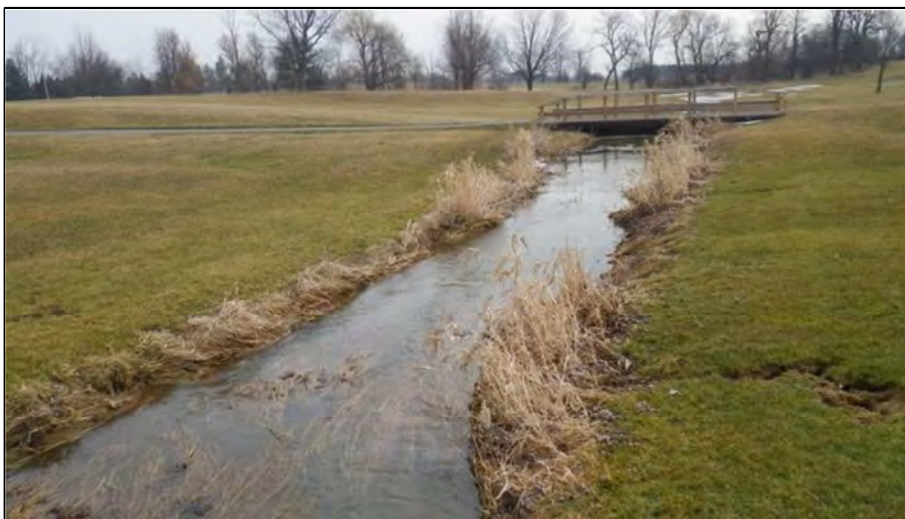
71. E -T1 -4 (Segment 1). Facing upstream towards third cart path crossing. In background of photo water is pooling at surface where it has overwhelmed the pipe. In foreground, pipe outlets into grasses area, where flow is relatively fast and erosion has occurred around the outlet. Wetted depth is 14cm. Feature type is classified as tiled drainage (buried stream/pipe) because the feature is primarily piped through the extent of the golf course. Flow condition is surface flow substantial.

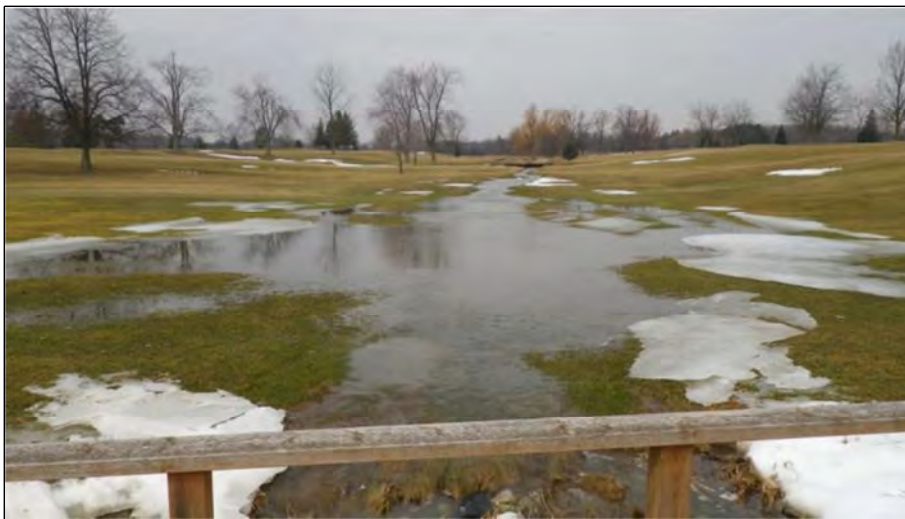
73. E -T1 -4 (Segment 1). Facing downstream towards fifth cart path crossing. Overland flow through piped section downstream of fourth cart path crossing. Hole in pipe as indicated by bubbling water in photo. Feature type is classified as tiled drainage (buried stream/pipe) because the feature is primarily piped through the extent of the golf course. Flow condition is surface flow substantial.

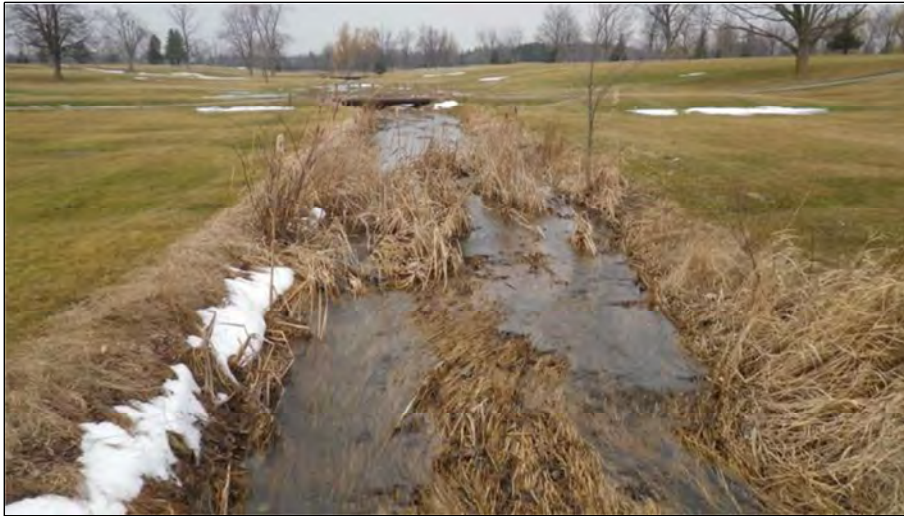
74. E -T1 -4 (Segment 1). Facing upstream from fifth cart path crossing, wide area of water pooling due to broken pipe. Two pipe outlets upstream of cart path crossing. Feature type is classified as tiled drainage (buried stream/pipe) because the feature is primarily piped through the extent of the golf course. Flow condition is surface flow substantial.

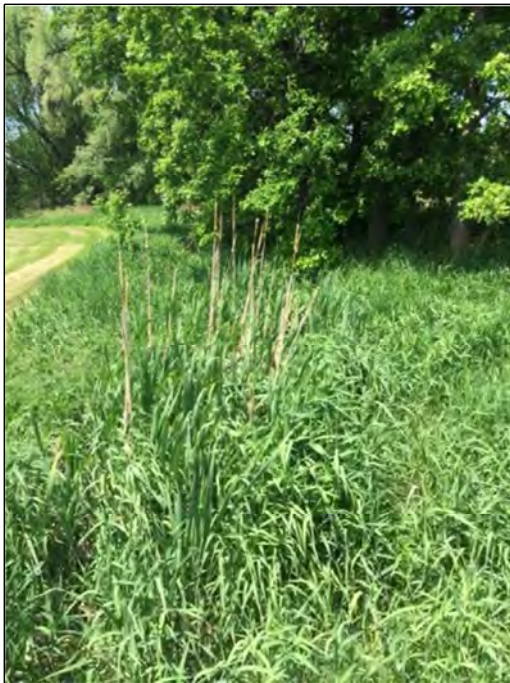
75. E -T1 -4 (Segment 1). Facing upstream towards fifth cart path crossing where feature appears to be open to surface, wetted width approximately 3.5m. Feature type is classified as tiled drainage (buried stream/pipe) because the feature is primarily piped through the extent of the golf course. Flow condition is surface flow substantial.

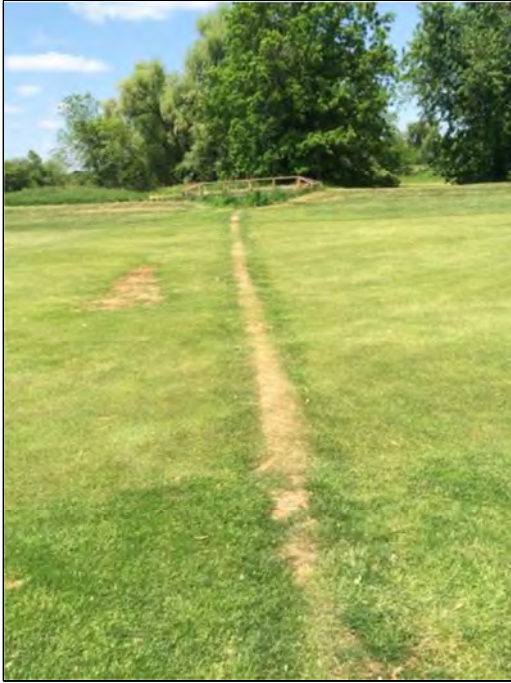
76. E -T1 -4 (Segment 1). Facing upstream at upstream end of golf course. No water or standing water only noted. Feature type is classified as tiled drainage; flow condition is no surface water.

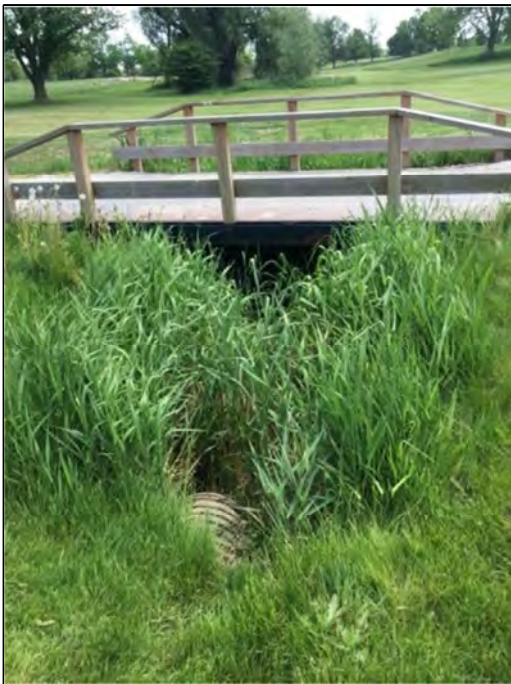
77. E -T1 -4 (Segment 1). Facing upstream towards first cart path crossing, feature is piped, no surface flow. Feature type is classified as tiled drainage; flow condition is no surface water.

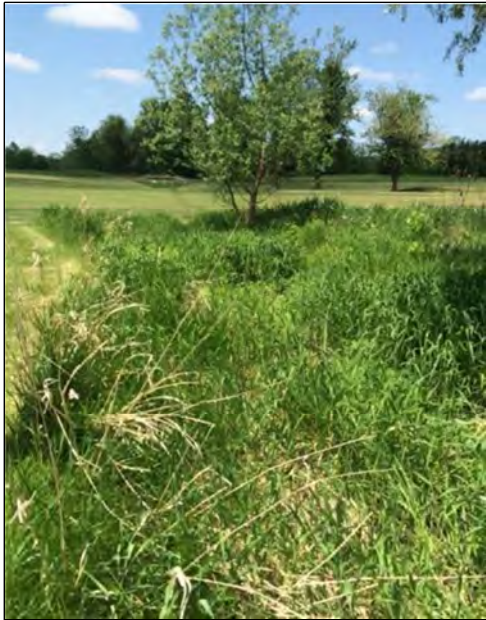
78. E -T1 -4 (Segment 1). Pipe outlet at second cart path crossing, facing downstream. No water noted. Feature type is classified as tiled drainage; flow condition is no surface water.

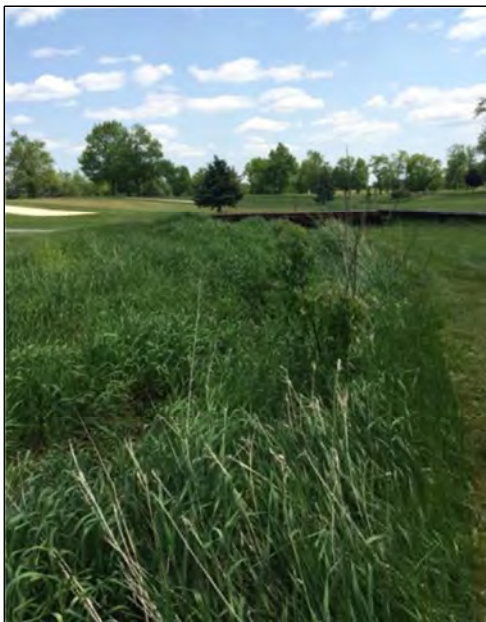
79. E -T1 -4 (Segment 1). Facing upstream towards second cart path crossing, within area where pipe outlets to surface. Standing water noted at the outlet only. A depression bare of grass was noted indicating previous flows. Feature type is classified as tiled drainage; flow condition is no surface water.

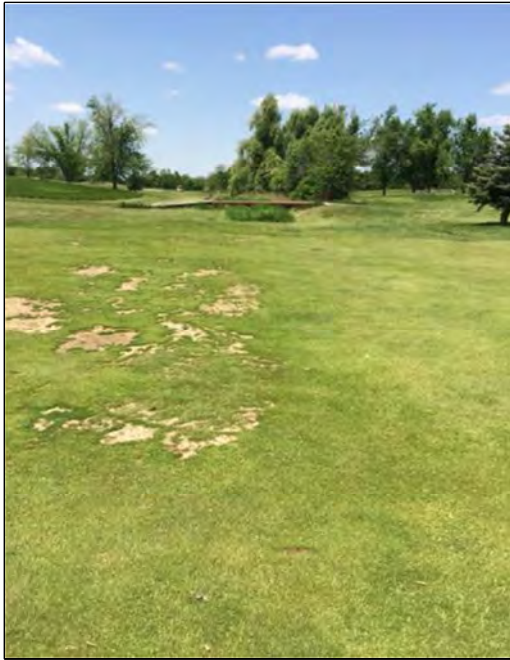
80. E -T1 -4 (Segment 1). Facing downstream towards third cart path crossing, where feature is at surface. Feature type is classified as tiled drainage; flow condition is no surface water.

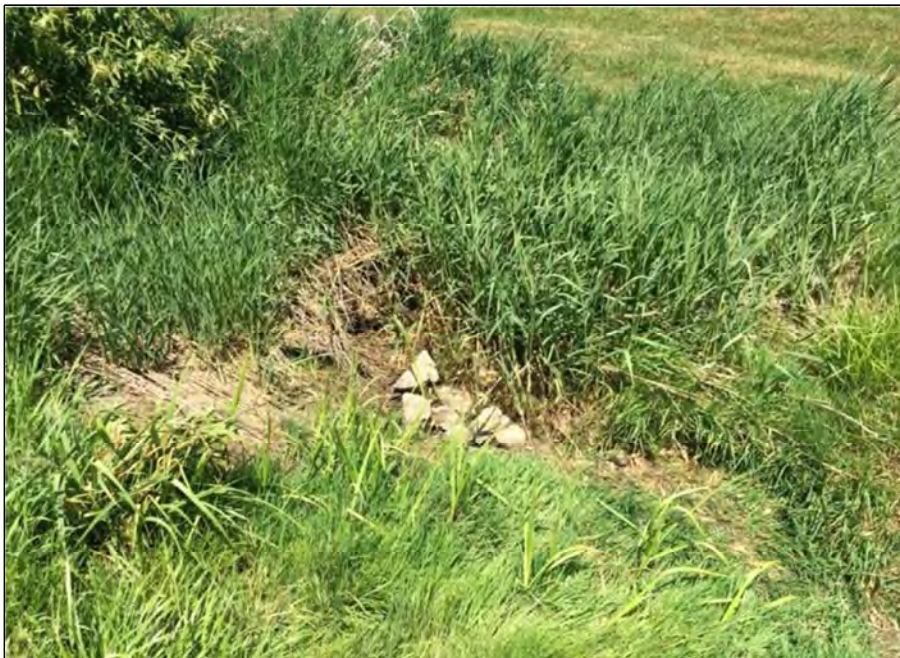
81. E -T1 -4 (Segment 1). Facing upstream to third cart path crossing, feature is piped beneath fairway. Feature type is classified as tiled drainage; flow condition is no surface water.

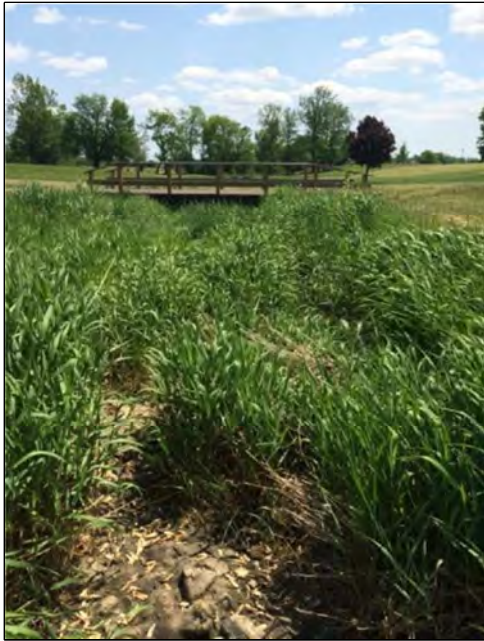
82. E -T1 -4 (Segment 1). Evidence of erosion by flows downstream of pipe outlet in section between third and fourth cart path crossing. Feature type is classified as tiled drainage; flow condition is no surface water.

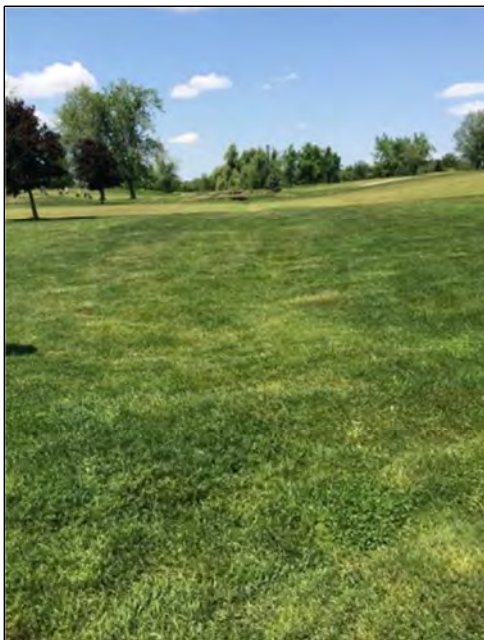
83. E -T1 -4 (Segment 1). Facing downstream towards fourth cart path crossing. Dry defined depression, evidence of previous flows from pipe outlet. Feature type is classified as tiled drainage; flow condition is no surface water.

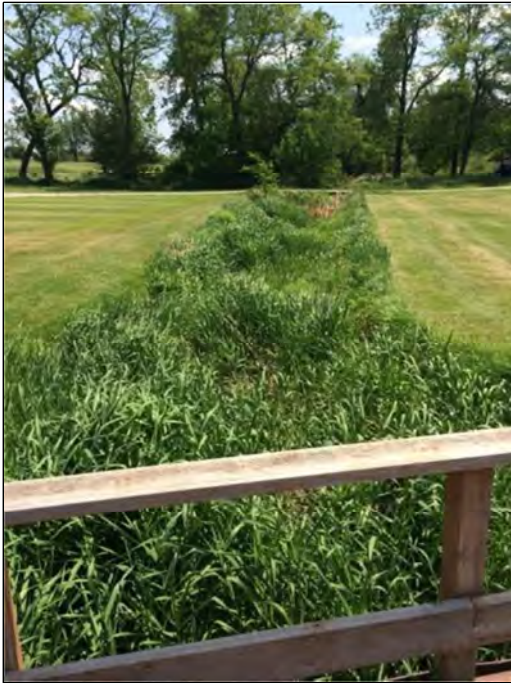
84. E -T1 -4 (Segment 1). Facing upstream towards fourth cart path crossing. Feature piped beneath fairways. Feature type is classified as tiled drainage; flow condition is no surface water.

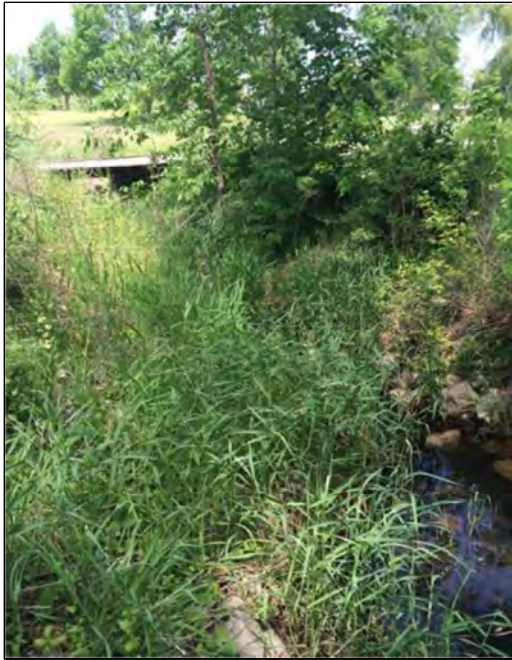
86. E -T1 -4 (Segment 2). Natural conditions downstream of last cart path crossing, until confluence with E -T1 -3 (approx. 40m). Feature type is classified as defined natural channel (visible banks) and flow condition is surface flow substantial.

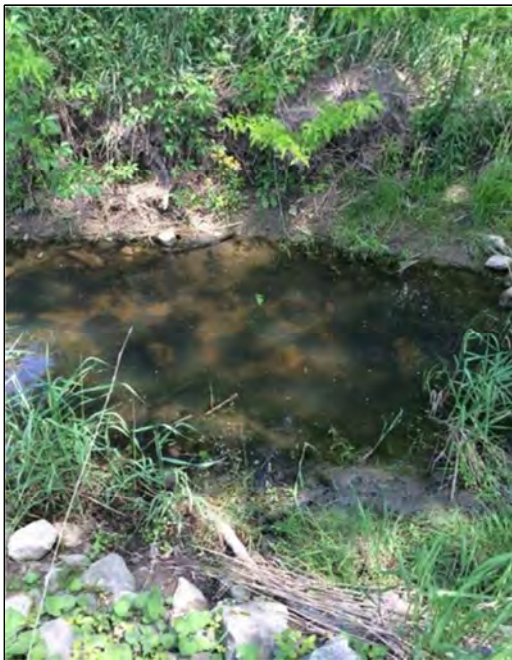
87. E -T1 -4 (Segment 2). At upstream end of Segment, facing upstream towards to sixth cart path crossing. Feature type is defined natural channel (visible banks) and flow condition is standing water.

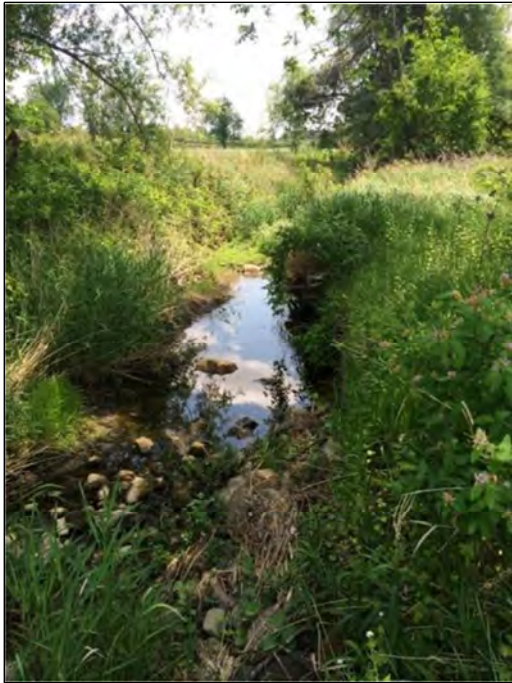
88. E -T1 -4 (Segment 2). Channel bed within Segment. Feature type is defined natural channel (visible banks) and flow condition is standing water.

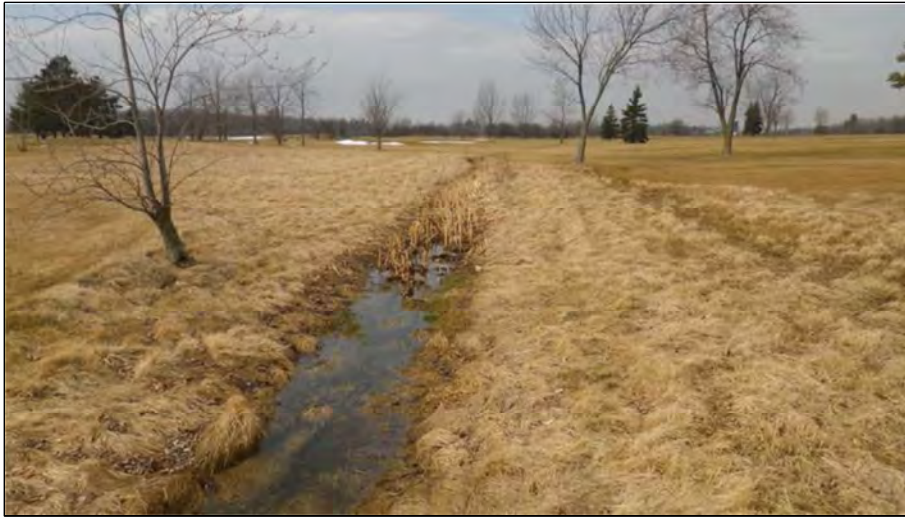
90. HDF -4. At upstream end of feature where flow initiates. Feature type is swale and flow condition is surface flow minimal.

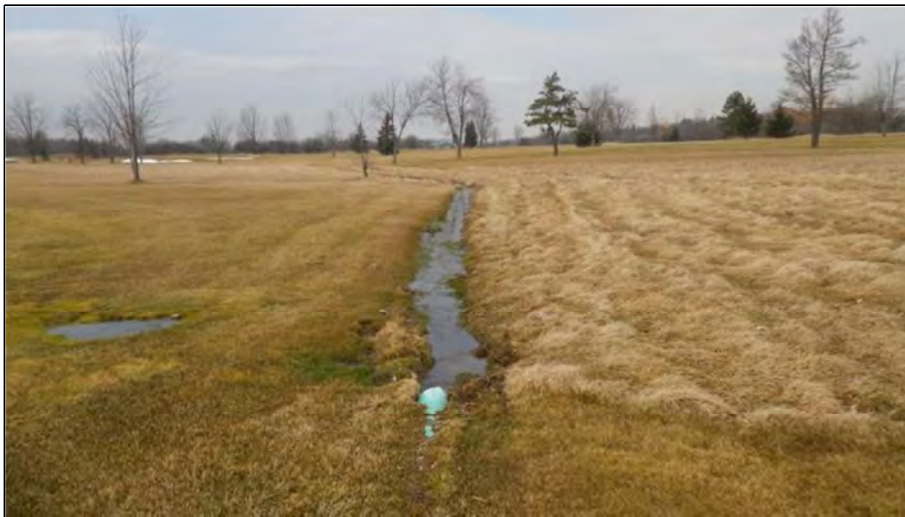
91. HDF -4. Facing upstream to upstream end of feature, cattail growth in wetted area was frequent. Feature type is swale and flow condition is surface flow minimal.

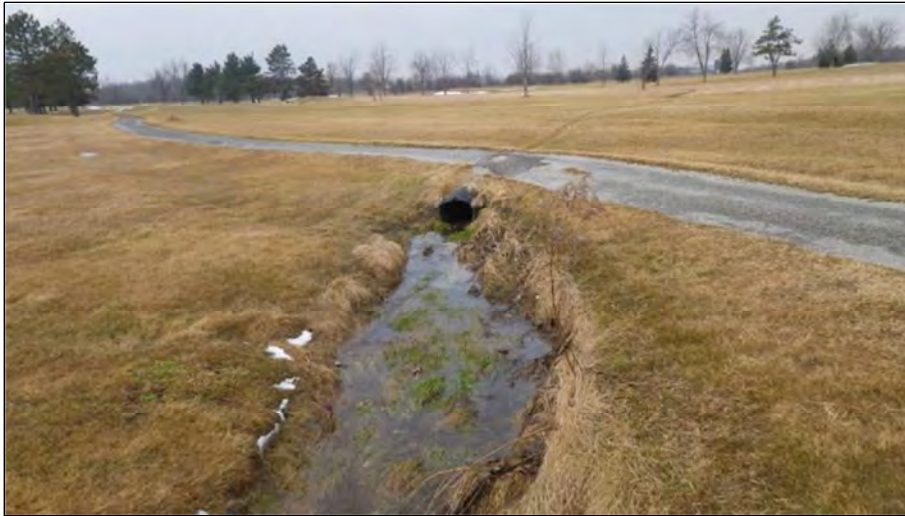
92. HDF -4. Facing upstream where feature drains into small pipe beneath fairways. Feature type is swale and flow condition is surface flow minimal.

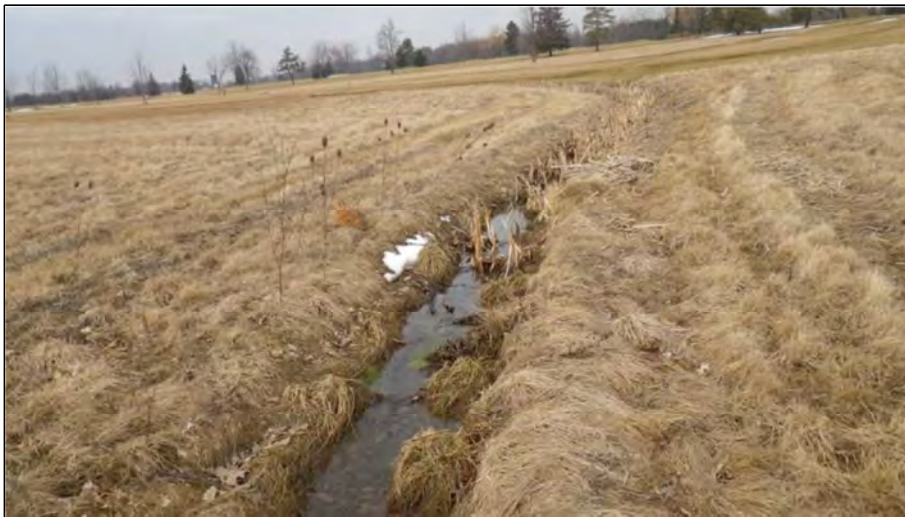
93. HDF -4. Facing upstream, feature is piped beneath fairway and outlets again downstream of a cart path. Feature type is swale and flow condition is surface flow minimal.

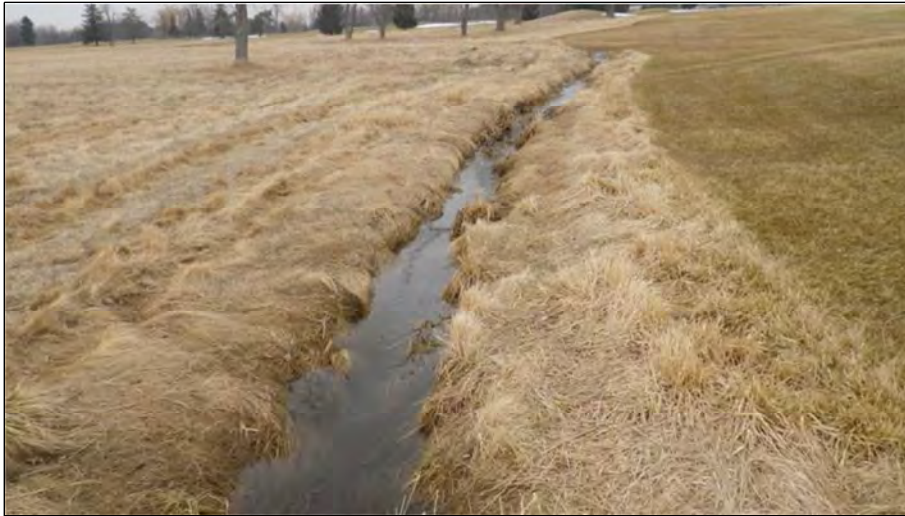
94. HDF -4. Facing upstream, frequent cattail growth is seen in feature. Feature type is swale and flow condition is surface flow minimal.

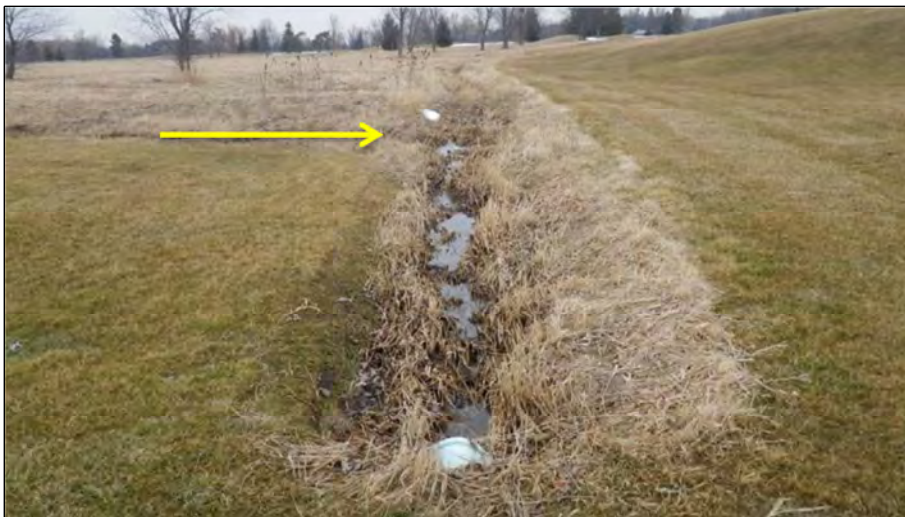
95. HDF -4. Facing upstream. Progressing further downstream, feature dimensions were relatively consistent throughout. Wetted width varied between 7cm to 15cm. Feature type is swale and flow condition is surface flow minimal.

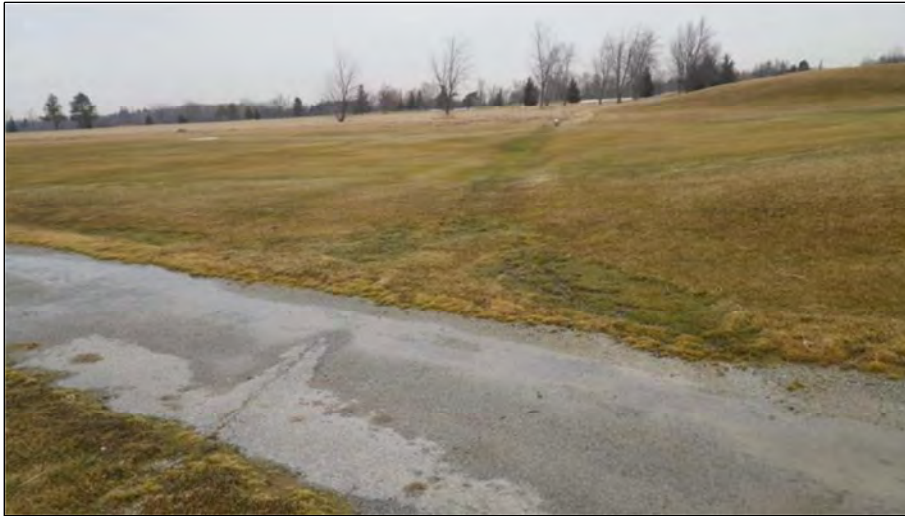
96. HDF -4. Facing upstream, feature enters pipe again. Note additional smaller feature joining in left side of photo (HDF -4a). Feature type is swale and flow condition is surface flow minimal.

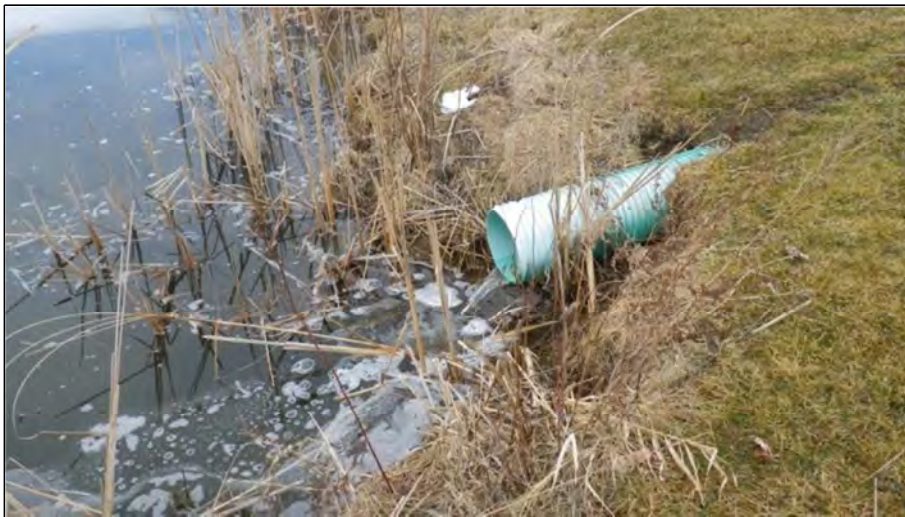
97. HDF -4. Facing upstream from downstream end of feature. Feature is piped to the downstream outlet at a pond. Feature type is swale and flow condition is surface flow minimal.

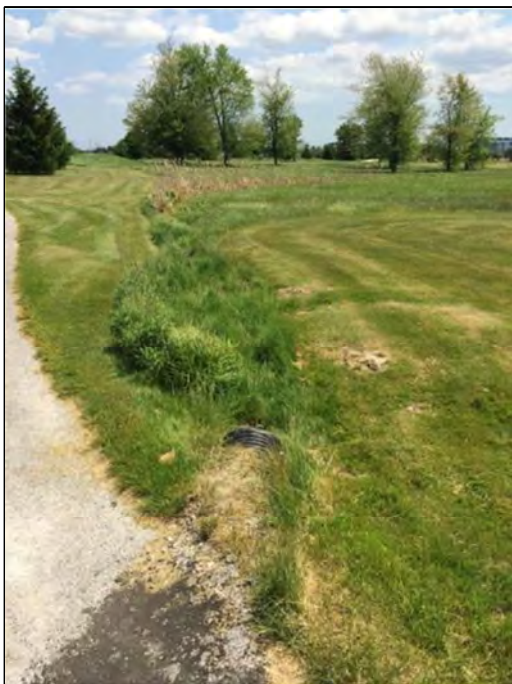
99. HDF -4. Facing upstream at upstream end of feature. Feature type is swale and flow condition is no surface water.

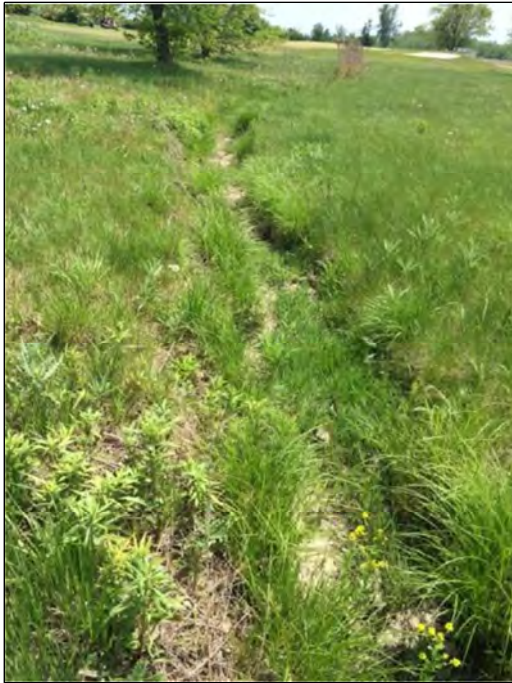
100. HDF -4. Facing upstream, area where feature is densely vegetated with cattails and grasses before entering a pipe. Feature type is swale and flow condition is no surface water.

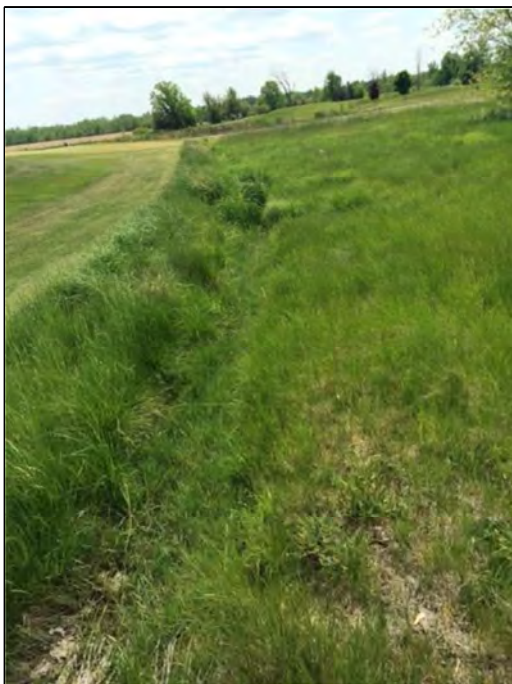
101. HDF -4. Facing downstream, defined depression with evidence of previous flows. Feature type is swale and flow condition is no surface water.

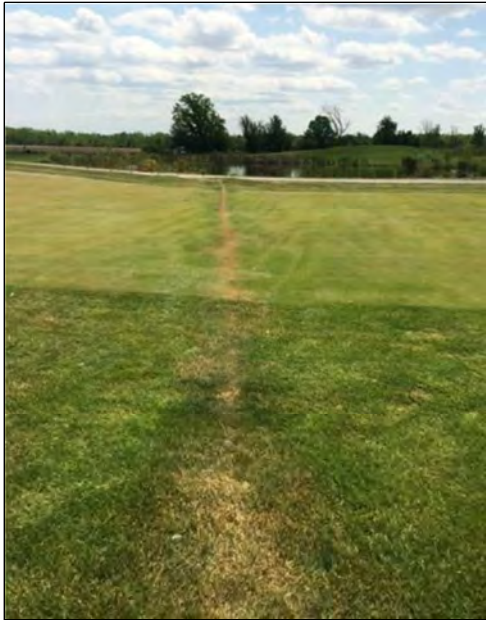
102. HDF -4. Facing downstream, feature runs along edge of manicured golf course green. Feature type is swale and flow condition is no surface water.

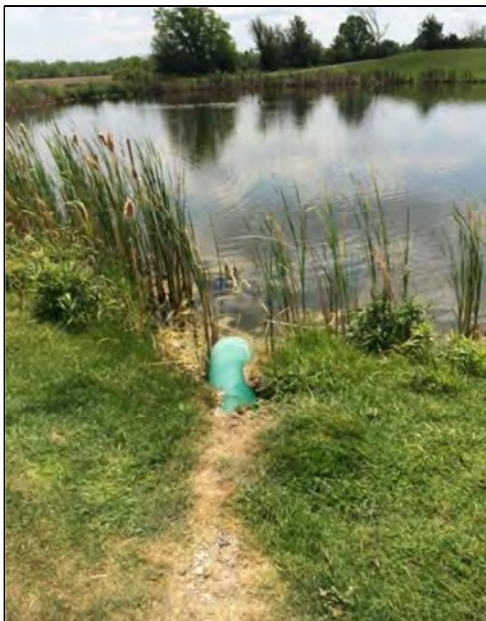
- 103. HDF -4.** Facing downstream towards golf course pond at downstream end. Feature is piped through last Segment. Feature type is swale and flow condition is no surface water.

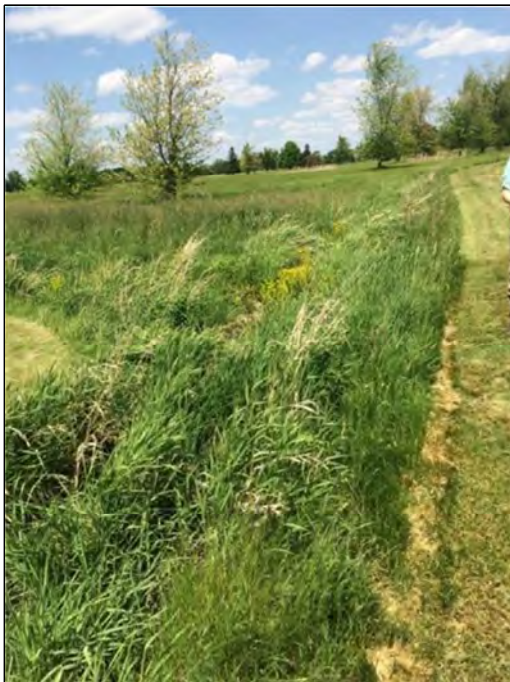
105. HDF -4a. Facing upstream from confluence with HDF -4. Feature type is swale and flow condition is standing water.
