Appendix F

Stream Morphology

Project: Premier Gateway SWS: HT-1 Detailed Site

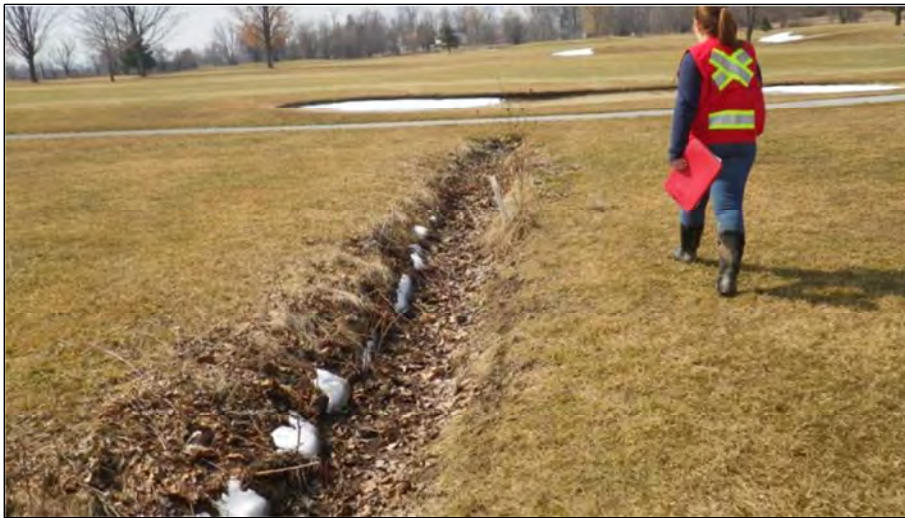
106. HDF -4a. Feature at downstream end joining HDF -4. Feature type is swale and flow condition is no surface water. **Management Recommendation: No management required**

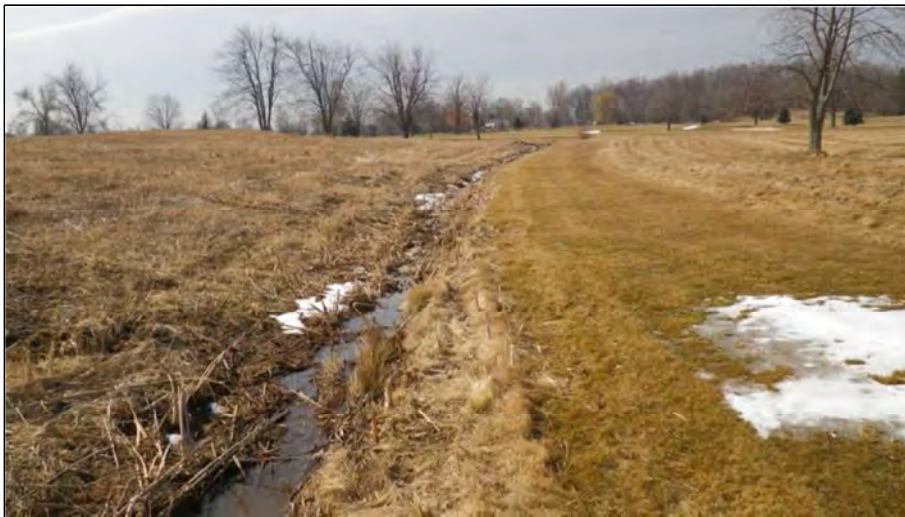
107. HDF -3. Upstream end of feature, facing upstream. Feature type is swale, flow condition is standing water

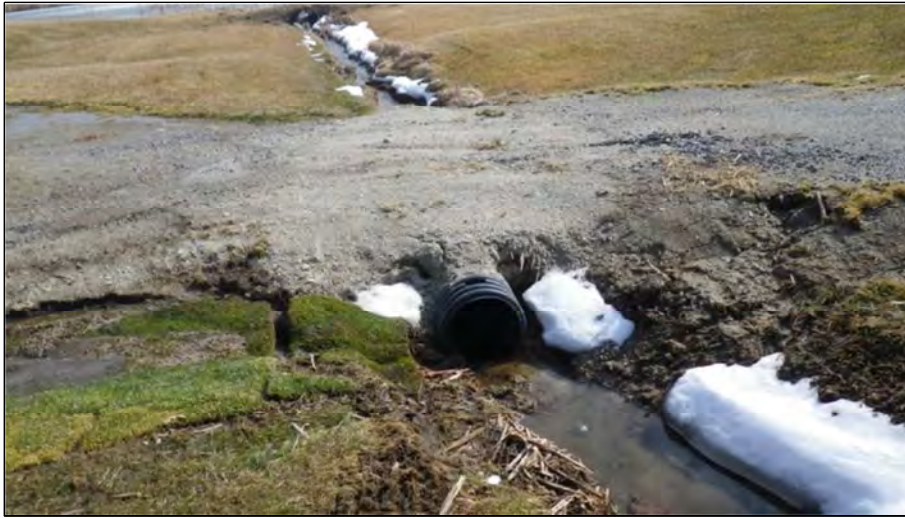
108. HDF -3. Facing upstream, mid -feature. Cattail growth noted within feature. Feature type is swale, flow condition is standing water.

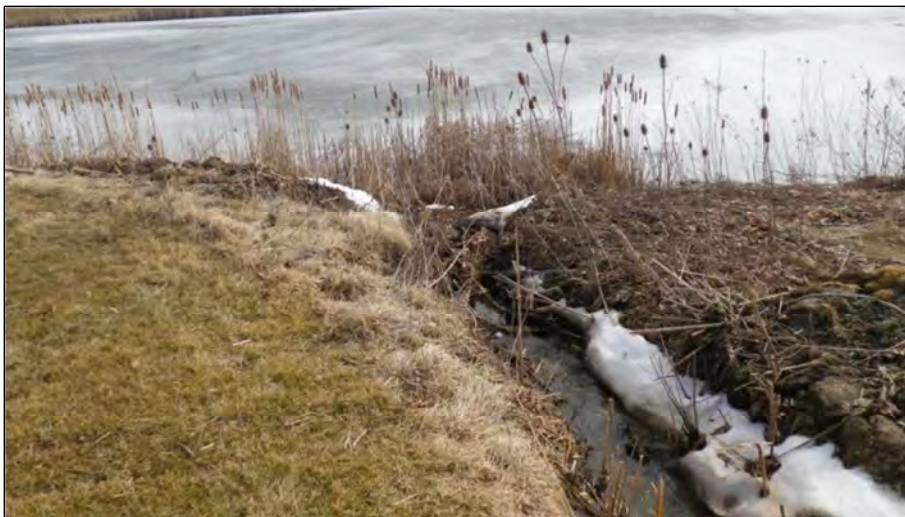
109. HDF -3. Facing downstream at downstream end of feature. Feature flows through two small pipes for path crossings before entering the golf course pond. Feature type is swale, flow condition is standing water.

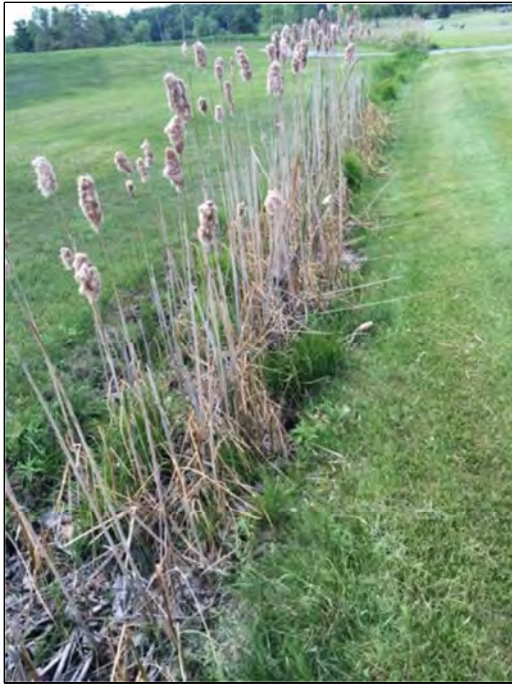
110. HDF -3. Downstream end of feature at golf course pond. Feature type is swale, flow condition is standing water.

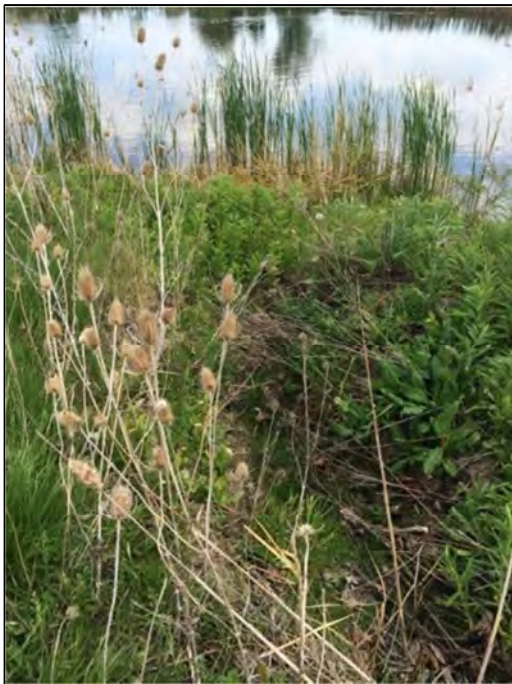
111. HDF -3. Facing upstream, near downstream end of feature. Feature heavily vegetated with cattails. Feature type is swale; flow condition is no surface water.

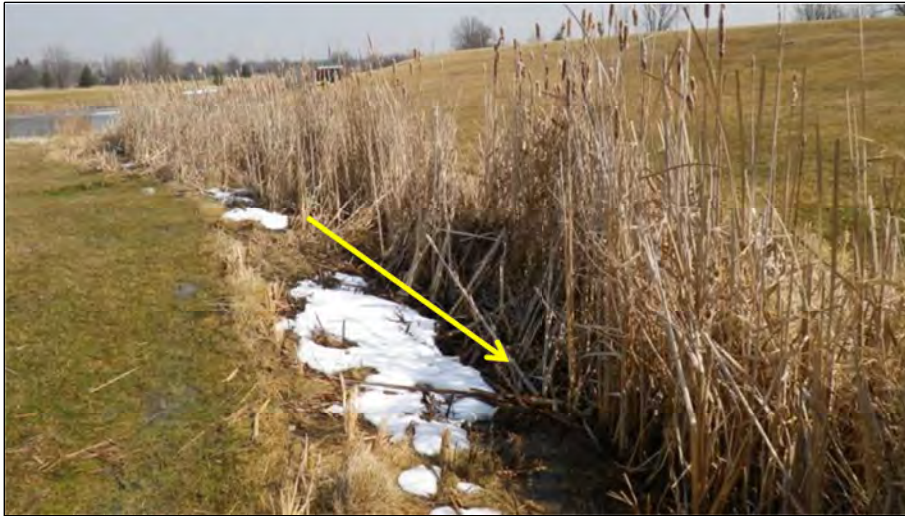
112. HDF -3. Downstream end of feature at golf course pond. Feature type is swale; flow condition is no surface water. **Management Recommendation: No management required.**

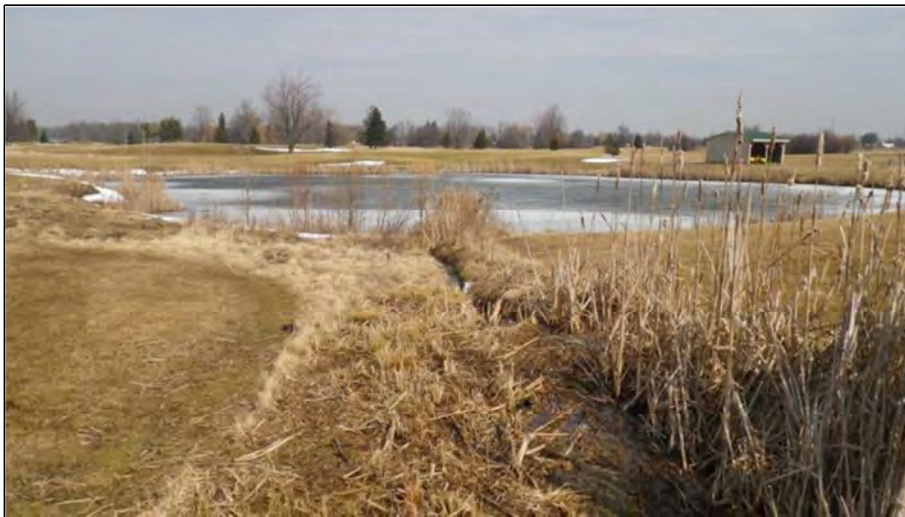
113. HDF -2. Facing western golf course pond. Feature is a surface connection between the two golf course ponds. Feature type is pond outlet; flow condition is surface flow minimal.

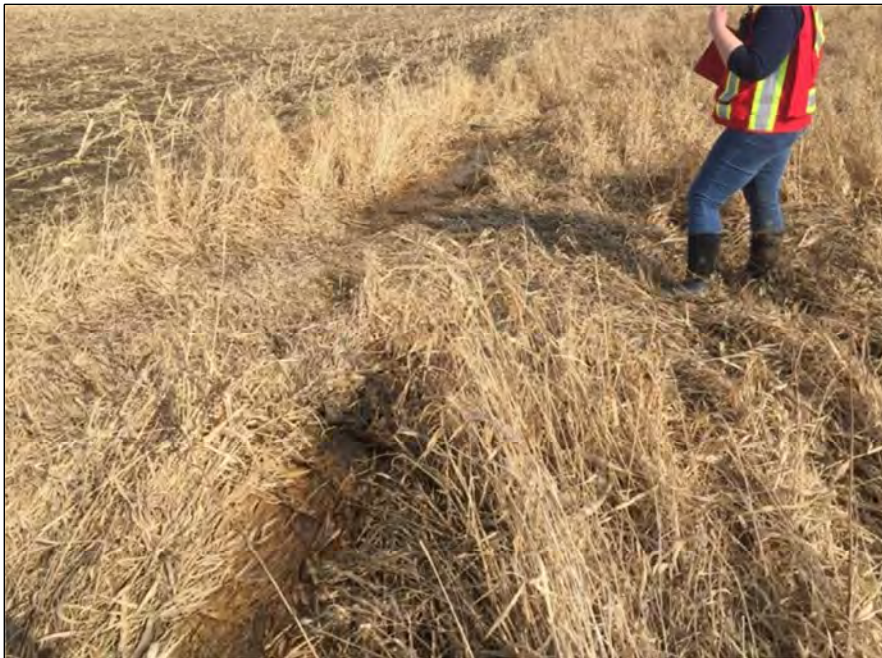
116. HDF -1 (Segment 1). At upstream end of feature, facing downstream. Upstream end has more water due to outlet from golf course ponds. Feature type is multi -thread and flow condition is standing water.

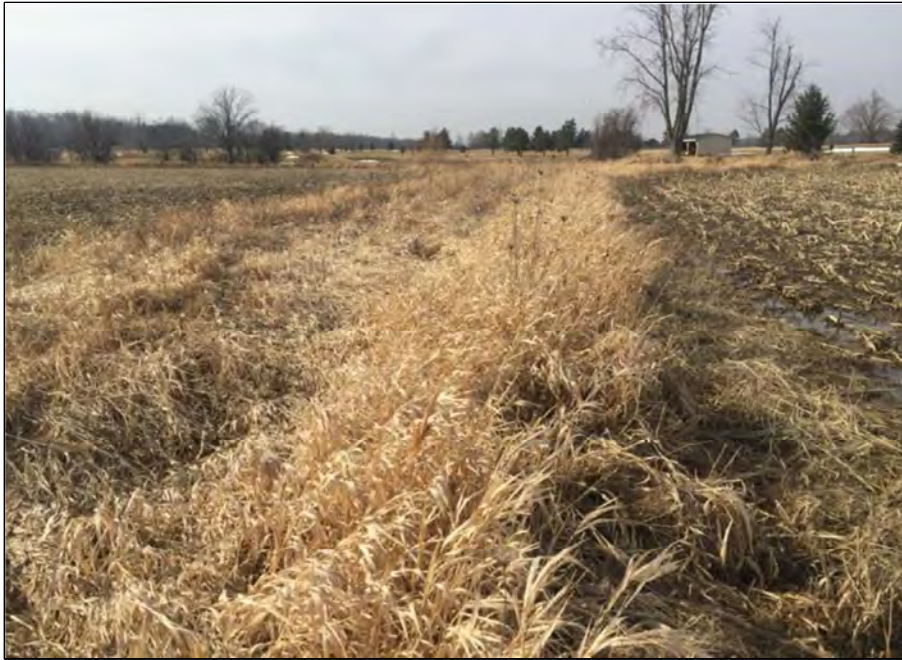
117. HDF -1 (Segment 1). Within feature, flow is distributed in pockets, lacks a continuous flow path. Wetted depth 5 cm to 10 cm. Feature type is multi -thread and flow condition is standing water.

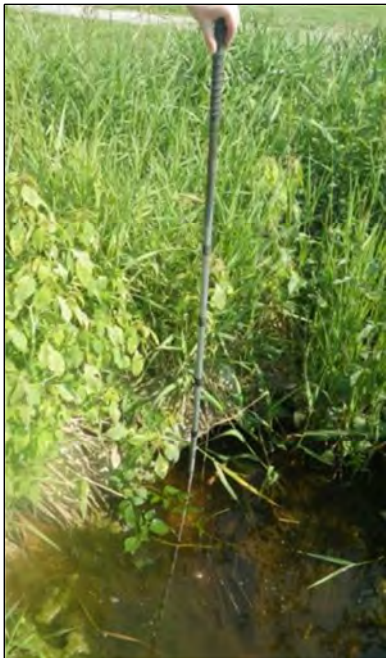
118. HDF -1 (Segment 1). Facing upstream towards golf course within Segment. Typical conditions, tall grasses with areas of pockets water. Feature type is multi -thread and flow condition is standing water.

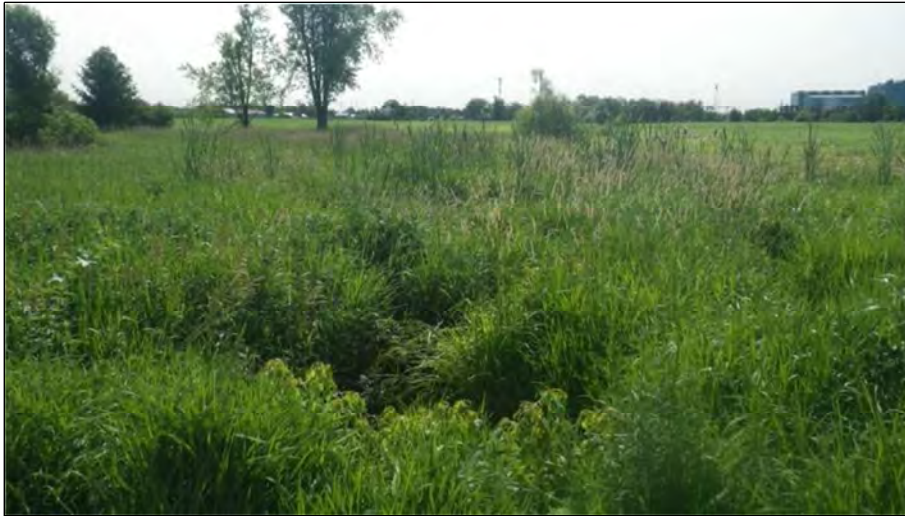
119. HDF -1 (Segment 1). Upstream end of feature at pond outlet from golf course. Feature type is multi -thread and flow condition is standing water.

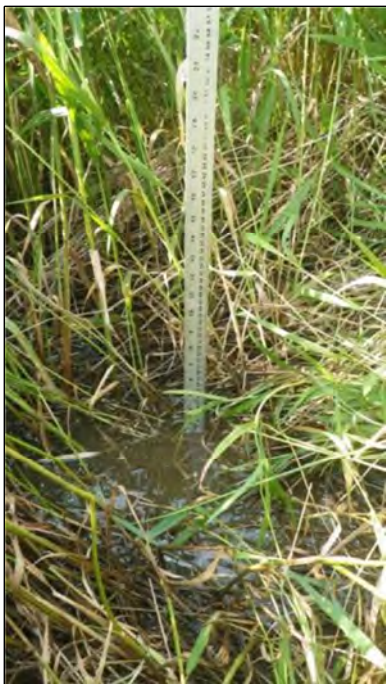
120. HDF -1 (Segment 1). Facing downstream from upstream end of Segment, dense vegetation through feature, including some cattails. Feature type is multi -thread and flow condition is standing water.

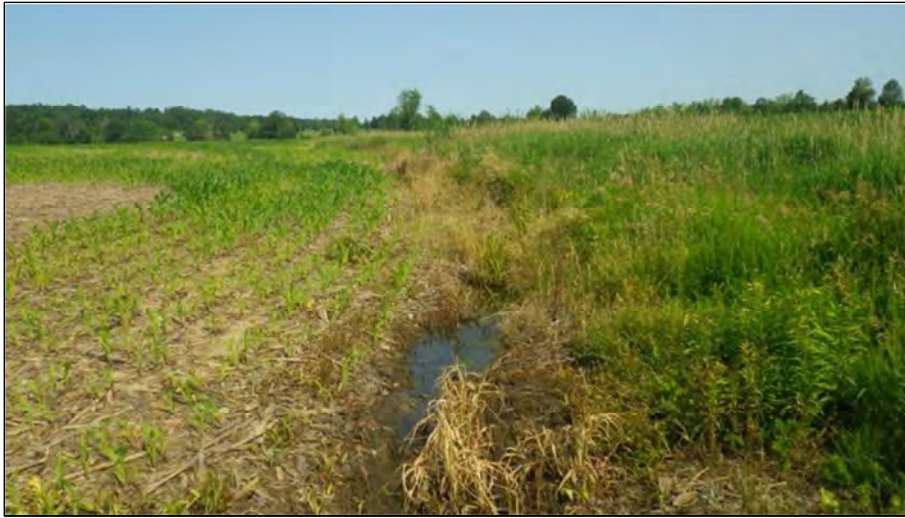
121. HDF -1 (Segment 1). Standing water throughout feature up to 20cm. Feature type is multi -thread and flow condition is standing water.

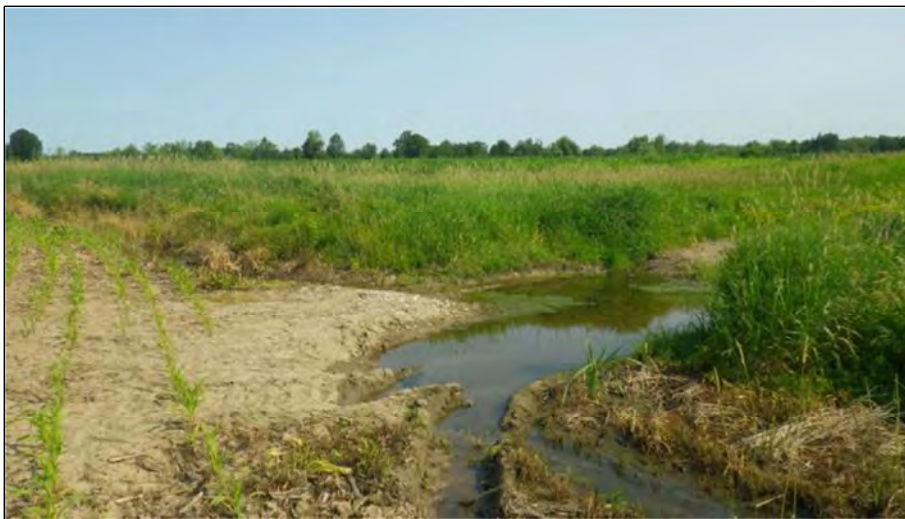
- 122. HDF -1 (Segment 1).** Facing upstream from downstream end of Segment. Note dense vegetation. Water beginning to focus along boundary between cropland and vegetation. Feature type is multi -thread and flow condition is standing water. **Management Recommendation: Conservation**

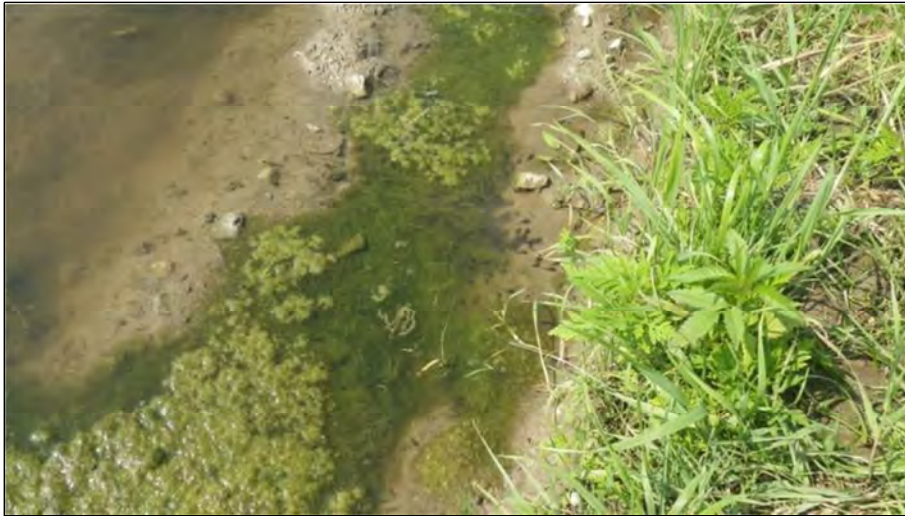
- 123. HDF -1.** Transition point between Segment 1 and 2, facing upstream. Large area of ponded water as a result of farm lane depression.

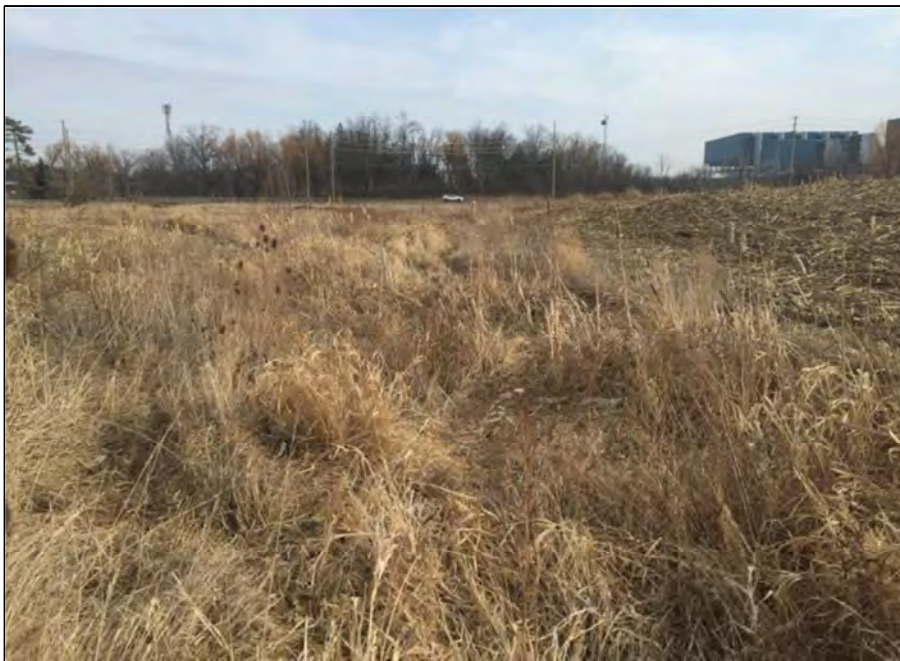
124. HDF -1. Tadpoles noted in farm lane crossing ponded water area.

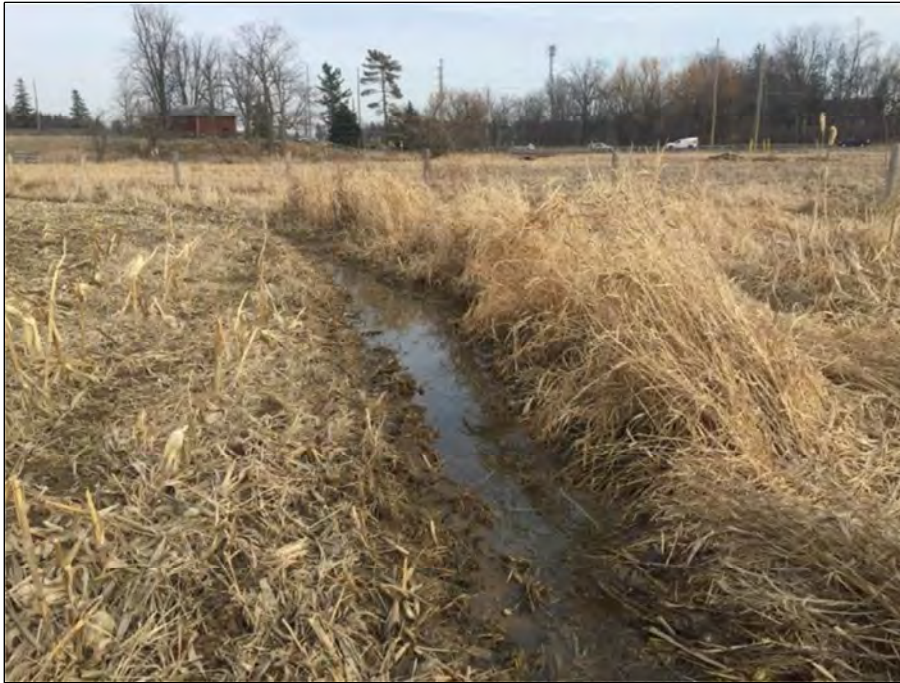
125. HDF -1 (Segment 2). Facing downstream within Segment. Water becomes more concentrated between crops and grasses. Feature type is swale and flow condition is surface flow minimal.

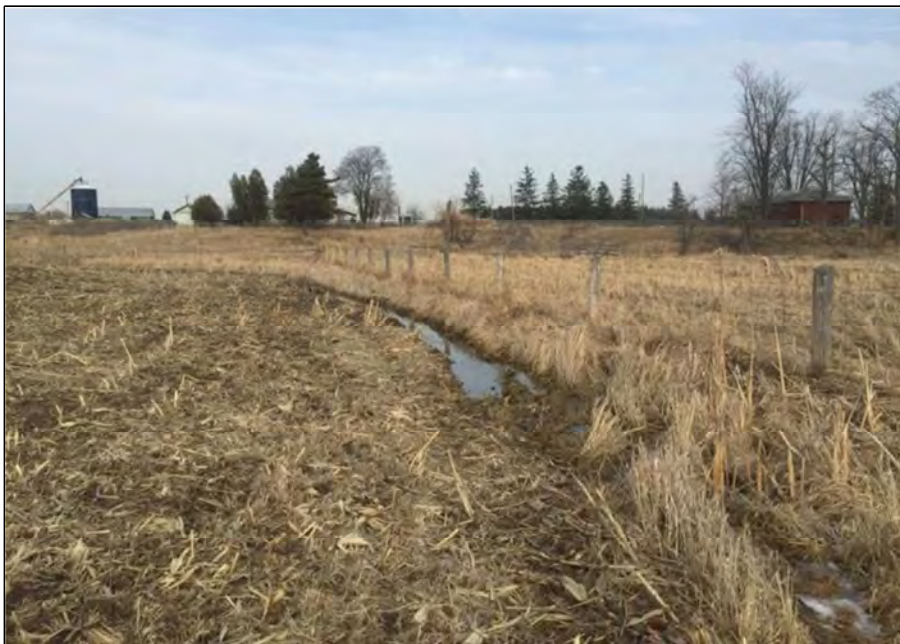
126. HDF -1 (Segment 2). Facing downstream, flow path is more defined. Feature type is swale and flow condition is surface flow minimal. Wetted depth is 18 cm.

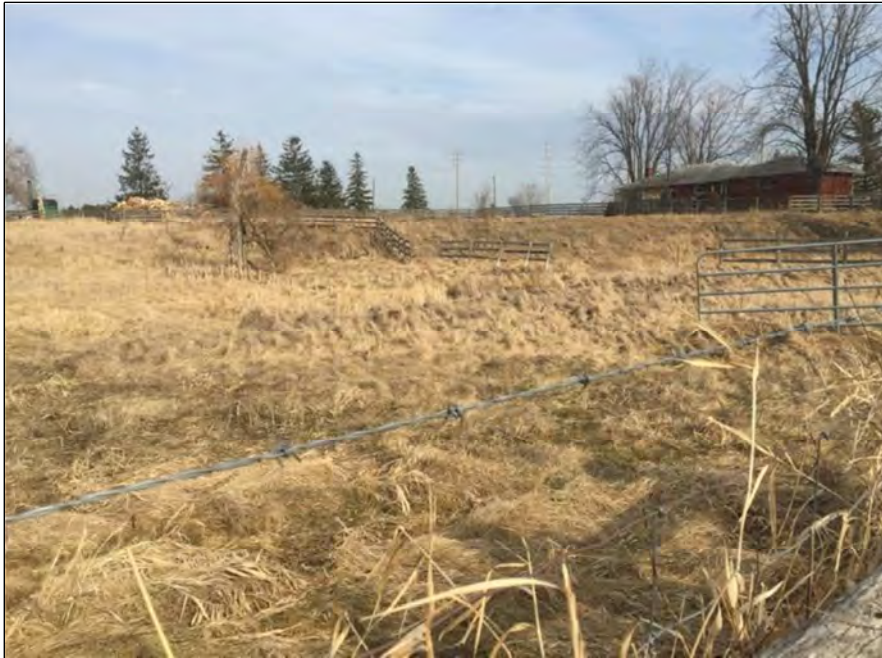
127. HDF -1 (Segment 2). Facing downstream towards E -T1 -2. Definition is lost approaching E -T1 -2. Feature type is swale and flow condition is surface flow minimal.

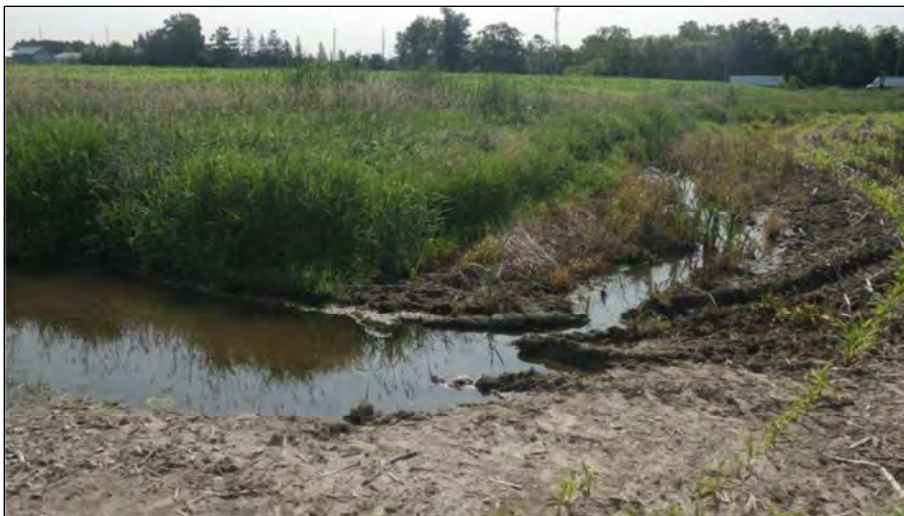
128. HDF -1 (Segment 2). Looking towards confluence location with E -T1 -2. Flow discontinues in this area, a confluence could not be identified in the field based on presence of flow or topography. Feature type is swale and flow condition is surface flow minimal.

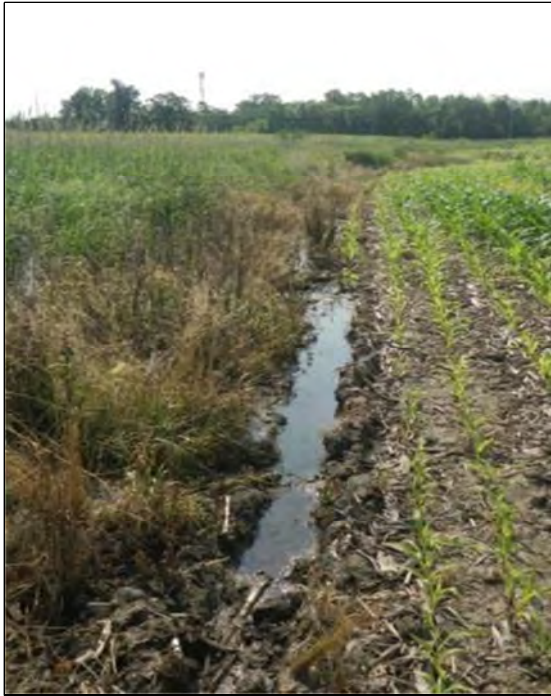
129. HDF -1 (Segment 2). Upstream end of Segment, facing downstream. Feature type is swale and flow condition is surface flow minimal.

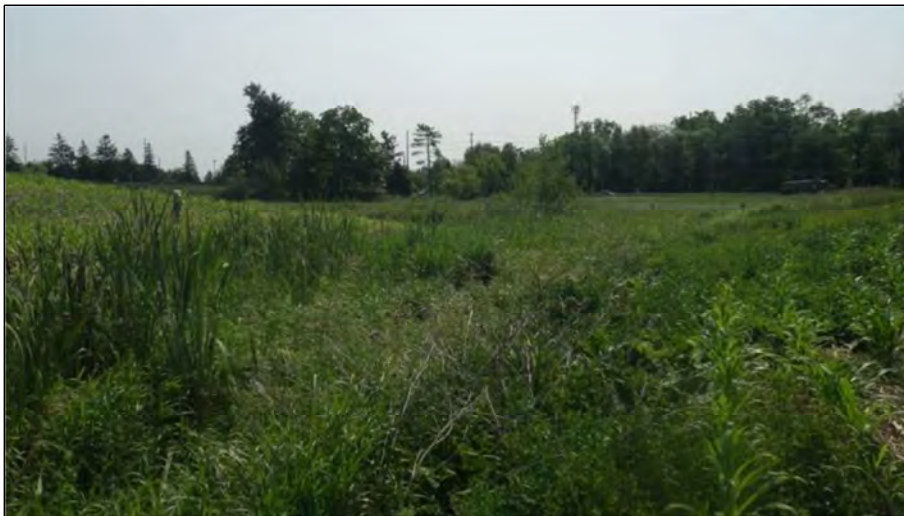
130. HDF -1 (Segment 2). Facing downstream, flow concentrated along boundary between cropland and vegetated area. Feature type is swale and flow condition is surface flow minimal.

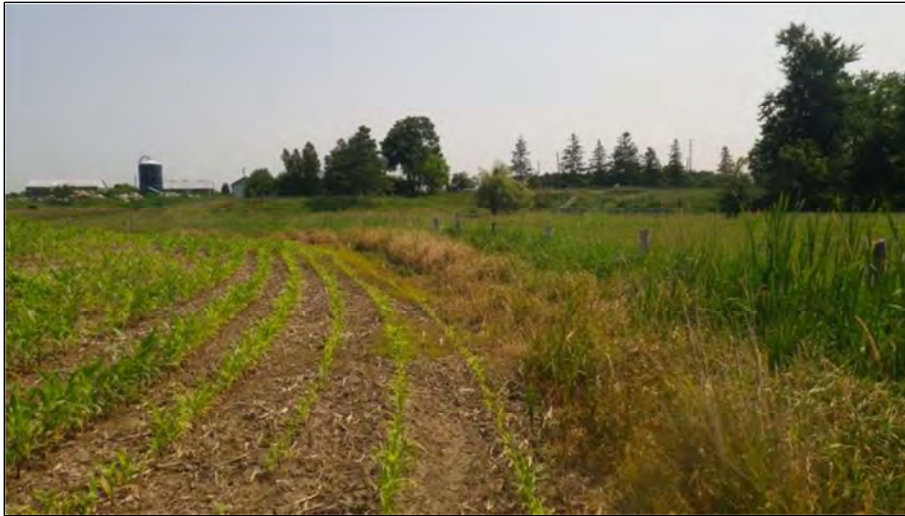
131. HDF -1 (Segment 2). Facing downstream. Dense vegetation, some wetland species (cattails). Feature type is swale and flow condition is surface flow minimal.

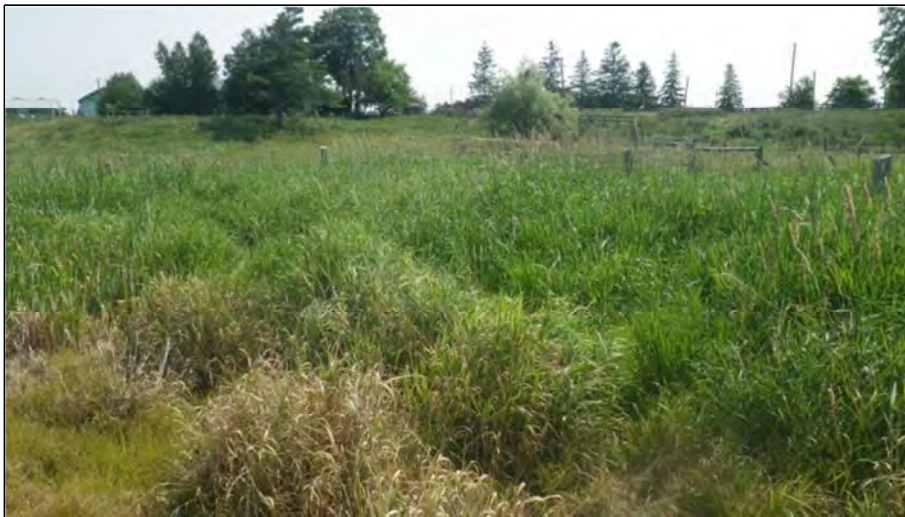
132. HDF -1 (Segment 2). Facing downstream towards E -T1 -2. Flow is reduced through this section. Feature type is swale and flow condition is surface flow minimal.

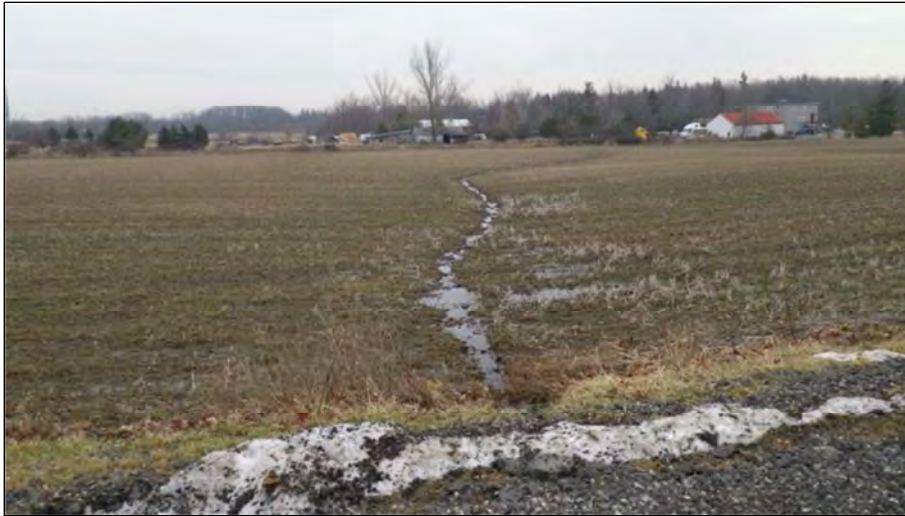
133. HDF -1 (Segment 2). At downstream end of feature, feature goes dry and is not able to be identified through tall grass section to confluence with E -T1 -2. Confluence could not be located. Feature type is swale and flow condition is surface flow minimal. **Management Recommendation: Conservation**

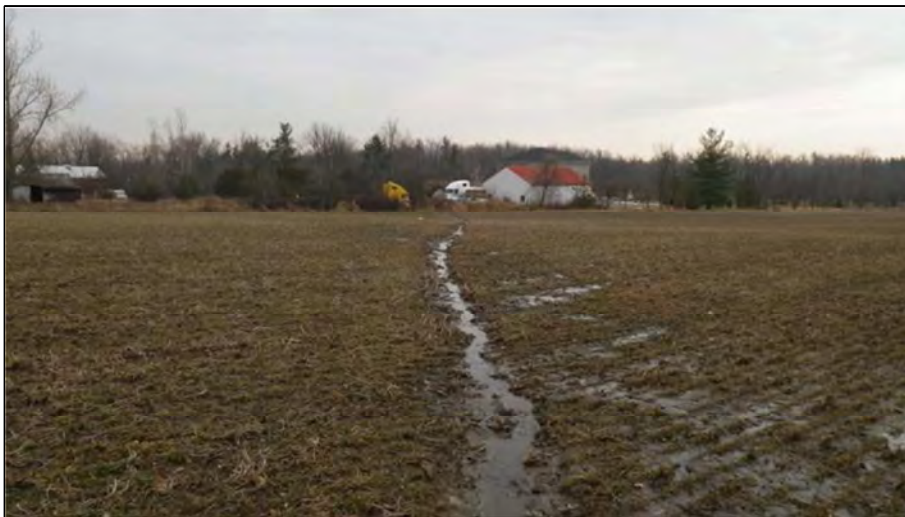
134. W -T1 -2b (Segment 1). Upstream end of Segment 1 facing downstream. Feature type is swale and flow condition is surface flow minimal.

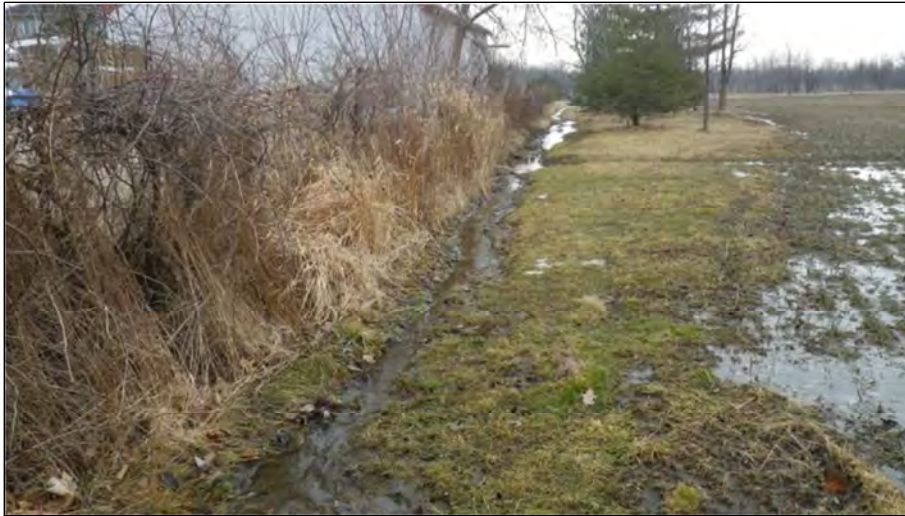
135. W -T1 -2b (Segment 1). Facing downstream within Segment. Feature type is swale and flow condition is surface flow minimal.

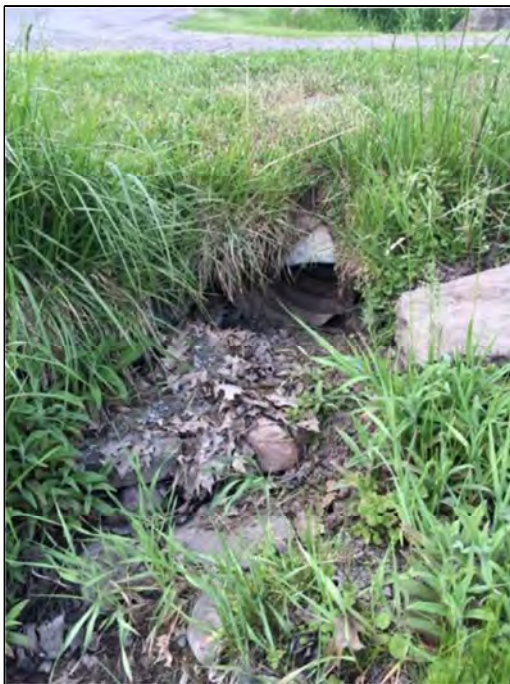
136. W -T1 -2b (Segment 1). Downstream end of feature. Feature makes a turn westward and drains towards Sixth line. Feature type is swale and flow condition is surface flow minimal.

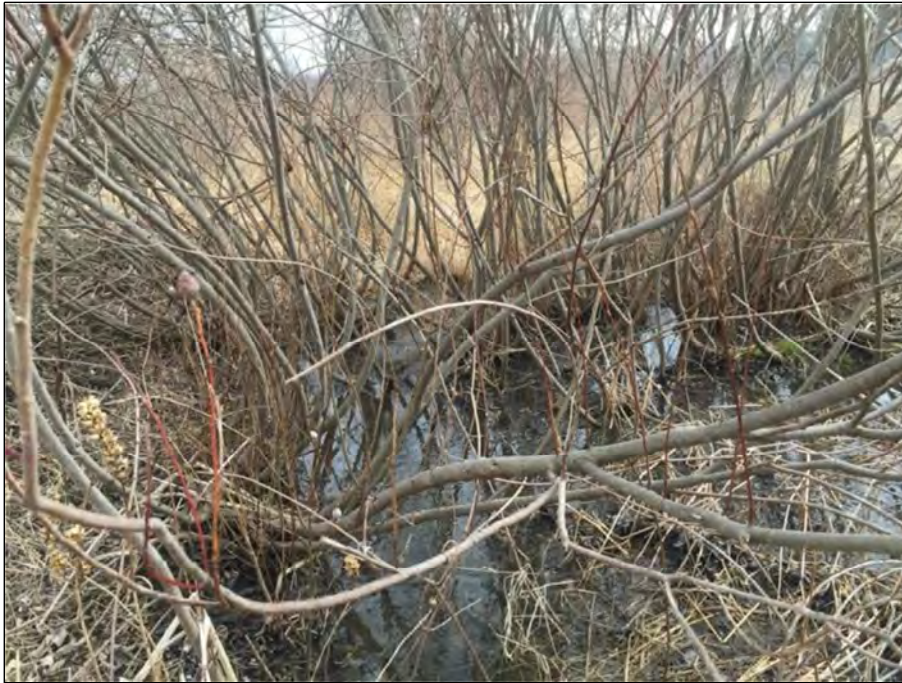
139. W -T1 -2b (Segment 3). Upstream end of Segment, facing upstream. Feature type is swale and flow condition is surface flow minimal.

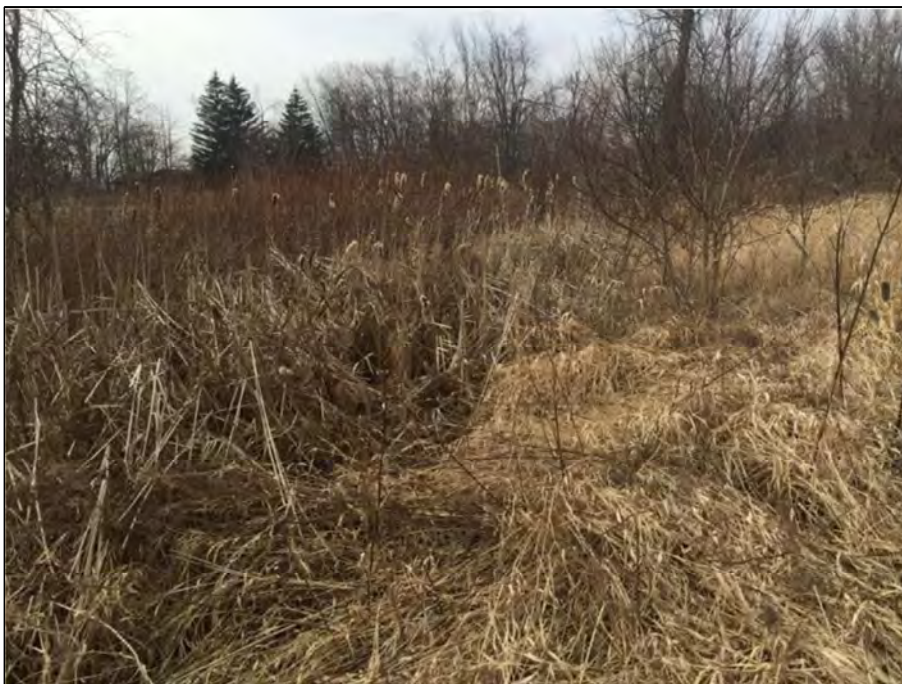
140. W -T1 -2b (Segment 3). Within Segment, dense vegetation. Feature type is swale and flow condition is surface flow minimal.

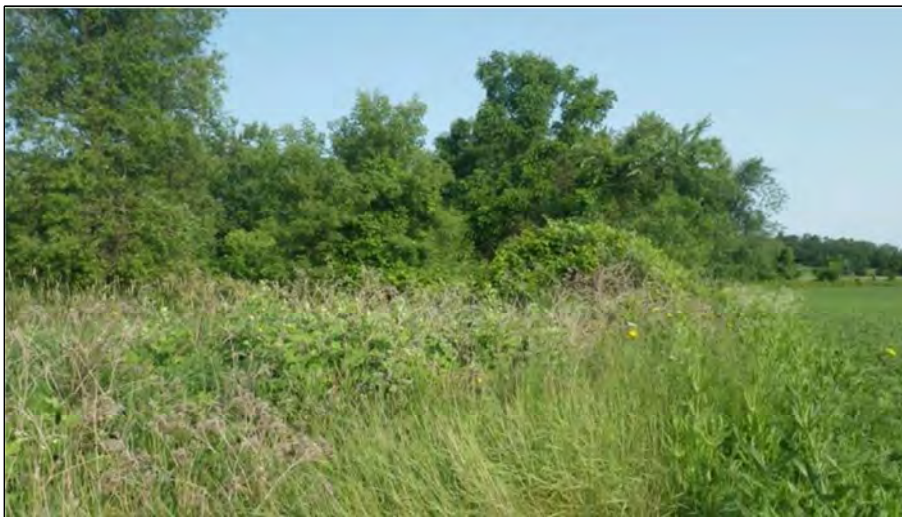
142. W -T1 -2b (Segment 3). Downstream end of Segment where water drains to CSP beneath farm lane crossing, facing downstream. Feature type is swale and flow condition is surface flow minimal.

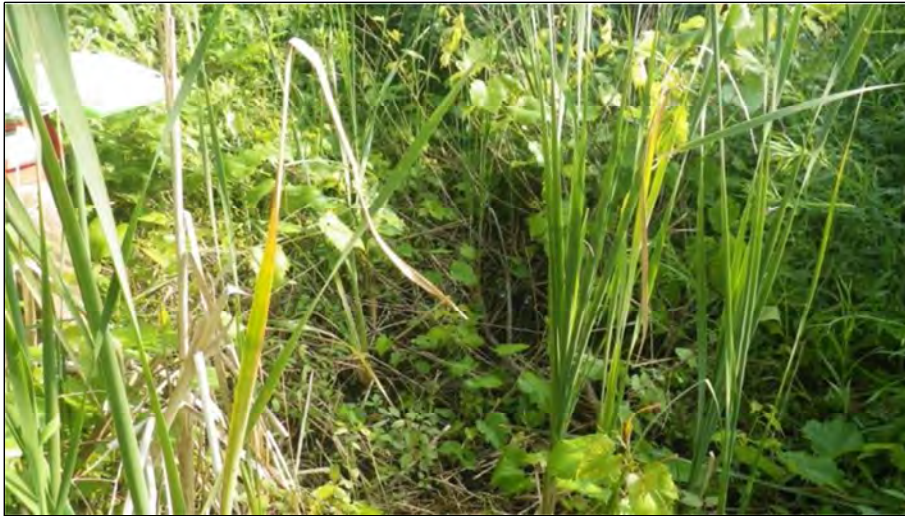
143. W -T1 -2b (Segment 3). Downstream end of Segment facing upstream. Feature is densely vegetated with wetland vegetation (cattails), tall grasses, and deciduous trees. Feature type is swale and flow condition is no surface water.

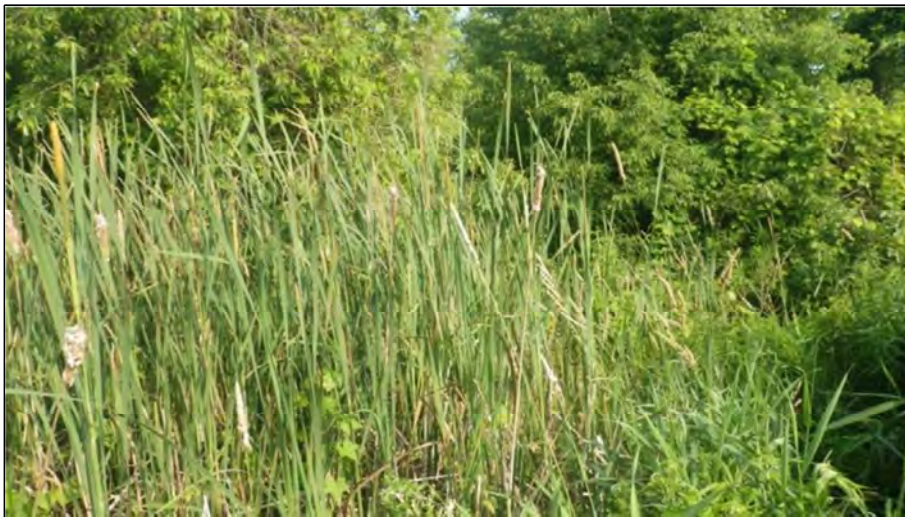
144. W -T1 -2b (Segment 3). Small depression noted within vegetation, no water noted. Feature type is swale and flow condition is no surface water.
