Phase I Environmental Site Assessment

Rinaldi Property Part of Lot 21, Concession 9 Halton Hills, Ontario

Project No : 19-025-100 Date: 2019-03-15

DS CONSULTANTS LTD.

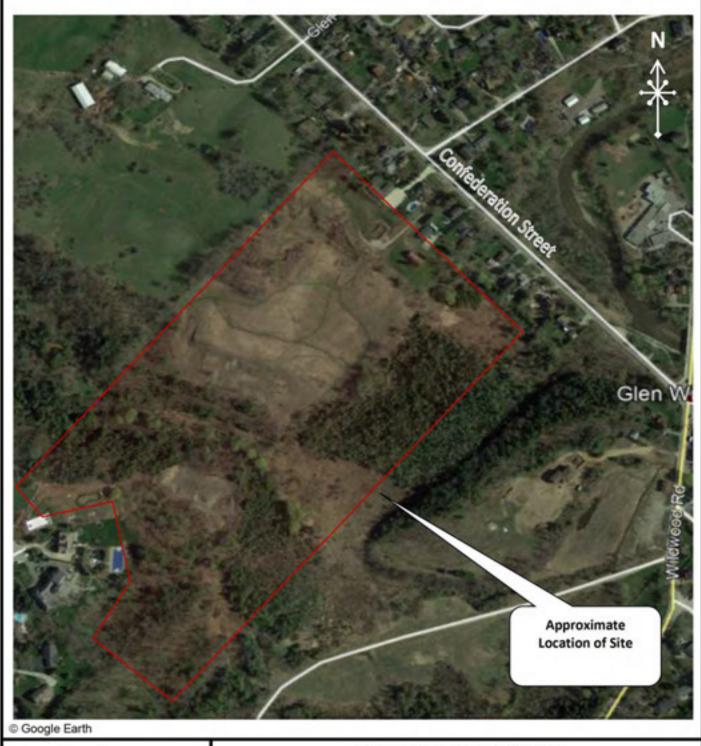
SATELLITE IMAGE: 2018			
	Scale:	PHASE I ENVIRONMENTAL SITE	Prepared By:	
	~1:4,600	ASSESSMENT	TL	
i221 Highway 7	Date:	Part of Lot 21, Concession 9, Town of	Reviewed By:	
	Mar-19	Halton Hills, Ontario	RF	
ghan, ON L4H 0K8	Project:	Prepared For: Urbantech Consulting	Drawing No.	
4-9393 F: 905-264-2685	19-025-100		D-5
