Terraprobe

HYDROGEOLOGICAL ASSESSMENT WEST HALF LOT 21, CONCESSION 9 (ESQUESING) GLEN WILLIAMS, ONTARIO

File No. 1-18-0438-46
November 7, 2019
© **Terraprobe Inc.**

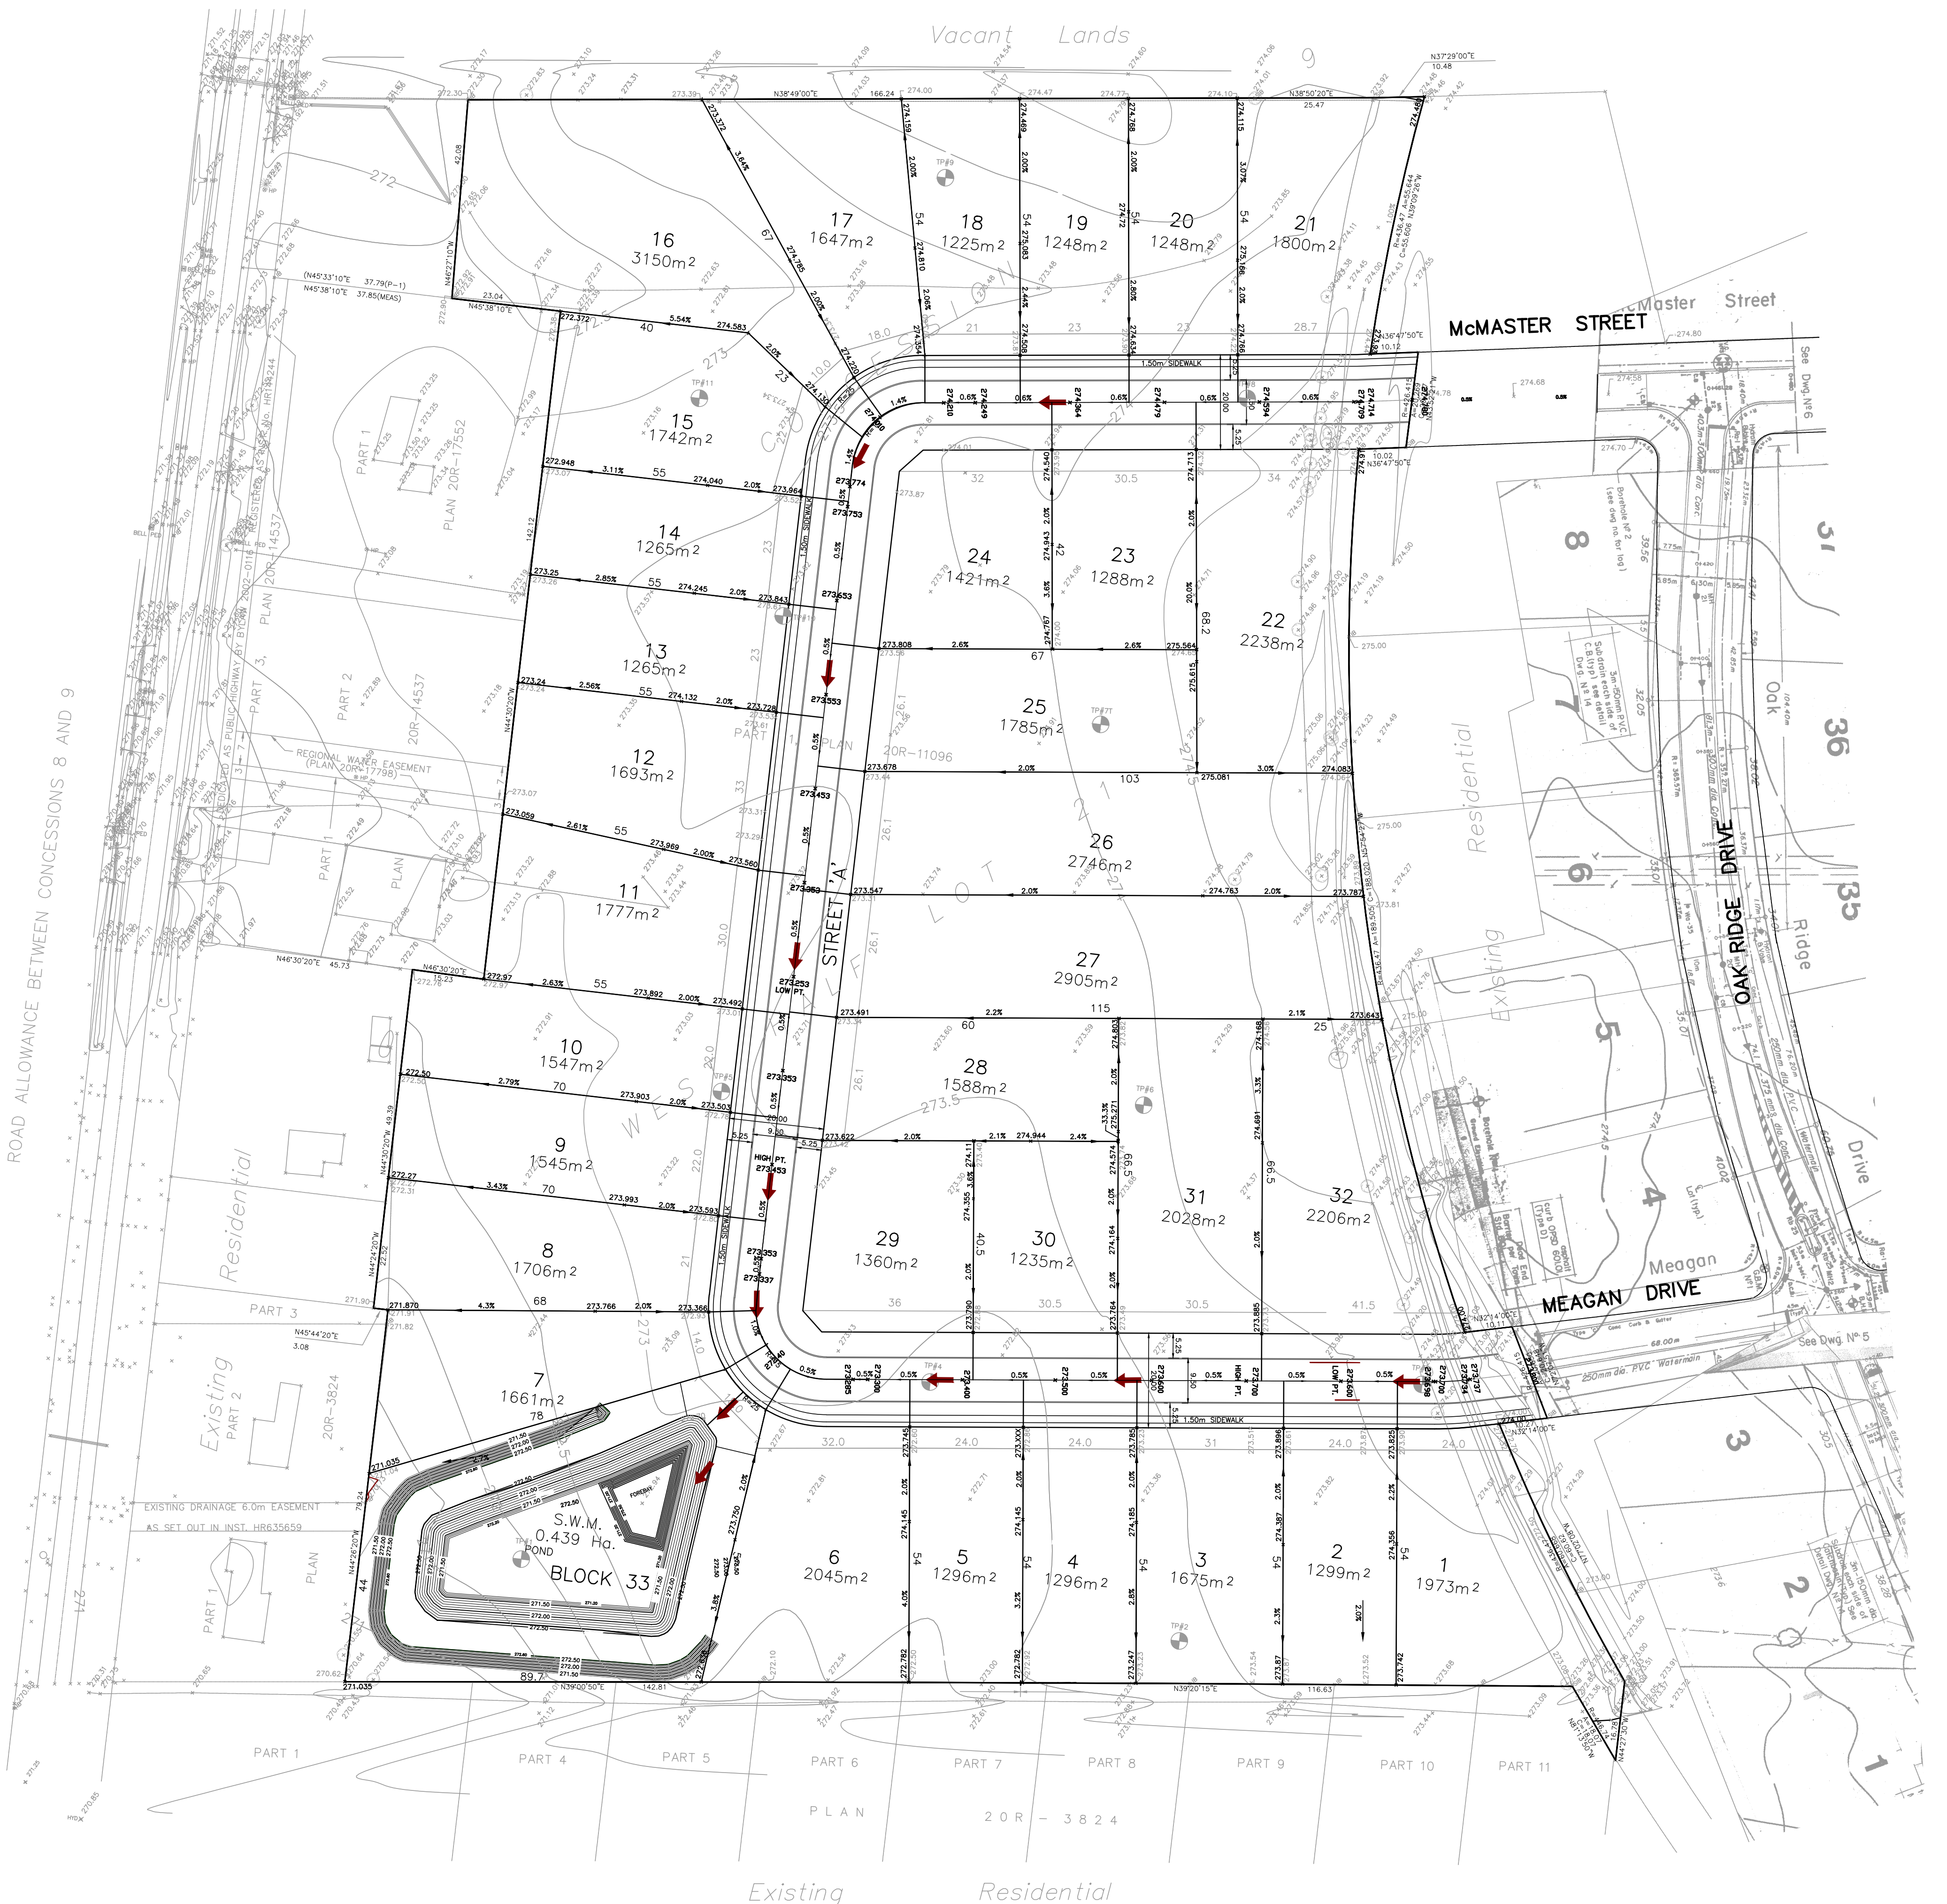
DESIGNED BY: D.O.H.	DATE: AUGUST 2018	CHECKED BY: MEH.
DRAWN BY: MA.	FIGURE 4	TOWN FILE
SCALES HOR 1/500	080215-04 Sheet 04 OF 17

CONCEPTUAL GRADING PLAN

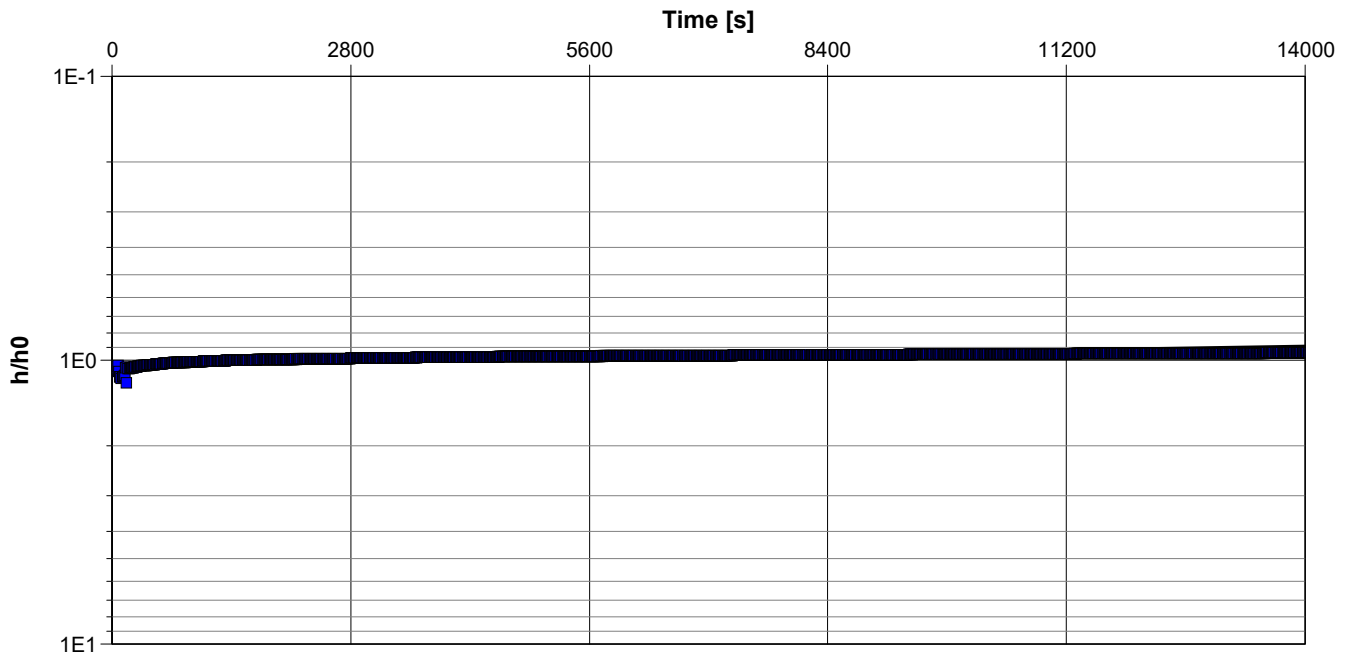
Location: Glen Williams, ON	Slug Test: Rising Head Test BH3S	Test Well: BH3S
Test Conducted by: BR		Test Date: 11/2/2018
Analysis Performed by: SAA	Single Well Response Test	Analysis Date: 12/21/2018
Aquifer Thickness: 2.30 m

Calculation using Bouwer & Rice

Observation Well	Hydraulic Conductivity [m/s]
BH3S	3.68×10^{-8}
