Appendix F
Stream Morphology

APPENDIX A
Field Data Summaries

Project: Premier Gateway SWS: HT-1 Detailed Site

APPENDIX B
Field Photograph Summary

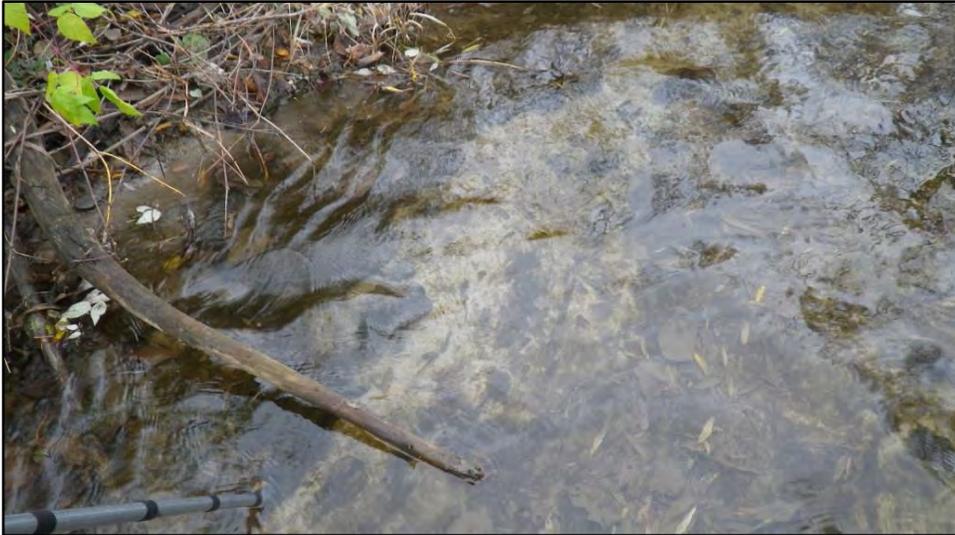
3. W-T1-3 Exposed clay on bed

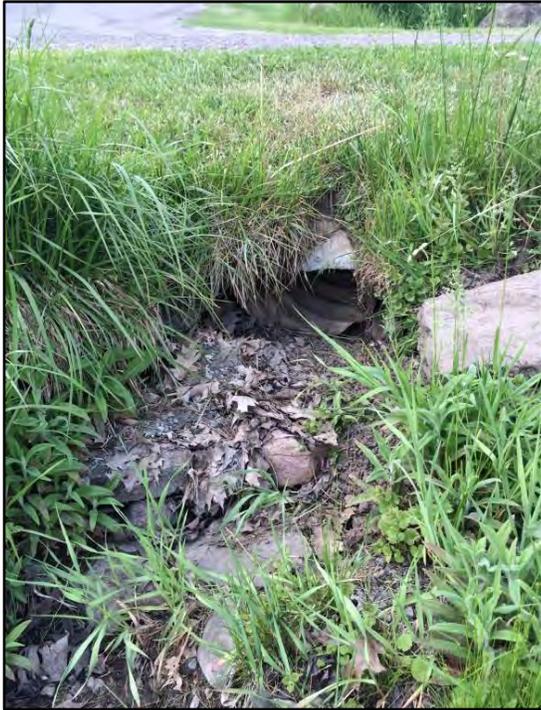
5. W-T1-2b CSP under driveway at far upstream end of reach.

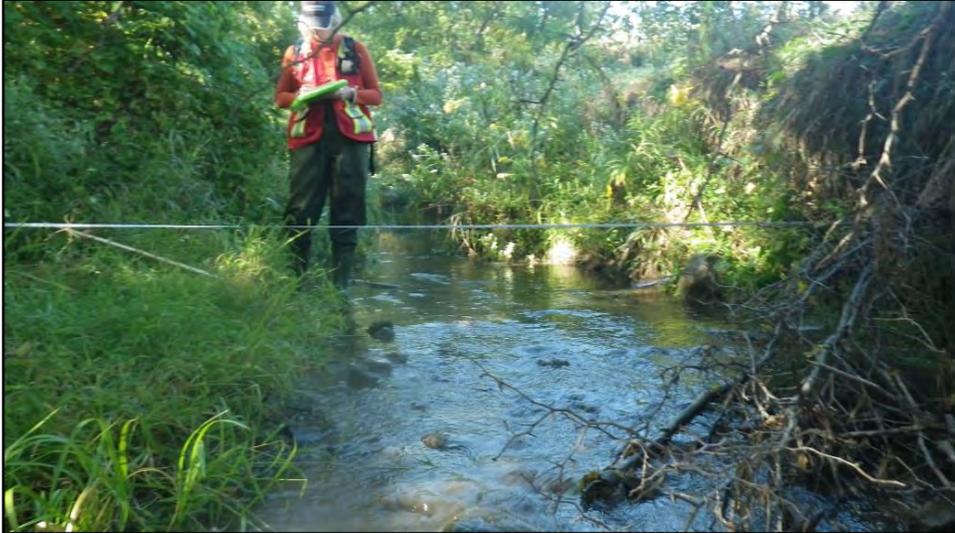
17. W-T1-2 Cross-section 3 facing upstream

LB has exposed clay
Lb vertical and overhanging veg
RB has low bank angle

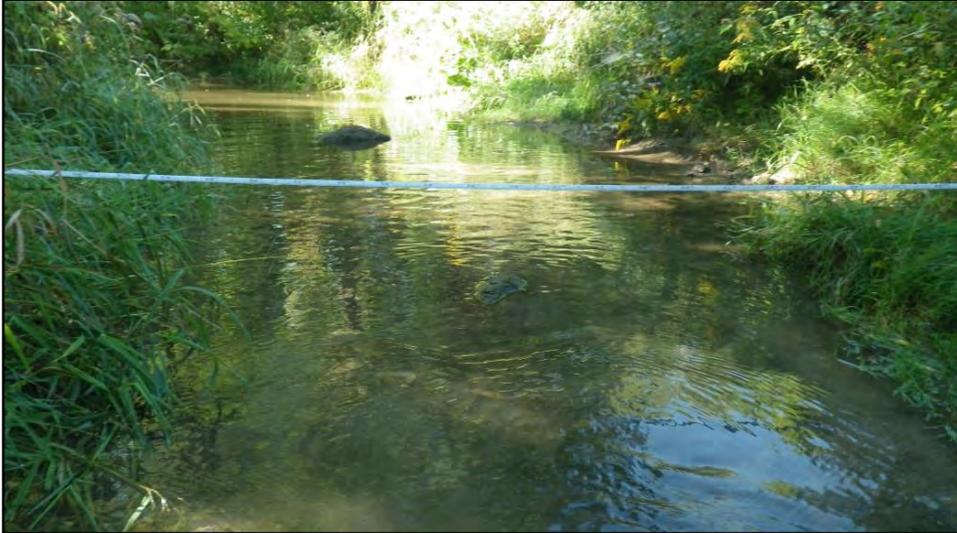
19. W-T1-2 Cross-section 4 facing upstream

LB has exposed clay along toe and bed
LB is vertical an slumped
RB has low bank angle

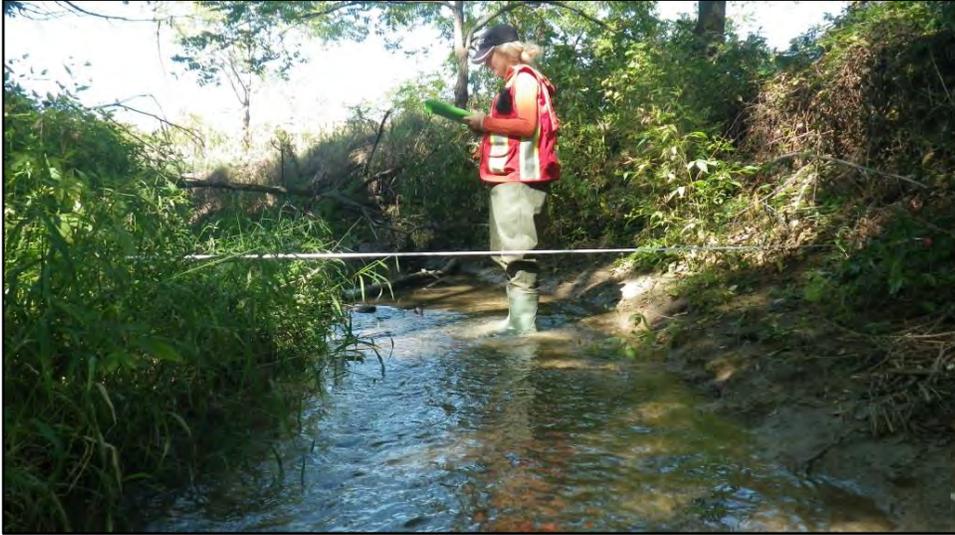
23. W-T1-2 Cross-section 6 facing upstream

RB has low bank angle
LB is eroded with vertical banks near the top of bank.
LB has exposed clay

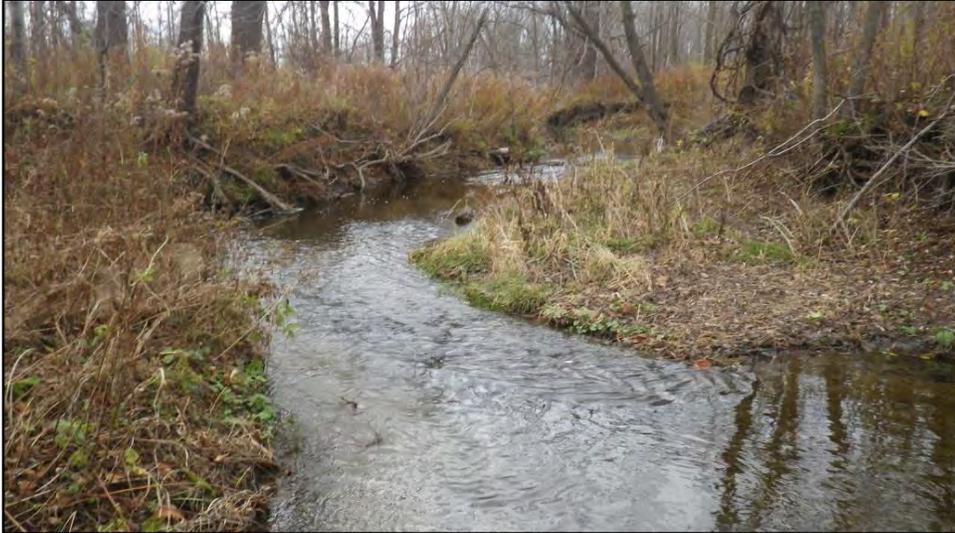
27. W-T1-3 facing downstream. Large vegetated lateral bars inducing sinuosity.

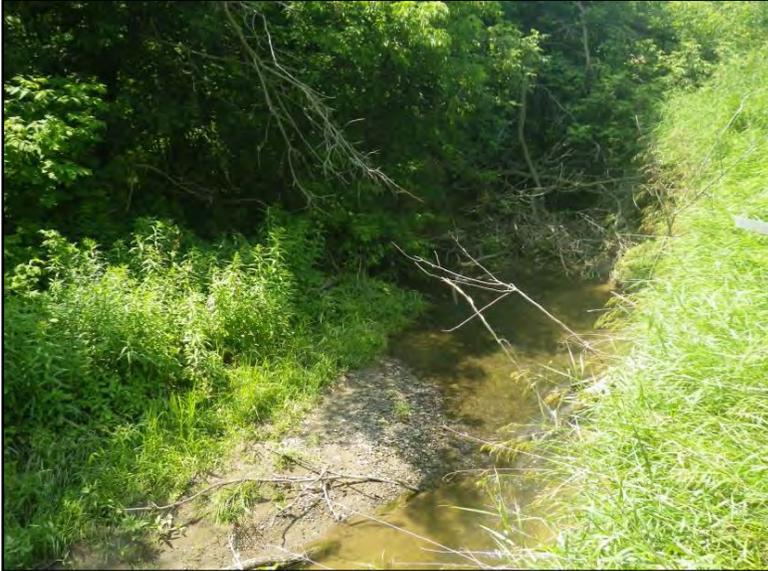
31. W-T1-2 gravel bar accumulation along inner bank.

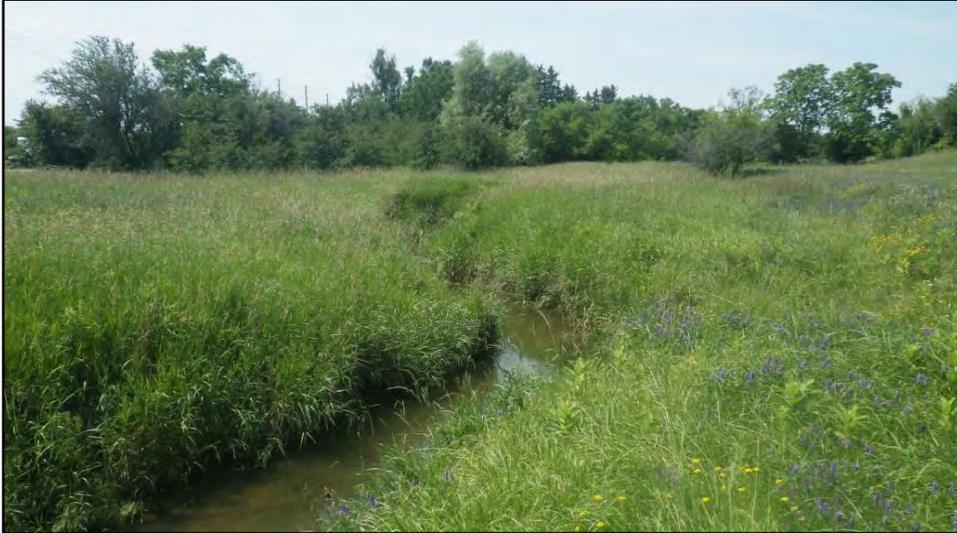
33. W-T1-1 Channel flows through dense meadow vegetation.

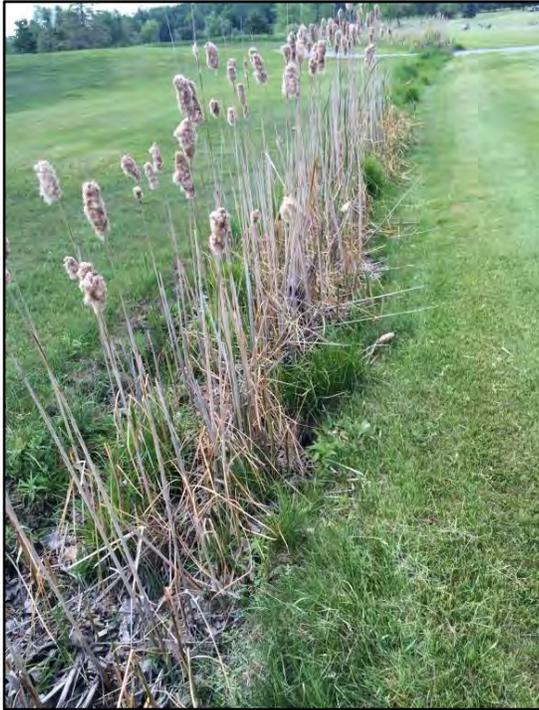
35. HDF-3 channel with cattails in channel and manicured lawn banks.

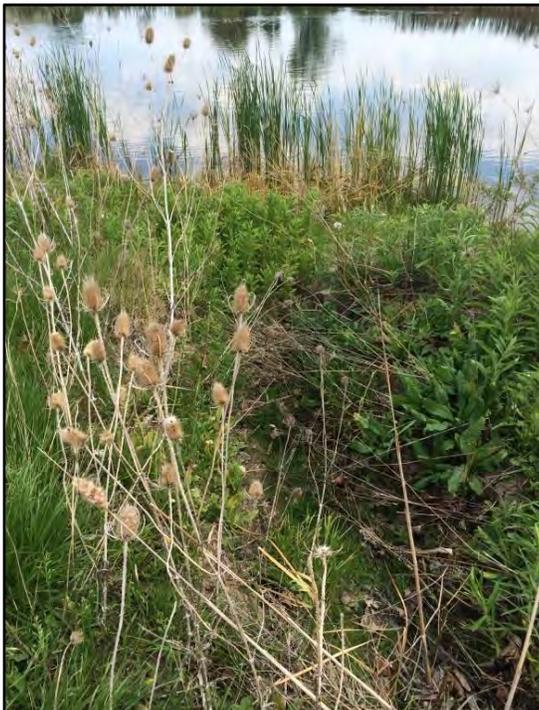
36. HDF-3- channel confluence into pond.

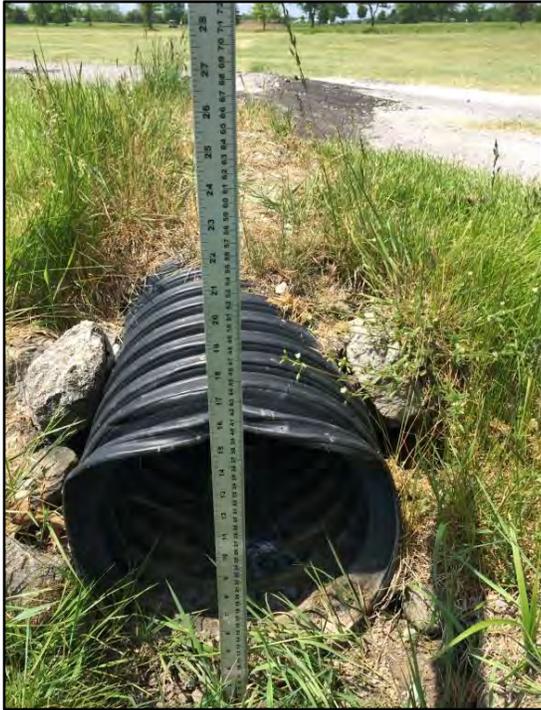
37. HDF-4 culvert under golf course trail.

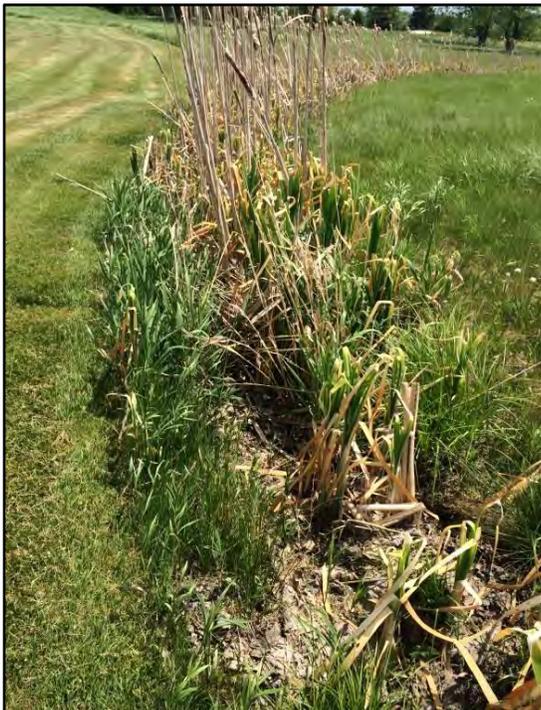
38. HDF-4 dry channel dry at time of photo.

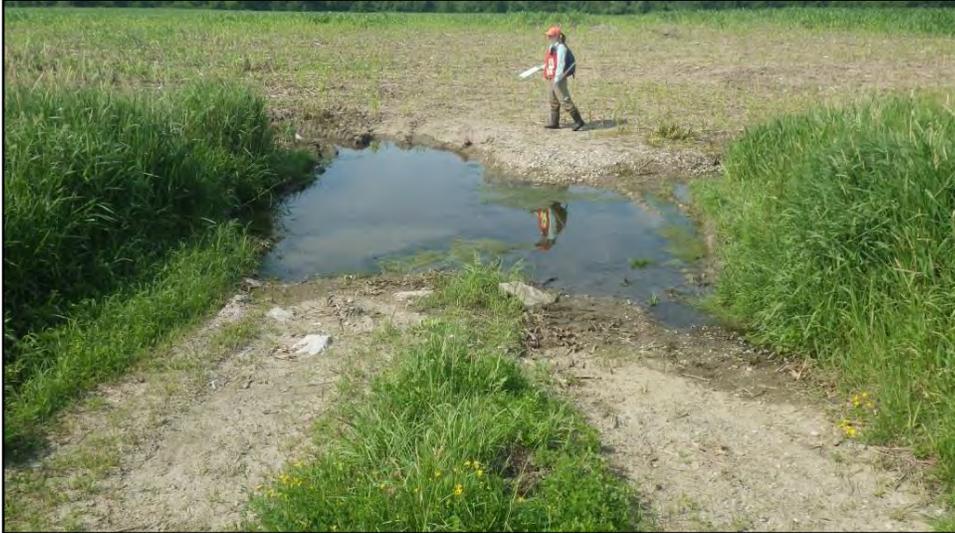
39. HDF-1- poned area at farm lane.

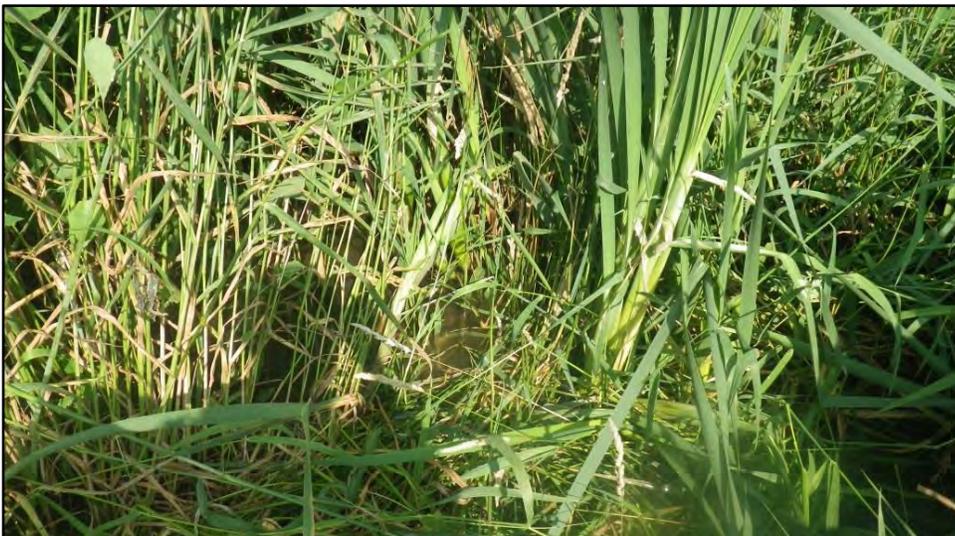
40. HDF-1- Stagnant water located in grass channel undefined.

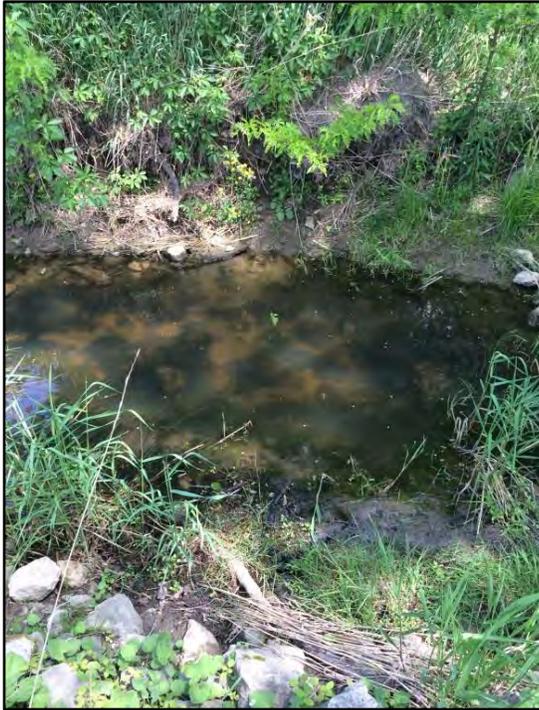
42. E-T1-4 Standing water in trapezoidal shaped channel at downstream extent of RGA/RSAT analysis

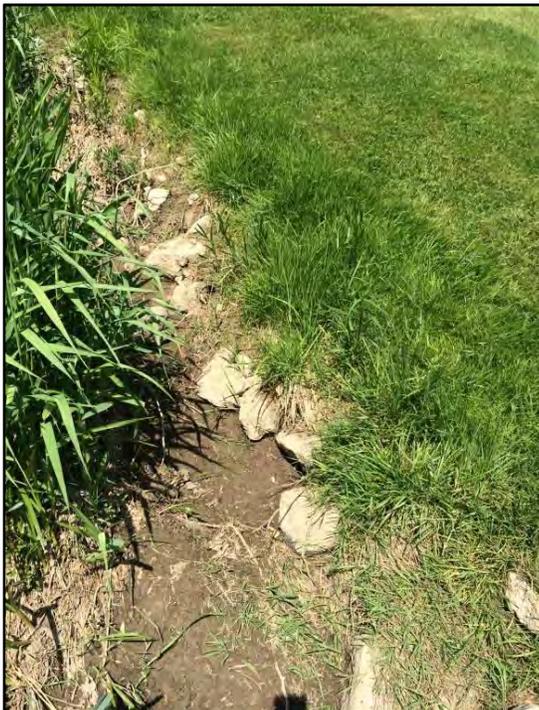
43. E-T1-4 Channel is dry and armoring placed along left bank placed to prevent erosion along fairway boundary.

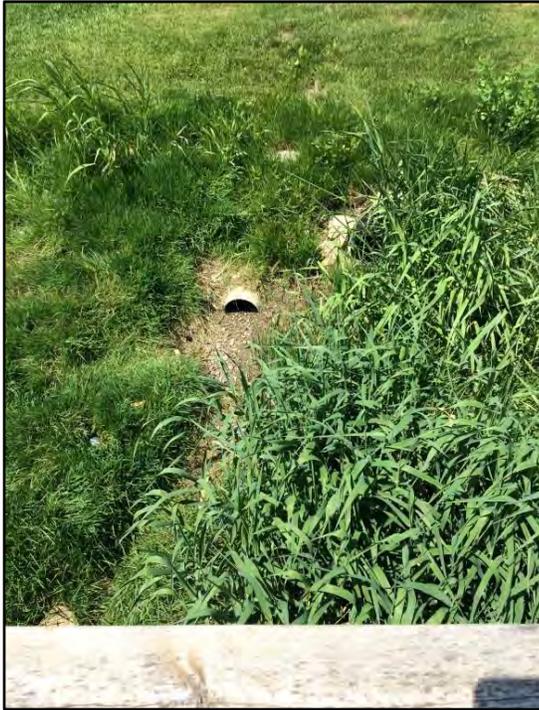
44. E-T1-4 Channel alternates between being piped under golf course fairways (as seen in this photograph) and being a grassed trapezoidal channel.

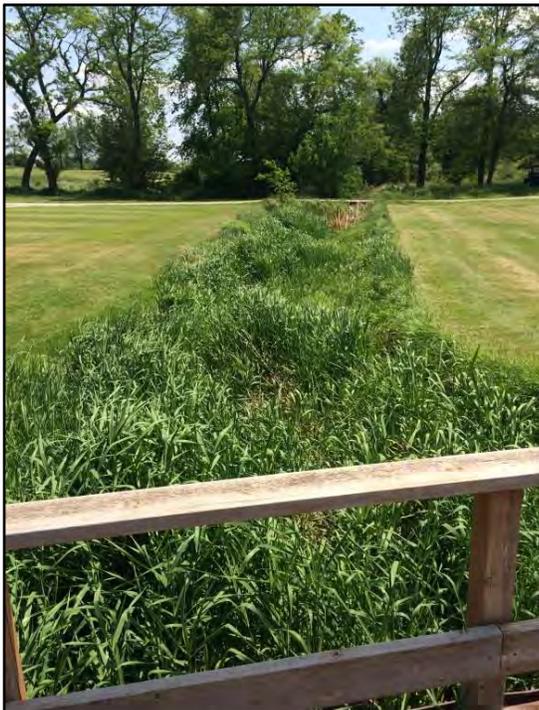
45. E-T1-4 Channel alternates between being piped under golf course fairways and being an intermittent grassed trapezoidal channel (as seen in this photograph).

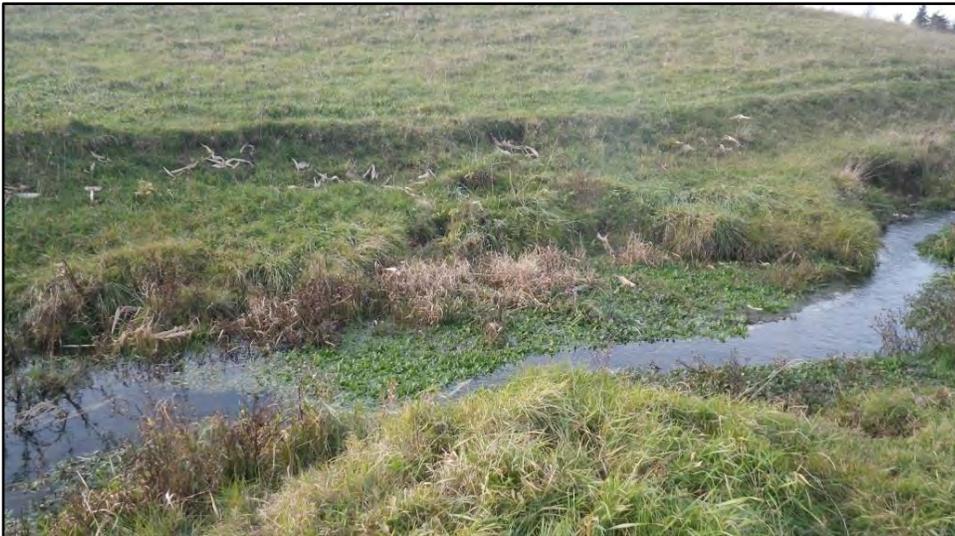
57. E-T1-2 Channel wetted width varies throughout reach.

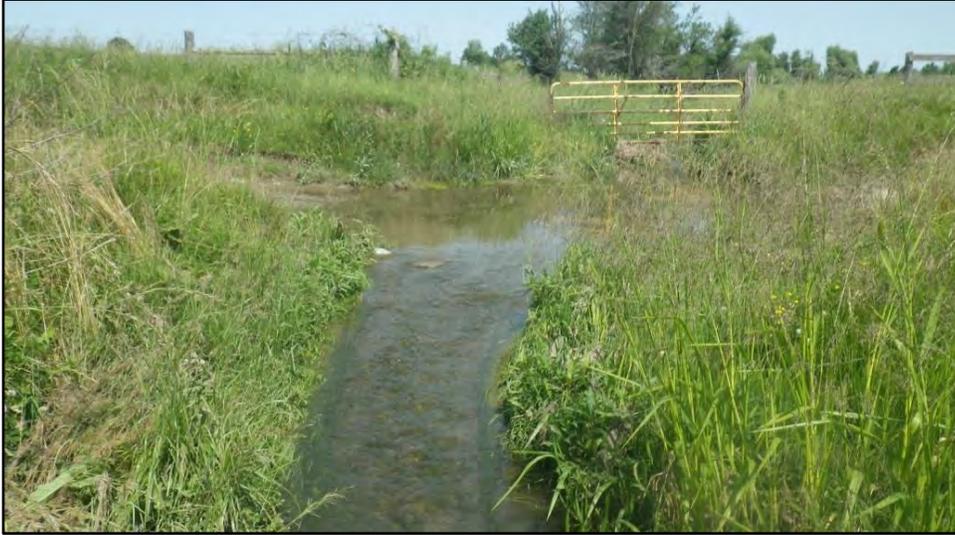
60. E-T1-1 Channel crossing farm lane with no CSP.

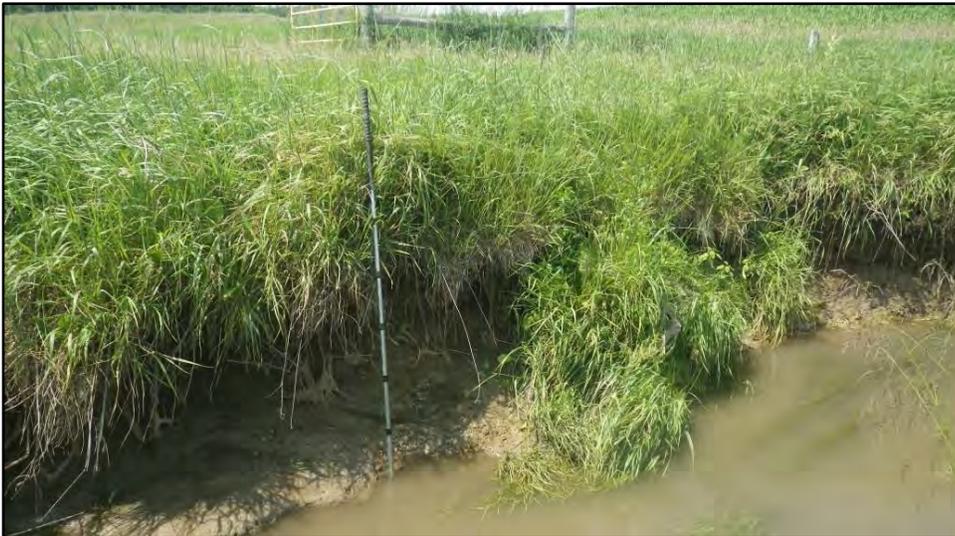
61. E-T1-1 Active erosion and undercutting on outside bend of reach downstream of farm lane.

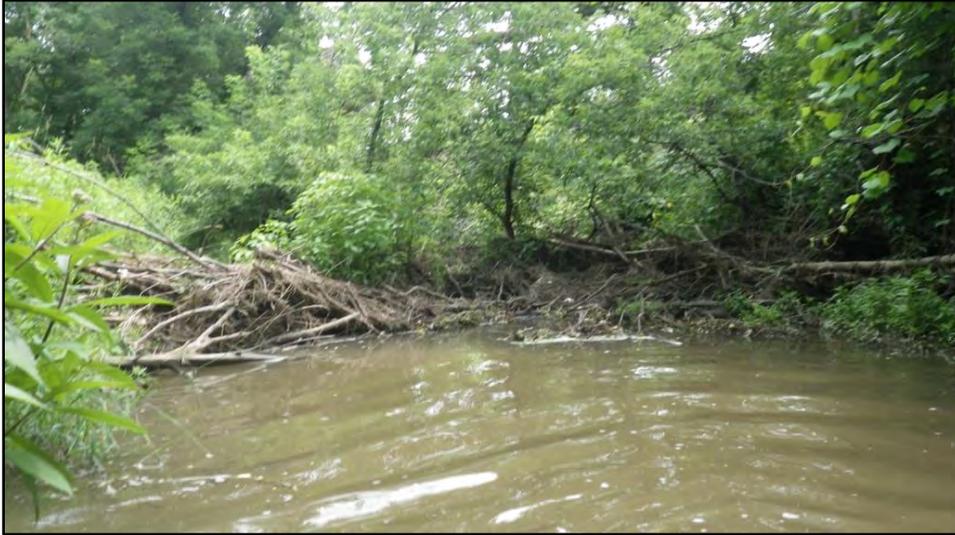
63. T1 Woody debris jam.

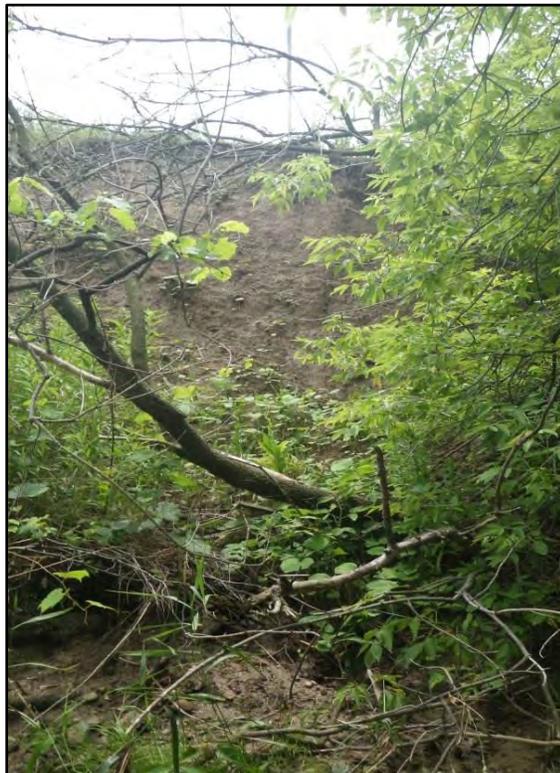
64. T1 Erosion being experienced on embankment that meets road. Some places embankment has become concave (not shown in photograph).

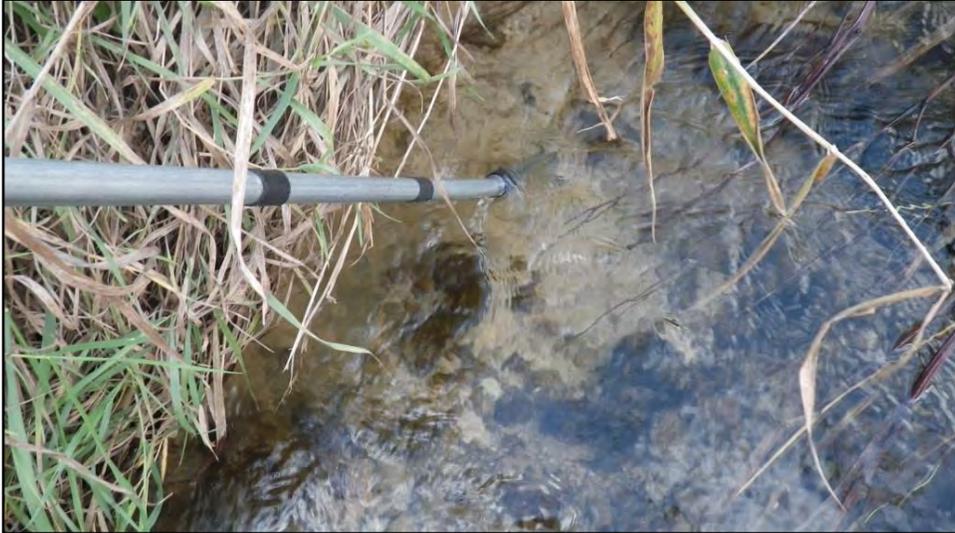
70. HT-2a-1 Exposed clay along bed at toe of bank.

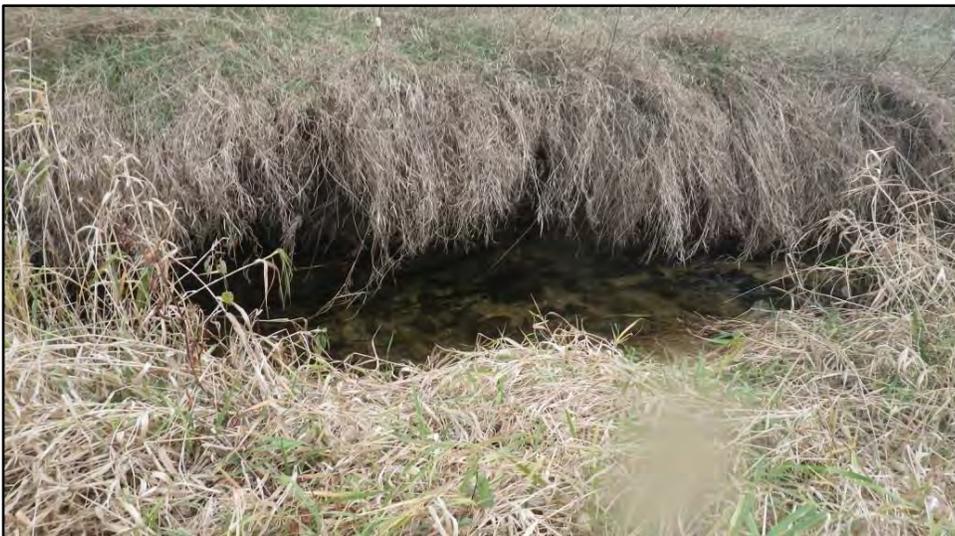
71. HT-2a-1 Severe undercutting on bank with overhanging vegetation.

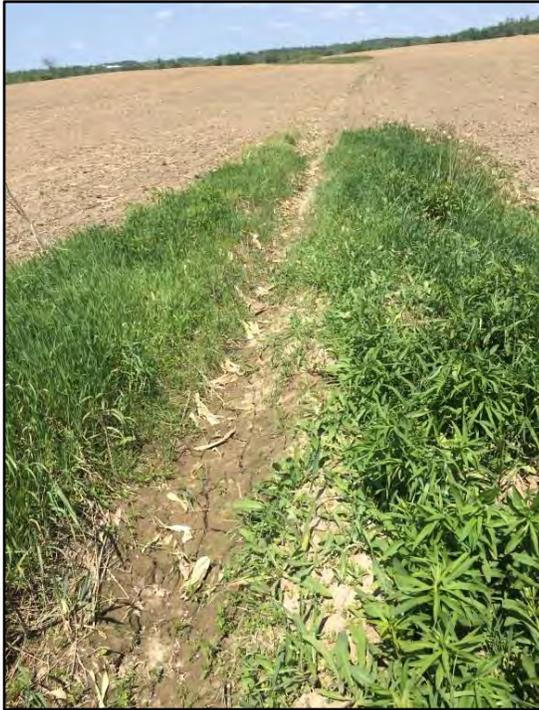
72. HT-2b-3 Dry at time of visit, localized depression on an agricultural property.

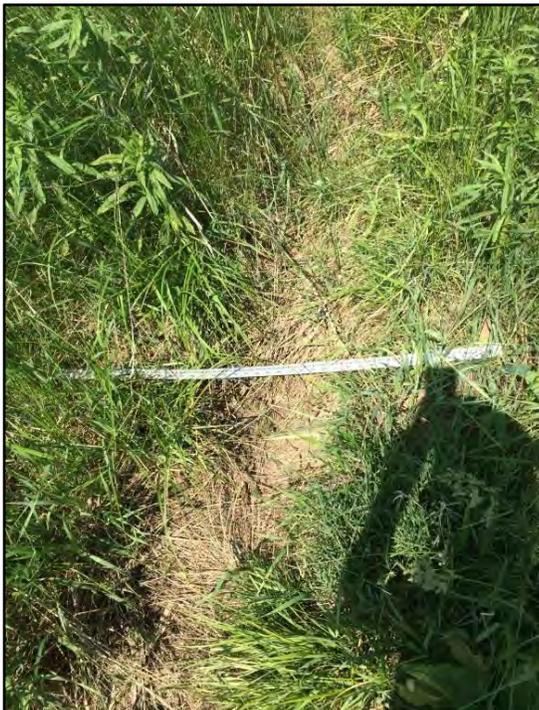
73. HT-2b-3 Depression is approximately 0.5m in width and 0.15m in depth.

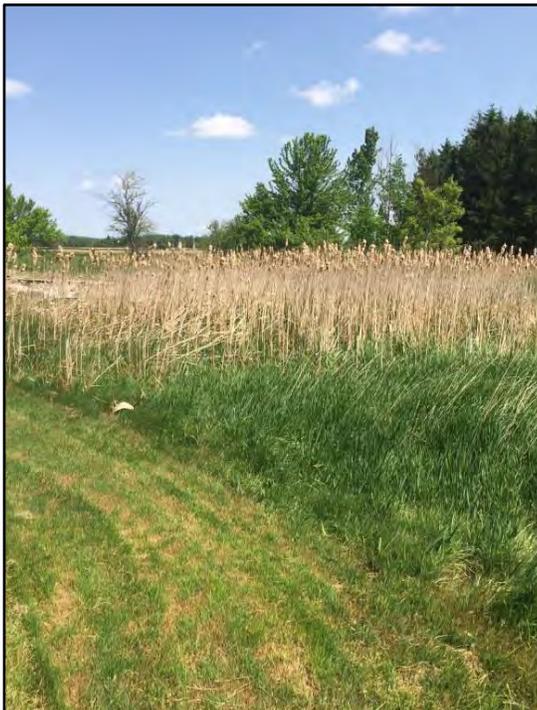
75. HT-2b-2 Feature disperses into cattail marsh.

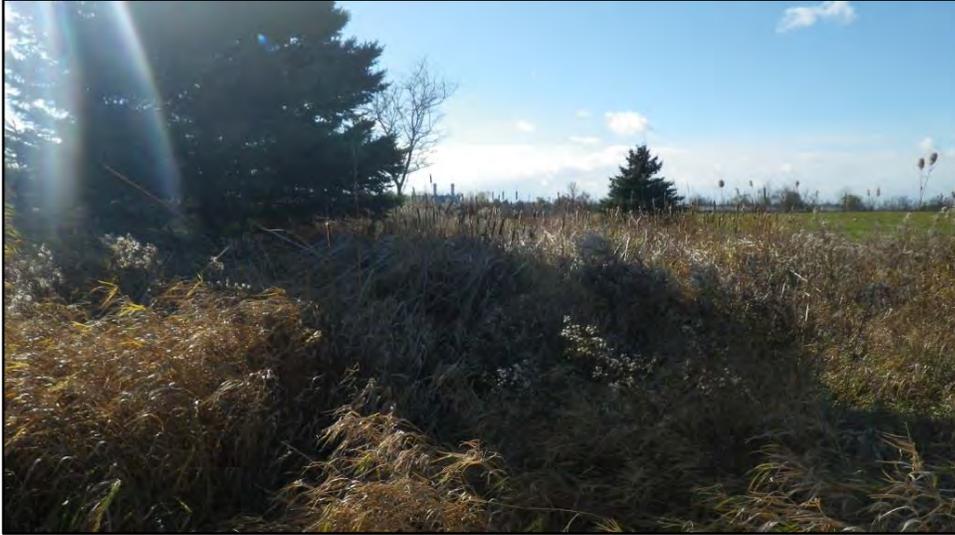
78. HT-2b-1 Channel becomes undefined through cattail patch.

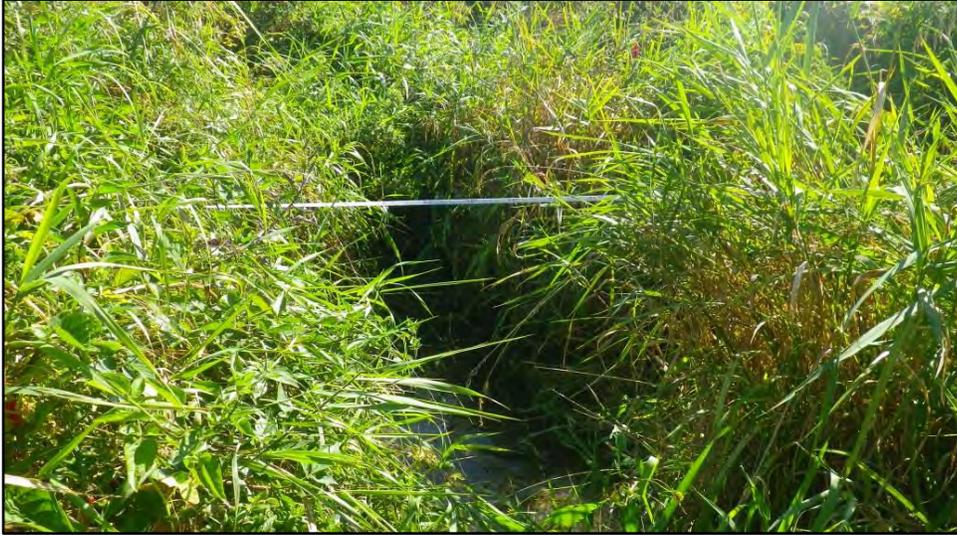
99. HT-1 Cross-section 4 facing upstream

left bank is terraced

xs is in apex of meander bend

heavily vegetated banks

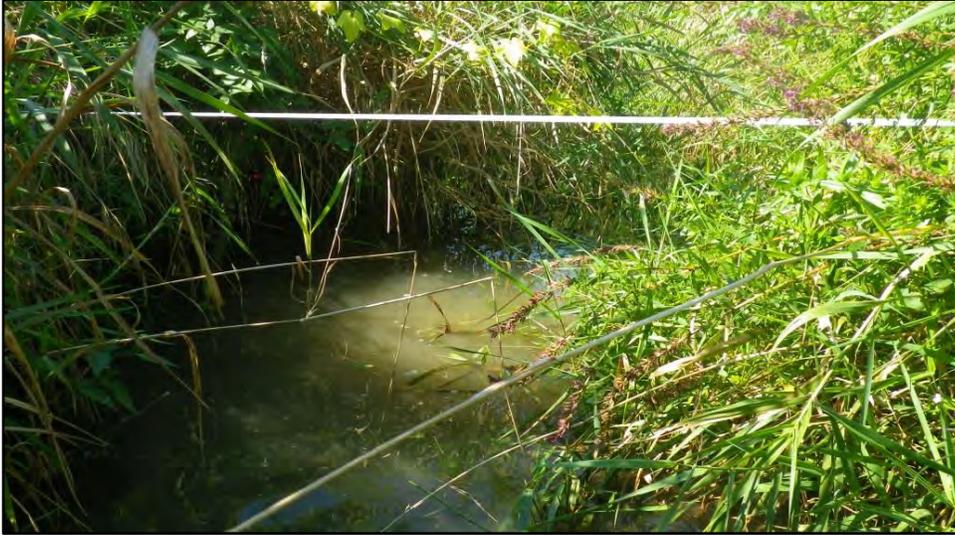
101. HT-1 Cross-section 6 facing upstream

LB is slumped 30cm U/S

substrate is unconsolidated

xs is in apex of meander bend

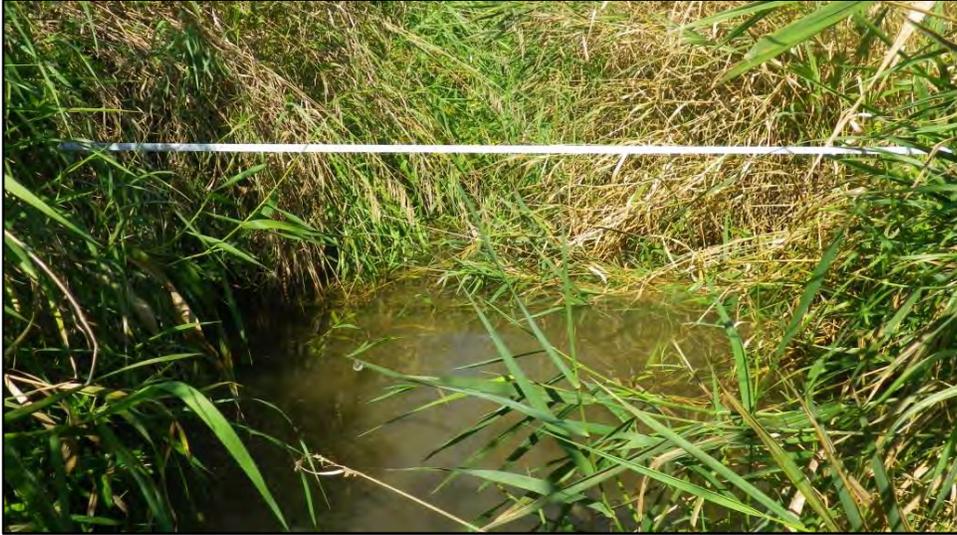
103. HT-1 Cross-section 7 facing upstream

LB is slumped

substrate has coarser gravel, cobbles with silt overlay

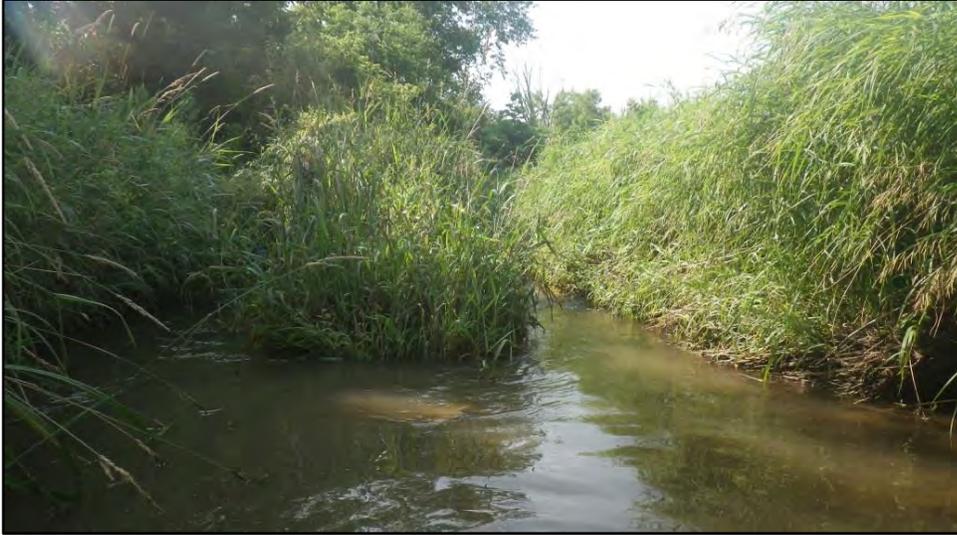
105. HT-1 Material that has slumped off bank has created island causing the flow to split.

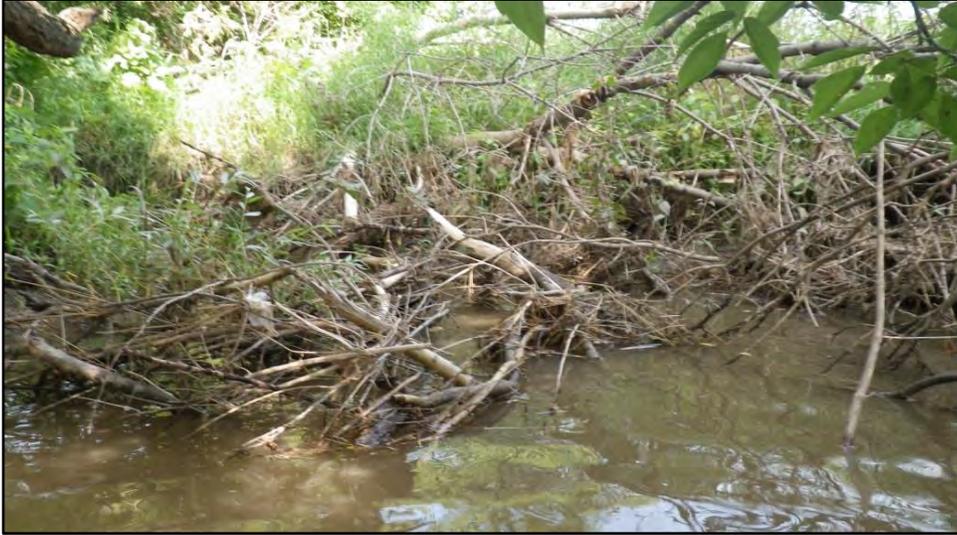
107. HT-1 Woody debris causing obstacles for regular flow patterns.
