CULTURAL HERITAGE IMPACT ASSESSMENT

PROPOSED MCGIBBON CONDOMINIUM PROJECT  
69 MAIN STREET SOUTH, 71-77 MAIN STREET SOUTH, 79 MAIN STREET SOUTH, AND 94-96 MILL STREET,  
FORMER ESQUESING TOWNSHIP, HALTON COUNTY  
COMMUNITY OF GEORGETOWN, TOWN OF HALTON HILLS, ONTARIO

ASI File: 15TS-266

February 2016

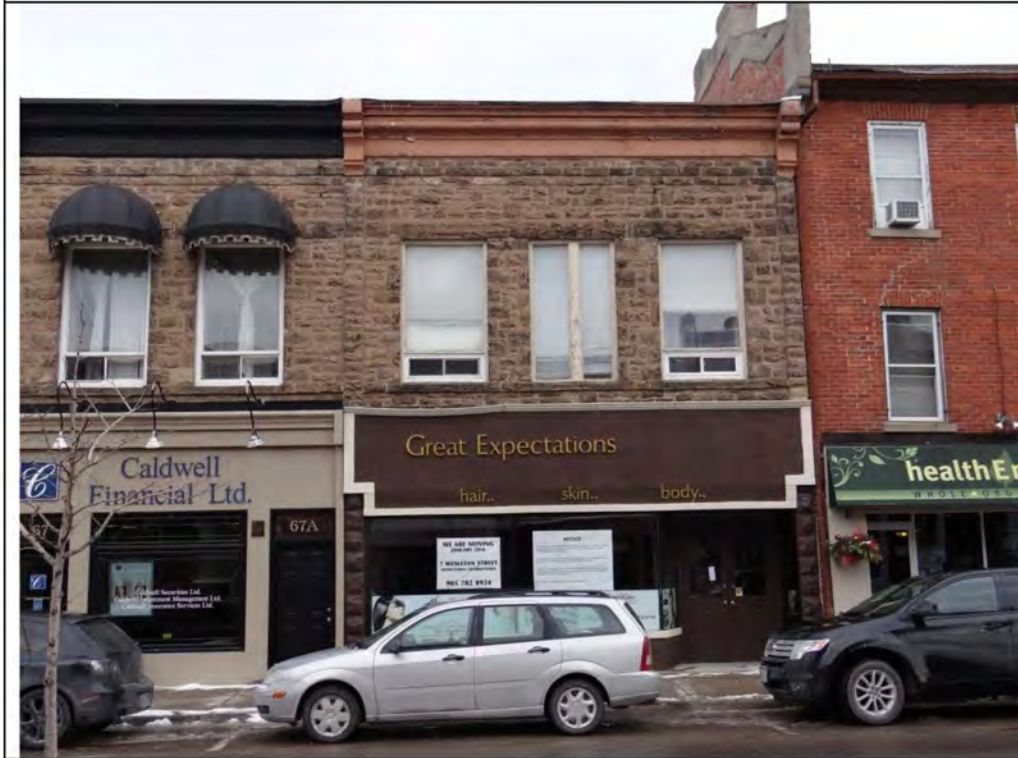
Plate 1: West elevation of 69 Main Street South, looking east.

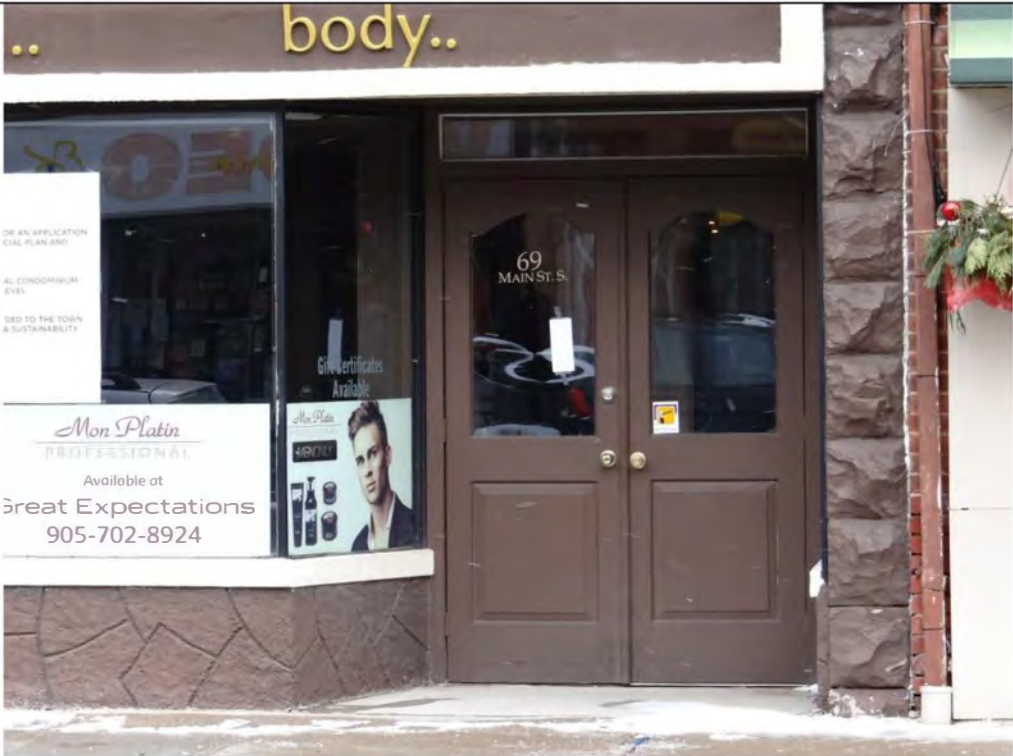
<p>Plate 4: Detail of recessed entryway and large windows on the west elevation of 69 Main Street South, looking east.</p>

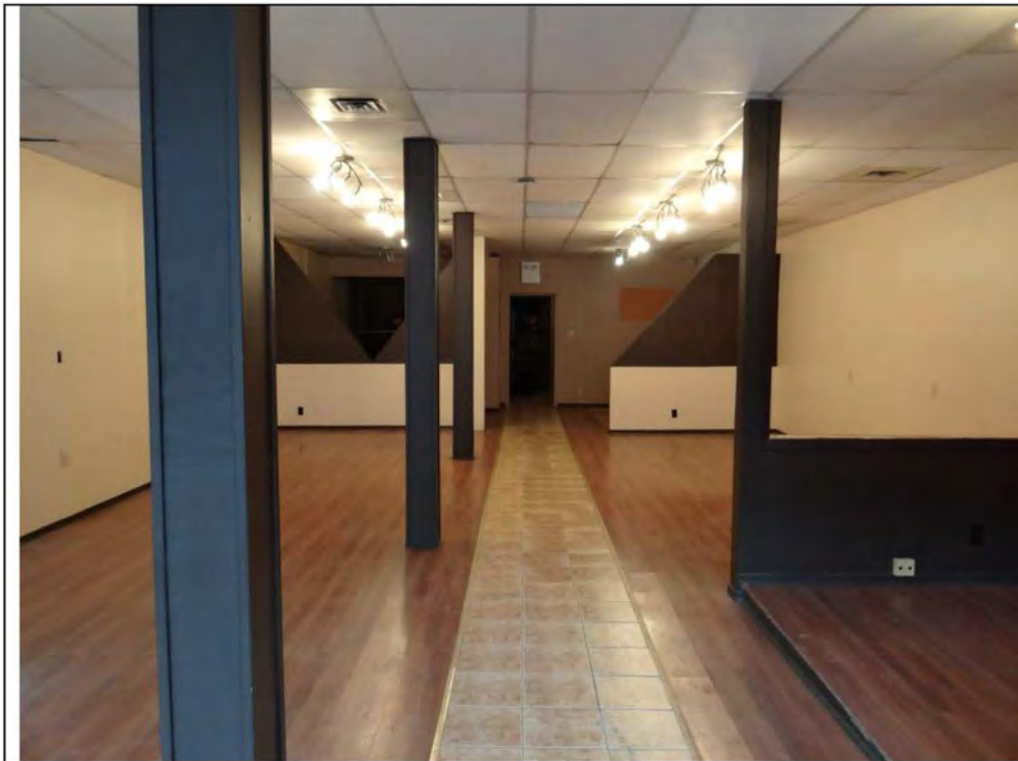
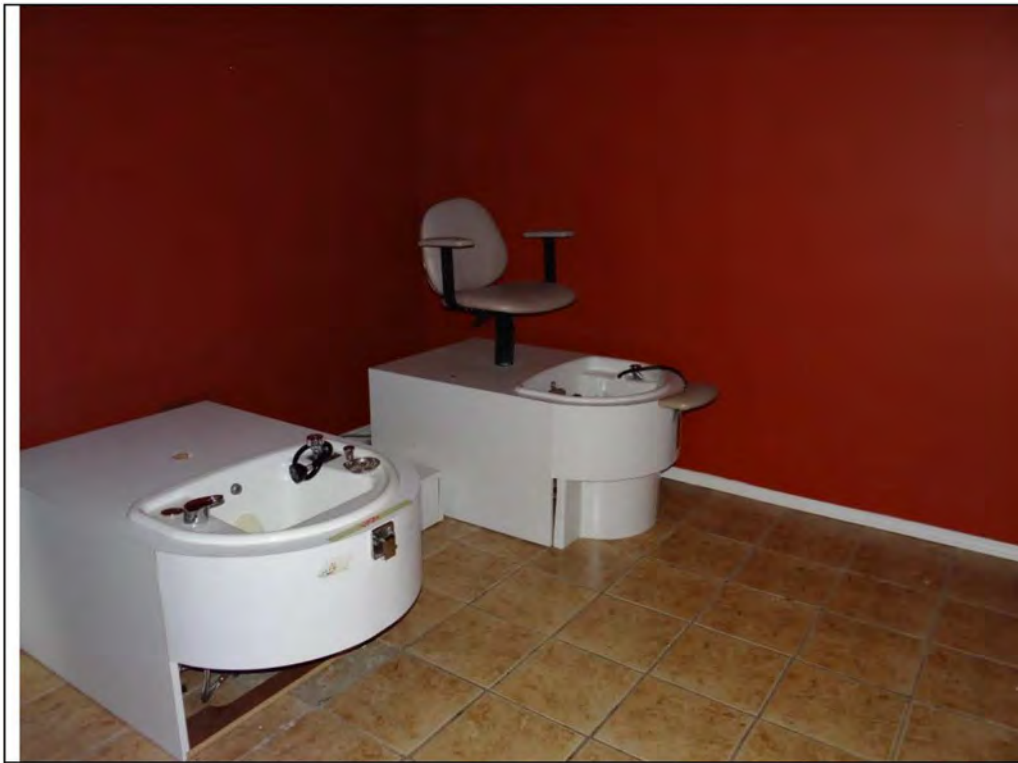
The interior of the original structure has been heavily modified from its original construction and was most recently used as a salon and spa. The interior was completely renovated within the past 20-30 years, leaving no visible heritage elements. Stamped tin ceiling tiles are visible above two successive modern dropped ceilings composed of gypsum tiles on the main floor. These tin ceiling tiles are still visible in-situ on the original ceiling above the modern drop ceiling tiles, and likely represent one of the earlier phases on the buildings use (Plate 8). The floor plan includes a reception area and hair salon area at the front, with spa facilities in the rear (Plates 9-11).

Plate 9: Interior of former salon at 69 Main Street South, looking east.

Plate 10: Interior of former salon at 69 Main Street South, looking west towards Main Street.

Plate 11: Detail  
spa facilities in  
69 Main Street  
South.

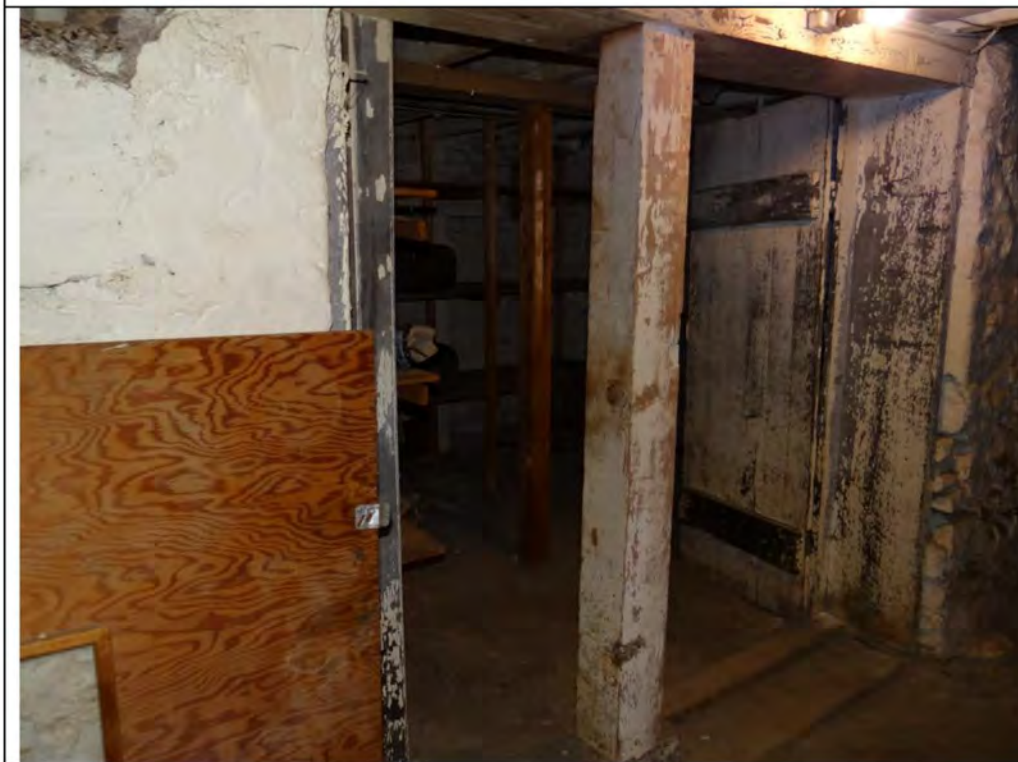
Plate 14: Wooden support posts in the basement of 69 Main Street South.

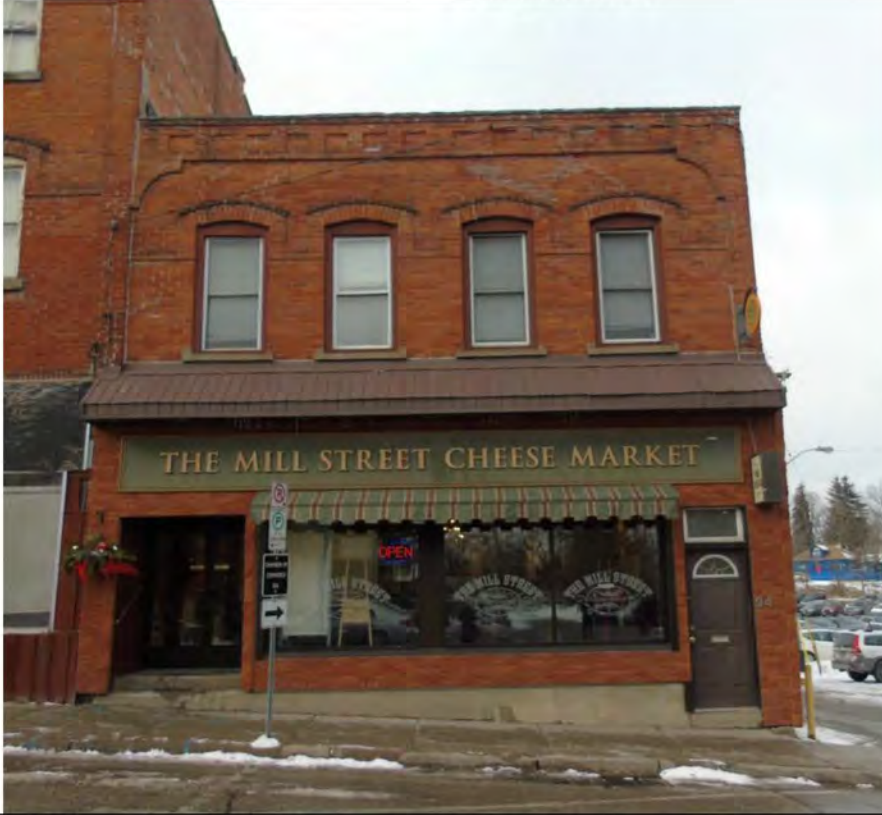
Plate 17: South elevation of the structure at 94-96 Mill Street, looking north.

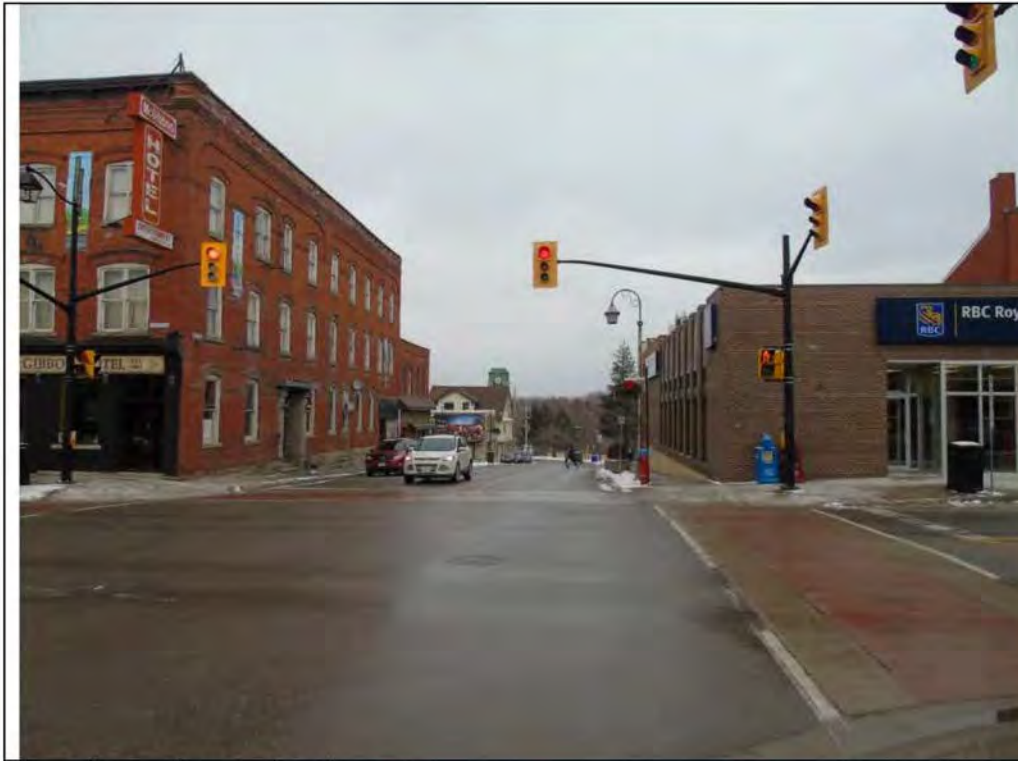
Plate 75: View from the intersection of Main Street South and Mill Street, looking east on Mill Street.

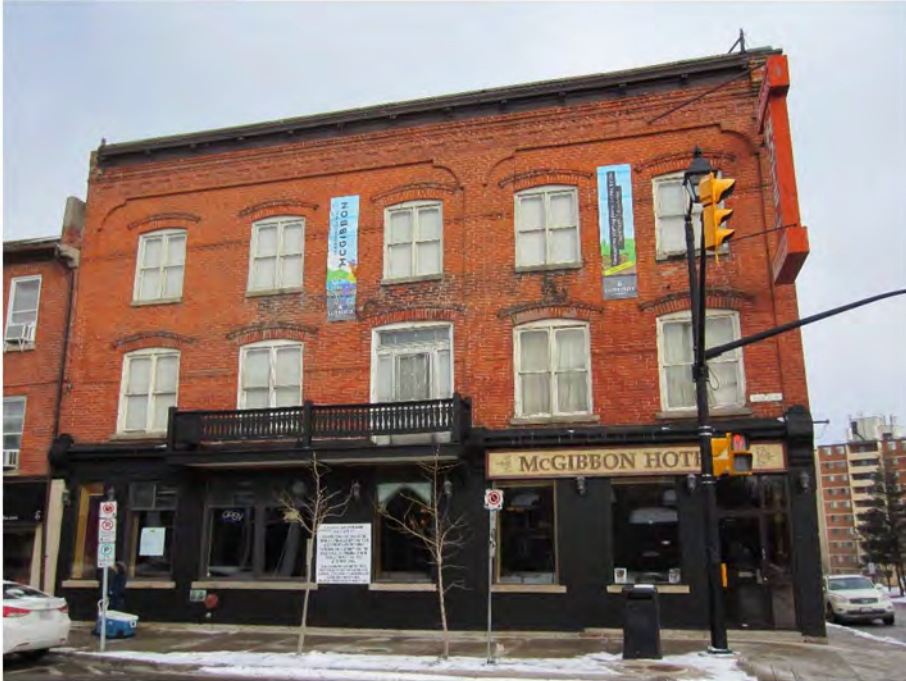
Photo #1: Front of the building (on Main Street South)
